Providing information to the Port and Harbor Subcommittee of the Transport Policy Council

NEGI Takashi, Head
 KUMAGI Kentaro (Dr. Eng.), Senior Researcher
 WATANABE Yuji, Research Engineer

Coastal and Marine Department, Coastal Disaster Prevention Division

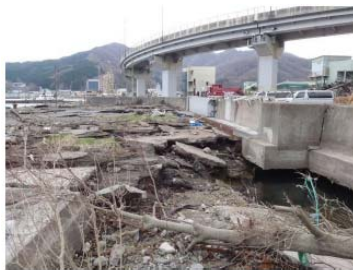
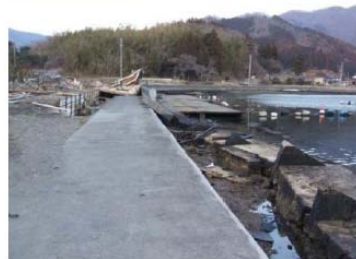
Photo 1. View of Damage to a Seawall (by the Backwash)

Taking damage to seawalls (and other shoreline protection structures) as an example, it provided photos taken during field surveys, hypothesized damage mechanisms, and presented problems with stability during backwash and the severe impact of scouring by the flow during overflow and return flow.

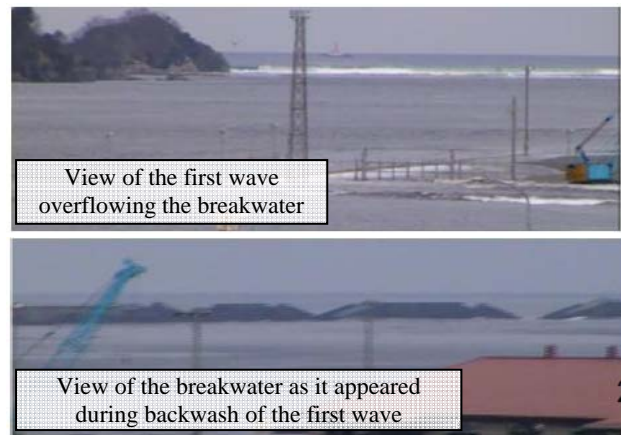
For breakwaters, it proposed presentations based on photos captured from videos, permitting the presentation of the state of functions of a breakwater when the first wave stuck.

Photo 2. Presentation Using Photos Captured from a Video
