Survey of Damage to Road Bridges by the Bohol Island Earthquake in the Philippines

MABUCHI Toshiaki, Senior Researcher

Earthquake Disaster Prevention Division, Research Center for Disaster Management

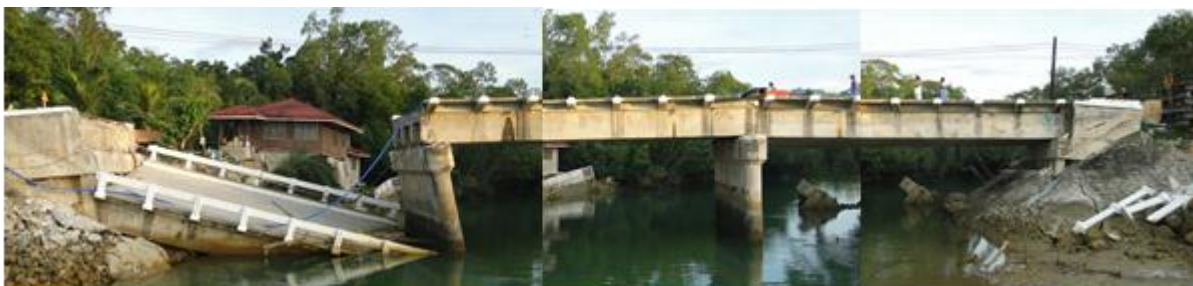
Damage to road bridges occurred on the west side of the roads running around Bohol Island. We investigated 16 bridges during the survey period. The photo shows the collapsed Moalong Bridge. The deformation in the surrounding ground caused the abutment and intermediate abutment to tilt. The bridge girder then collapsed because of the shortened girder seating. In many other affected bridges, damage resulting from the movement of the abutment due to the subsidence of surrounding ground was seen.

Photo: Damage to Moalong Bridge (Built in 1982)

Such form of damage was also seen in the 1990 Luzon Earthquake¹⁾. It is, therefore, necessary to take seismic improvement measures including the seismic design of substructure, and bridge collapse prevention measures, according to ground conditions.
