Extent of Damage to Buildings Caused by the Flooding of the Kinugawa River in the City of Joso, Ibaraki Prefecture, on September 10, 2015

(Keywords) Flooding of the Kinugawa River, City of Joso, investigation of flood damage

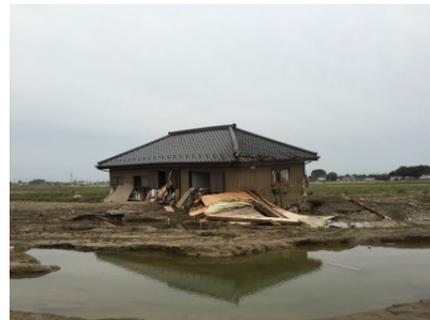
Photo 1. Wooden residential house whose structural frame was heavily damaged and washed away

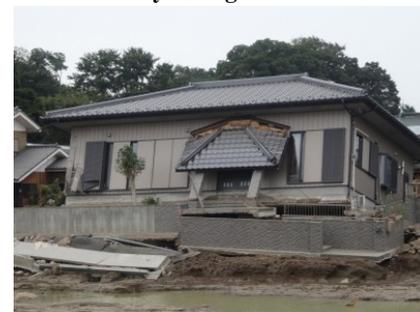
Photo 2. Wooden residential house with the ground of its premises scoured
