# Prevention of the Recurrence of Disasters in Revetments of Small-and-medium-size Rivers

(Study period: Fiscal 2015 and 2016)

SUWA Yoshio, Head, FUKUSHIMA Masaki (Dr. Eng.), Senior Researcher, YAMAMOTO Yoko, Senior Researcher, SUZUKI Atsunori, Researcher, River Division, River Department

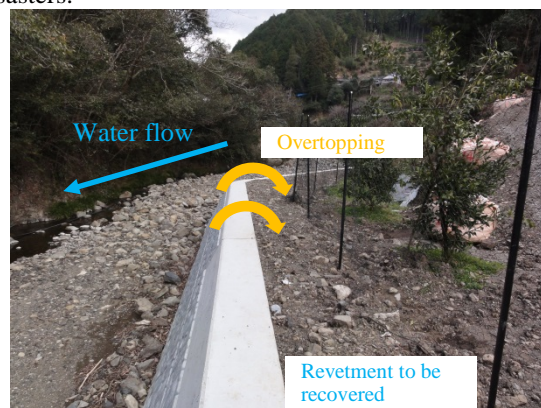
In one of the target rivers, there were a number of areas where the inner side of the bend, not the outer side of the bend, which constitutes the water colliding front. As a result of checking the site, the discharge capacity is not so large and disaster seemed to have occurred from the crown of revetment due to the rise

of water level in the event of a flood (Photo 1). Since the recovery work was conducted so as to connect with the existing dry masonry revetment of the upstream, if the dry masonry revetment suffers damage, the area may suffer damage again. In order to prevent the recurrence of disasters, when the revetment to be recovered is constructed so as to insert it to the stable area of the mountain side (base rock, etc.), it would be possible to prevent recurrence of damage to the revetment to be recovered even if the existing revetment suffers damage (Photo 2). Our Division intends to continue the survey on the situations of disasters in small-and-medium-size rivers and provide information to prevent recurrence of disasters.

Photo 1: Recovery from the damage in the inner side of the bend

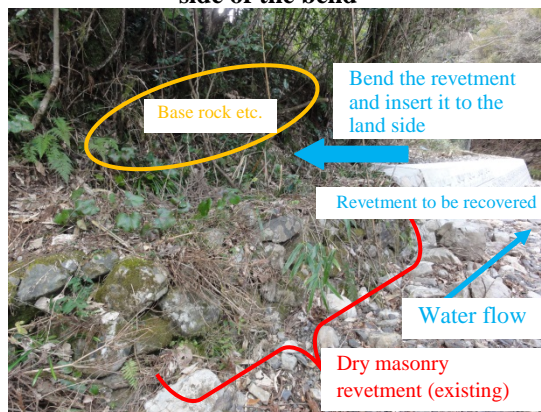
Photo 2: Proposal for recovery to prevent recurrence of disasters
