Joint Research on the Maintenance of Concrete Deck Bridges

(Research period: FY2018 to FY2021)

Road Structures Department, Bridge and Structures Division

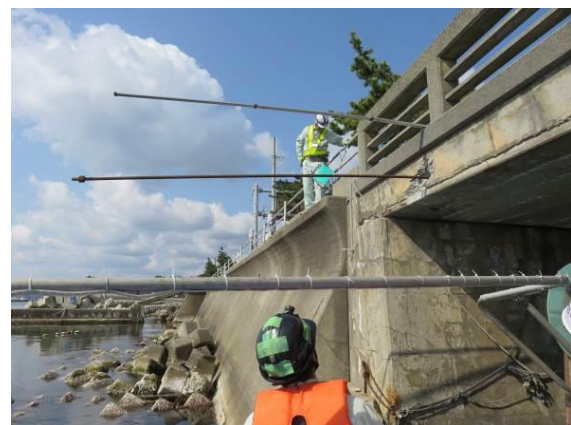
In recent years, among the deck bridges managed by the government, there have been cases of fracture or protrusion of the lateral fastening of PC steel due to corrosion in pretensioned deck bridges (**Photo 1**). At present, about 5,900 pretensioned deck bridges have been built, and as shown in the schematic diagram in **Fig. 2**, their structure consists of precast concrete members that were manufactured in factories and constructed on the site, and integrated using lateral-fastening PC steel.

Photo 1: Fracture / protrusion of lateral-fastening PC steel

and cast-in-place sections from the bridge surface, etc., but the lateral-fastening PC steel is usually protected by grout. However, if the filling is insufficient for some reason, the lateral-fastening PC steel will corrode and, in some cases, break. If the grout does not adhere sufficiently, the prestressing force released by fracturing may lead to protrusion as shown in Photo 1.

Such an accident may reduce the load-bearing capacity of the bridge, and further cause serious damage to passersby and others in the vicinity of the bridge. Moreover, since there are multiple lateral-fastening PC steels in one bridge, there are concerns about protrusion of other steels, which may cause secondary damage during inspection or

survey, etc. in close proximity to the bridges where an accident was observed because of the risk of secondary damage during the survey. Therefore, it is necessary to take measures to prevent secondary damage before conducting a detailed survey. For example, regarding the bridge shown in Photo 1, we installed steel on the sides of the bridge as an emergency measure to reduce the risk of protrusion in the event of fracture (Photo 2a) as a measure to prevent secondary damage before conducting the detailed survey. After that, as a permanent measure, the grout was re-injected into the insufficiently filled areas of all lateral-fastening PC steels, and then preventive measures were taken to prevent protrusion by attaching steel strips and fiber sheets (Photo 2b). In order to systematically summarize the know-how described above, we will continue to conduct surveys, etc.

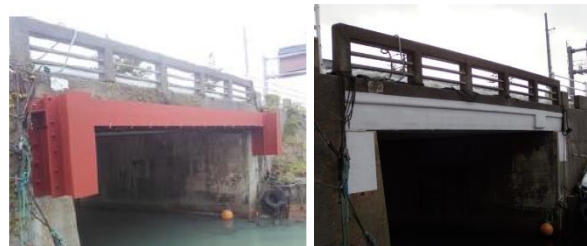
a. Emergency measure

b. Permanent measure

Photo 2: Prevent protrusion measure
