**Technical Note of National Institute for Land and Infrastructure Management**

**BRI Research Paper**

**Summary of the Field Survey and Research on  
“The 2011 off the Pacific coast of Tohoku Earthquake”  
(the Great East Japan Earthquake)**

National Institute for Land and Infrastructure Management (NILIM)  
Ministry of Land, Infrastructure, Transport and Tourism, Japan

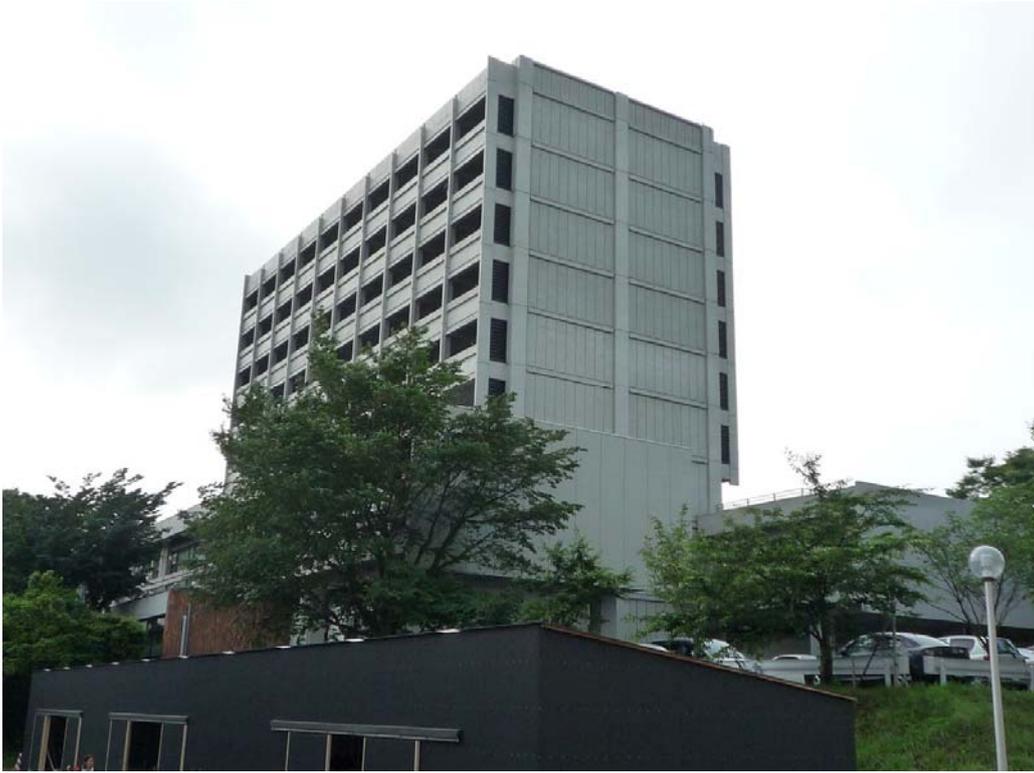
During the Tohoku earthquake, multi-story shear walls suffered bending failure and other damage. Strong motion records were obtained during the mainshock as shown in Fig. 5.3-3. Maximum accelerations on the first floor exceeded  $330 \text{ cm/s}^2$  in both of the directions. A maximum acceleration on the ninth floor was twice to three times larger than that on the first floor, and exceeded  $900 \text{ cm/s}^2$  in the transverse direction. The fundamental natural periods in Fig. 5.3-3 (e) represented about 0.7 s at the initial time of the earthquake motion in both of the directions, but increased to about 1 s in the first wave group at the time of 40 to 50 s, and increased from 1.2 s to about 1.5 s in the second wave group at the time of 80 to 100 s. Due to the seismic damage, the fundamental natural period finally became twice longer than the natural period at the initial stage. The stiffness of the building was reduced to 1/4.

Photo 5.3-1 The research building of Tohoku University

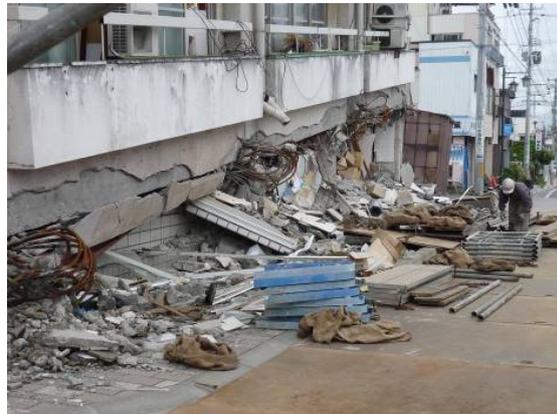
Photo 6.3-3 Close-up view of the fallen story

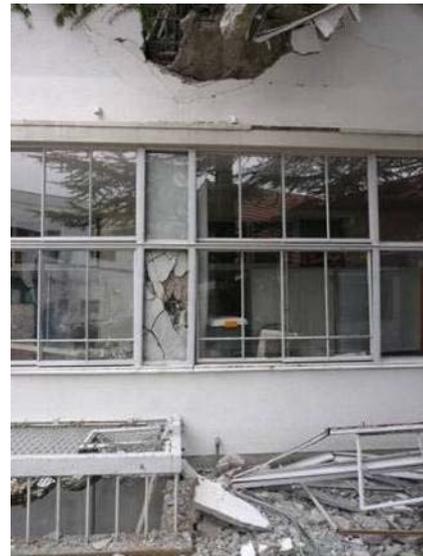
Photo 6.3-8 Shear failure of the first-story column

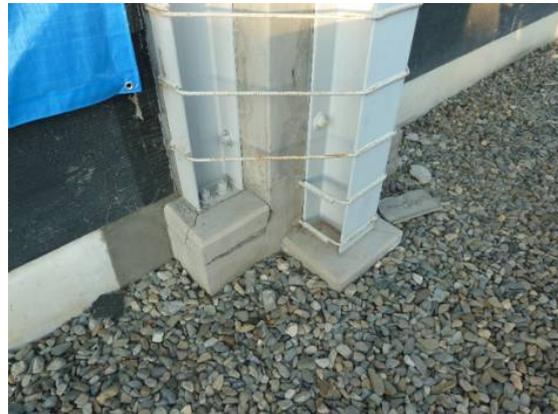
Photo 6.3-11 Column strengthened with H-shaped steel

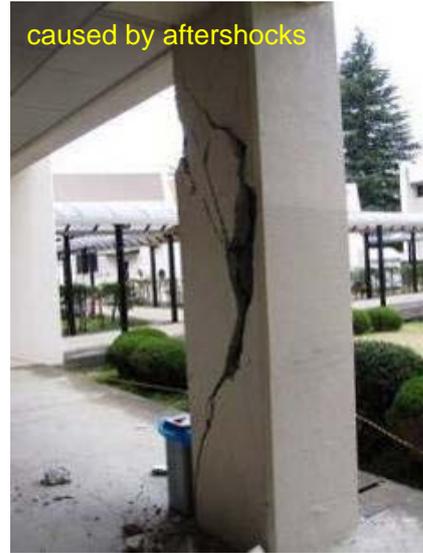
Photo 6.3-13 Shear cracks of first-story columns

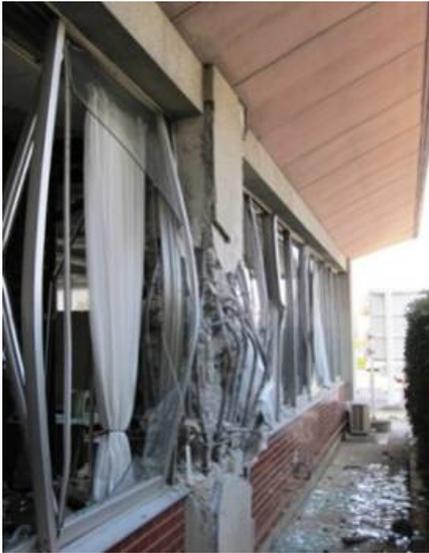
Photo 6.3-15 Shear failure of short column

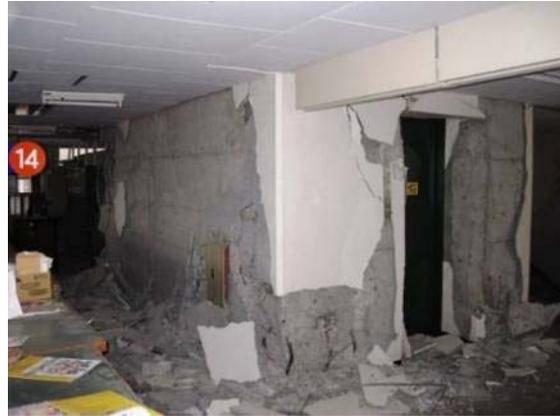
Photo 6.3-16 Failure of shear wall

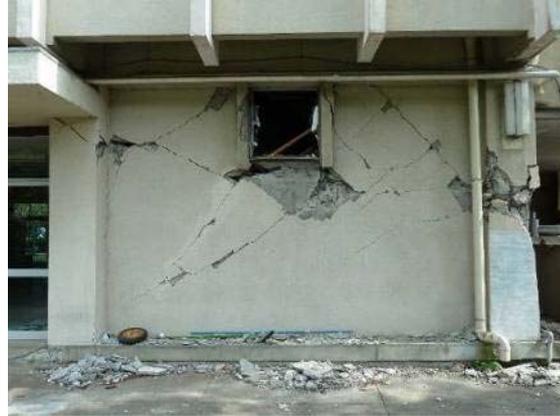
Photo 6.3-19 Shear failure of wall with opening

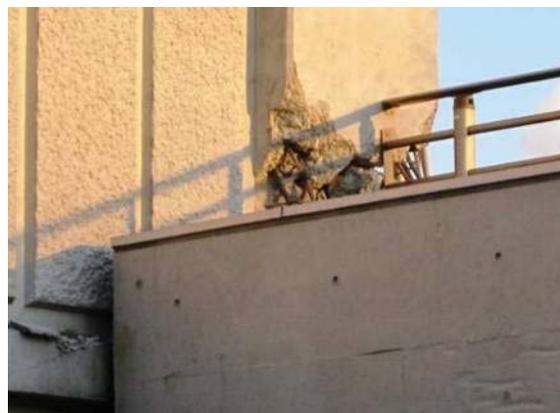
Photo 6.3-21 Crushing at the bottom of column of the multi-story shear wall

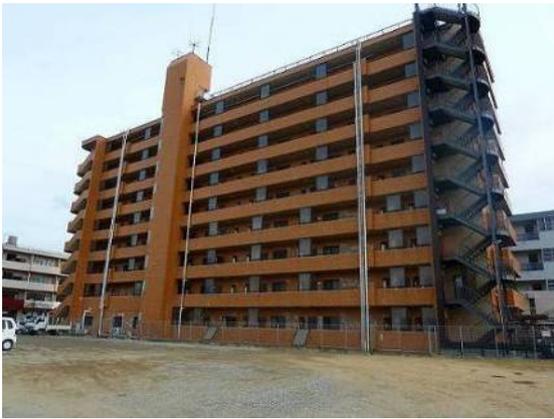
Photo 6.3-22 shows the appearance of a damaged building, which is the nine-story SRC residential building constructed in 1991 in Koriyama city. Pullout of anchor bolts, buckling of reinforcing bars and compressive failure of concrete occurred at the corner column and the bottom of multi-story shear wall in the first story, as shown in Photo 6.3-23, and shear cracks and bond splitting cracks were observed on the first story columns.

Photo 6.3-22 Appearance of damaged building (Koriyama city)

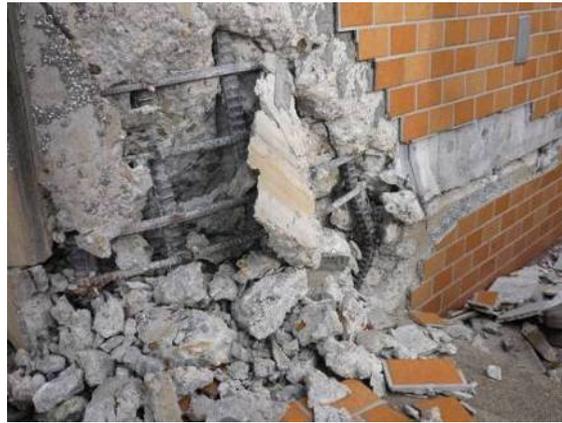
Photo 6.3-23 Damage at the bottom of SRC column

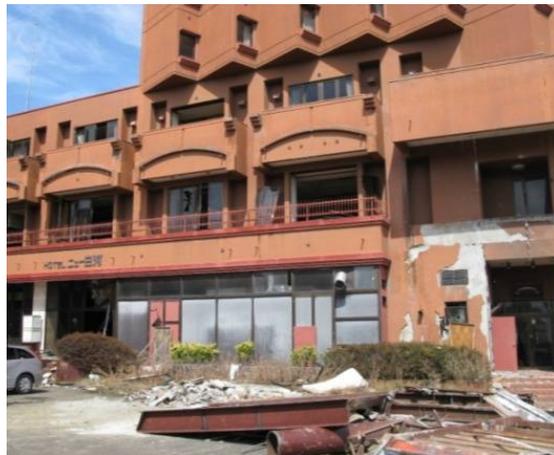
The damage at the bottom of SRC column and shear wall was also observed on the building in Shirakawa city shown in Photos 6.3-24 and 6.3-25, which was composed of RC and SRC structures. Pullout of anchor bolts of the exposed-type column base occurred. In consequence, the reinforcing bars were forced to stretch large and the buckling of them occurred around the base plate, as shown in Photo 6.3-26.

Photo 6.3-24 Appearance of damaged building (Shirakawa city)

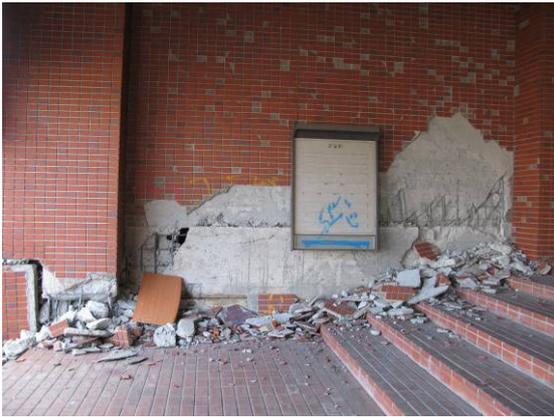
Photo 6.3-25 Damage of the bottom of SRC column and shear wall

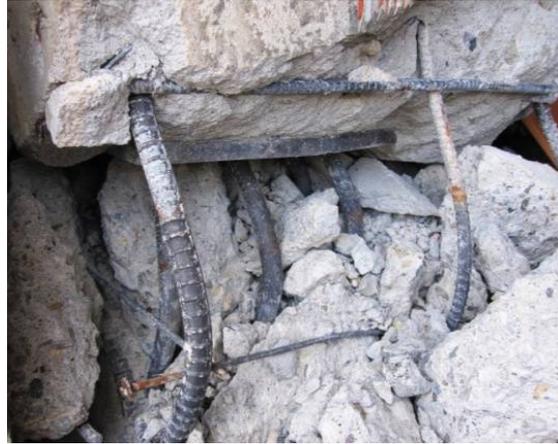
Photo 6.3-26 Close-up view of the bottom of SRC column

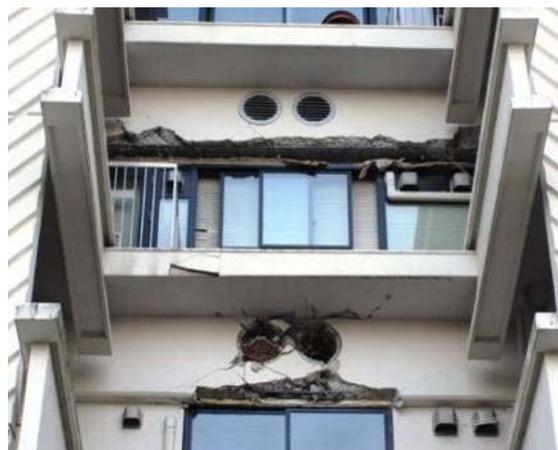
Photo 6.3-28 Damage of boundary beam with opening

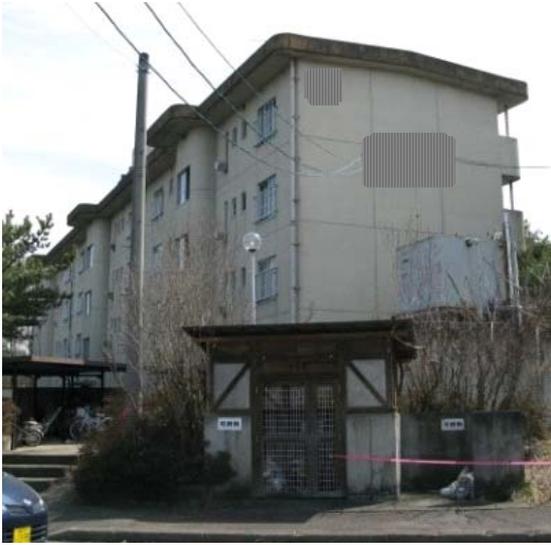
Significant settling was also observed on a sidewalk in surrounding area.

Photo 6.3-32 Appearance of sunken and leaned building (Shirakawa city)

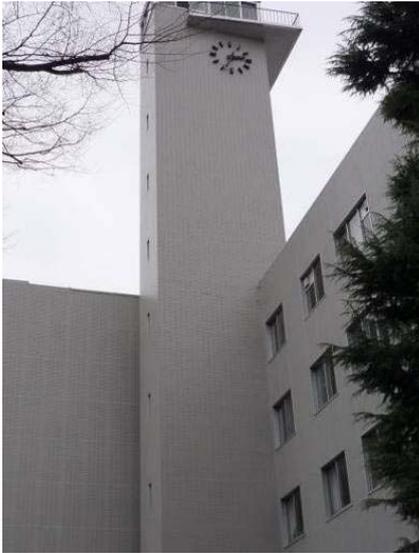
Photo 6.3-35 Damaged clock tower  
(Fukushima city)

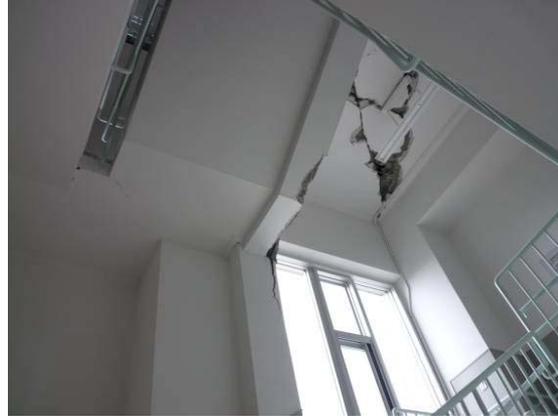
Photo 6.3-36 Bottom of the tower

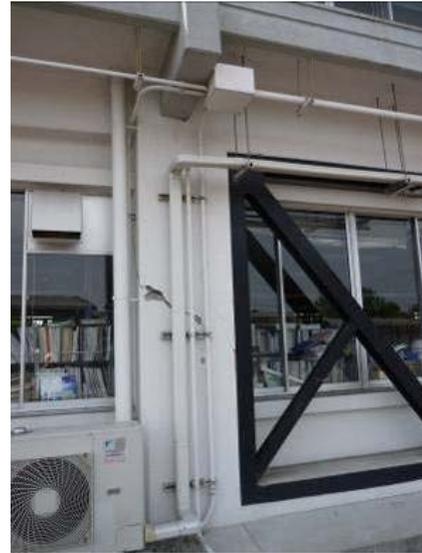
Photo 6.3-38 Shear crack on column with framed steel braces

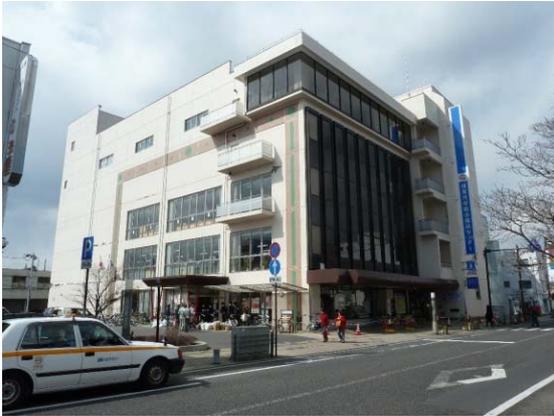
The separation of cover concrete at the bottom of wing wall was observed on the five-story RC building constructed in 2007 in Sukagawa city, as shown in Photos 6.3-39 and 6.3-40. In this report, that case is classified as the damage of nonstructural elements, because the wing wall is generally designed as the nonstructural element, which is not expected to resist the external force.

Photo 6.3-39 Appearance of damaged building (Sukagawa city)

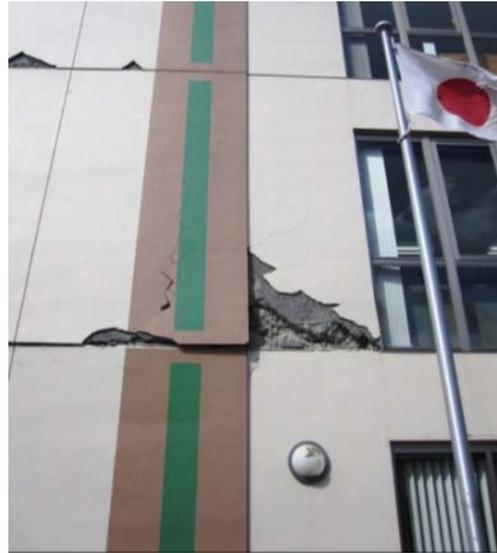
Photo 6.3-40 Separation of concrete of wing wall

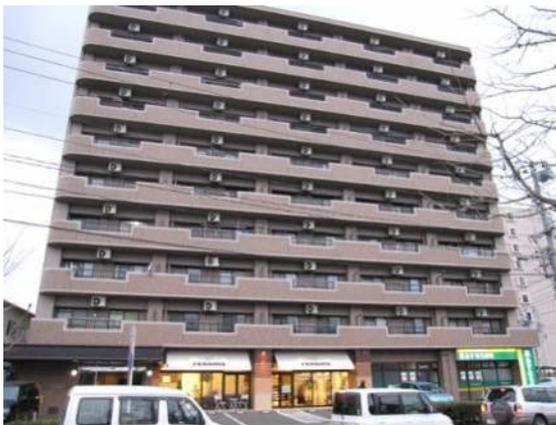
The nonstructural walls around the front doors from lower to top floors were subject to shear failure, while the doors were deformed on the ten-story SRC residential building constructed in Aoba ward, Sendai city in 1996, as shown in Photos 6.3-41 and 6.3-42. In addition, shear cracks were observed on the mullion walls on balconies in some of the lower floors.

Photo 6.3-41 Appearance of damaged building (Aoba ward, Sendai city)

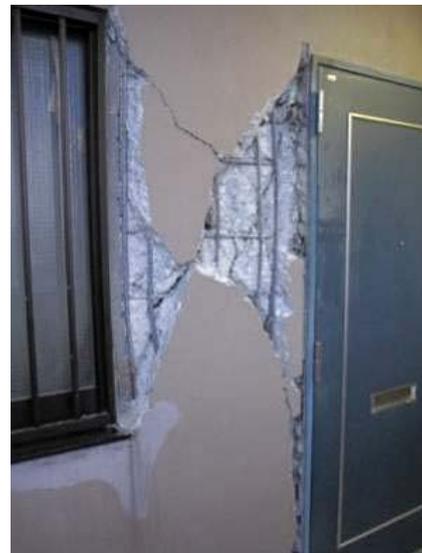
Photo 6.3-42 Shear failure of nonstructural wall

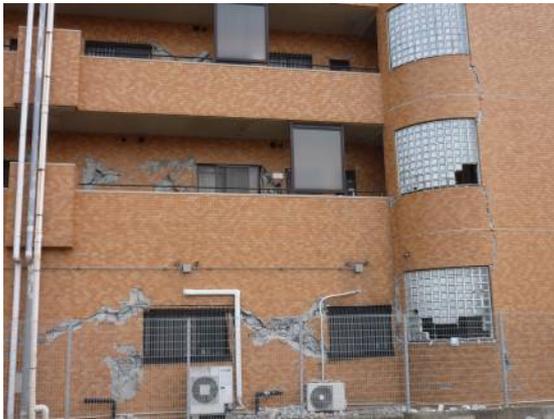
The cases where shear cracks occurred on the nonstructural walls around the front door or on the mullion wall of the balcony were relatively often observed in urban residential buildings, regardless of the seismic design codes applied to.

Photo 6.3-43 Damage of nonstructural wall in same building shown in Photo 6.3-22

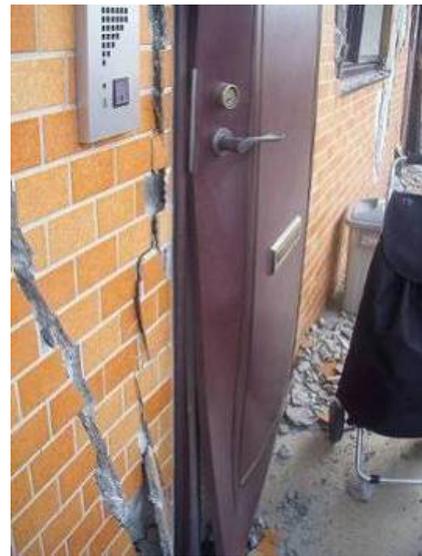
Photo 6.3-44 Damage of nonstructural wall and deformed door in same building shown in Photo 6.3-22

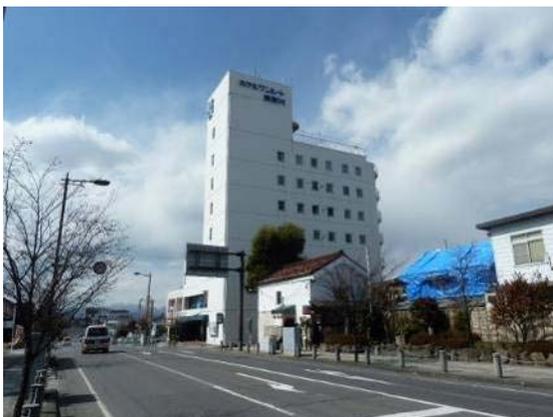
Photo 6.3-45 Appearance of damaged building (Sukagawa city)

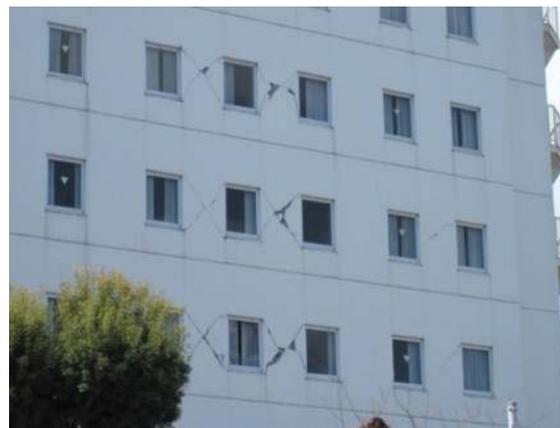
Photo 6.3-46 Shear crack on nonstructural wall

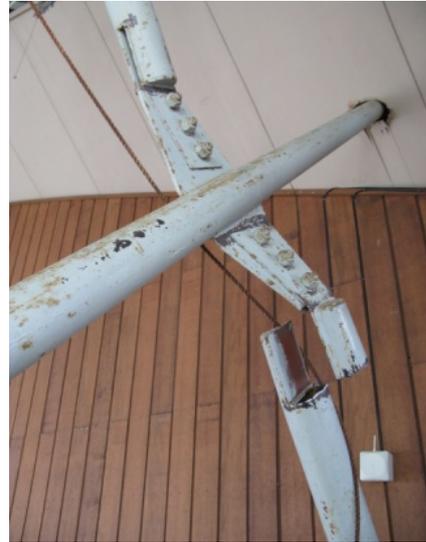
(b) Fracture at brace crossing

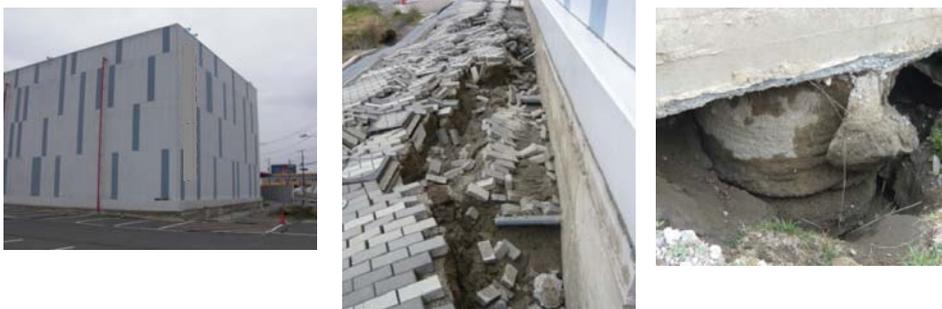
Finishes of the sidewalks around a large-scale commercial establishment along Route 11 were scattered. The subsidence of the surrounding ground was about 40 cm, and the settlement of the facility in itself was slight. The commercial building was tilted about 0.7/100 in the longitudinal direction. The pile foundation type of the building was observed from an opening between surrounding fissures (Photo 6.5-1).

Photo 6.5-1 Situations around the commercial building and state of pile head

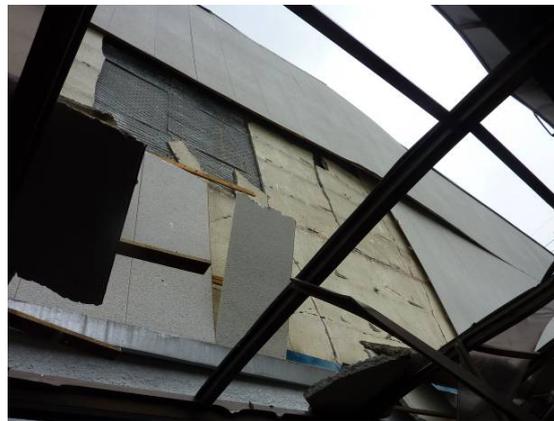
Photo 6.6-5 Damage to gymnasium gable end wall

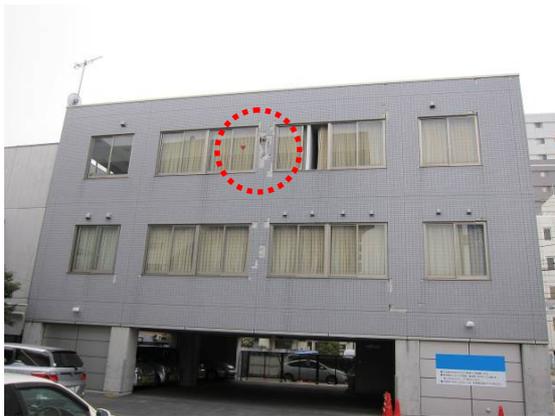
Photo 6.6-6 Falling of ceramic wall tiles and breakage of AAC panels

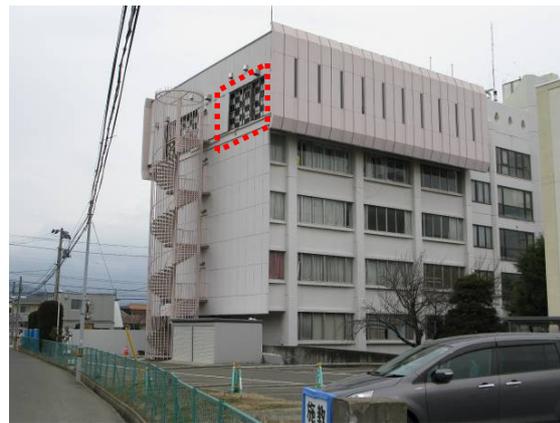
Photo 6.6-7 Detachment of AAC panels

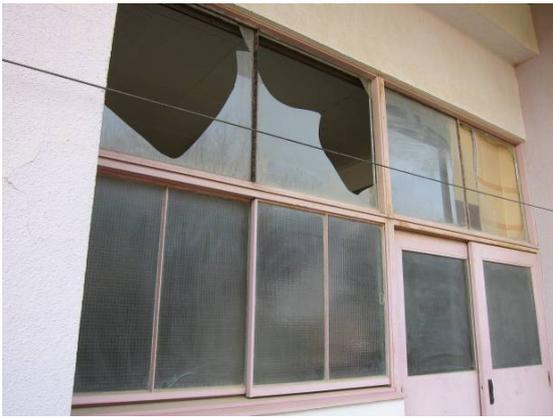
Photo 6.6-9 Breakage of window glasses installed to fixed window frame with hardening putty

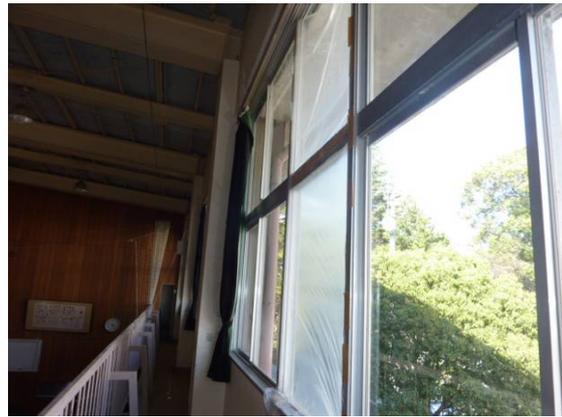
Photo 6.6-10 Breakage of window glasses installed to fixed window frame with glazing bead

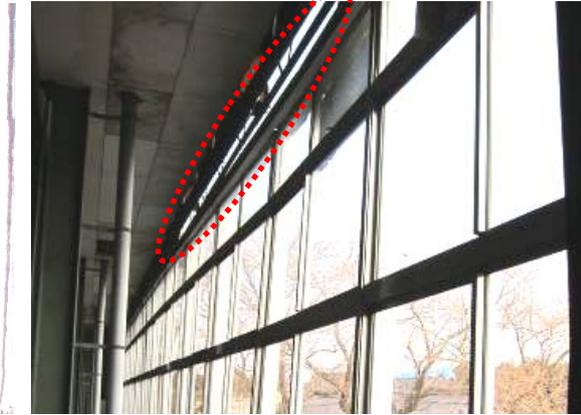
Photo 6.6-12 Breakage of glass mullion of glass wall system

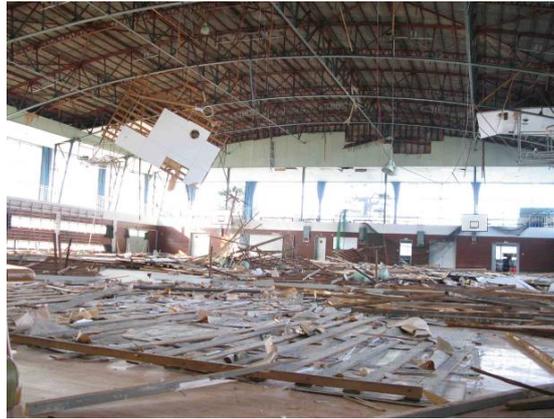
Photo 6.6-14 Falling of wooden suspended ceiling

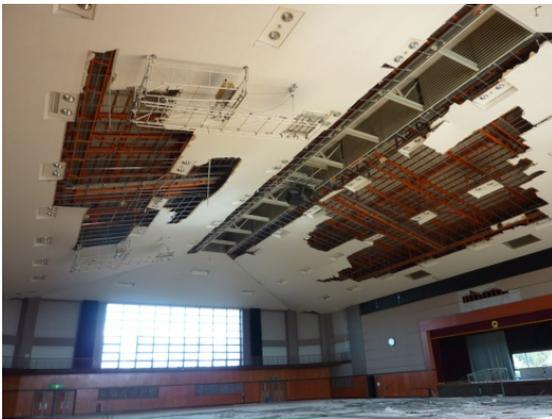
Photo 6.6-15 Falling of metal furring suspended ceiling

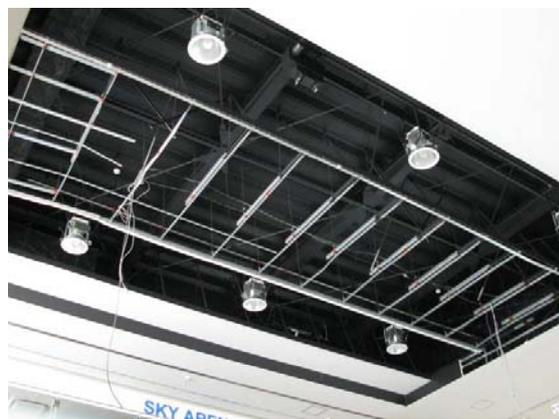
Photo 6.6-16 Falling of metal furring suspended ceiling

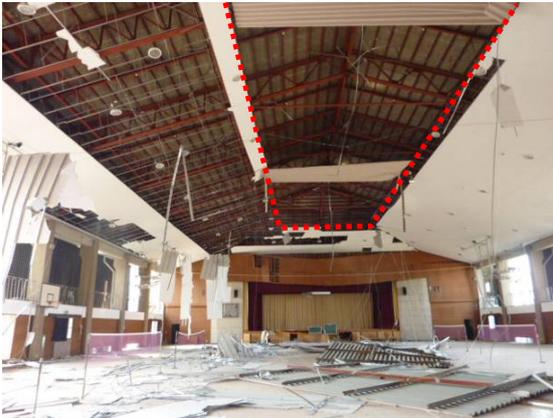
Photo 6.6-17 Falling of metal furring suspended ceiling and corrugated steel plates

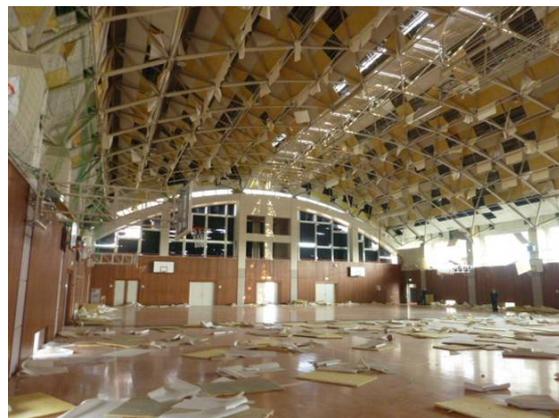
In the gymnasium shown in Photo 6.6-18, many glass wool boards on exposed T system fell. Flaking of concrete was observed in the structure.

Photo 6.6-18 Falling of glass wool board of T system ceiling

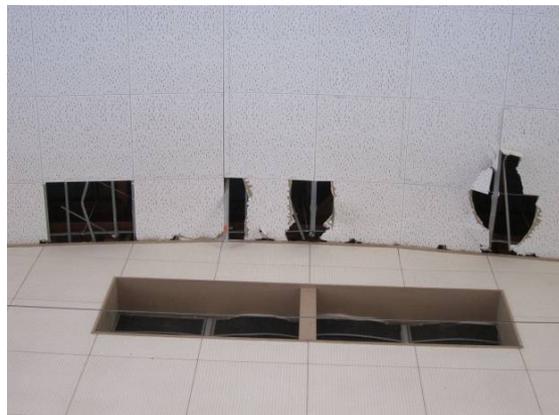
Photo 6.6-20 Damage to metal furring ceiling at the connection wall

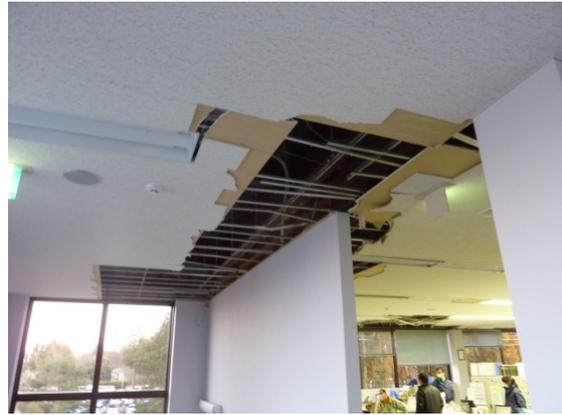
Photo 6.6-22 Damage to metal furring suspended ceiling at the connection

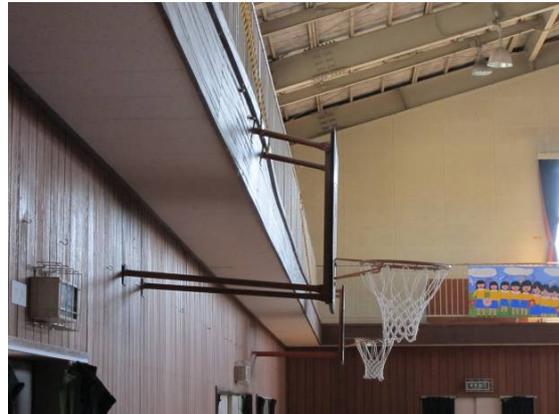
Photo 6.6-25 Damaged interior wall

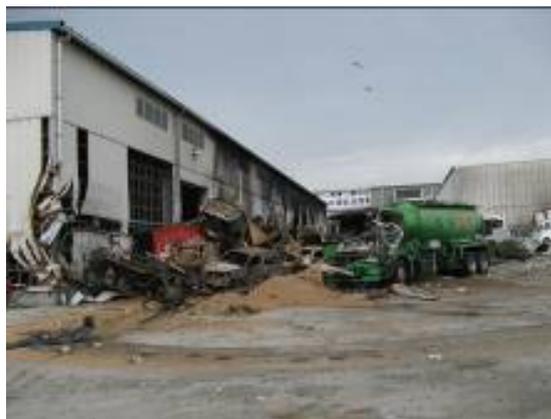
Photo 8.2-2 Tsunami fire at a port warehouse (Sendai city, Miyagi prefecture)

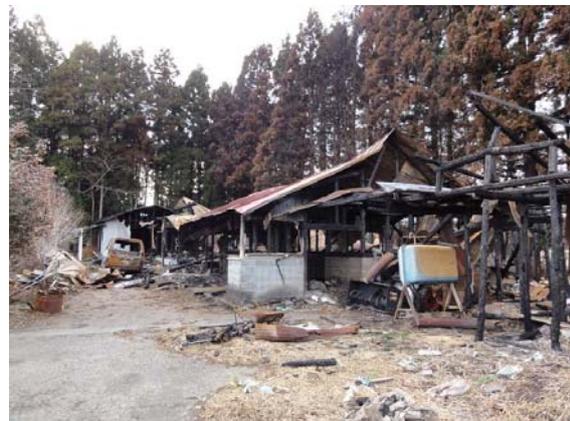
Photo 8.3-1 Fire scene of a house (Oushu city, Iwate prefecture)

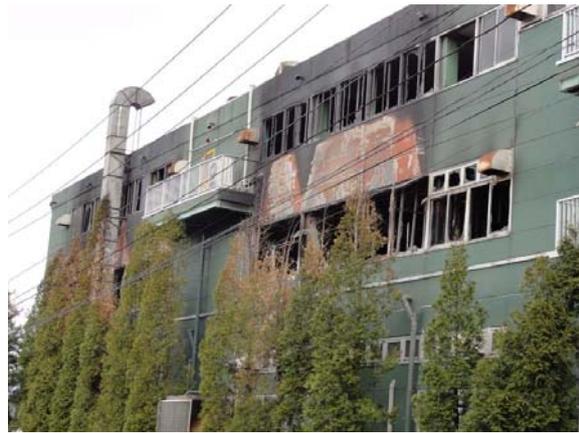
Photo 8.3-2 Fire scene at a factory building (Oushu city, Iwate prefecture)

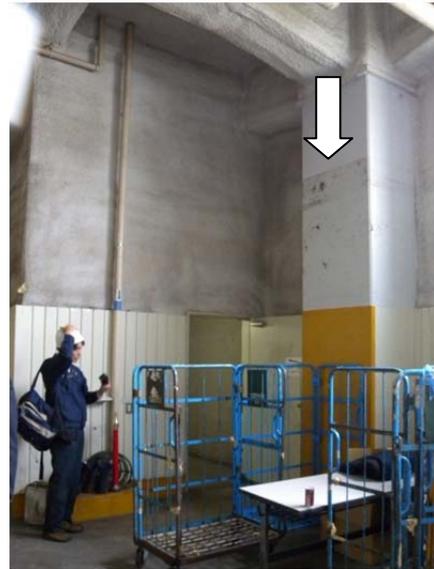
Photo 9.2-7 Trace of tsunami water

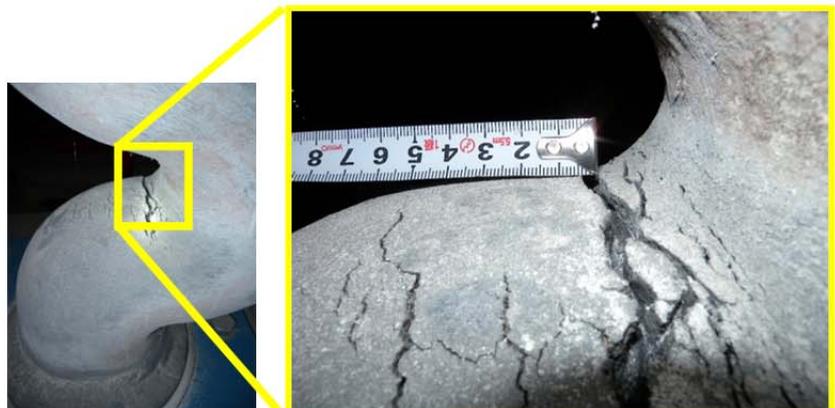
Photo 9.2-17 Lead damper and cracks on the surface

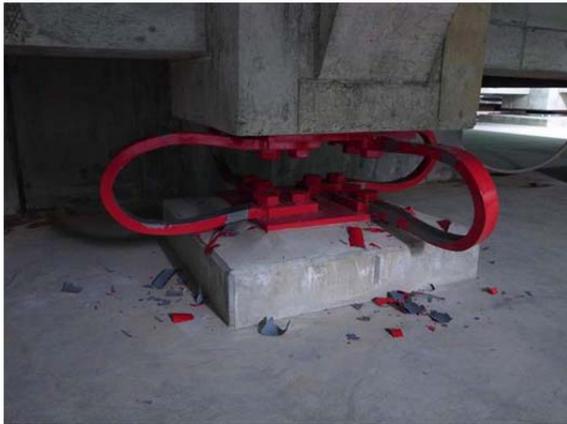
(a) Peeling off of paint
