NILIM Research Report No.52

Initiatives by the National Institute for Land and Infrastructure Management in
Response to the 2011 Great East Japan Earthquake

Emergency Responses and Engineering Contributions by NILIM
for the Recovery from the 2011 Great East Japan Earthquake

National Institute for Land and Infrastructure Management
Ministry of Land, Infrastructure, Transport and Tourism, Japan

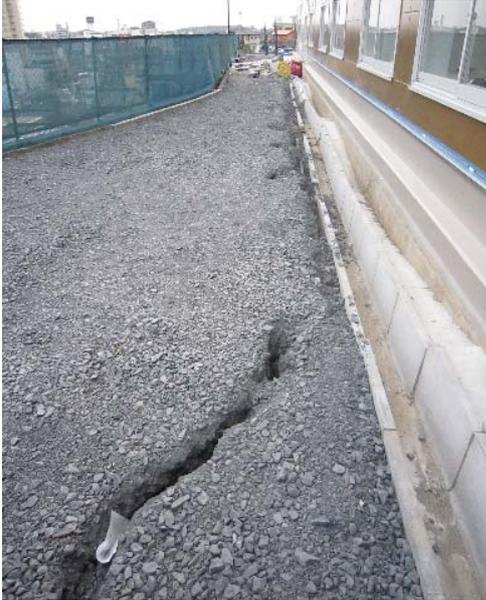
Photo 3.3.1.1 A crack along a building

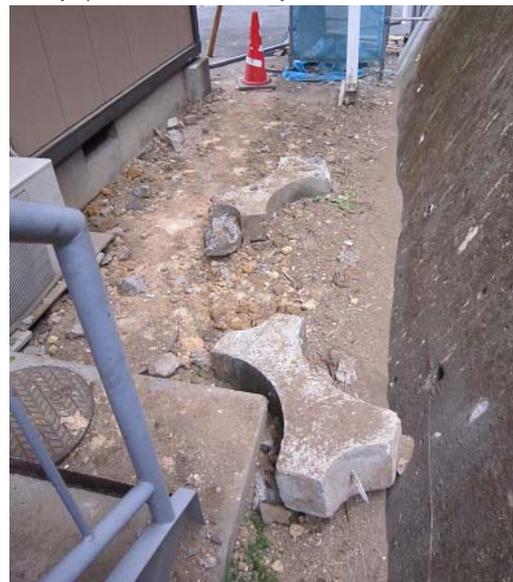
Photo 3.3.1.5 Broken cribwork pieces that dropped to the lower portion of the slope

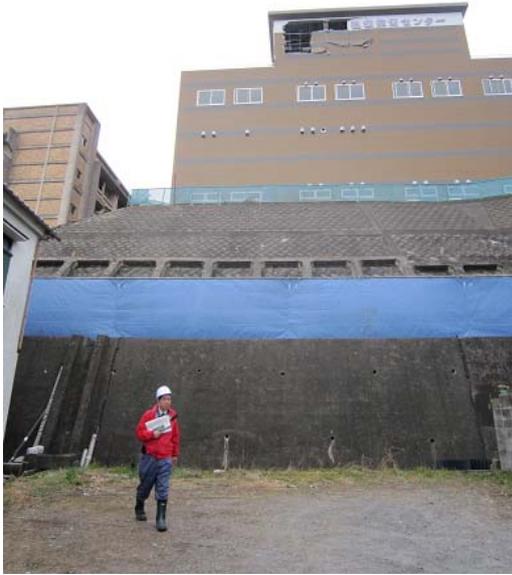
Of a facility consisting of a gravity retaining wall and a three-stage block pitching work (Photo 3.3.1.6), the top of the slope slipped off forward, distorting the lower block pitching work. No distortion was seen at the bottom retaining wall (Photo 3.3.1.7).

Photo 3.3.1.6 Retaining wall, cribwork, block pitching work

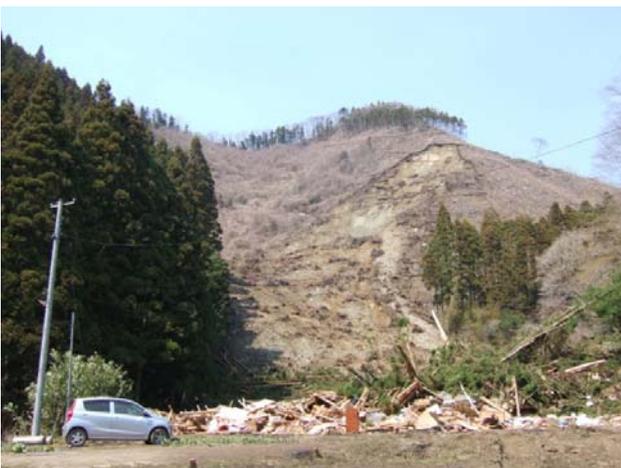
Photo 3.3.1.23 A whole picture of the slope failure

Figure 3.3.1.2 gives an overview of the slope failure. Photo 3.3.1.23 indicates the whole picture of the failure.

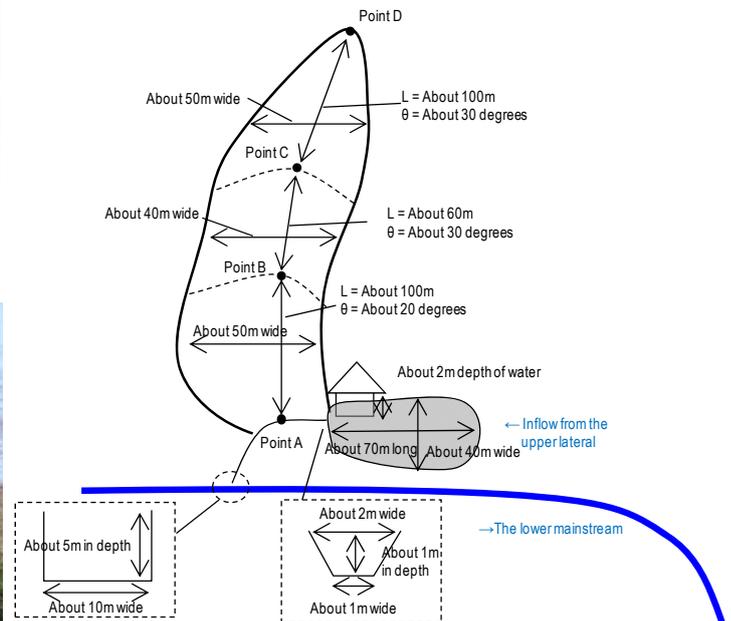
Figure 3.3.1.2 An overview of the slope failure

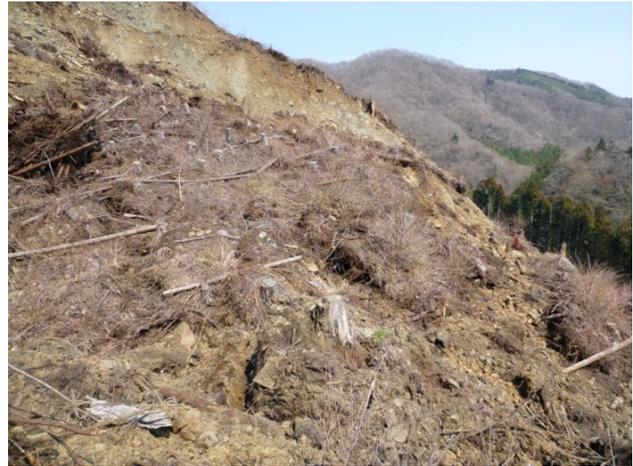
Photo 3.3.1.26 Stubs lined up on the terrace

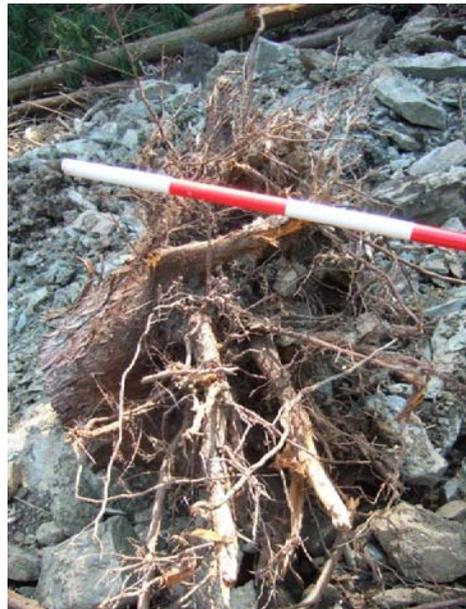
Photo 3.3.1.29 A stub with shorter roots

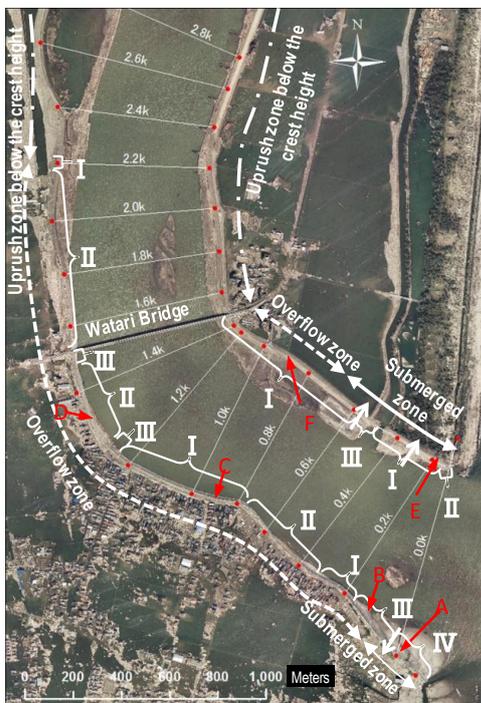
Judging from the observation that the high water level of the right bank of the Watari Ohashi was higher than that of the downstream, it is estimated that the damage level corresponds, to some degree, to the overflow water depth. However, this alone cannot fully explain the difference in damage level between the left and right banks. On this point, it is assumed that erosion of back slopes and toes of slopes was mitigated by the water cushion effect (Figure 3.3.3.1). This effect is caused either by inundation of protected land earlier than the overflow from the river side or by inundation of protected land shortly after the overflow. The following paragraph provides a quantitative study on the factors that determine the magnitude of disaster, using the results of simulation of the tsunami of 2011³⁾ (hereinafter referred to as "simulation result").

Photo 3.3.3.1 Relations between high water level of the tsunami and height of levees and the extent of damage

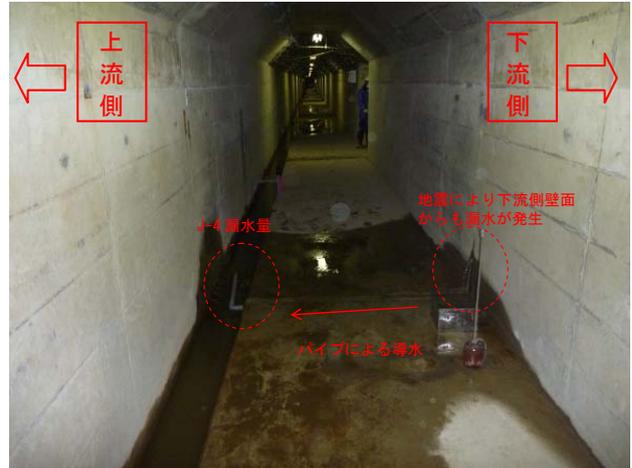
Photo 3.3.4.7 Leakage at the joint of the concrete gravity dam section (J-4) (Goshō dam, concrete gravity dam section)

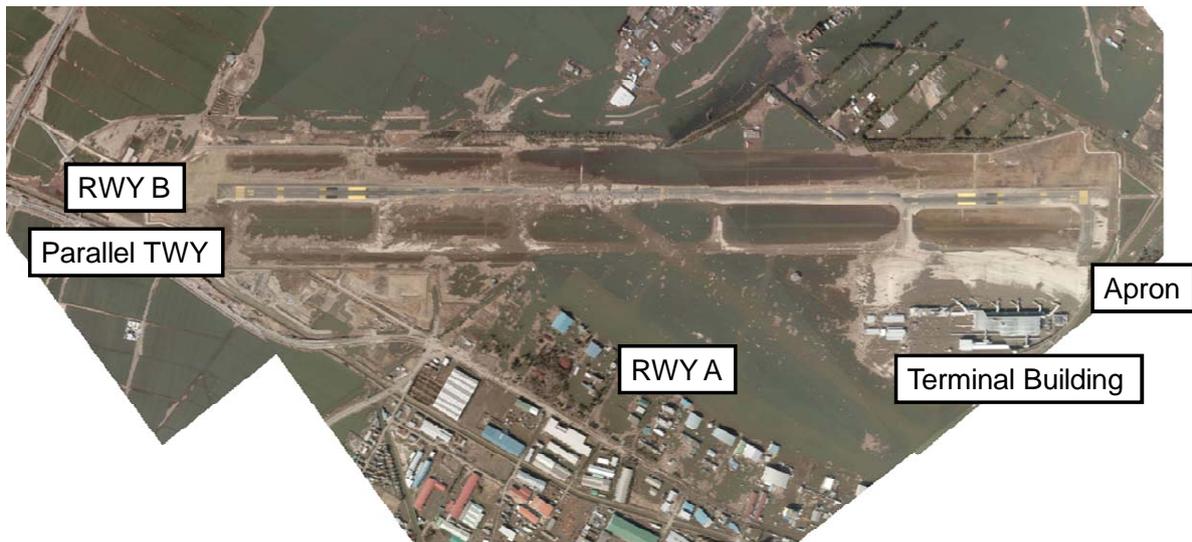
Photo 3.3.8.1 Situation at Sendai Airport around 14:00 on March 12, 2011
(photograph by the Geospatial Information Authority of Japan)

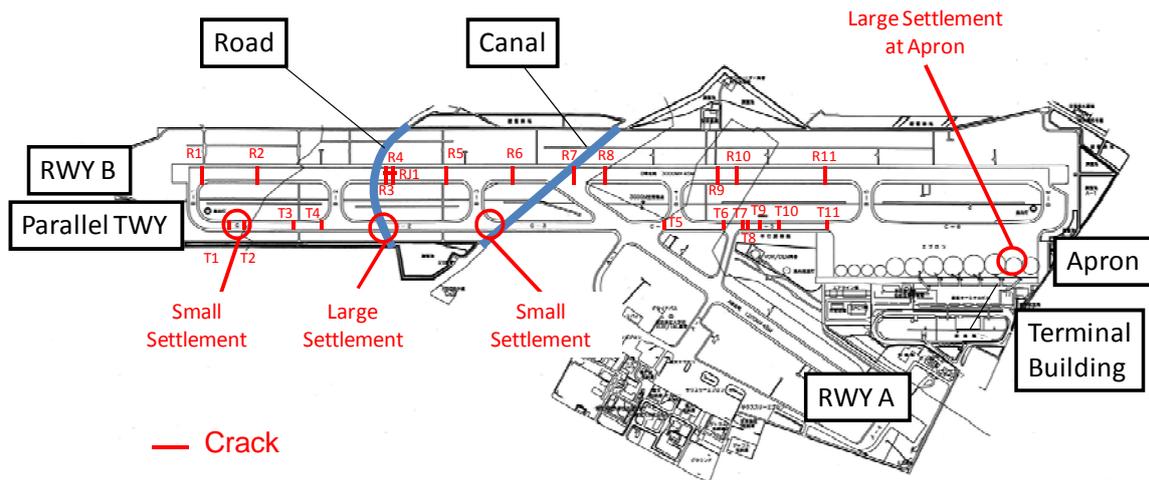
Figure 3.3.8.1 Status of Damage to Pavement

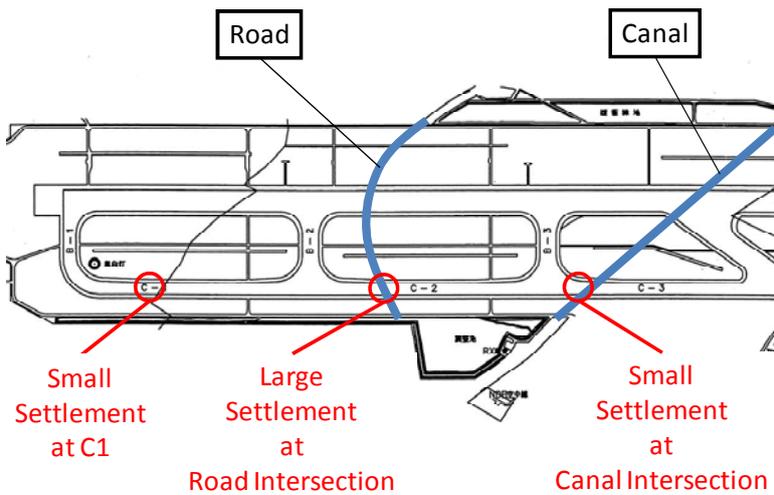
Figure 3.3.8.2 Positions of Areas of Settlement due to Liquefaction on the Parallel Taxiway

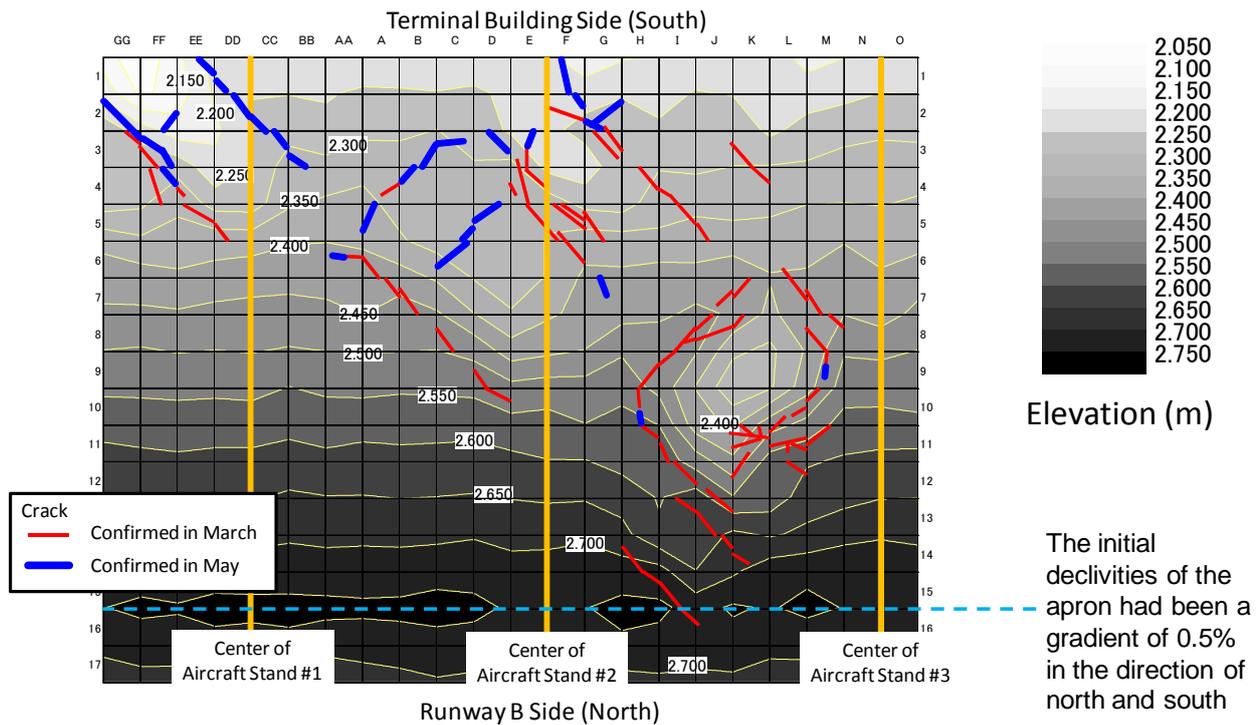
Figure 3.3.8.3 Apron Cracks and Height (squares represent a single slab of concrete (7.5m×7.5m))

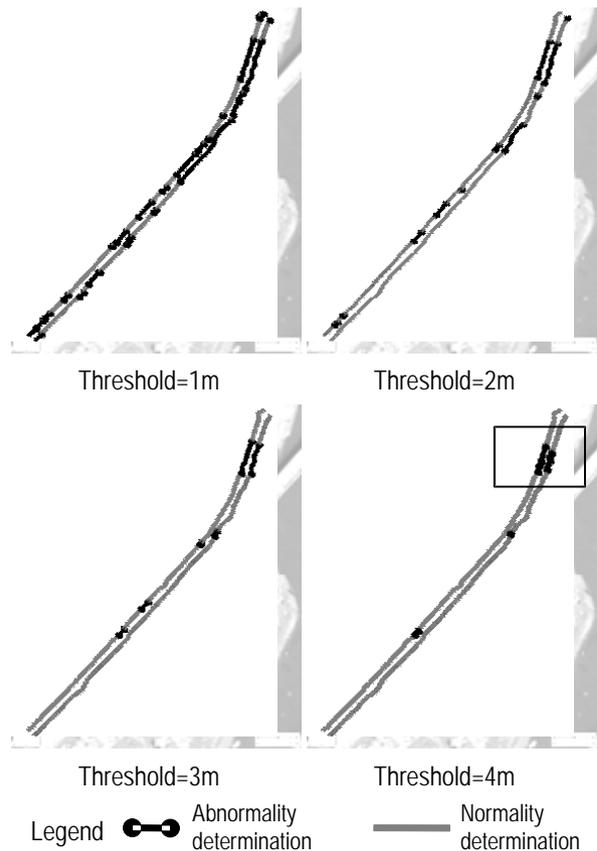
Figure 3.4.5.10 Damaged locations along the river bank
