No.18
September 2006

News Letter

Report on Buildings and Houses Damaged by the Jogjakarta Earthquake, Indonesia on June 27, 2006 Housing Production Division

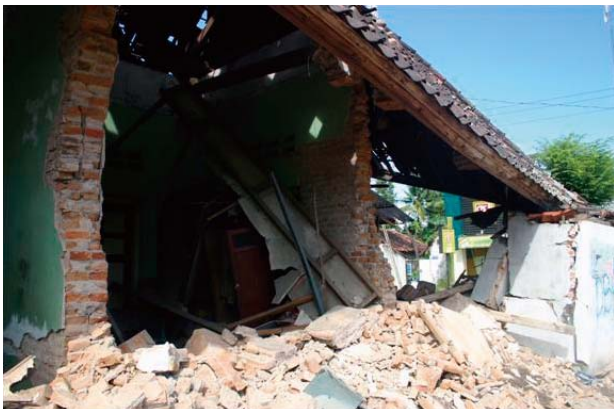
The masonry walls of old and traditional houses are mainly unreinforced masonry structures, in which the mortar bed is generally made of mud and lime; pozzolanic sand and lime; or red brick powder and lime, owing to the high price of cement. This combination material causes a low bonding strength between bricks and mortar, which could be the main damage factor as so many people were killed or seriously injured by the earthquake due to the shear or out-of-plane rupture

Photo 1 Damage to unreinforced concrete building

mechanism. Another cause of damage was rupture of the roof frame and its roof cover (Photo 1).

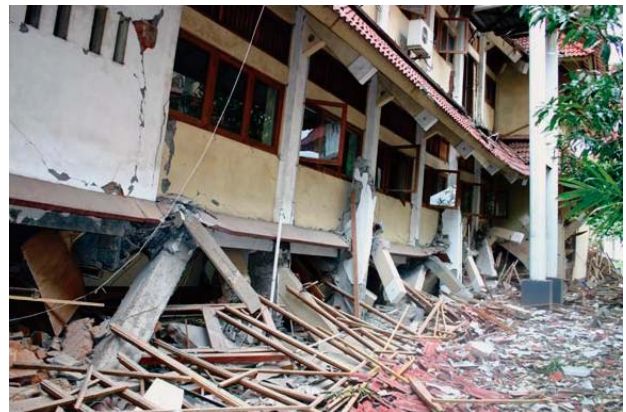
(2) The earthquake caused typical damage such as shear failure and out-of-plane rupture of the infill walls, and hence building collapse leading to death and injury (Photo 2).

Photo 2 Damage to reinforced concrete building

Observation of the structural conditions of the reinforced walls that collapsed (shear failure and out-of-plane damage) showed that the failure was due to incorrect bar arrangement of the practical columns of the walls and large wall openings.

It is necessary to consider the structural details of the design and building construction methods that would ensure infill walls of buildings do not collapse in order to prevent human injury.
