No.26

国総研ニューズレター NILIM News Letter

平成 20 年岩手・宮城内陸地震被害調査概要

Summary of Survey on the Damage caused by the Iwate-Miyagi Nairiku Earthquake in 2008

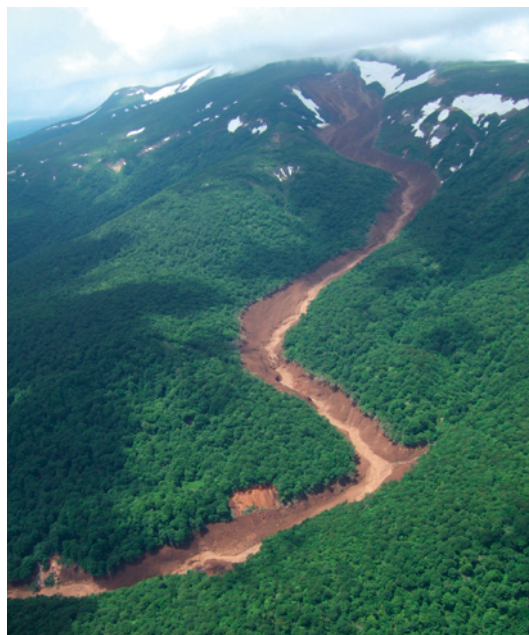
今回の地震では、震度5強以上のエリアを中心に、多数の山腹崩壊が発生した。大規模な土砂移動現象としては、宮城県栗原市三迫川上流で発生した土石流（写真-1）、同三迫川荒砥沢ダム上流で発生した大規模地すべりなどがある。三迫川の土石流では、崩壊地から約5km下流の駒ノ湯温泉の旅館が押し流された。

In this earthquake, many hillsides collapsed mainly in the area hit by quakes above intensity 6 lower. Large sediment migration phenomena include debris flows upstream of Sanhasama River in Kurihara City of Miyagi Prefecture (Photo 1), and the large landslide upstream of Aratozawa Dam on Nihasama River of Miyagi Prefecture. The debris flow on Sanhasama River washed hotels of Komanoyu Spa about 5 km downstream of the landslide.

写真-1 三迫川上流の土石流

Photo 1 Debris flow on the upstream of Sanhasama River

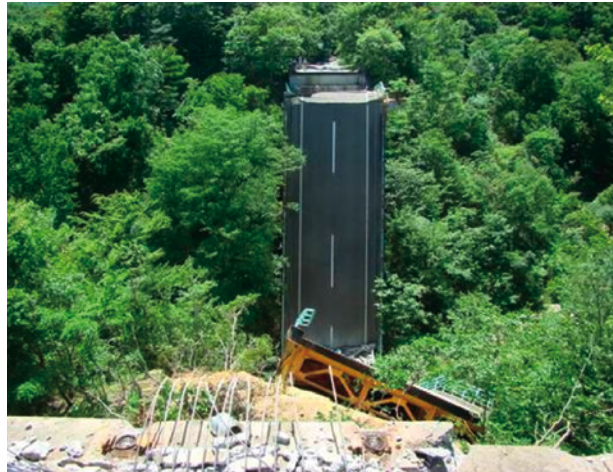
道路橋では、震源に近い国道342号の祭時 (まつるべ) 大橋が落橋する被害が発生した (写真-2)。祭時大橋を始め、その周辺の道路橋に対して緊急調査を行ったが、祭時大橋以外の道路橋では、その直近においても、橋梁の構造部材の損傷等により構造安全性が問題となるような被害は確認できなかった。

祭時大橋は、昭和53年架設の橋長94.9mの3径間連続非合成鋼鈹桁橋である。下部構造は、逆T式橋台及びT型橋脚であり、いずれも直接基礎である。祭時大橋では、上部構造が破壊したP2 (一関側) 橋脚付近で落下し接地していたとともに、両端で橋台から脱落していた。本橋周辺各所の地山崩壊の状況と橋の状態から、秋田側の下部構造 (A1橋台、P1橋脚) が地盤とともに一関側に移動して上部構造全体をA2橋台の方へ押し出し、その結

Matsurube Bridge on National Highway Route 342 was close to the epicenter and collapsed. (Photo 2) An emergency survey was conducted on this bridge and other neighboring road bridges. The survey indicated that no road bridges, even the bridge nearest to collapsed Matsurube Bridge, suffered any structural damage that may pose any safety hazards.

Built in 1978, Matsurube Bridge was a 94.9-m-long three-span continuous noncomposite steel plate girder bridge. Its substructure was comprised of an inverted T-type abutment and a T-type pier, each of which was supported by a spread foundation. This bridge fell on the ground around the P2 bridge pier (on the Ichinoseki side), where the superstructure collapsed, and both ends fell from the bridge seats.

Judging from the condition of the bridge and ground collapse of its neighboring area, possibly the substructure on the Akita side (bridge abutment A1 and bridge pier P1) moved to the Ichinoseki side together with the ground and pushed

果、P2橋脚とA2橋台が大きく破壊して橋桁落下を生じた可能性が考えられた。なお、落橋メカニズムの正確な把握には、今後の詳細な位置測量や各部の損傷状態の詳細調査が必要である。

out the entire superstructure toward the bridge abutment A2; subsequently, the bridge pier P2 and the bridge abutment A2 collapsed, thereby completely destroying the bridge. However, in order to gain correct understanding of the bridge collapse, it is necessary to conduct a detailed survey of damaged parts and accurately measure their positions.

写真-2 落橋した祭時大橋
Photo 2 Collapsed Maturube Bridge

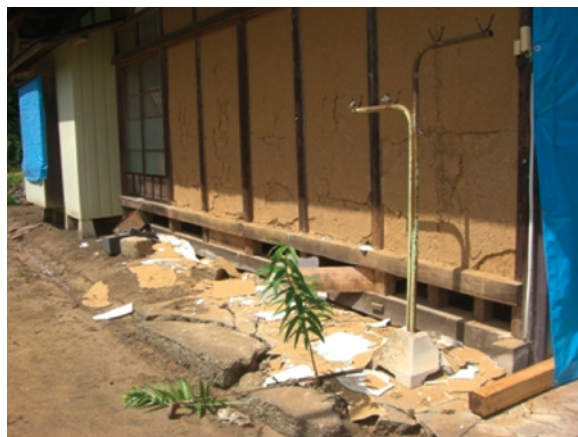
を実施し、その外装材等の被害状況をすでに報告⁵⁾している。写真-3は同報告で「戸建て木造住宅の振動的被害」とされたものであり、栗駒沼倉地区（上滝の原）の伝統的構法の住宅の西面外壁の被害状況である。南面の玄関付近では、近代的な工法で改築された部分の外壁の損傷、建具の脱落等があった。また隣接する牛小屋でも写真-3と同様な土壁の落下被害が見られた。いずれの構造部分についても残留変形は小さく、木造躯体の損傷は確認されなかった。その近隣では、補強鉄筋の入っていないと見られるブロック塀の倒壊が確認された。

A field survey was conducted with an emphasis on school buildings, and the damage caused to non-structural members in these buildings has already been reported.⁵⁾ Photo 3 shows the post-earthquake image of a single-family wooden house in the Kurikoma-Numakura area of Kurihara City in Miyagi Prefecture. As shown in the photo, the outer structural wall (mud wall) on the west side of the house that was constructed by traditional methods collapsed completely.

The outer wall near the south entrance of the house that was renovated using modern specification was also damaged, and the fixtures along the wall collapsed. An adjacent cowshed had the same damage as that shown in Photo 3. In both these cases, the residual deformation was relatively less and the extent of damage to the wooden structural frame was not confirmed. In the neighboring area, concrete-block walls without reinforcing bars collapsed.

写真-3 戸建て住宅外壁損傷の状況（土壁の落下）

Photo 3 Damage to the outer wall of a single-family house (a mud wall collapsed completely)
