N I L I M

No.37
Summer 2011

Special Edition: The 2011 off the Pacific coast of Tohoku Earthquake (Great East Japan Earthquake)

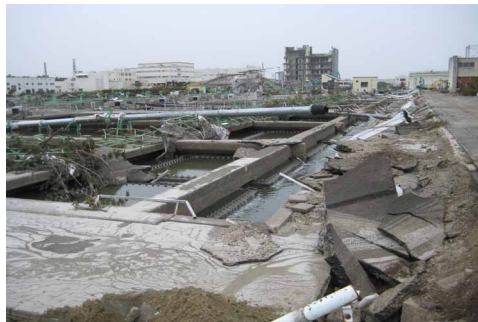
The first unique characteristic of this earthquake was the unforeseen tsunami it generated, and the way that the external force (wave force) of the tsunami, the inundation it caused, and the floating debris it carried inflicted catastrophic damage on sewage treatment facilities along the coastline. Along with damage to civil engineering structures, damage to electrical machinery and electric power equipment was astonishing, and it is necessary to not only aim for total recovery of their functions, but to improve their functions to prepare for future

View of Damage at the Minami Gamo Wastewater Treatment Center (Sendai City)

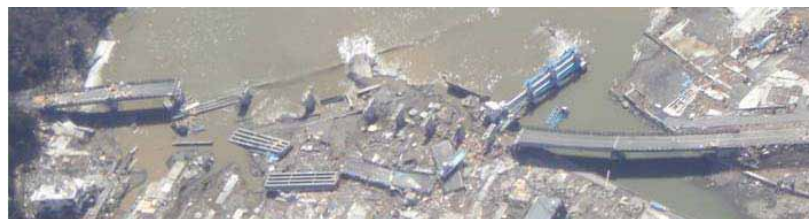
Bridge with Part of its Spans of its Superstructure Washed Away (Photo provided by the Tohoku Regional Development Bureau)

Damage caused by the tsunami which struck the Pacific coast of the Tohoku and Kanto regions includes the washing away of bridges erected in the region.

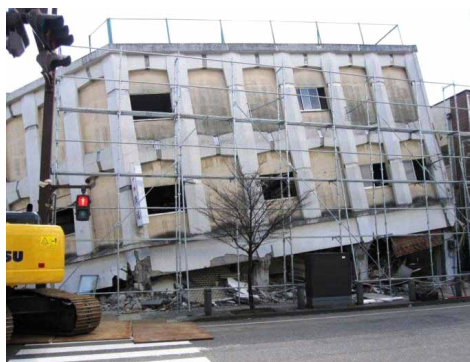
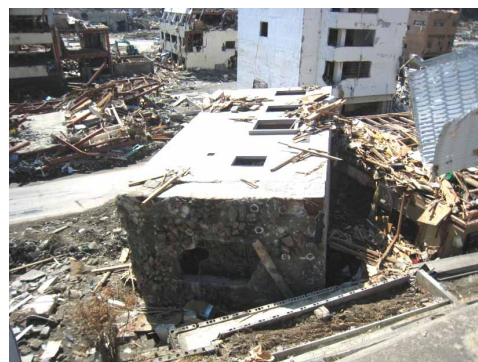
Buildings etc. damaged by earthquake motions included wooden structures, steel structures, reinforced concrete structures, residential land and foundations, and non-structural elements. The results of surveys have revealed that characteristics of the damage caused by the earthquake motion include relatively widespread damage to non-structural elements of steel gymnasiums (fallen ceilings, etc.), damage to wooden buildings caused by ground deformation in developed housing areas, and large-scale ground liquefaction, etc. Almost all reinforced concrete buildings in which structural damage was observed were designed under the old seismic design standards, and the types of damage states were clearly identical to those observed after past destructive earthquakes.

With respect to damage to buildings caused by the tsunami, field surveys were conducted in the primary tsunami disaster regions. The details of damage states such as overturned or washed-away structural elements and broken openings were collected as well as inundation depth and fundamental specifications of structural elements necessary to calculate horizontal load-carrying capacity. The results of the above surveys are summarized as “the

Examples of Building Damage Caused by Earthquake Motion (Left) and Tsunami (Right)

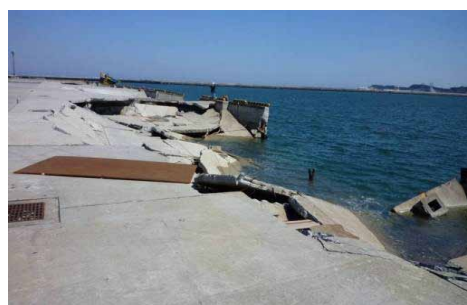
In Soma Port and Ibaraki Port, earthquake motion caused severe damage to quaywalls. Quaywalls collapsed at multiple locations, particularly in Soma Port shown in the photograph. It is hypothesized that first, the earthquake ground motion caused the quaywalls to bulge out towards the sea and the aprons behind them to subside, then the

tsunami acted on the quay walls in this condition and the backwash caused a large water level difference, collapsing the quaywalls. Damage caused by the combined action of earthquake motion and tsunami of this kind is extremely rare. Another characteristic is that as a result of variations of ground conditions, even in a single port or harbor, the degree of damage varied greatly. In Onahama Port for example, the ability to explain the gap between the severe damage at No. 3 Pier and the absence of any damage at the Otsurugi Pier as a difference in the dominant frequencies of the ground was confirmed by observing microtremors.

Collapsed Quaywall (Soma Port)

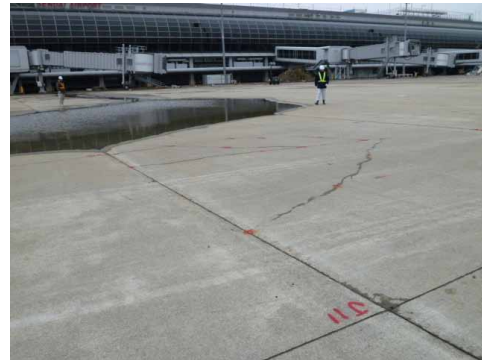
Subsidence occurred in part of the international service area of the aprons, causing deviation of gradient and cracking of concrete slabs (photo). In this part, liquefaction countermeasure works followed by restoration of the paving is necessary, so for the time being, the facilities are closed and work to restore the entire surface is now in progress.

Cracks and puddles on an apron
