PART TWO :

FACT FINDING

In this part, fact finding on building damages and social economic disruptions in inundation areas in 7 cities are shown.

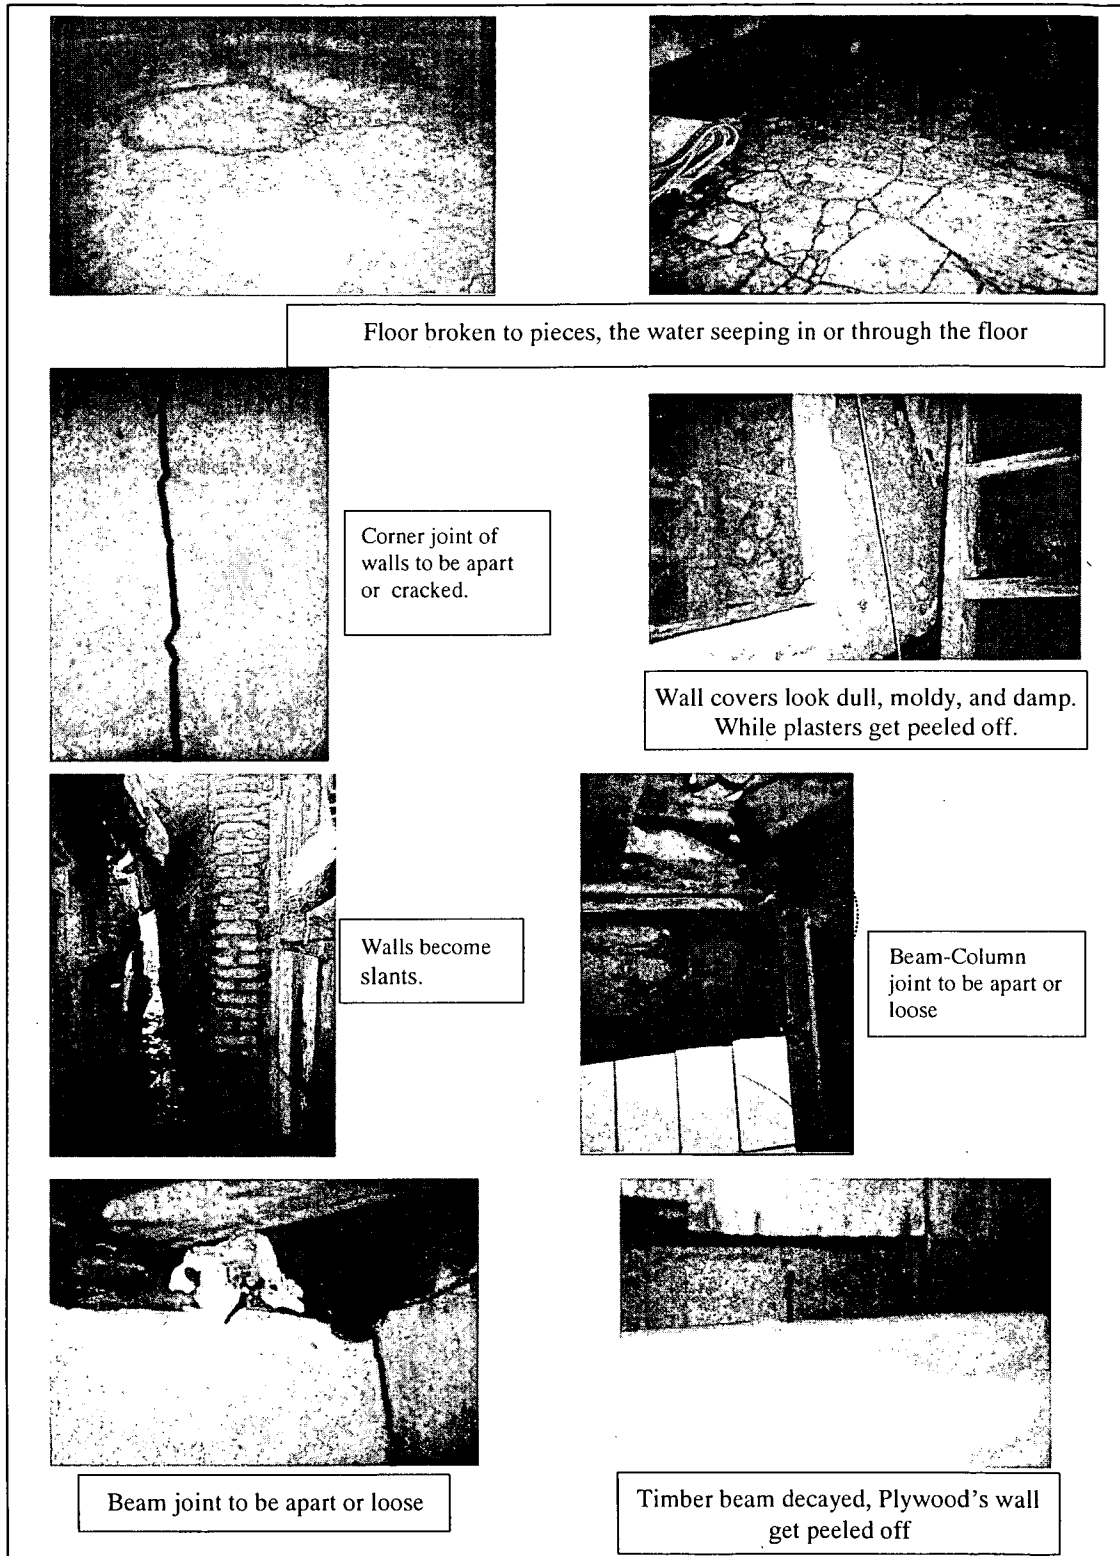
Figure 2.2.4: Deterioration of Building Elements

Component of Building	Kind of Building		
	Masonry	Mixed Brick & Timber/Bamboo	Timber/Bamboo
Floor	Floors become bumpy or broken to pieces.	Floors become bumpy or broken to pieces.	Floors become bumpy or broken to pieces.
Wall	<ul style="list-style-type: none"> • Walls become slants • Walls become cracked, especially at the corner joint • Wall plasters get peeled off • Wall covers look dull, moldy, and damp. 	<ul style="list-style-type: none"> • Walls become slants • Walls become cracked, especially at the corner joint • Wall plasters get peeled off • Wall covers look dull, moldy, and damp • Plank walls look moldy and decayed • Triplex walls get peeled off. 	<ul style="list-style-type: none"> • Plank walls look moldy and decayed • Triplex walls get peeled off • Plaited bamboo walls decayed
Ceiling ^{*)}	Cracked or broken to pieces, look dull & stained (due to water spots)	-	-
Roof Frame	Timber/bamboo decayed	Timber/bamboo decayed	Timber/bamboo decayed

Roof Cover	Roofs become bumpy or broken to pieces.	Roofs become bumpy or broken to pieces.	Roofs become bumpy or broken to pieces.
Door & Windows Frame	<ul style="list-style-type: none"> • Frames become slants and decayed • Windows cannot be opened. 	<ul style="list-style-type: none"> • Walls become slants and decayed. 	<ul style="list-style-type: none"> • Walls become slants and decayed.
Column	<ul style="list-style-type: none"> • Reinforced bar cover concrete which get peeled off • Timber decayed • Wall-Column joint be apart or cracked. 	Timber decayed	Timber decayed
Beam	<ul style="list-style-type: none"> • Reinforced bar cover concrete which get peeled off • Timber decayed 	Timber decayed	Timber decayed
Beam-Column Joint	Beam-Column joint to be apart or loose.	Beam-Column joint to be apart or loose.	Beam-Column joint to be apart or loose.

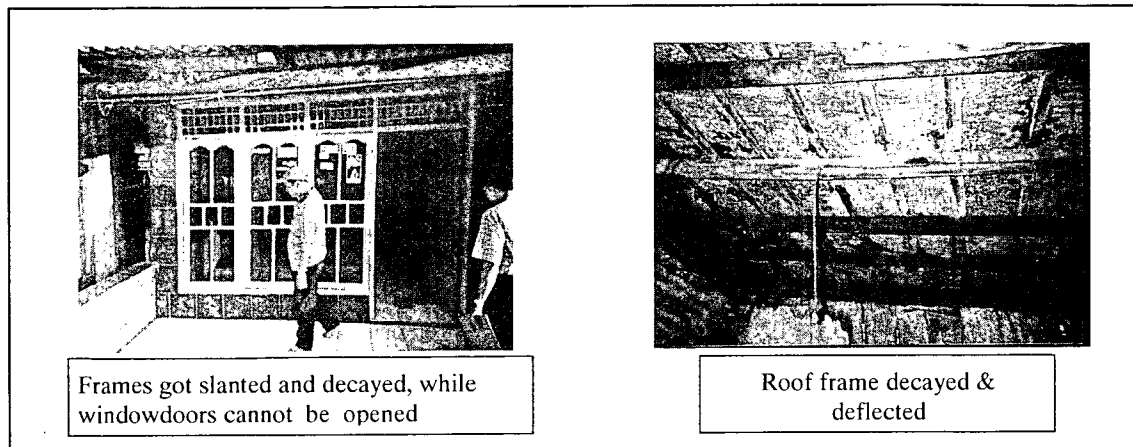
Figure 2.2.4 (Continuation): Deterioration Kinds of Building Elements

The effect of the past inundations on the buildings deterioration in Tanjung Mas has reached thousands of dwelling units. The main cause of buildings deterioration is land subsidence and the tide (*rob*) which reaches the height of 40 to 60 cm from the ground and unfortunately these matters take place at the same time annually. Furthermore, the all parts of sub district of Tanjung Mas are located in the inundated areas which is 0.5 m above sea level and which the slope is $0 - 2^0$.

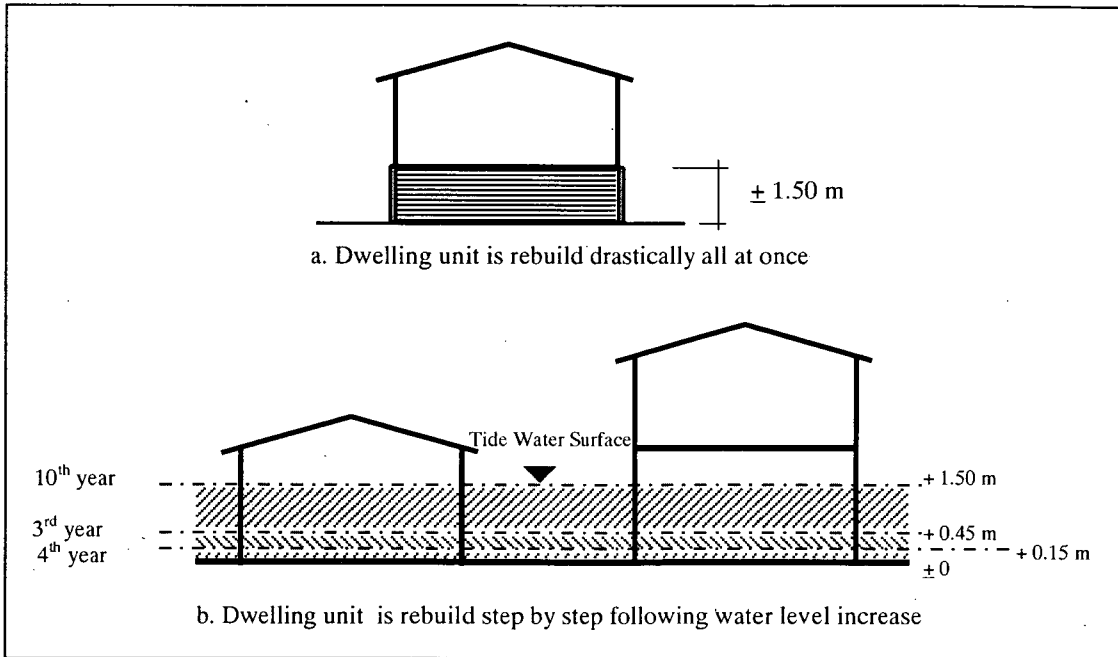
Figure 2.2.5: Sketch of the Building Physical Adaptation Method

To make inhabitants feel secure living in the area affected caused by continuously rising sea water level, building physical adaptation is done by the residents for themselves. The most common adaptation is to build a small embankment in the front entrance, or to elevate both the yard as well as floor house step by step to sea water level up. On the other hand some people who belong to middle to high-income level are able to rebuild their dwelling units drastically all at once. The rubble stone foundation of their houses is built as high as 1.5 – 2 meters from the ground, so the floors of their houses are about 1.5-2 meters above the land surface. The newly rebuilt houses are constructed about 1.5-2.0 m above the existing land surface. They realize that life time of their houses are only for 10-15 years, because within 15 years their houses will be influenced by inundation either (see figure 2.2.7).

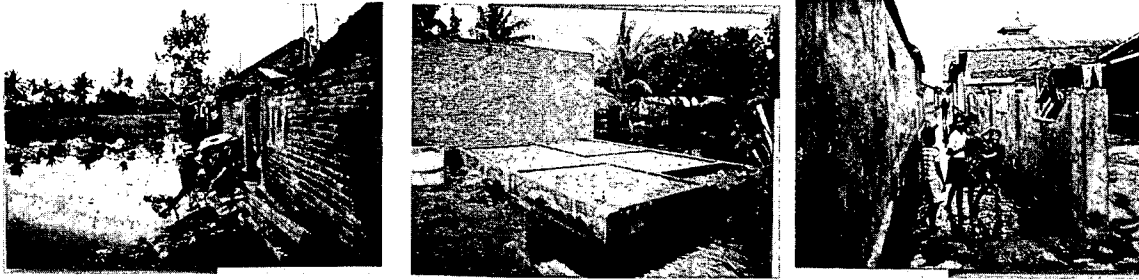
Photo 1: Inundation around the houses

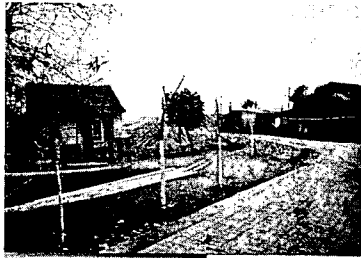
Housing area is located about 50M away from coastal line. Inundation very frequently occurs during high tide and many houses are partly submerged. Sand Embankment makes sedimentation likely faster. In one way the bank it clogs water flow from the river, but blocks the huge wave during high tide. After the huge flooding in January 2002, dike about 1 M height has been constructed to reduce house damages.

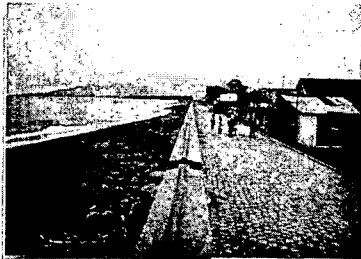
Houses are located in a cave that is about 5 – 6 meter away from the beach. The wave on January 2002 caused huge damage on the houses, its content and infrastructure. In order to prevent the next damages, local government has built concrete dike about 5 M in high along the beach and paving block road was also build. The dike and the road have been successful in reducing abrasion and tide.

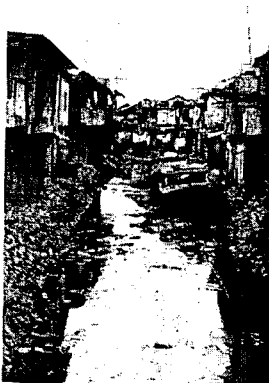
Photo. 2.7.4. Condition of Canal (Drainage), which is full of garbage

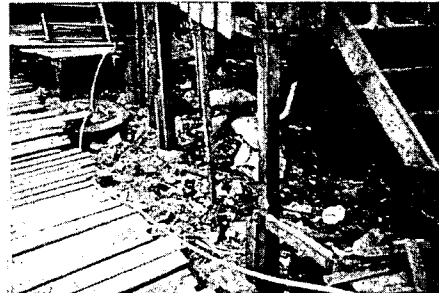
Photo. 2.7.7. Condition of underneath of house which is full of garbage

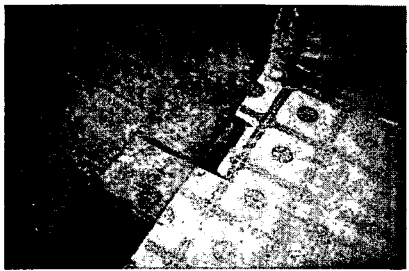
C	Two storey House	Lower storey : - Cement plaster covered by vinyl. - Trash Tile. Upper Storey : Wooden board covered by vinyl.	Lower storey : Some fungus caused by inundation for a long time Upper storey: No deterioration

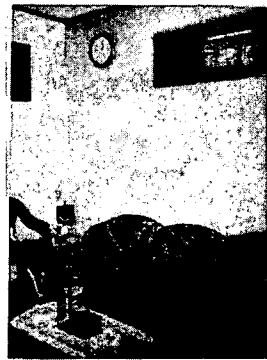
B	Platform House	- Wooden frame with plywood or zinc	- There are some peelings on plywood There are some rust on zinc	
C	Two storey House	- Lower storey : brick masonry / wooden board / plywood / zinc - Upper storey : Wooden board / plywood / zinc.	- There is no deterioration on infill wooden board. - There are deterioration on plywood wall (got peeled) There are damaged on zinc wall (rust) because of humidity from the rain. -

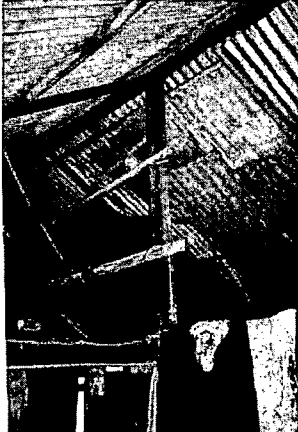
R O O F				
Type	Type of House	Material	Deterioration	Figure .
A	Detached House	- Wooden frame with zinc	There are some damage on the roof cover because of rust that can make the zinc broken and water that come into the house to damage plafond.	
B	Platform House	- Wooden frame with zinc	- Ditto -	
C	Two storey House	- Wooden frame with zinc	- Ditto -
