September 2011

**Summary of the Field Survey and Research on
“The 2011 off the Pacific coast of Tohoku Earthquake”
(the Great East Japan Earthquake)**

National Institute for Land and Infrastructure Management (NILIM)
Ministry of Land, Infrastructure, Transport and Tourism, Japan

Building Research Institute (BRI)
Incorporated Administrative Agency, Japan

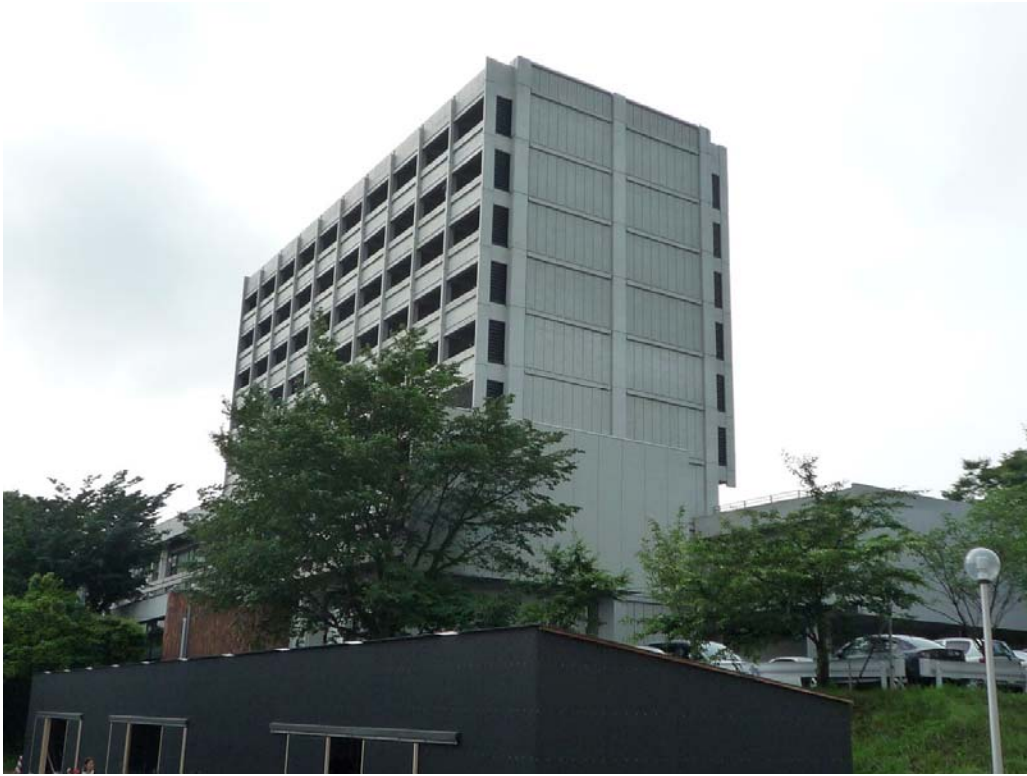
During the Tohoku earthquake, multi-story shear walls suffered bending failure and other damage. Strong motion records were obtained during the mainshock as shown in Fig. 5.3-3. Maximum accelerations on the first floor exceeded 330 cm/s^2 in both of the directions. A maximum acceleration on the ninth floor was twice to three times larger than that on the first floor, and exceeded 900 cm/s^2 in the transverse direction. The fundamental natural periods in Fig. 5.3-3 (e) represented about 0.7 s at the initial time of the earthquake motion in both of the directions, but increased to about 1 s in the first wave group at the time of 40 to 50 s, and increased from 1.2 s to about 1.5 s in the second wave group at the time of 80 to 100 s. Due to the seismic damage, the fundamental natural period finally became twice longer than the natural period at the initial stage. The stiffness of the building was reduced to 1/4.

Photo 5.3-1 The research building of Tohoku University

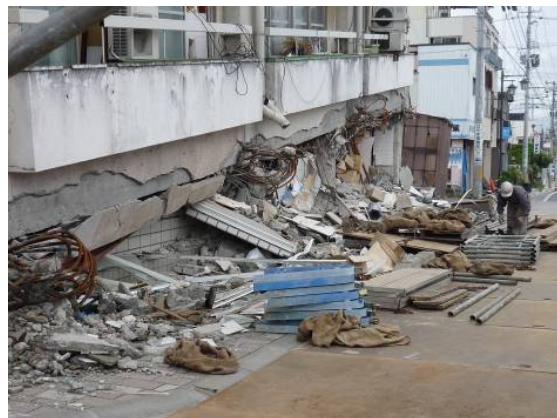
Photo 6.3-3 Close-up view of the fallen story

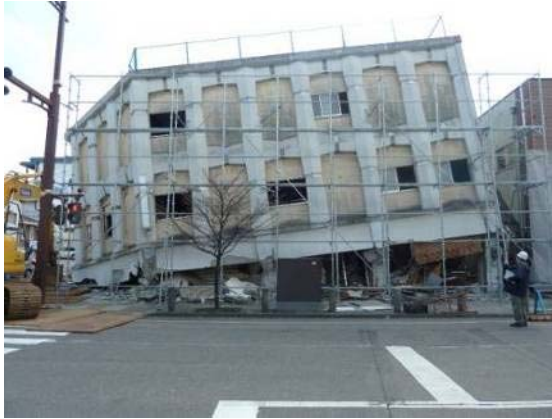
The three-story RC building shown in Photo 6.3-4 was severely damaged on the first story, which was located at the intersection in Sukagawa city, had a few walls on the facade on the first story and many walls on the back of the first story and the second story and higher. The corner columns faced to the intersection were significantly destroyed as shown in Photo 6.3-5. The loss of axial load carrying capacity of the first-story columns caused the drop of the second and higher stories.

Photo 6.3-4 First-story collapsed building (Sukagawa city)

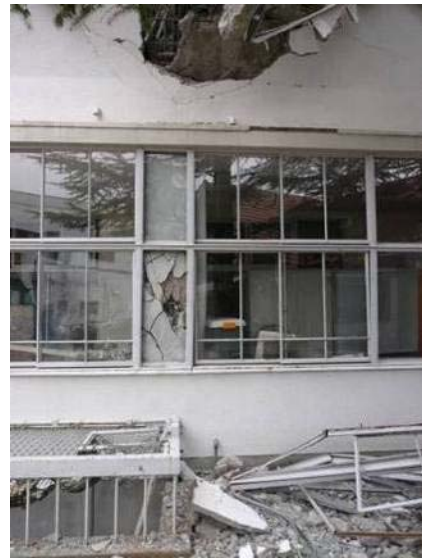
Photo 6.3-8 Shear failure of the first-story column

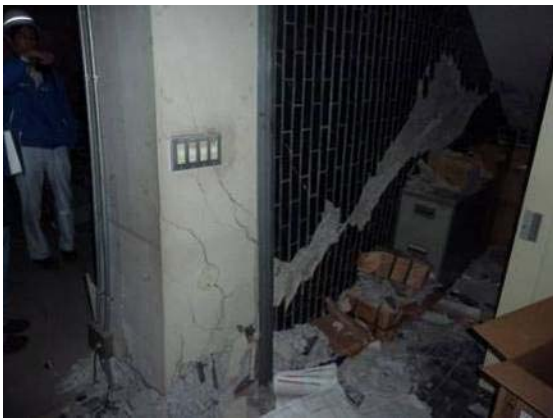
Photo 6.3-10 Shear crack on shear wall

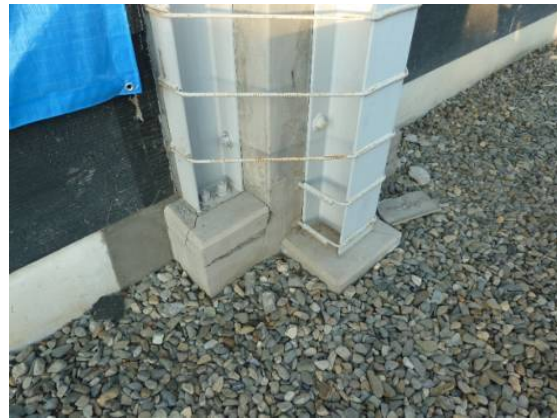
Photo 6.3-11 Column strengthened with H-shaped steel

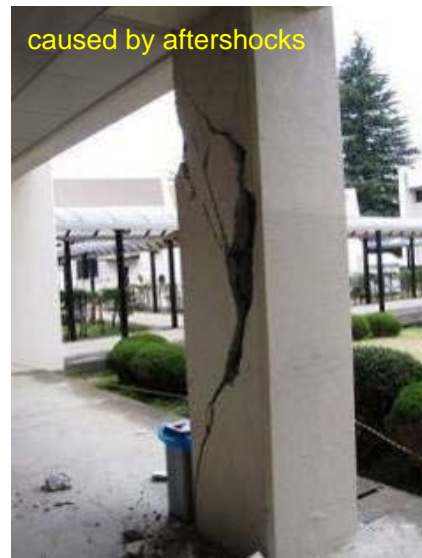
Photo 6.3-13 Shear cracks of first-story columns

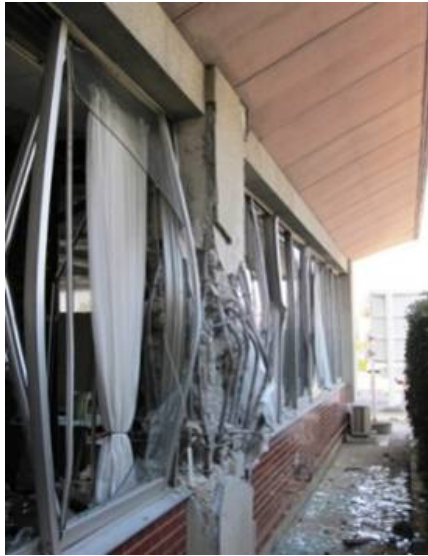
Photo 6.3-15 Shear failure of short column

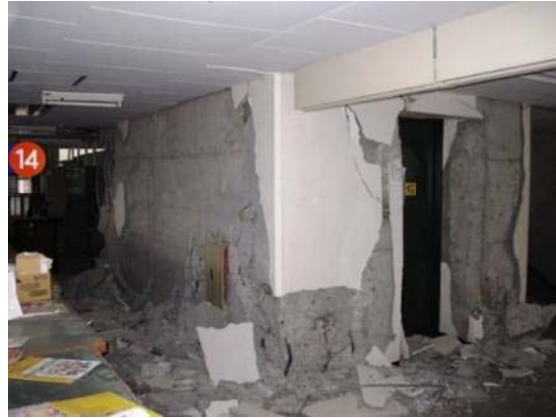
Photo 6.3-16 Failure of shear wall

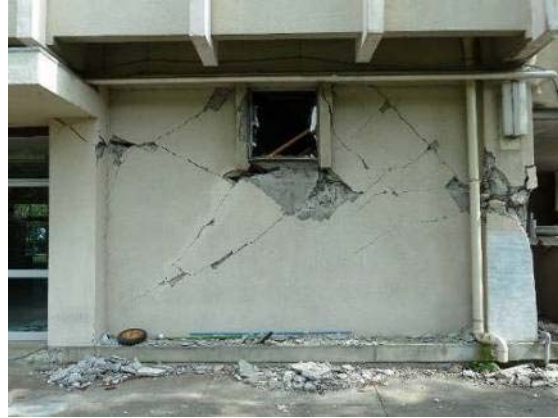
Photo 6.3-19 Shear failure of wall with opening

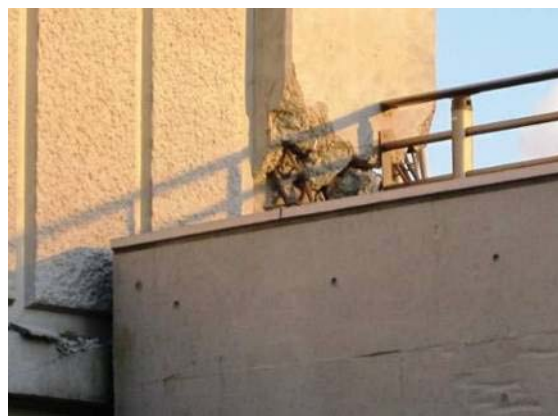
Photo 6.3-21 Crushing at the bottom of column of the multi-story shear wall

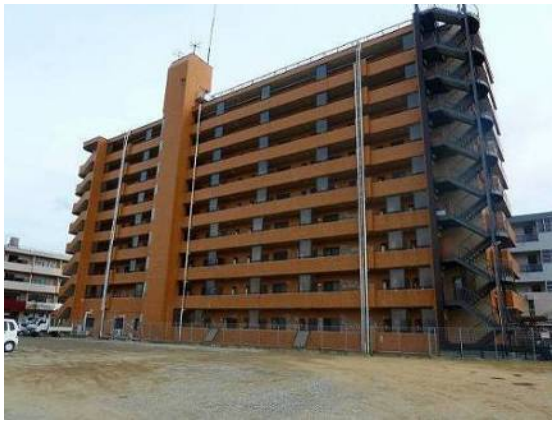
Photo 6.3-22 shows the appearance of a damaged building, which is the nine-story SRC residential building constructed in 1991 in Koriyama city. Pullout of anchor bolts, buckling of reinforcing bars and compressive failure of concrete occurred at the corner column and the bottom of multi-story shear wall in the first story, as shown in Photo 6.3-23, and shear cracks and bond splitting cracks were observed on the first story columns.

Photo 6.3-22 Appearance of damaged building (Koriyama city)

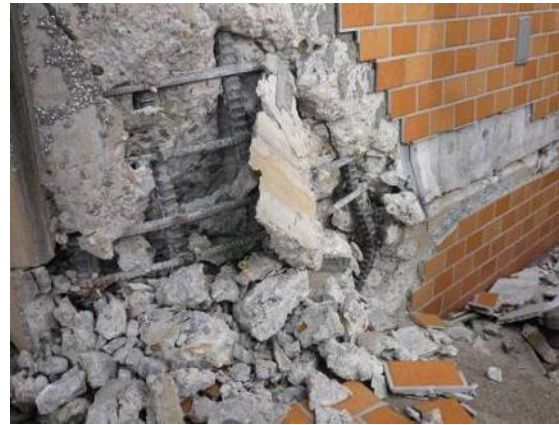
Photo 6.3-23 Damage at the bottom of SRC column

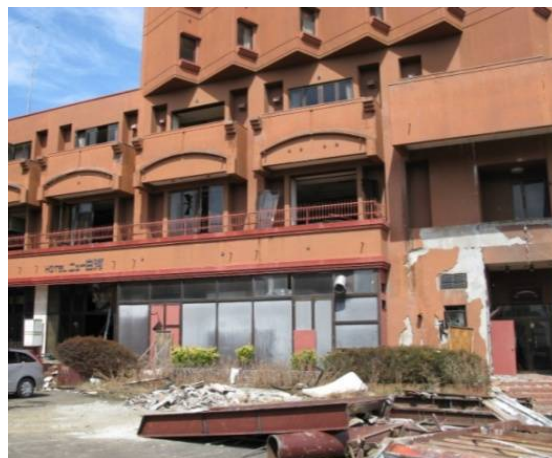
The damage at the bottom of SRC column and shear wall was also observed on the building in Shirakawa city shown in Photos 6.3-24 and 6.3-25, which was composed of RC and SRC structures. Pullout of anchor bolts of the exposed-type column base occurred. In consequence, the reinforcing bars were forced to stretch large and the buckling of them occurred around the base plate, as shown in Photo 6.3-26.

Photo 6.3-24 Appearance of damaged building (Shirakawa city)

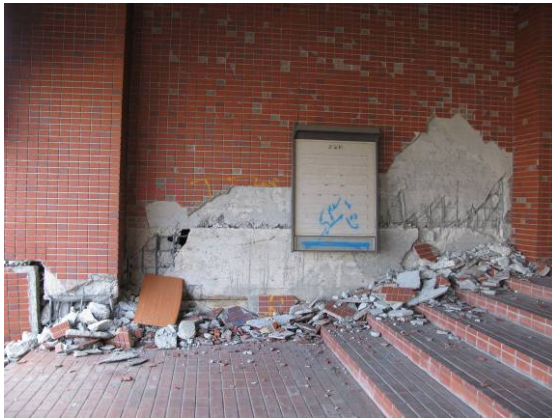
Photo 6.3-25 Damage of the bottom of SRC column and shear wall

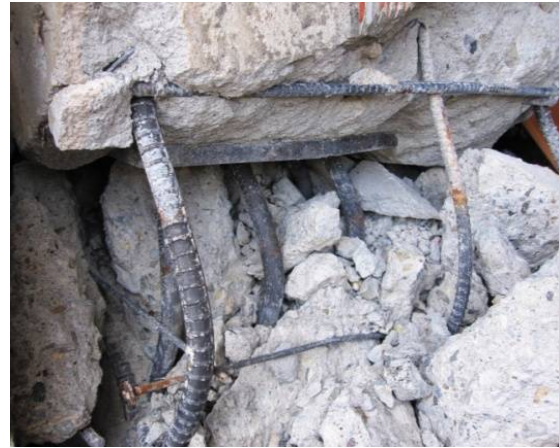
Photo 6.3-26 Close-up view of the bottom of SRC column

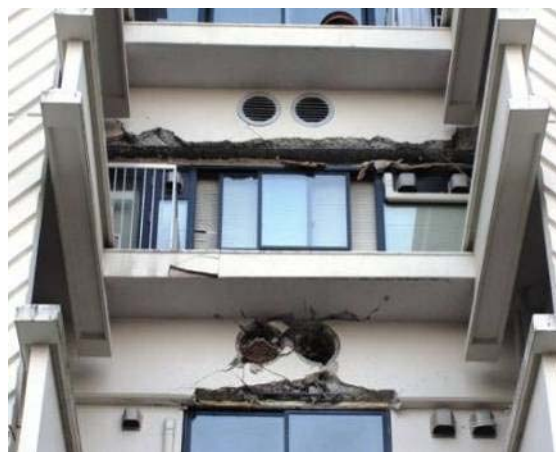
Photo 6.3-28 Damage of boundary beam with opening

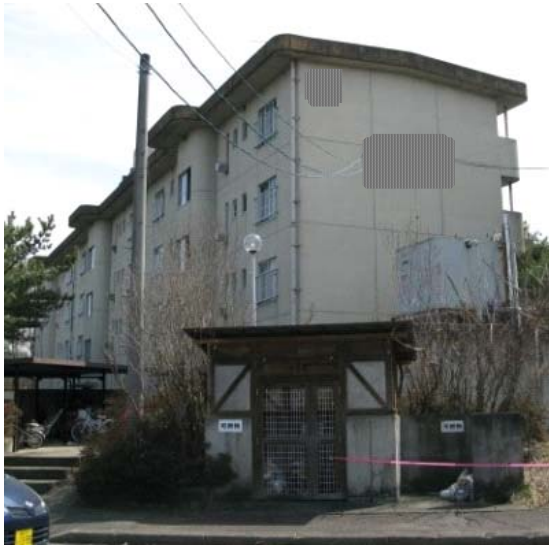
Photo 6.3-32 Appearance of sunken and leaned building (Shirakawa city)

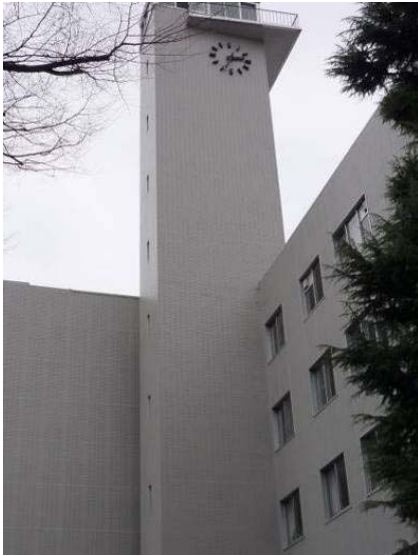
Photo 6.3-35 Damaged clock tower
(Fukushima city)

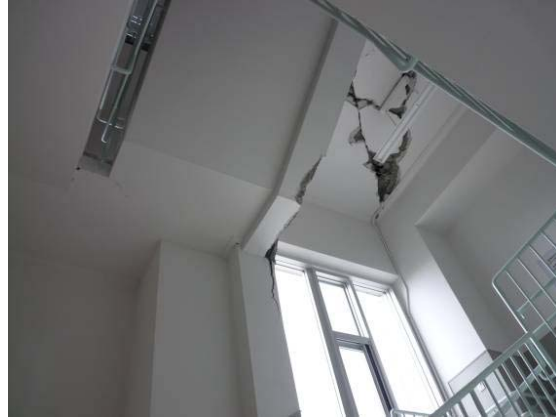
Photo 6.3-36 Bottom of the tower

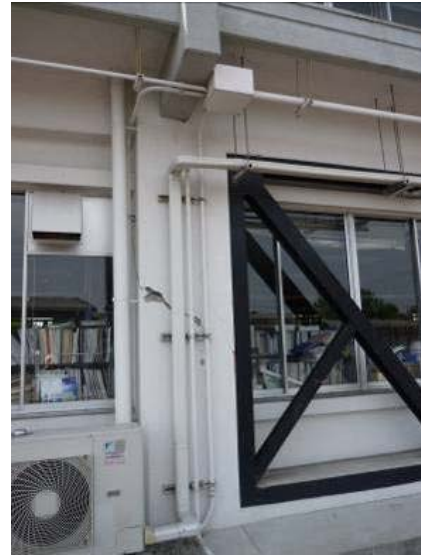
Photo 6.3-38 Shear crack on column with framed steel braces

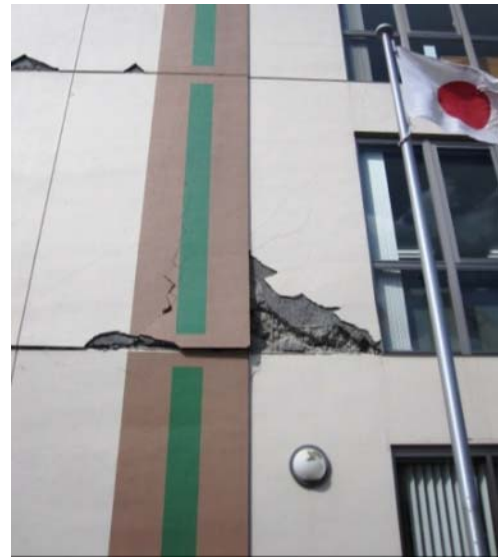
Photo 6.3-40 Separation of concrete of wing wall

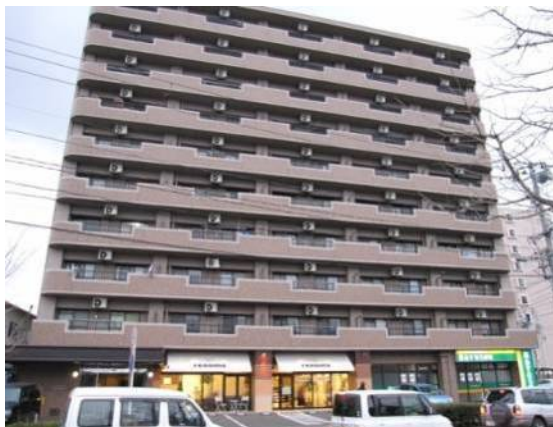
The nonstructural walls around the front doors from lower to top floors were subject to shear failure, while the doors were deformed on the ten-story SRC residential building constructed in Aoba ward, Sendai city in 1996, as shown in Photos 6.3-41 and 6.3-42. In addition, shear cracks were observed on the mullion walls on balconies in some of the lower floors.

Photo 6.3-41 Appearance of damaged building (Aoba ward, Sendai city)

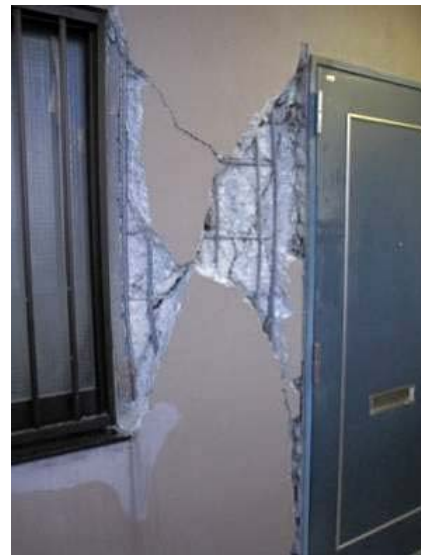
Photo 6.3-42 Shear failure of nonstructural wall

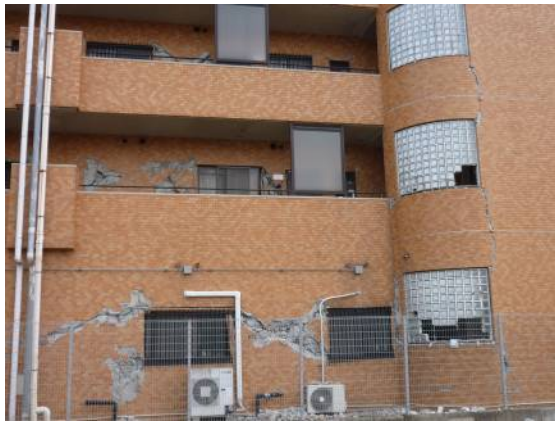
The cases where shear cracks occurred on the nonstructural walls around the front door or on the mullion wall of the balcony were relatively often observed in urban residential buildings, regardless of the seismic design codes applied to.

Photo 6.3-43 Damage of nonstructural wall in same building shown in Photo 6.3-22

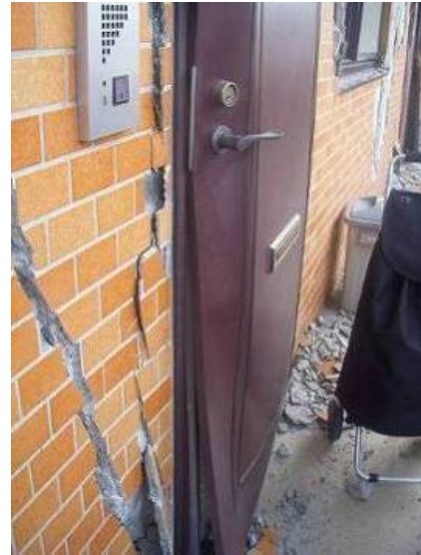
Photo 6.3-44 Damage of nonstructural wall and deformed door in same building shown in Photo 6.3-22

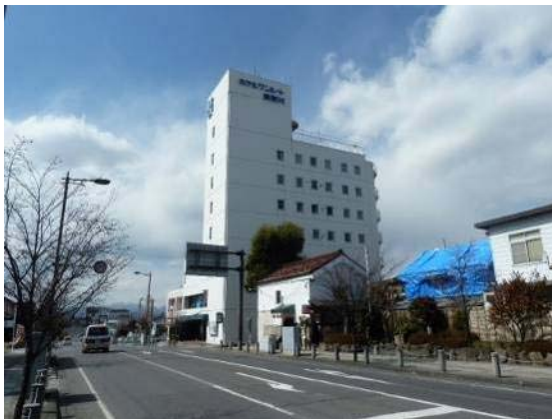
Photo 6.3-45 Appearance of damaged building (Sukagawa city)

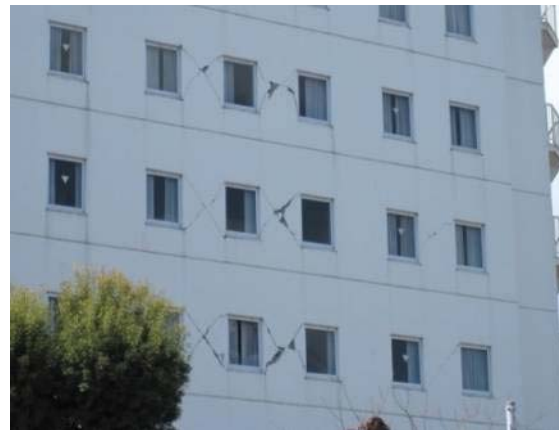
Photo 6.3-46 Shear crack on nonstructural wall

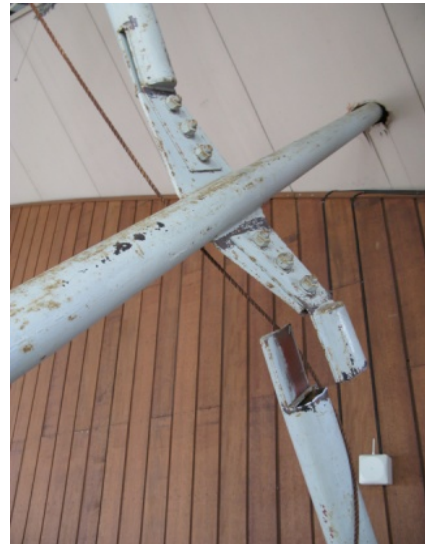
(b) Fracture at brace crossing

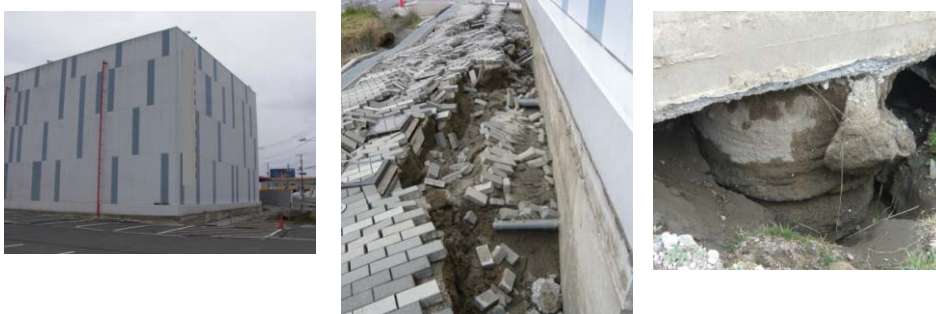
Finishes of the sidewalks around a large-scale commercial establishment along Route 11 were scattered. The subsidence of the surrounding ground was about 40 cm, and the settlement of the facility in itself was slight. The commercial building was tilted about 0.7/100 in the longitudinal direction. The pile foundation type of the building was observed from an opening between surrounding fissures (Photo 6.5-1).

Photo 6.5-1 Situations around the commercial building and state of pile head

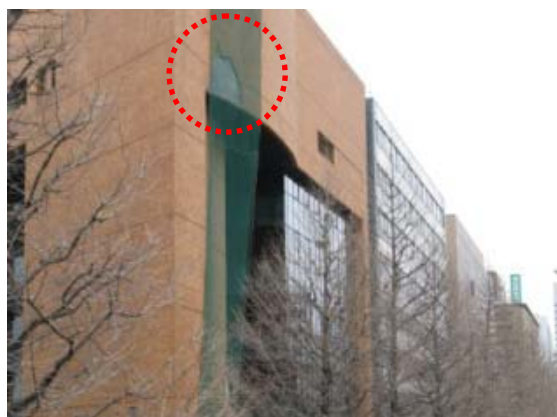
Photo 6.6-2 Detachment of ceramic wall tiles from RC wall

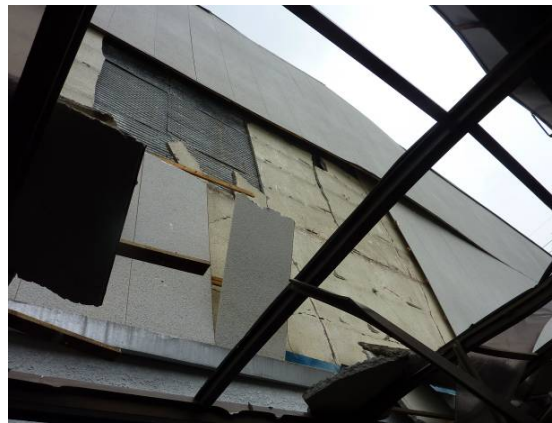
Photo 6.6-5 Damage to gymnasium gable end wall

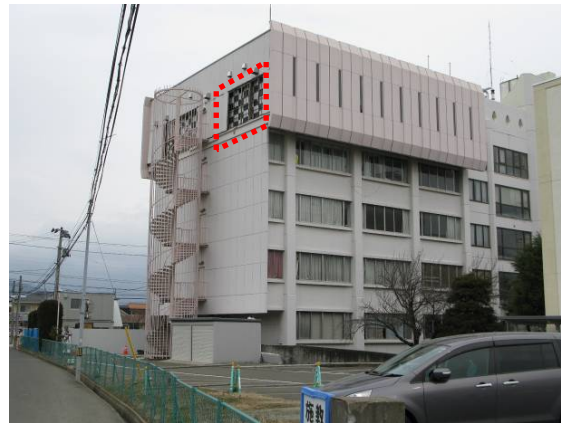
Photo 6.6-7 Detachment of AAC panels

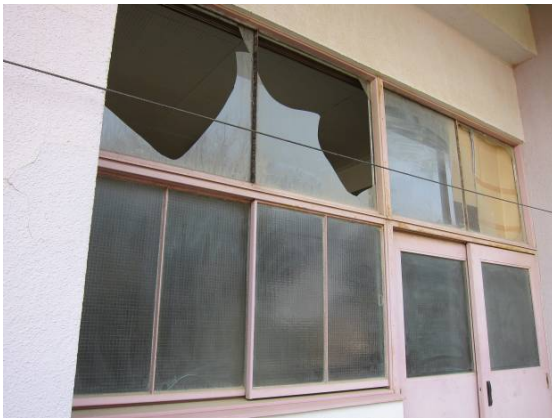
Photo 6.6-9 shows damaged window glasses installed to the upper fixed window with hardening putty at a gymnasium gable end wall. Cracked wired window glasses were also observed at the lower double sliding window with hardening putty. Flaking of paints was observed on the center of an arch beam of the gymnasium. Photo 6.6-10 shows breakage of window glasses in a gymnasium. The window glasses were installed to fixed window frames with glazing bead and twelve window glasses were broken at three exterior surfaces. There were observed flaking of concrete at the roof bearing support part, deformation of almost all roof horizontal braces and fracture of one roof horizontal brace in the gymnasium.

Photo 6.6-9 Breakage of window glasses installed to fixed window frame with hardening putty

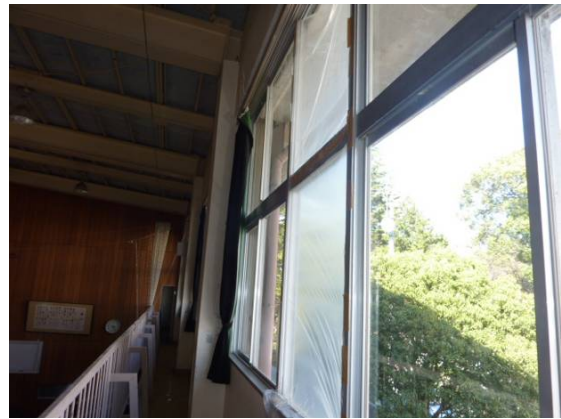
Photo 6.6-10 Breakage of window glasses installed to fixed window frame with glazing bead

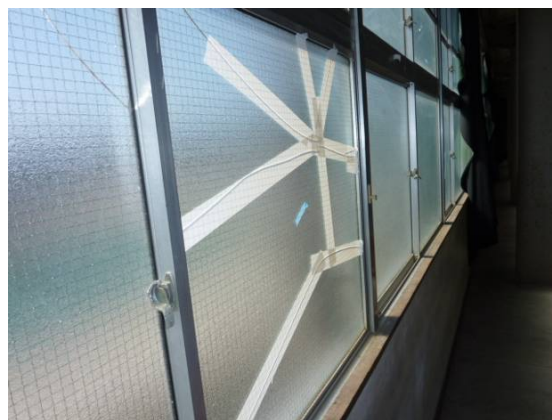
Photo 6.6-11 Breakage of wired window glass installed to double sliding window frame with glazing bead

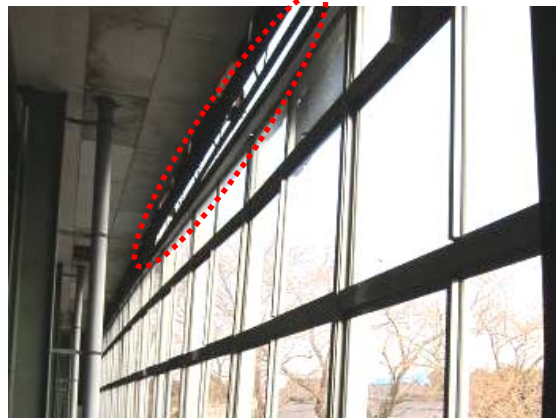
Photo 6.6-13 Dislocation of window frame

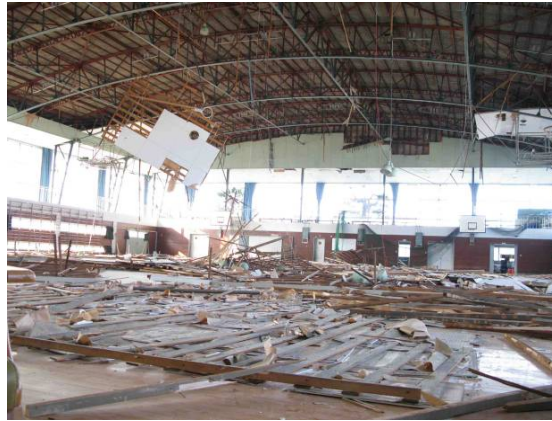
Photo 6.6-14 Falling of wooden suspended ceiling

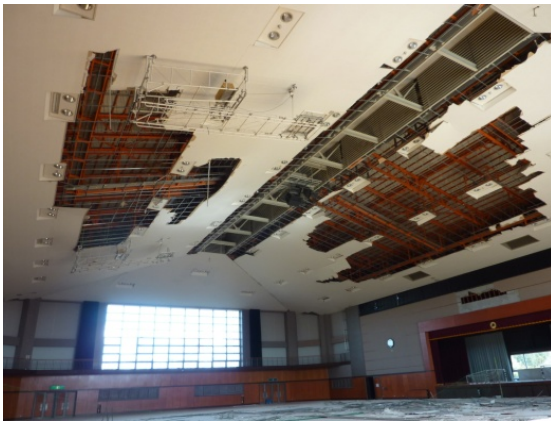
Photo 6.6-15 Falling of metal furring suspended ceiling

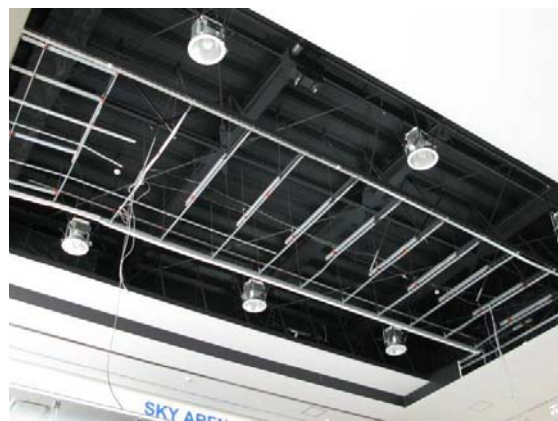
Photo 6.6-16 Falling of metal furring suspended ceiling

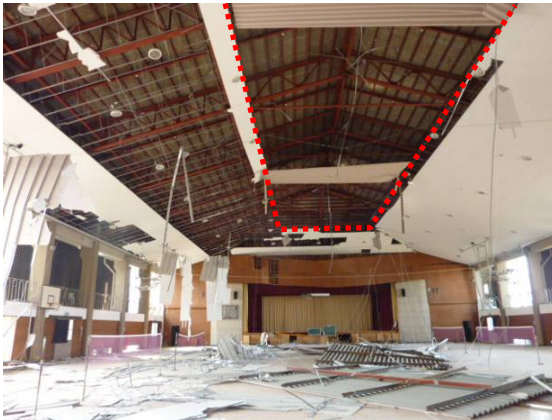
Photo 6.6-17 Falling of metal furring suspended ceiling and corrugated steel plates

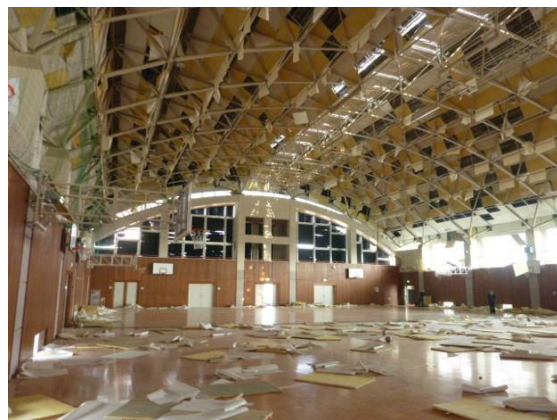
Photo 6.6-18 Falling of glass wool board of T system ceiling

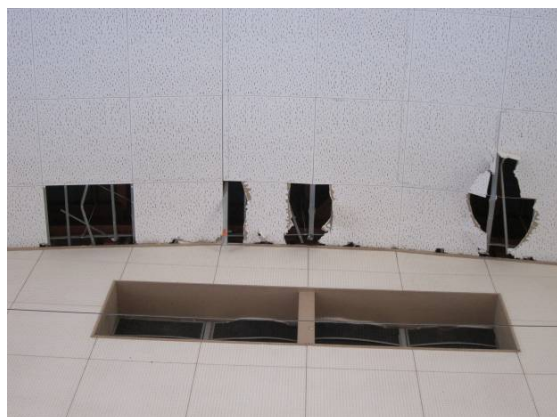
Photo 6.6-20 Damage to metal furring ceiling at the connection wall

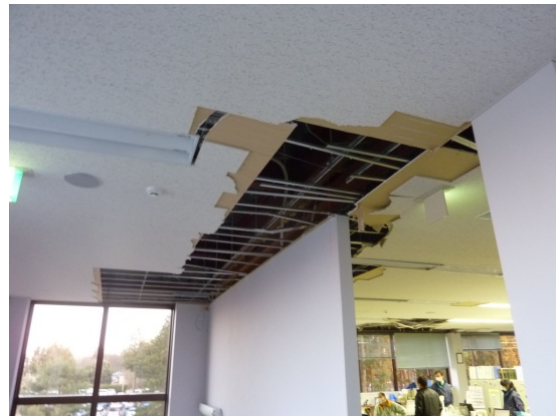
Photo 6.6-22 Damage to metal furring suspended ceiling at the connection

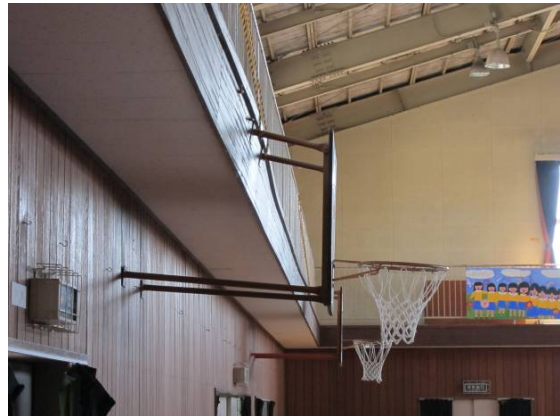
Photo 6.6-25 Damaged interior wall

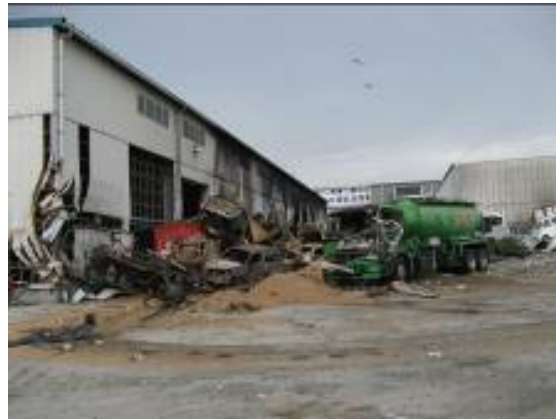
Photo 8.2-2 Tsunami fire at a port warehouse (Sendai city, Miyagi prefecture)

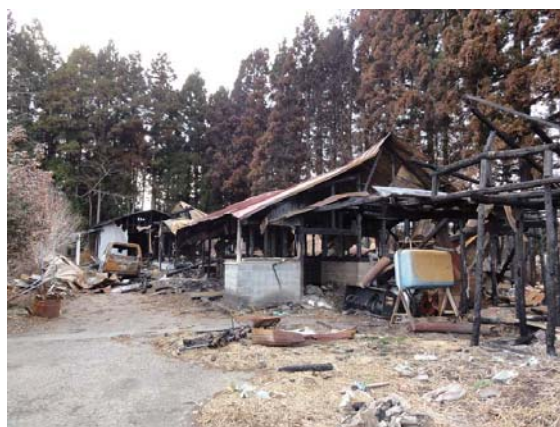
Photo 8.3-1 Fire scene of a house (Oushu city, Iwate prefecture)

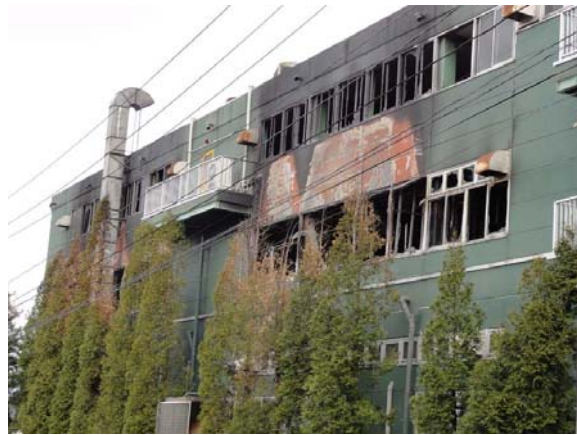
Photo 8.3-2 Fire scene at a factory building (Oushu city, Iwate prefecture)

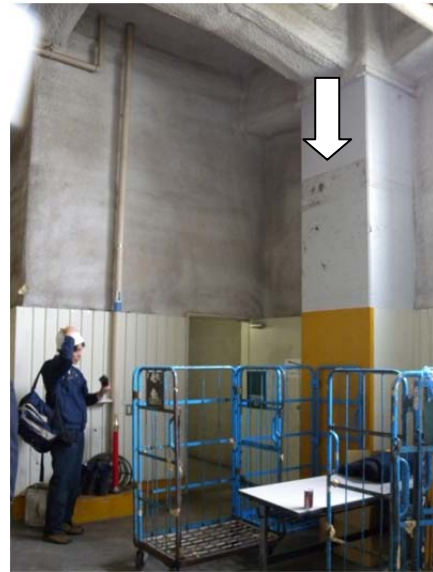
Photo 9.2-7 Trace of tsunami water

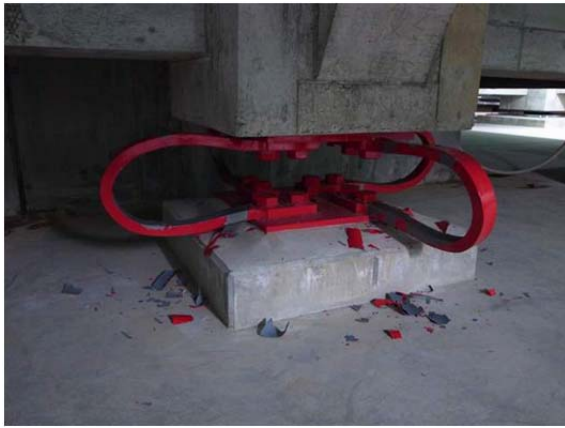
(a) Peeling off of paint
