## 2. Field scanning records

## 2.1. Antakya city and Hatay Airport Road

### 2.1.1. Viaduct on D817 near Saraykent, Antakya city

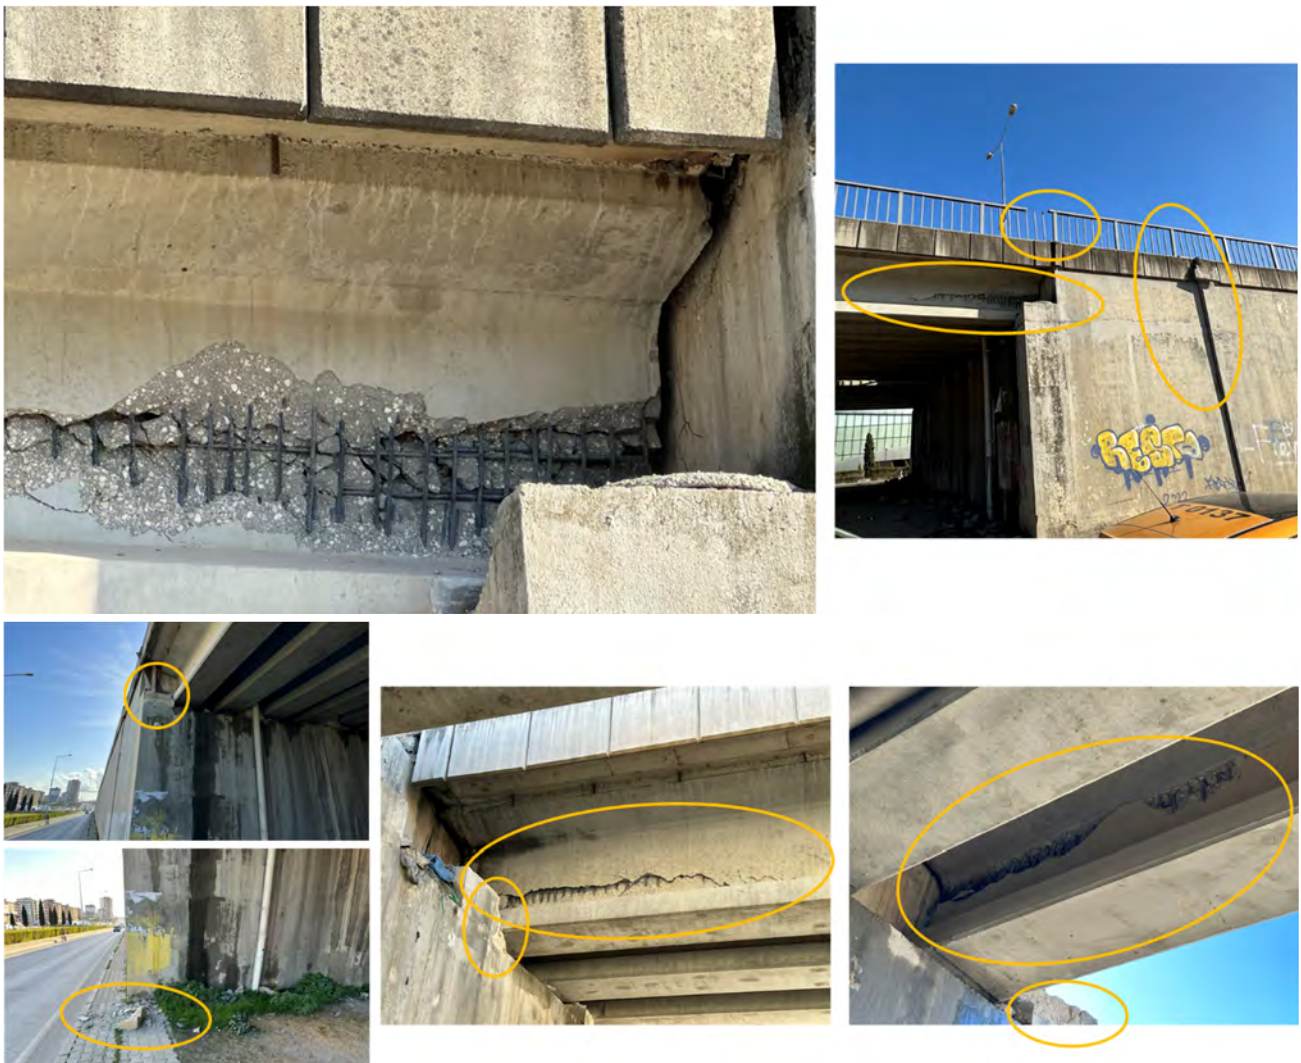
**Figure 2.1-3.** Damage to girder ends and shear keys

As shown in **Figure 2.1-3**, the ends of the girders were damaged. Although the bridge did not collapse, its shear keys and girder ends were severely damaged. The concrete inside the vertical and horizontal reinforcing bars was damaged, and the reinforcing bars were deformed, indicating that the shear strength of the girder ends decreased significantly. Assuming that these girders are prestressed concrete beams, the

present stress condition should be a significant concern because of the failure of the concrete cross-section. The spacing between the link slab support and the girder end was narrow, causing the girder ends to collide with the link slab support and the shear keys. There were no diaphragms at the girder ends. Theoretically, the energy generated by a collision could concentrate more on girder ends without an end diaphragm than on those with an end diaphragm. Another theory is that girder webs could be loaded transversely because of the inertial loads from the deck slab to the bearings or the shear keys and be damaged under out-of-plane flexure and shear in the absence of an end diaphragm.

Therefore, the seismic principles for controlling the location and form of damage in bridges must be studied. The damage to this bridge indicates that the lack of end transverse girders may severely exacerbate damage. Although seen from the inside of a moving vehicle, similar damage was observed on the girder ends on the abutment and the shear keys in another elevated bridge (same type) of D817 in the same city. Because several bridges have the same structural type and were similarly damaged, improving the typical structural details of their girder ends is recommended. Similar damage to concrete girder bridges was reported during the 2010 Chile Earthquake, and the effectiveness of a transverse diaphragm at girder ends has been discussed (Kawashima et al., 2011; Yen et al., 2011).

In addition, the existence of shear keys could hinder post-event inspection at the ground level. The spacing between the shear keys and the girders or between the link support and the girder ends of the bridge was extremely narrow to approach. Therefore, the effectiveness of designing a feasible process for inspecting girder ends and their surroundings should be studied.

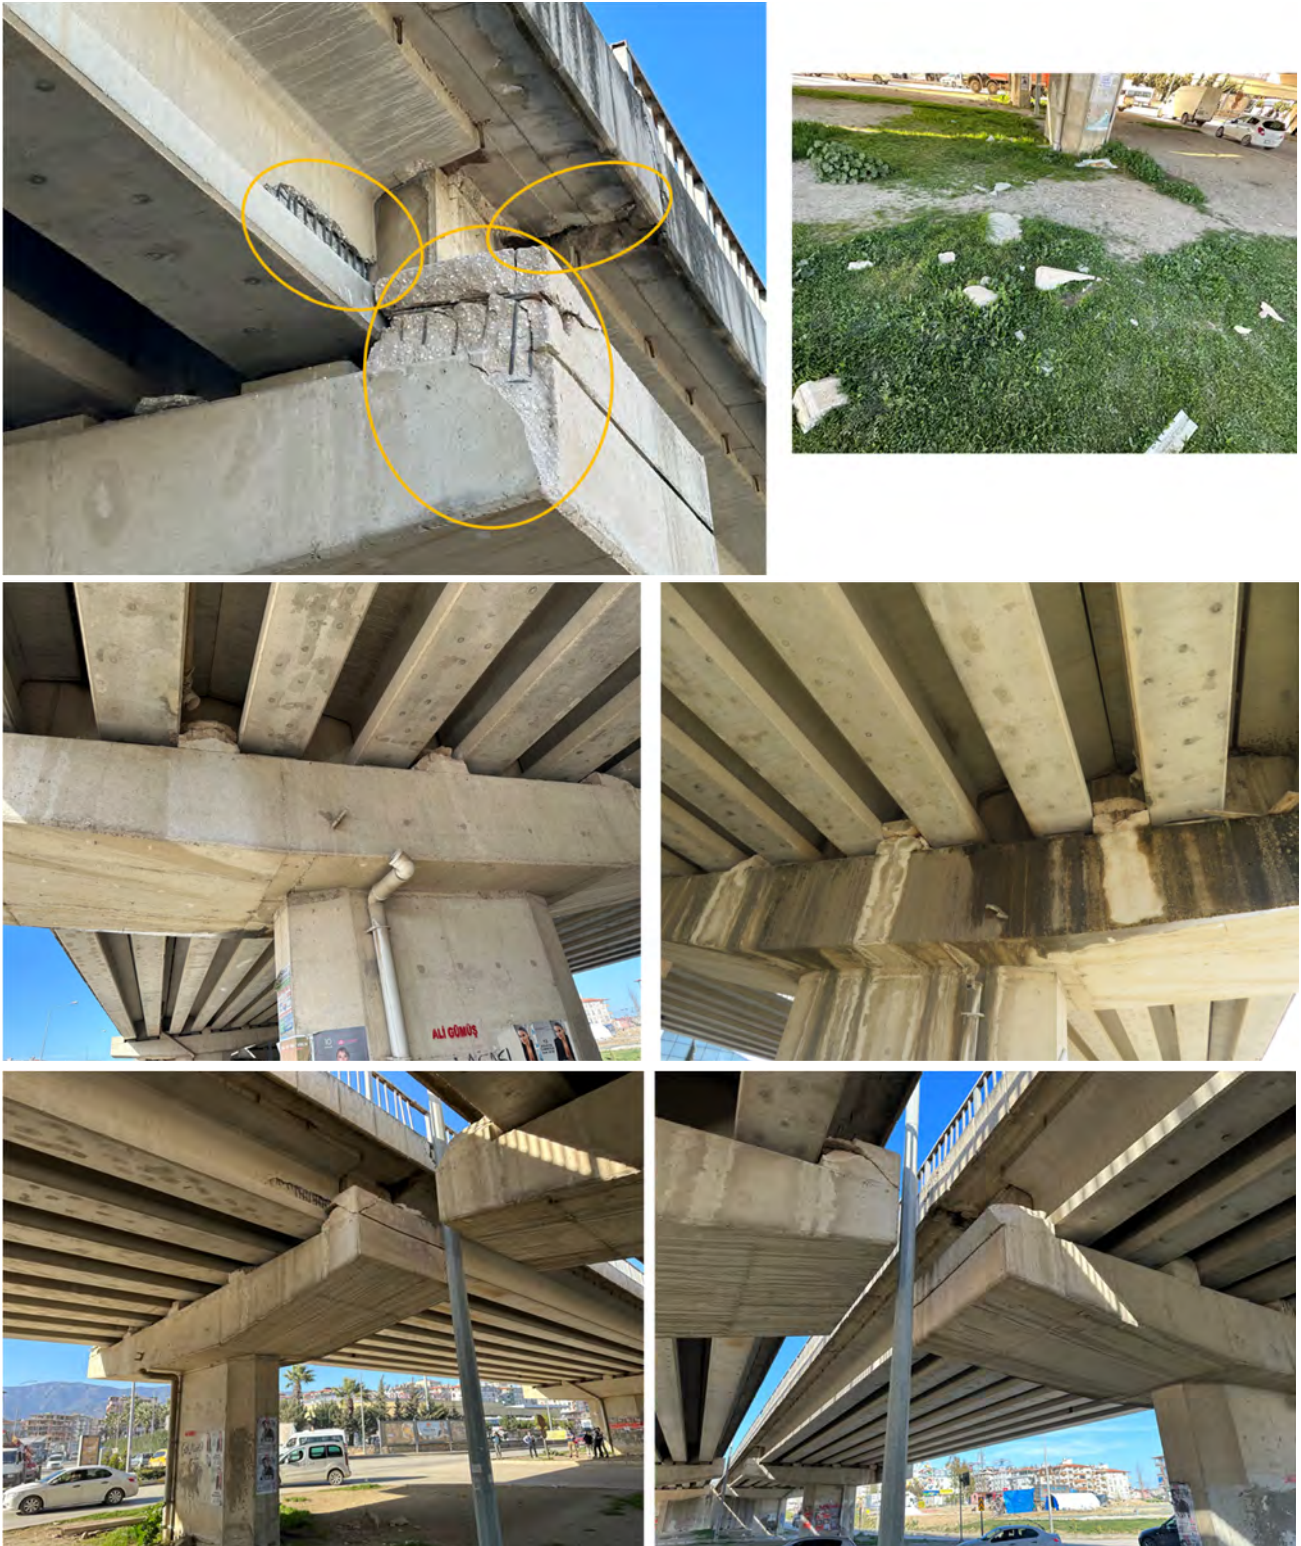
Figure 2.1-4. Examples of observed damage to girder ends and shear keys

On all piers, shear keys, link slabs, and girder ends were damaged (Figure 2.1-4), whereas no damage was found on the piers (Figure 2.1-5).

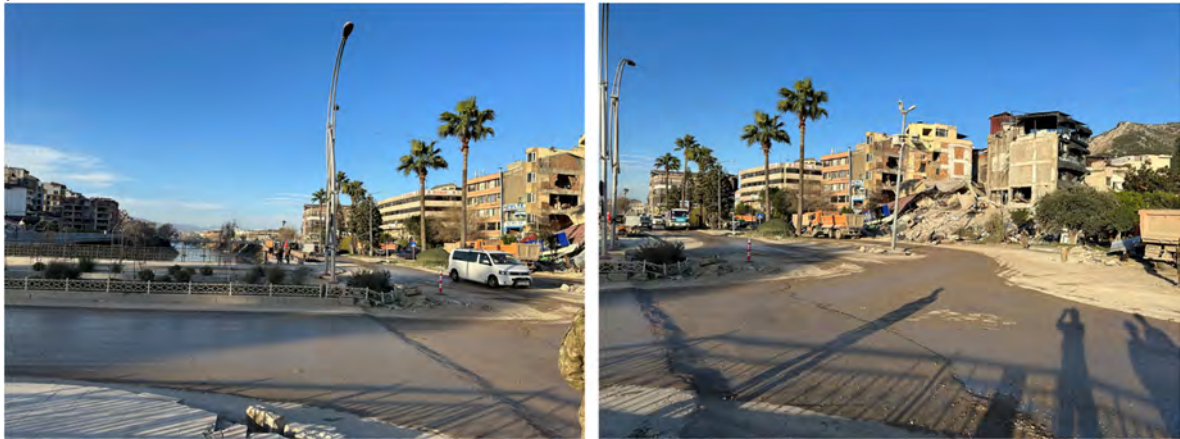
**Figure 2.1-11.** Approaches to Bridge #3

There were cracks on the road surface behind the abutment (**Figure 2.1-11**). Surrounding buildings had collapsed.

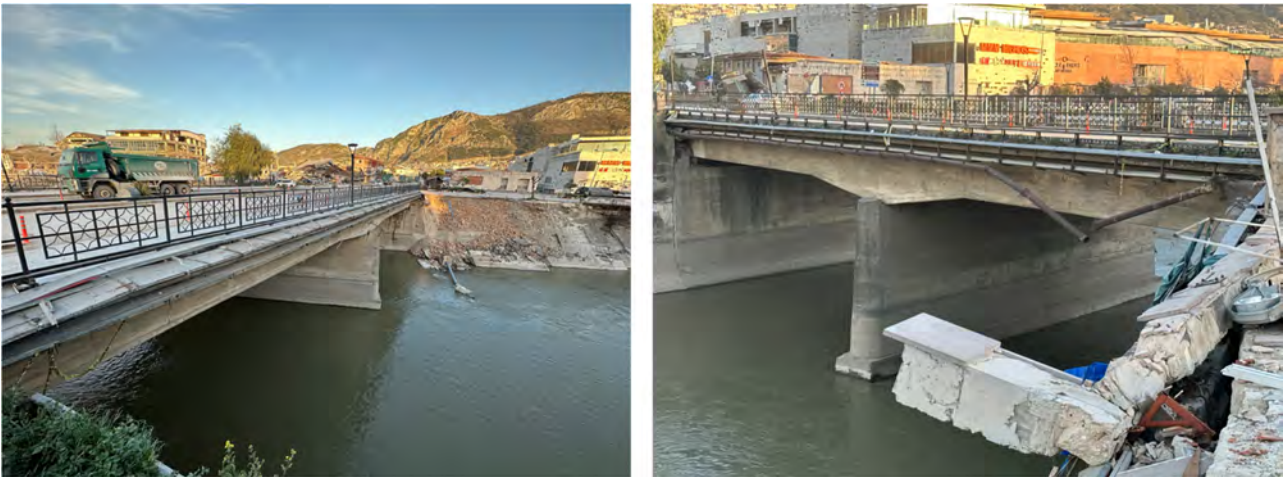
**Figure 2.1-13.** Bridge #4

Bridge #4 was a concrete bridge. Many construction vehicles passed over it (**Figure 2.1-13**).

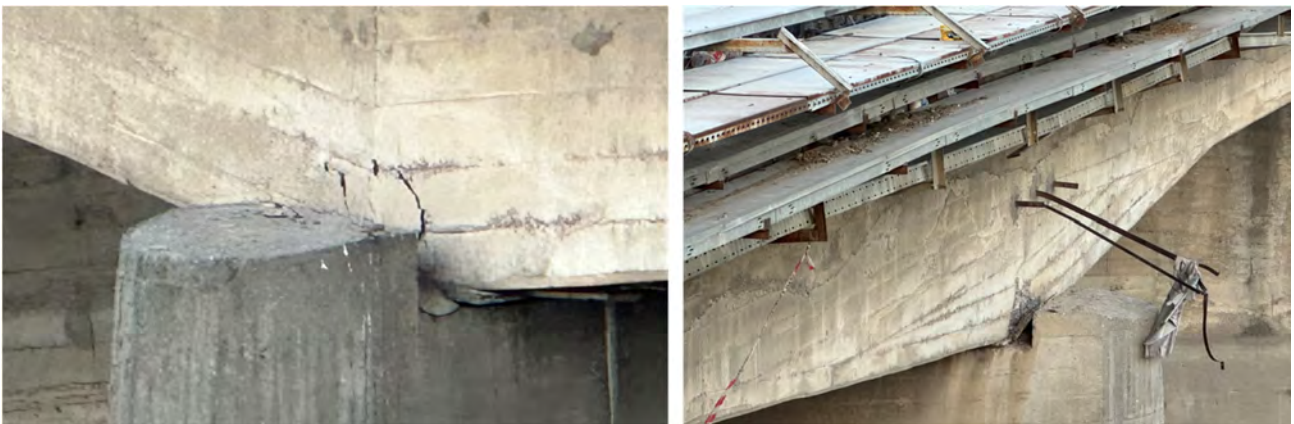
**Figure 2.1-14.** Example of damage to Bridge #4

As shown in **Figure 2.1-14**, the girders and shear keys on the upstream side had almost no gap and cracks were developed at the integral part of the girders and piers (left photo). In contrast, the girders and shear keys on the downstream side (right photo) showed a gap. The superstructure may have moved laterally and longitudinally owing to the earthquake. The cracks in the concrete of the girders could be due to the contact of the girders to the shear keys. However, if the pier and the girders were connected with Menase hinge bearings, the cracks could also be due to the spread of the damage along the extension of the Menase hinge reinforcing bars inside the girders.

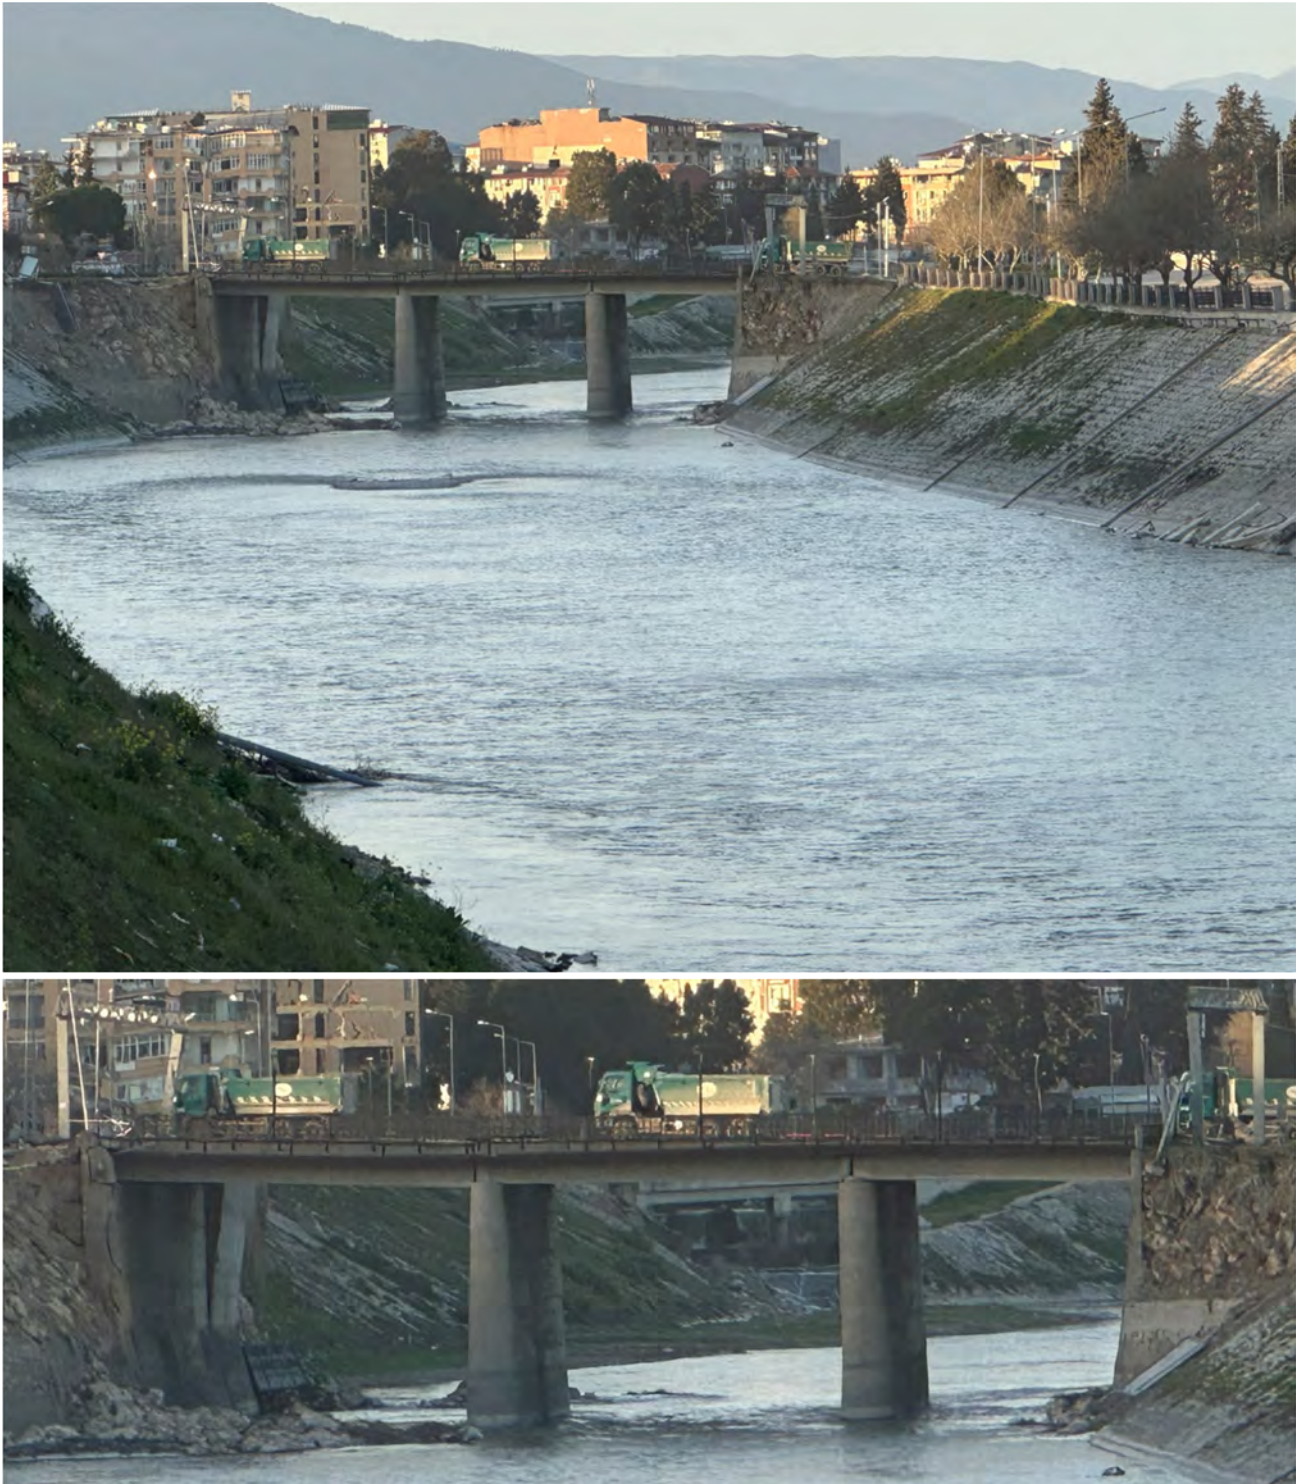
**Figure 2.1-17.** Photos of a bridge taken from Bridge #4

A bridge seen from bridge #4 is a three-span simple girder bridge. The embankment on the side of the right abutment in the photo collapsed. There were concerns about the alignment of the superstructure and damage to the bearings; however, we could not investigate this because of time and schedule constraints. Many construction vehicles used for removing debris passed over it.

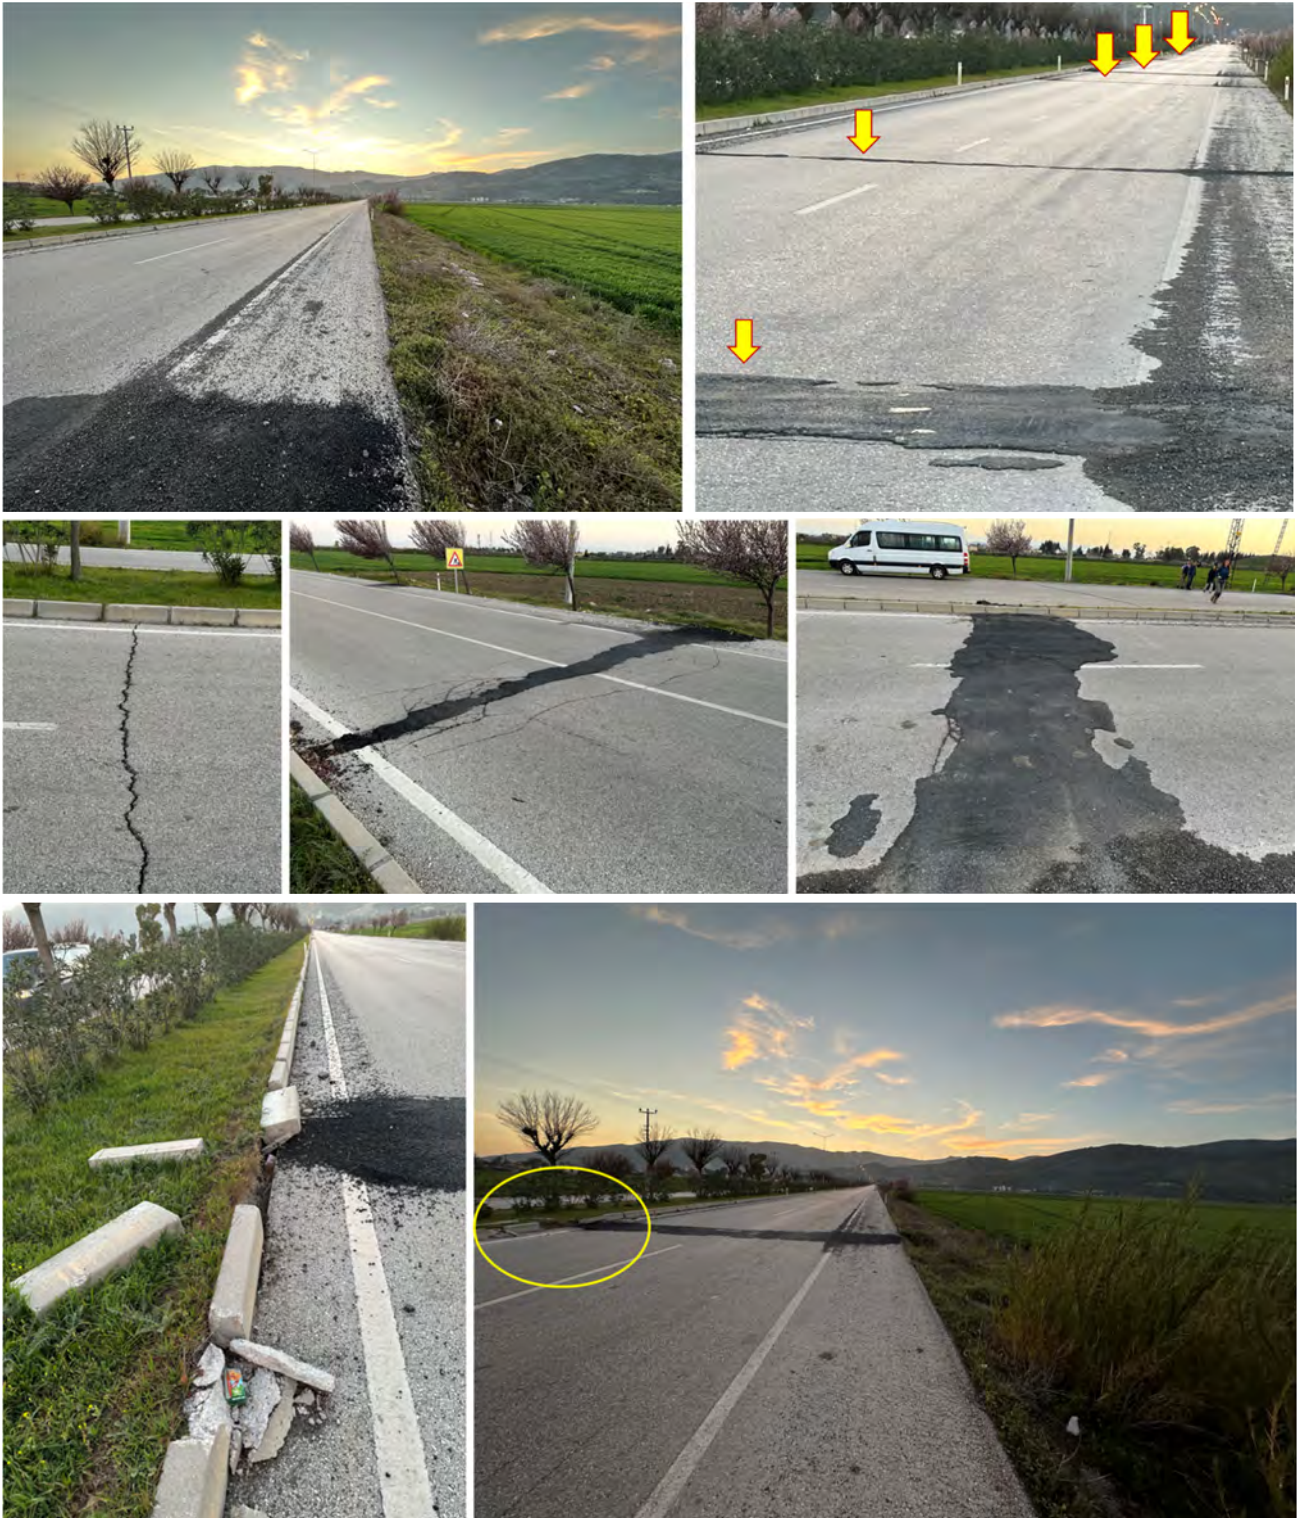
**Figure 2.1-19.** Cracks on surface of Hatay airport road

As shown in **Figure 2.1-19**, the road surface was cracked in several places and certain parts of the road were repaired. A relationship between the road surface cracks and crossing structures such as waterway pipes was supposed; however, no waterway was found within the confirmed range.

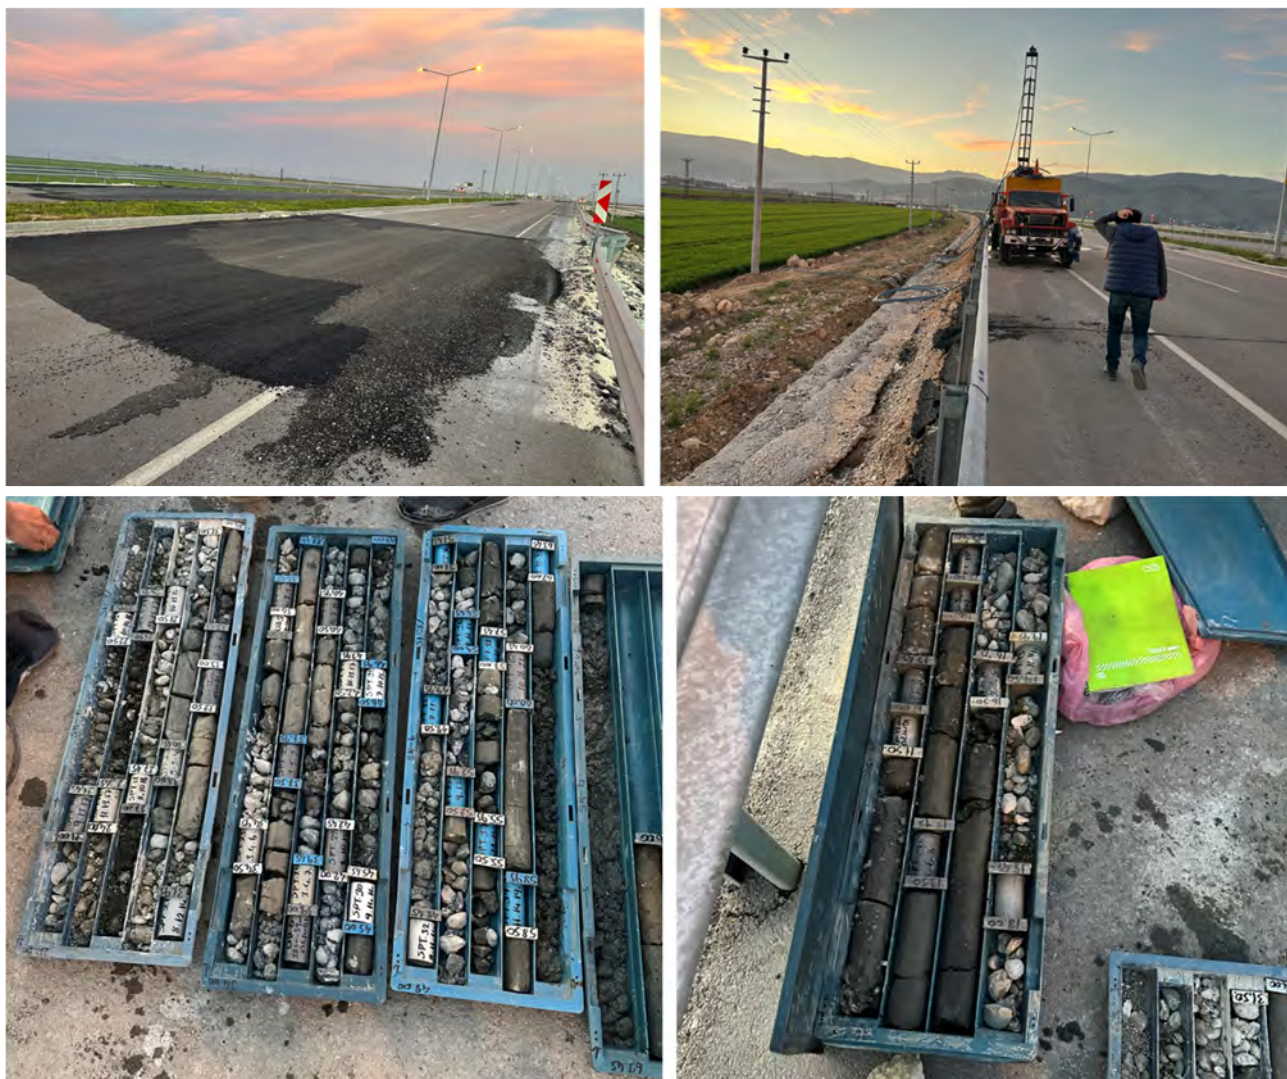
**Figure 2.1-20.** Examples of observed damage and boring investigation

As shown in **Figure 2.1-20**, in some places, the pavement was repaired over a relatively wide area. A boring survey was conducted and the cores showed that the subsoil consisted of thick cohesive soil layers.

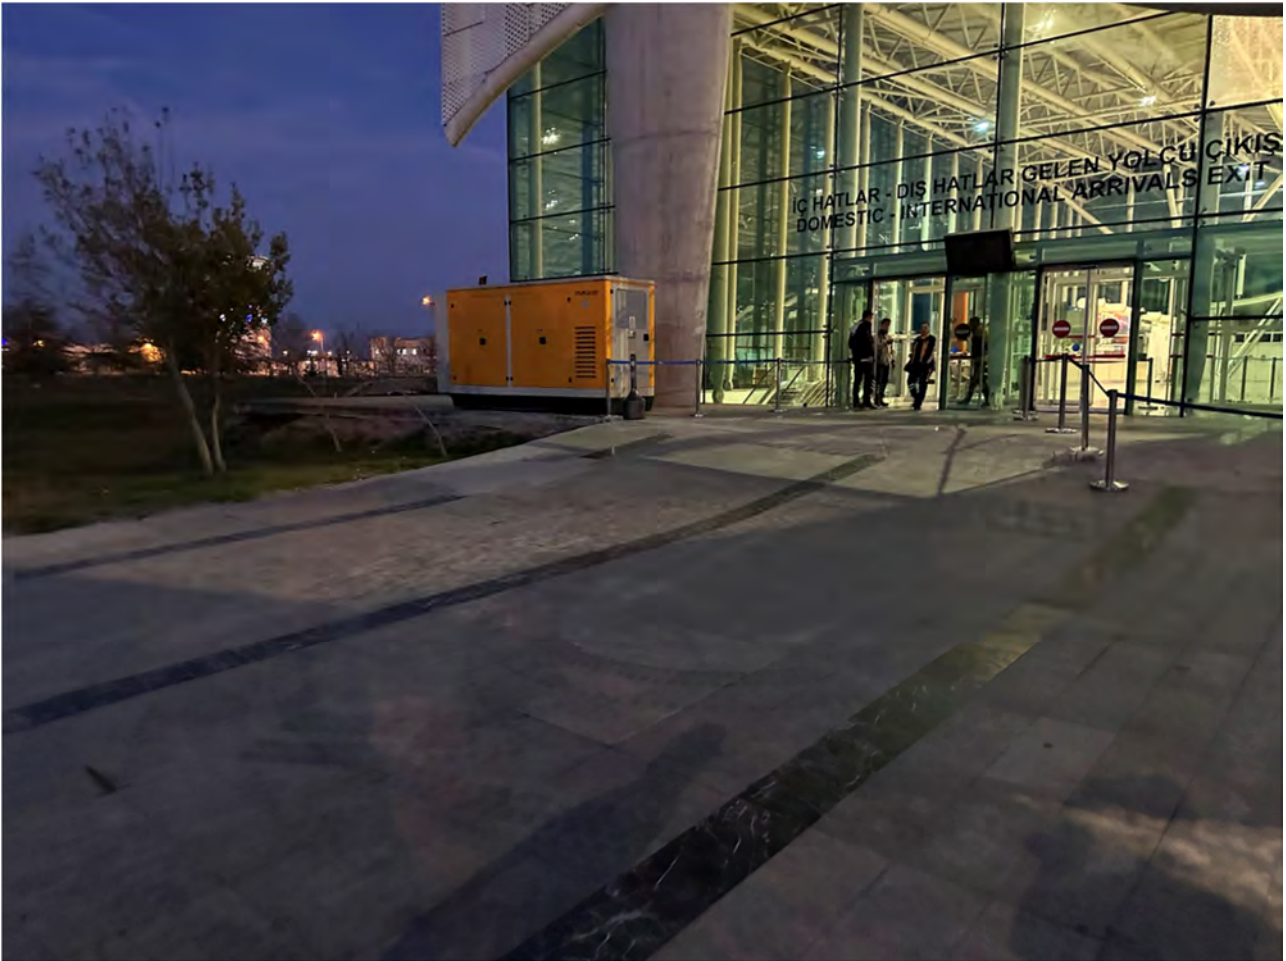
Figure 2.1-21. Slumping of ground surrounding Hatay Airport Terminal building

Figure 2.1-21 shows that the ground around the Hatay airport terminal building subsided.

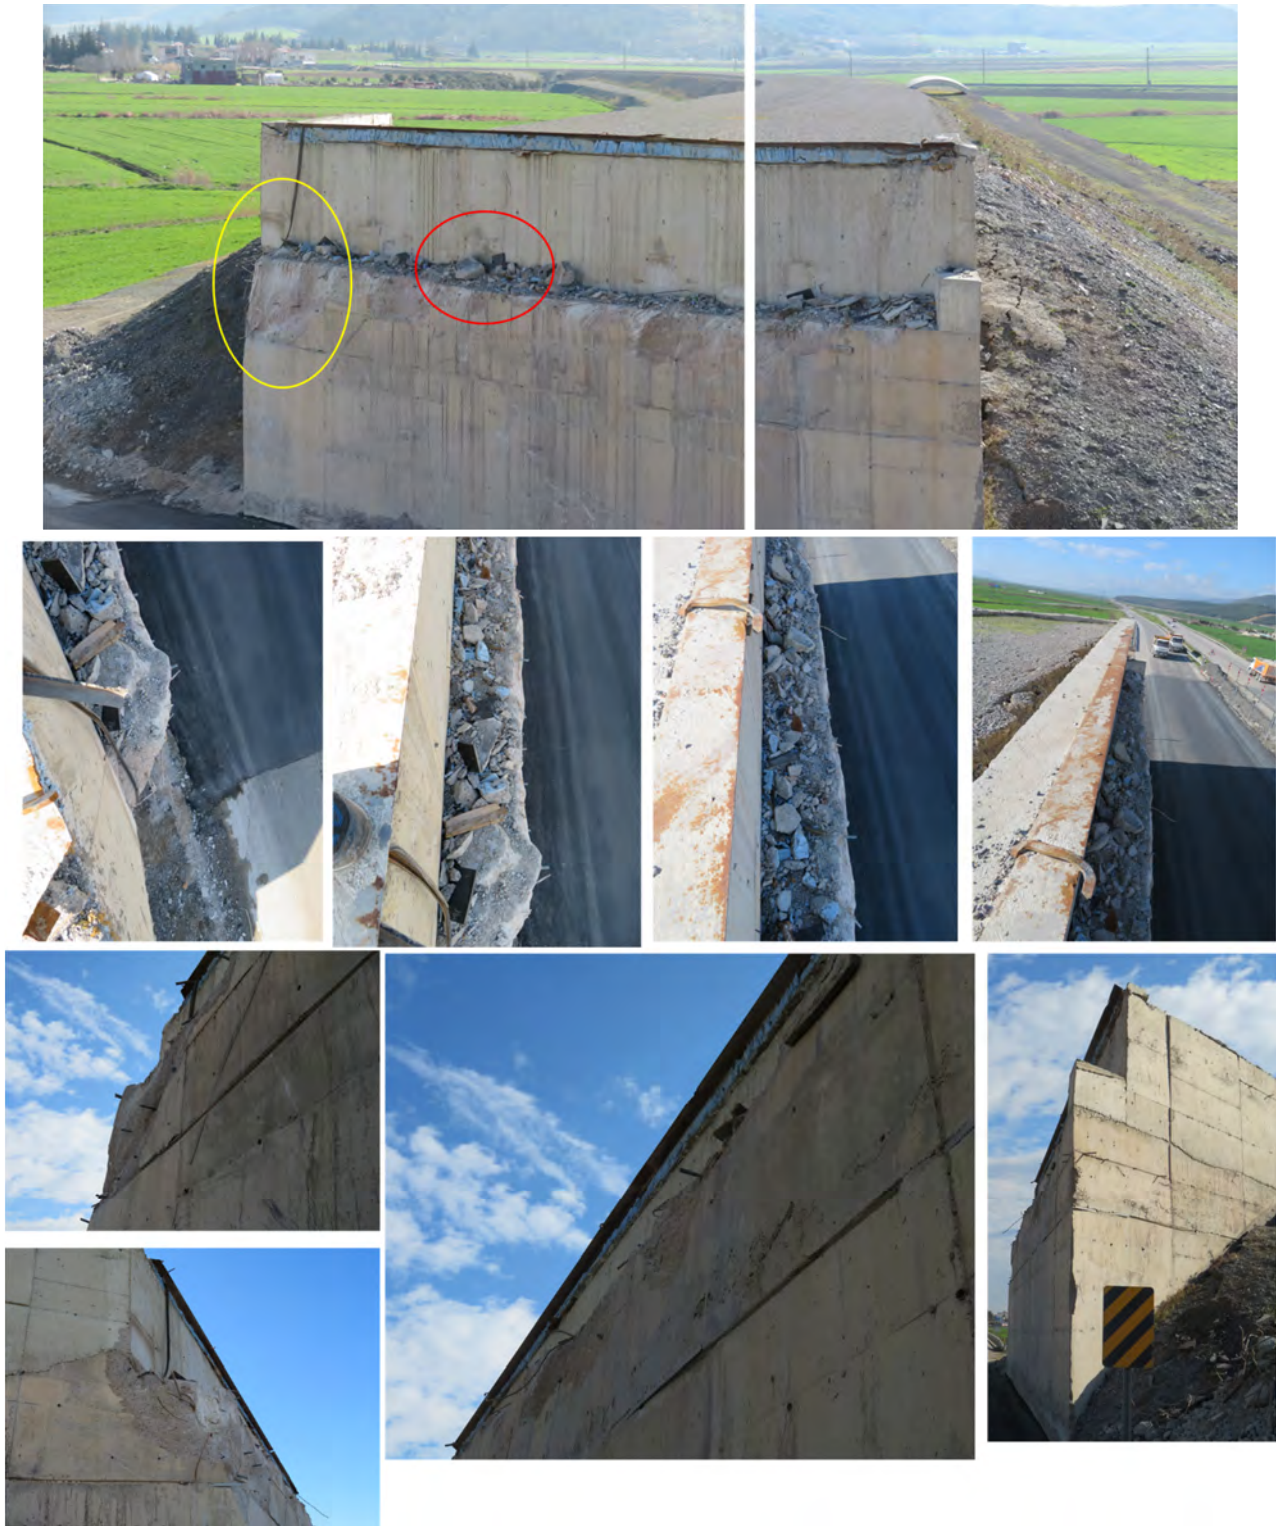
**Figure 2.2-4.** Observed damage to east-side abutment

Although the shear key on the left side was destroyed, there was no trace of contact with the girder on the shear key or the parapet on the right side (**Figure 2.2-4**). Scratches on the abutment and spalling of concrete were observed, which were caused when the girders fell off the acute side. Rubber pads were used as a part of the bearings. However, shear keys assumed to have been set between the girders were not observed. Information on whether they were destroyed or did not exist from the beginning was unavailable.

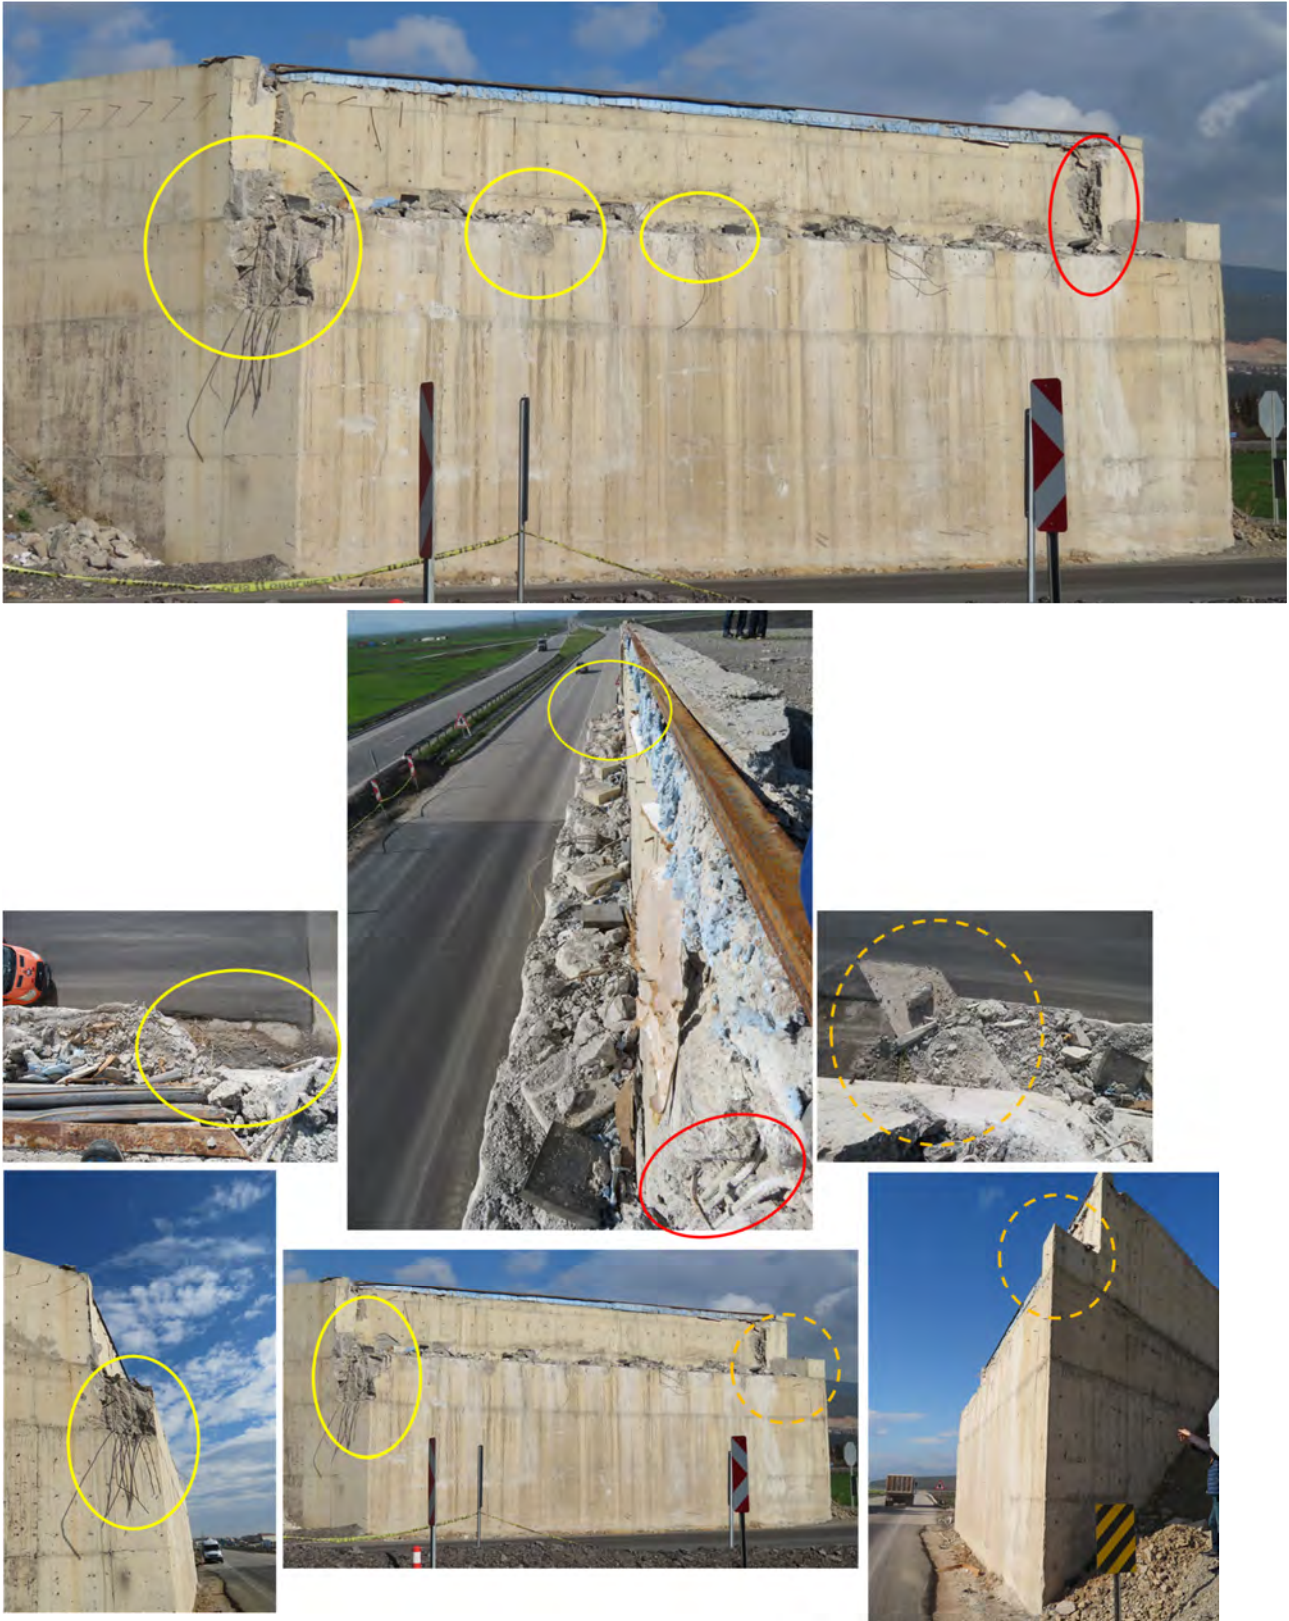
Figure 2.2-5. Observed damage to west-side abutment

Figure 2.2-5 shows that the external shear key on the left side was broken and concrete peeling and rebar exposure were also seen on the same side. Scratches were observed on the front side of the bridge seat. They were considered to be caused by the girders falling off. Although on the right side, scratches, dents, or cracks were not observed on the shear keys, the backwall was damaged. On the bridge seat, concrete blocks considered to be bearing pedestals or shear keys and rubber blocks assumed to be part of the bearings were observed.

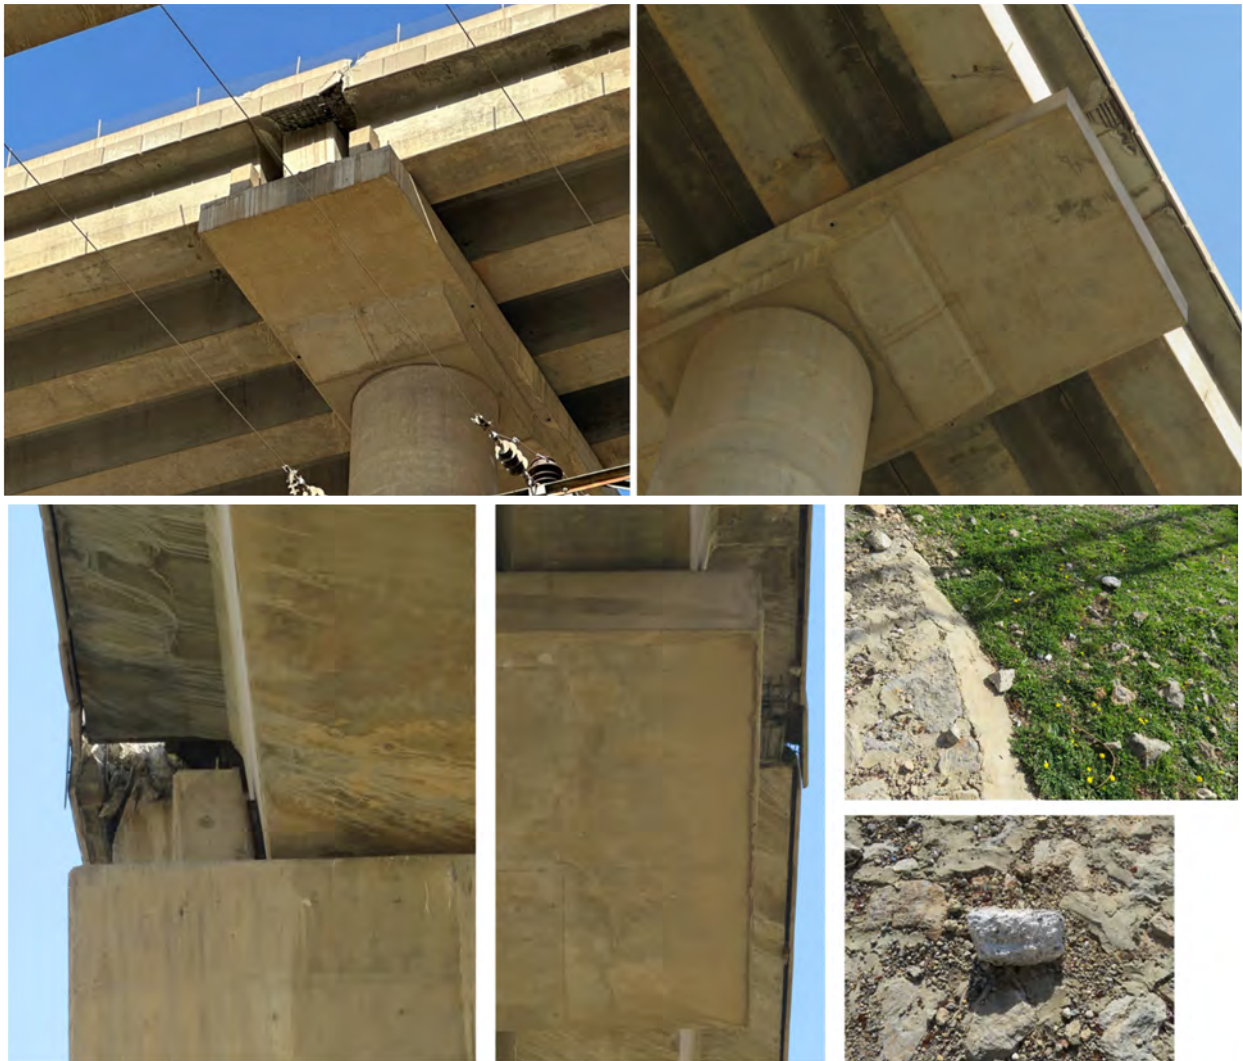
**Figure 2.3-4.** Damage to link slabs

**Figure 2.3-4** shows that the link slabs were damaged. Fallen concrete chunks were observed on the ground.

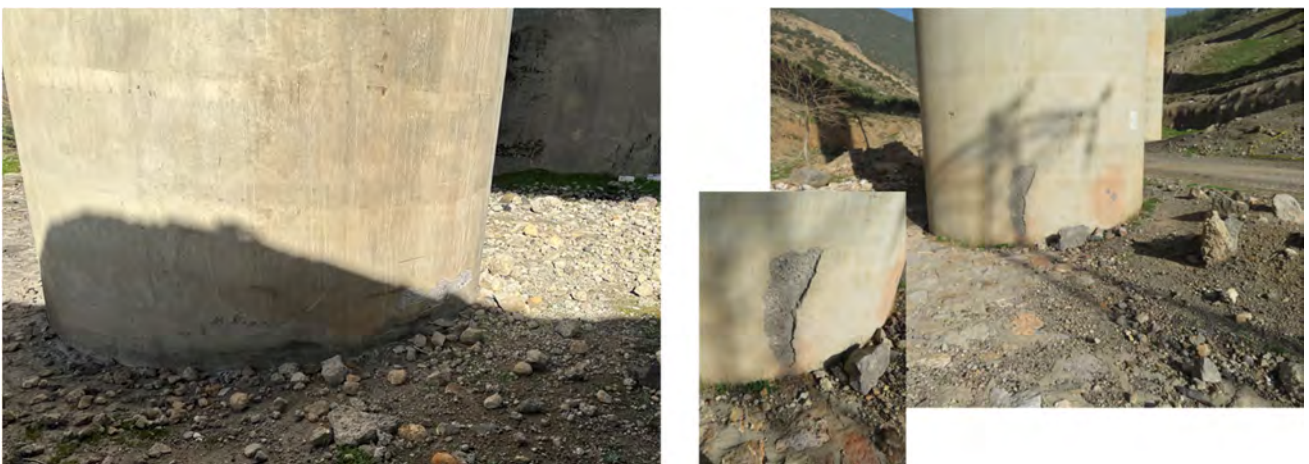
**Figure 2.3-5.** Examples of damage to columns

**Figure 2.3-5** shows an example of minor damage to the surface concrete at the base of high piers in the valley.

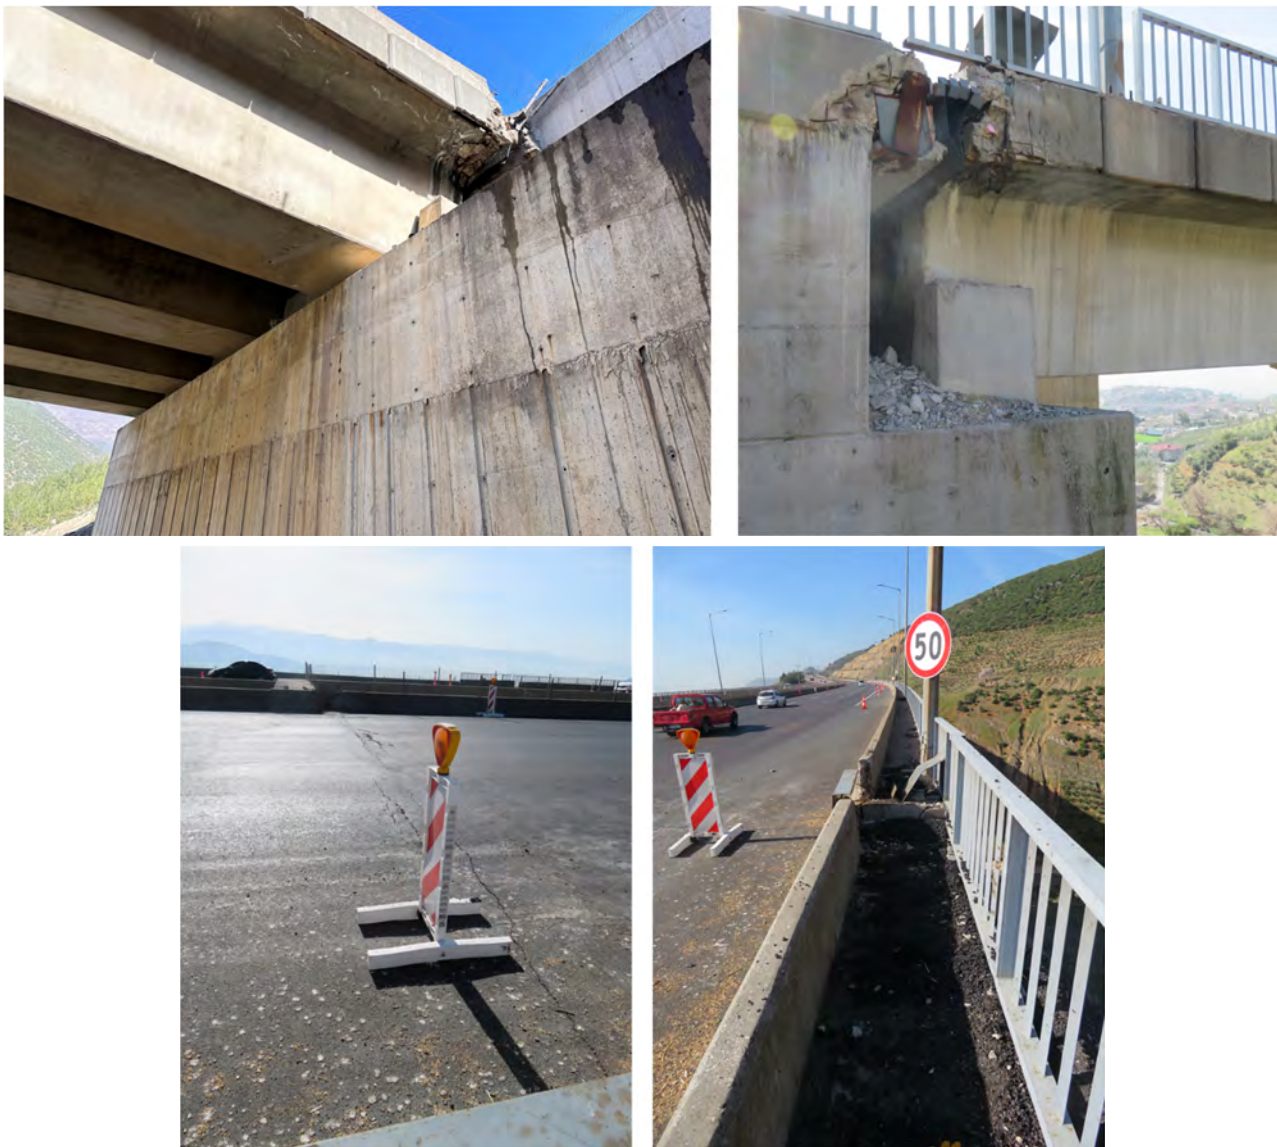
**Figure 2.3-6.** Examples of damage due to collision of superstructure and abutment at Gaziantep side

**Figure 2.3-6** shows that the superstructure collided with the abutment. There was a speed limit sign on the bridge.

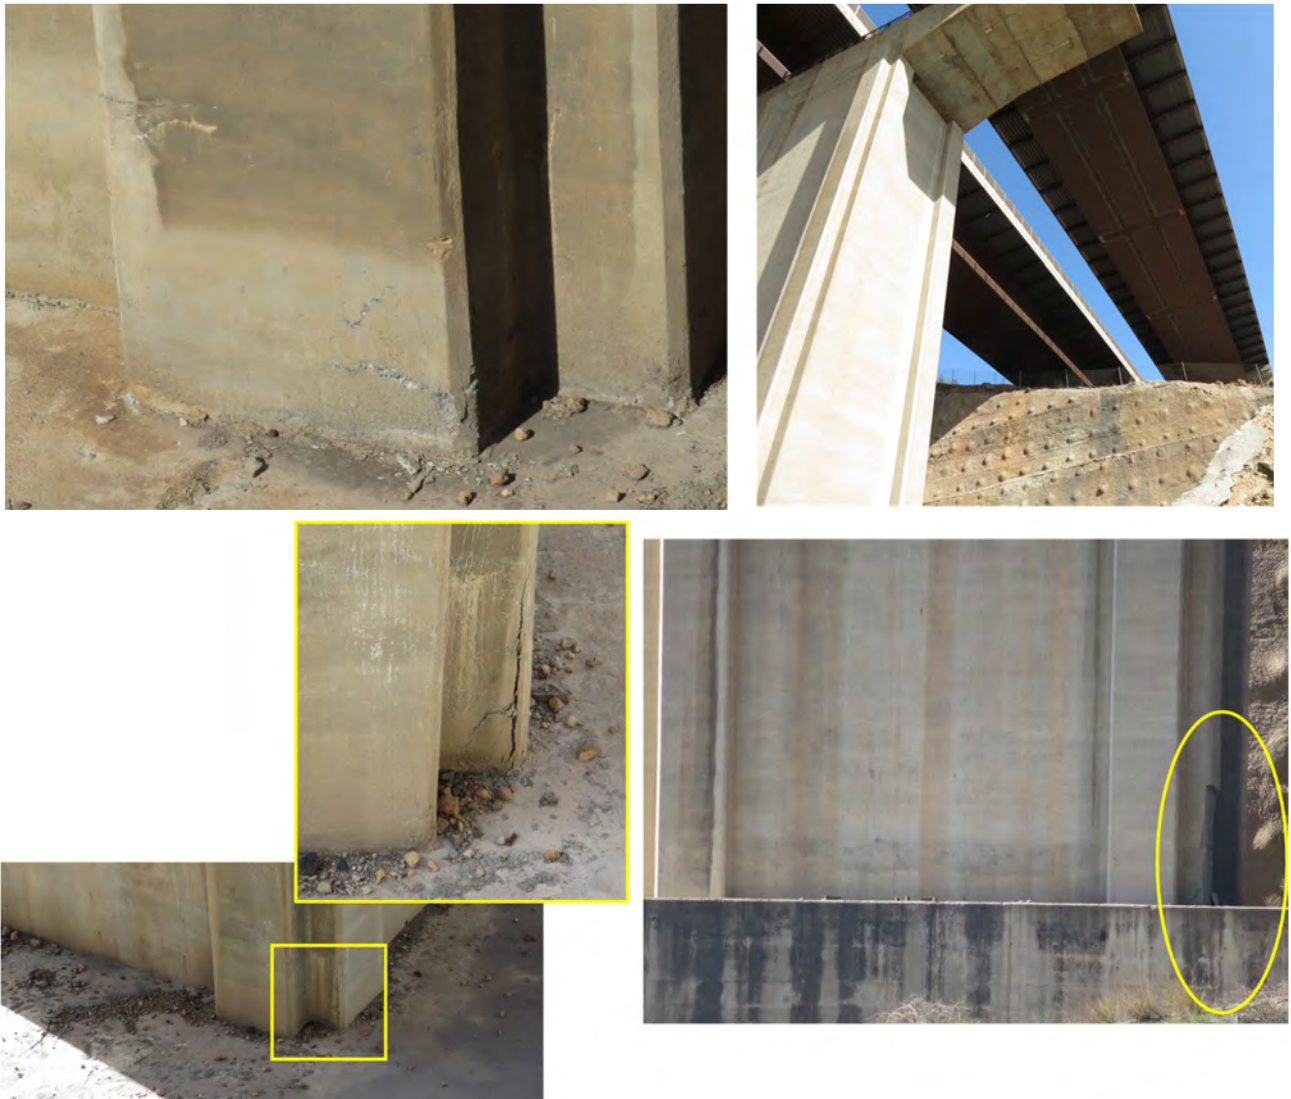
**Figure 2.3-9.** Examples of damage to column bases

**Figure 2.3-9** shows the surface concrete cracks at the base corners of some piers on the slope.
