## 2. Field scanning records

## 2.1. Antakya city and Hatay Airport Road

### 2.1.1. Viaduct on D817 near Saraykent, Antakya city

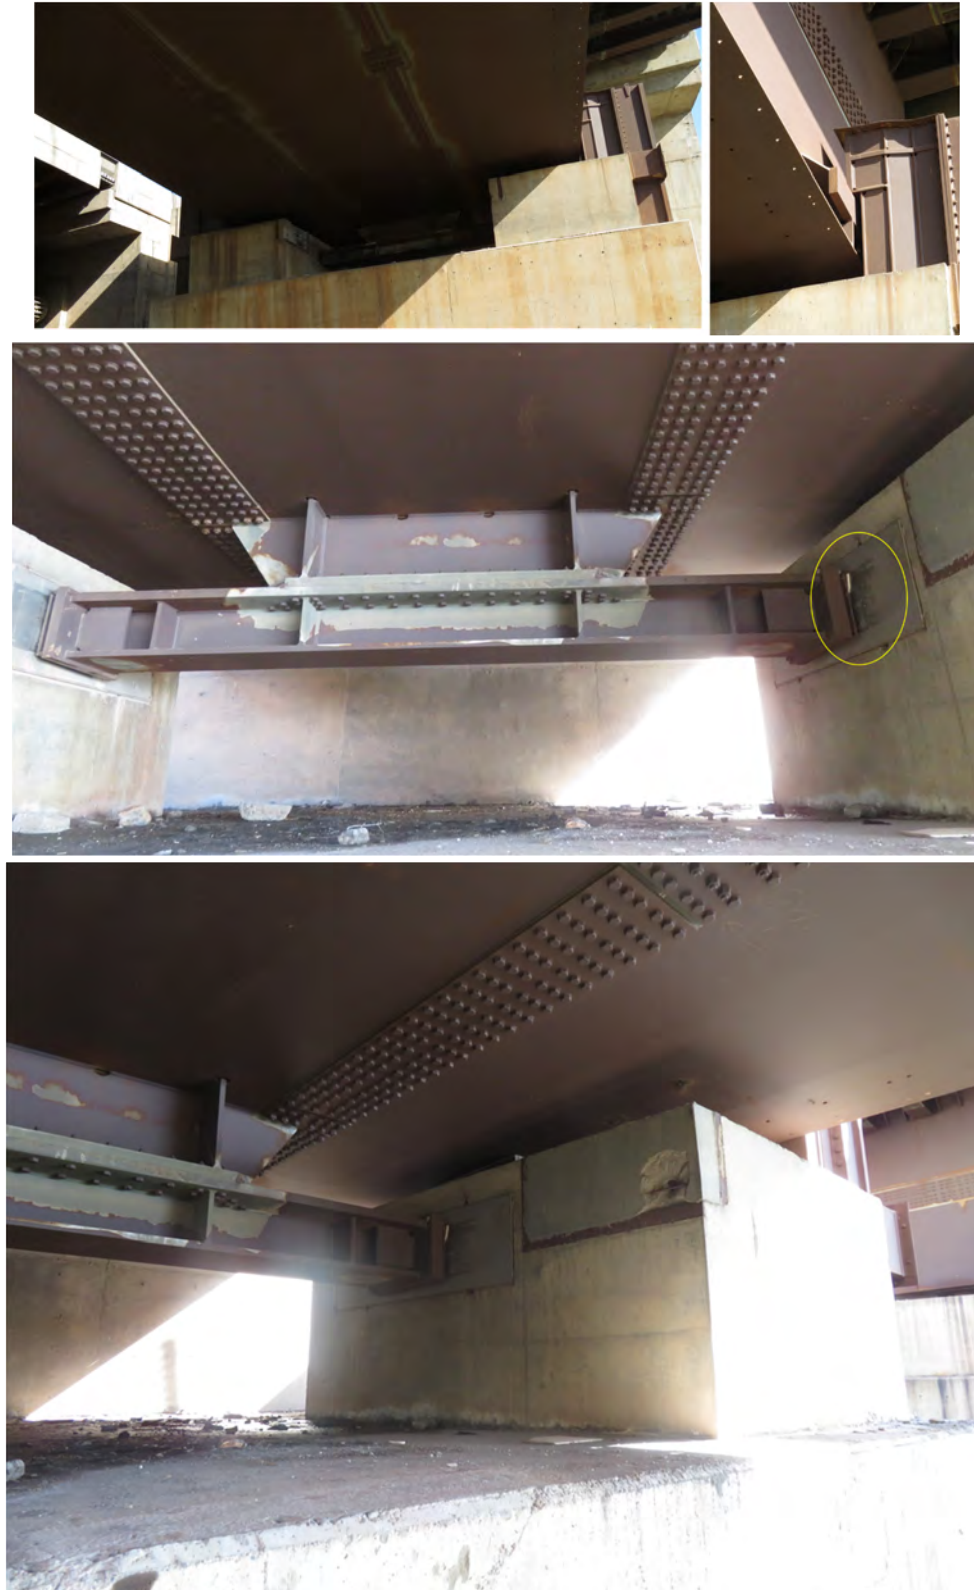
**Figure 2.3-11.** Lateral stopper below lower flange of box girder

As shown in **Figure 2.3-11**, there were contact marks on the concrete blocks of the abutment where the lateral stopper was installed on the underside of the lower flange of the box girder and was considered to have collided during the earthquake. Conversely, no contact traces were observed between the steel cantilever stopper installed on the abutment seat adhering to the girder web, which was considered to sandwich the superstructure to prevent it from falling laterally. However, it was unclear whether the lateral steel stopper under the superstructure and the steel cantilever stopper on the side were designed to work together or whether one of them was supposed to act as a backup after the other failed.

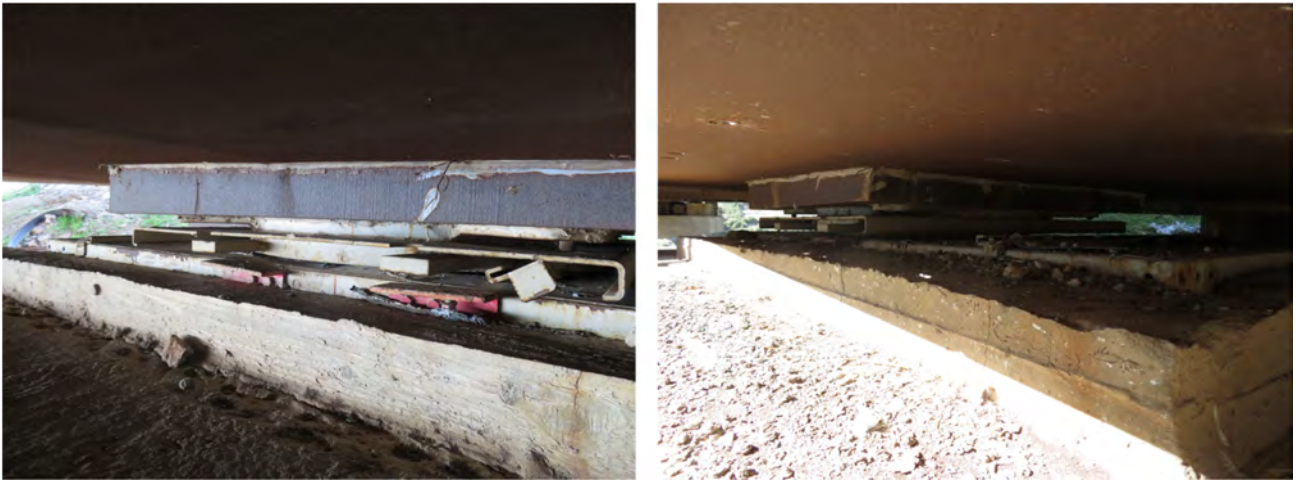
**Figure 2.3-12.** Bearing support on abutment

**Figure 2.3-12** shows a bearing on the abutment. The type of bearing support used was uncertain. No apparent trace of sliding displacement of the bearing was observed.

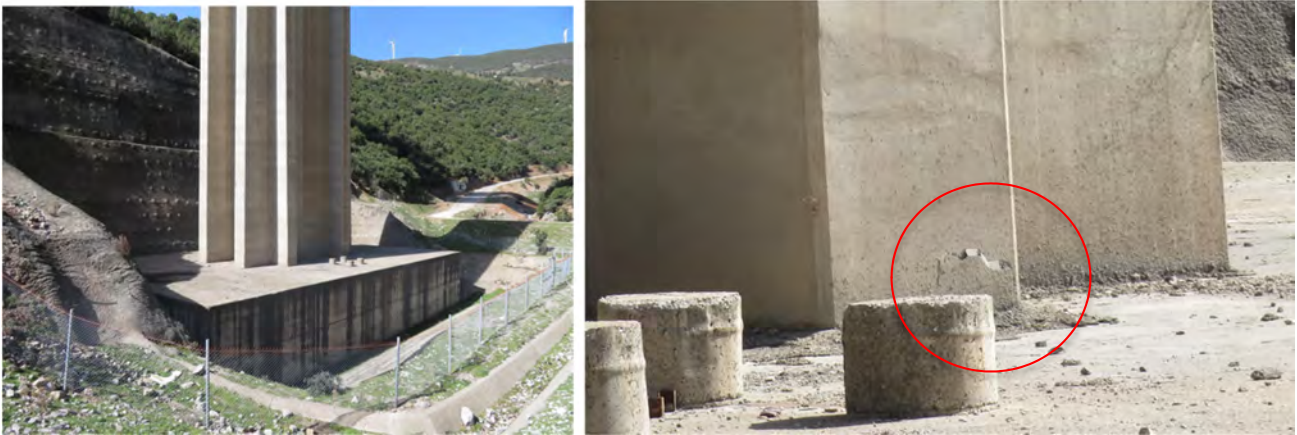
**Figure 2.3-16.** Examples of damage to column bases

The base of a pier in the valley was investigated. **Figure 2.3-16** shows concrete delamination at the base of the pier. Assuming the bridge structure is similar to the Turgut Özal viaduct structure, the shock absorbers connecting the girders and the abutment and the lateral stoppers below the lower flange of the box girder could be damaged as in the Turgut Özal viaduct. However, the Atatürk viaduct was extremely high to approach and investigate these components. Because the superstructure is supported by piers of considerably different heights, the bridge behavior could be complex. Therefore, it would be interesting to check how the bridge behaved and whether the displacements at the flexible columns, abutments, sliding bearings, and material serving as shock absorbers were balanced in the calculation.

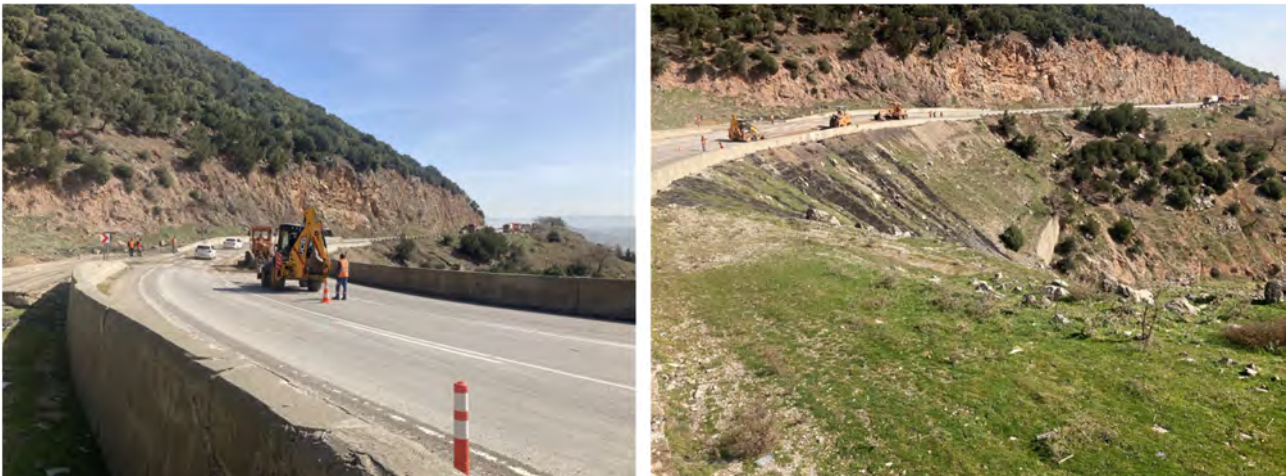
**Figure 2.3-17.** Repair of National Highway D400 near Atatürk viaduct

As shown in **Figure 2.3-17**, at the time of the survey, the road surface of National Highway D400, which is parallel to the pier location of the Atatürk viaduct, was being repaired.

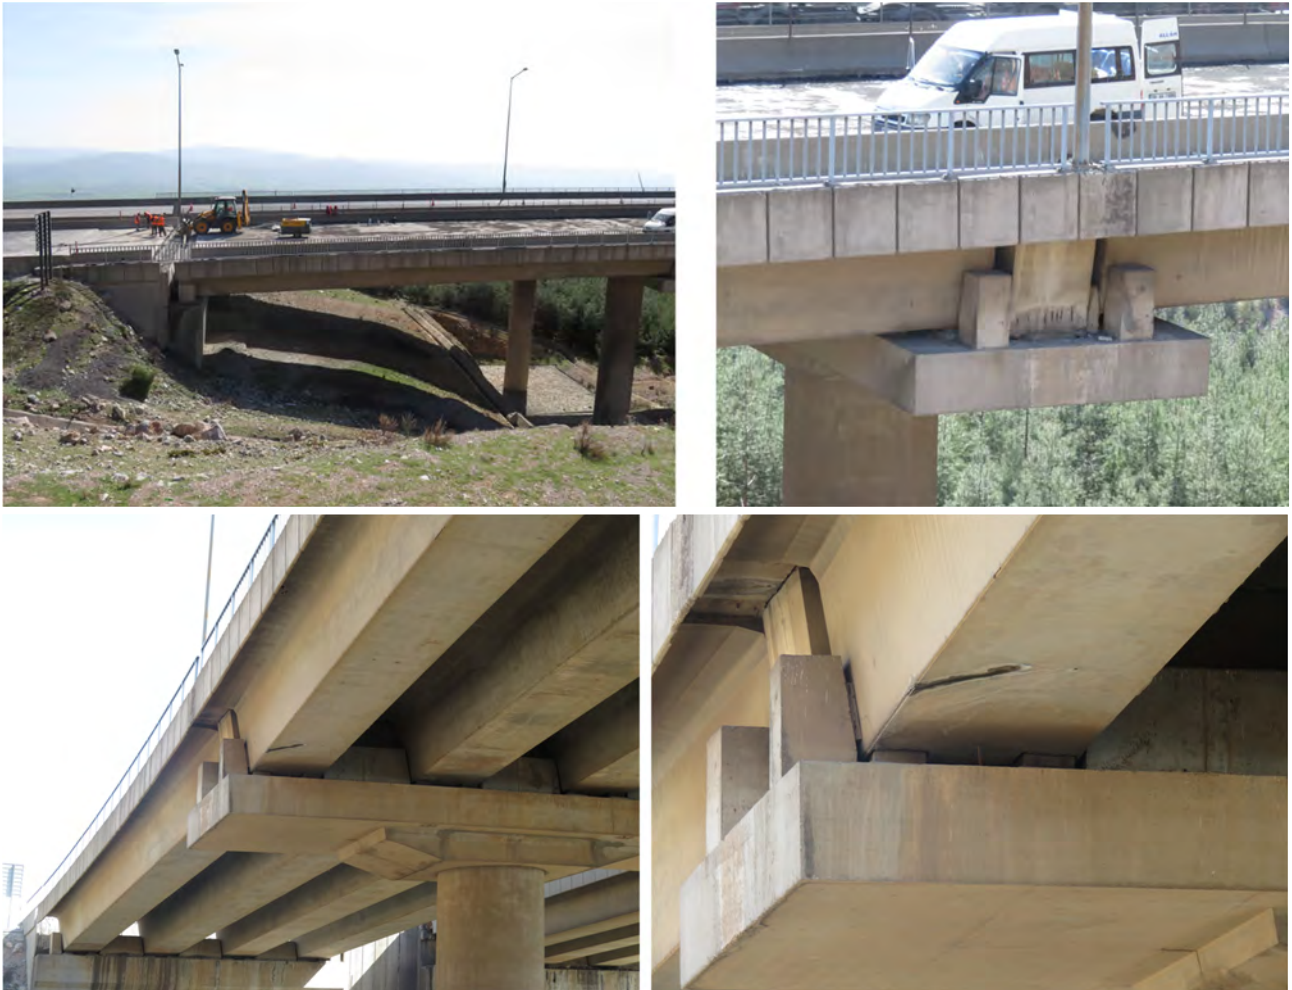
**Figure 2.3-20.** Expansion joint replacement work on Gaziantep-side abutment and concrete block to support link slab on column next to abutment on closed side of bridge.

**Figure 2.3-20** shows the abutment and the neighboring column supporting the closed superstructure. During the survey, expansion joint replacement of the abutment was underway. Concrete fell off from the block underneath the link slab with exposed rebar. From the long-distance observation, it was unclear if the girder end was damaged.

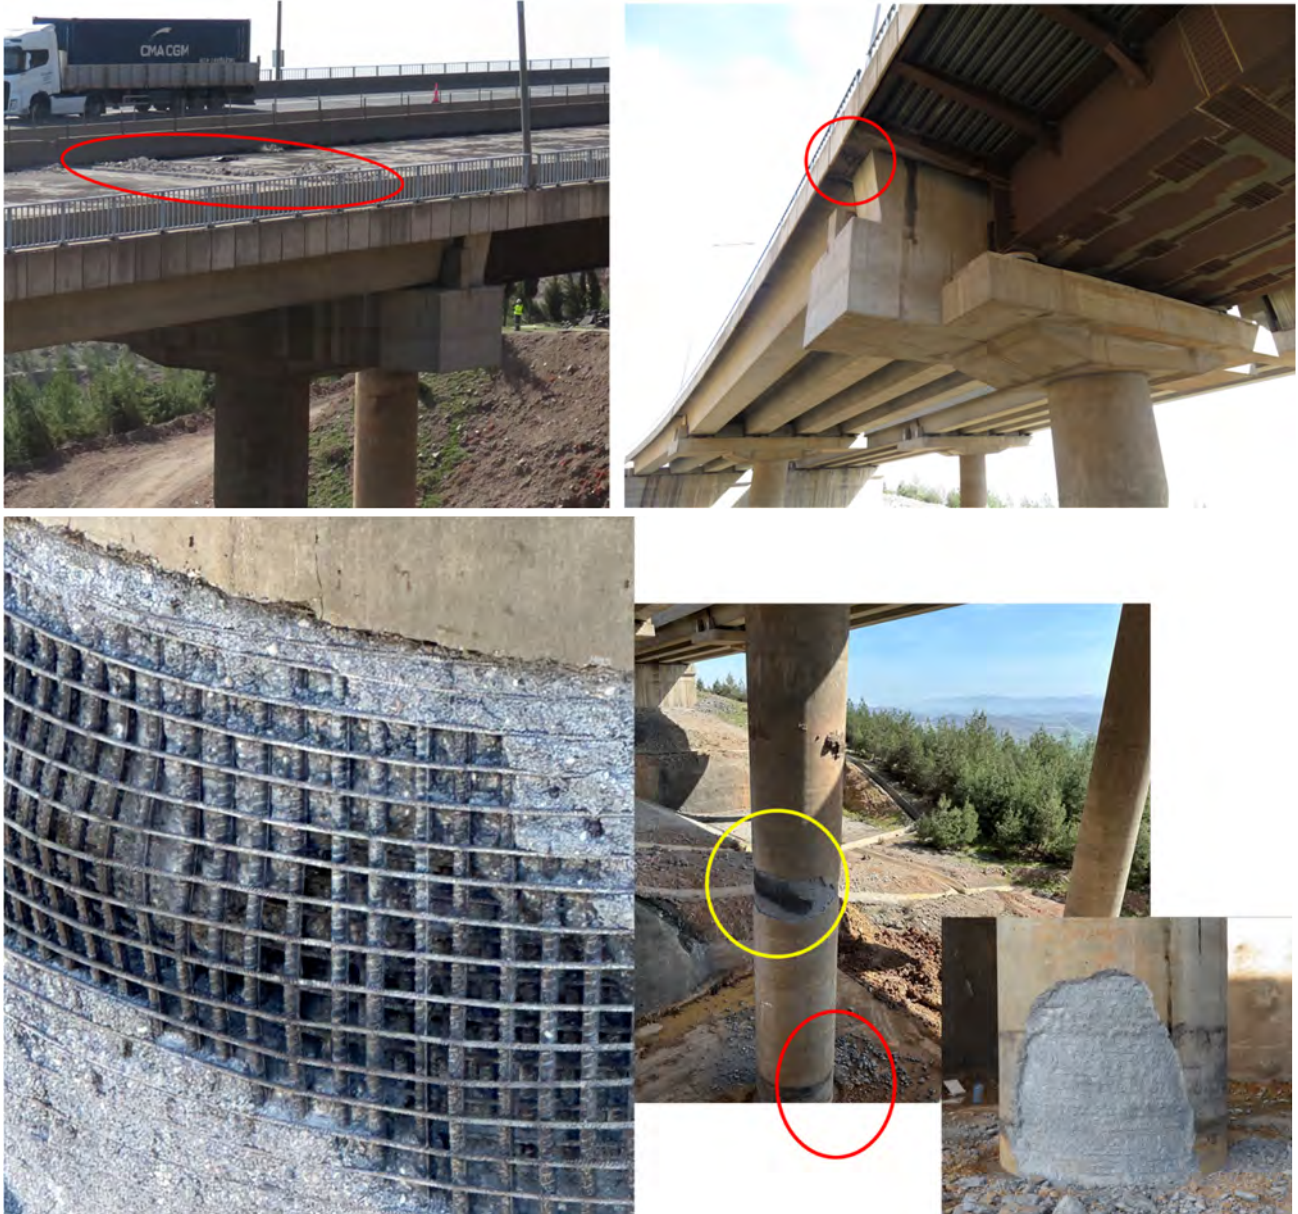
**Figure 2.3-21.** Severe damage to column supporting transition section from concrete girder to steel-box girder on closed side of bridge

As shown in **Figure 2.3-21**, on the closed side of the bridge, the superstructure transitioned from a concrete girder to a steel-box girder on the second pier from the Gaziantep-side abutment. The pier was damaged in the middle and the base. Particularly in the middle part, the surface and a part of the core concrete fell off, and the longitudinal rebars deformed, indicating a significant decrease in the shear and bending strengths. The photo also shows double hoop bars arranged inside. The bridge surface also appeared to be distressed above the same pier.

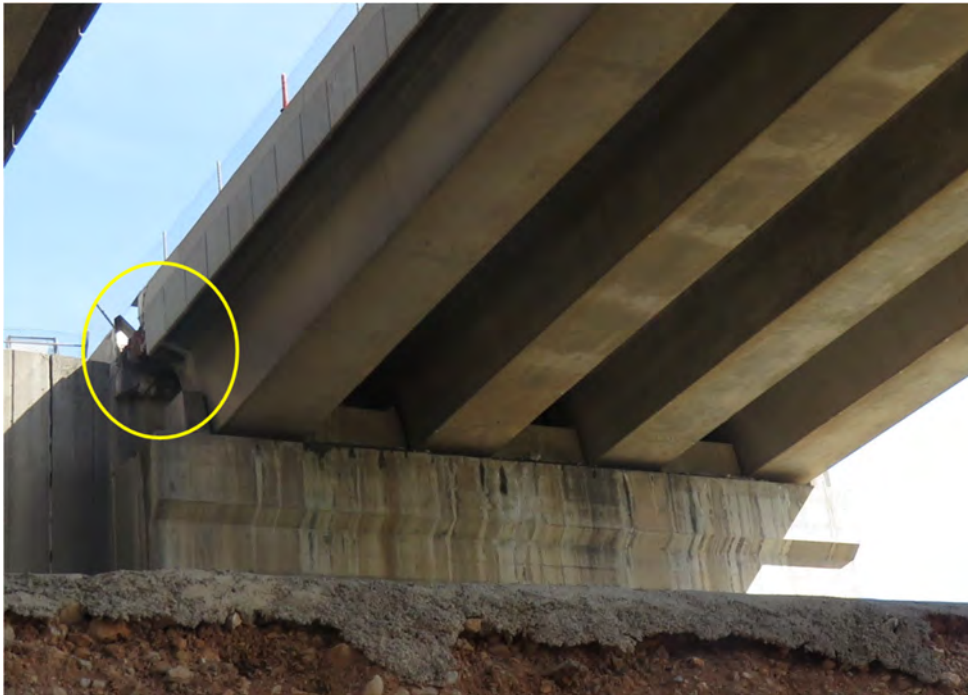
**Figure 2.3-22.** Gaziantep-side abutment on in-service side of bridge

**Figure 2.3-22** shows a photograph of the abutment on the Gaziantep side taken from under the bridge, viewing at the girder ends. This was the in-service side of the bridge. The expansion joint was considered to be damaged, even on the in-service side of the bridge, because the photos showed damage to the backwall near the expansion joint.

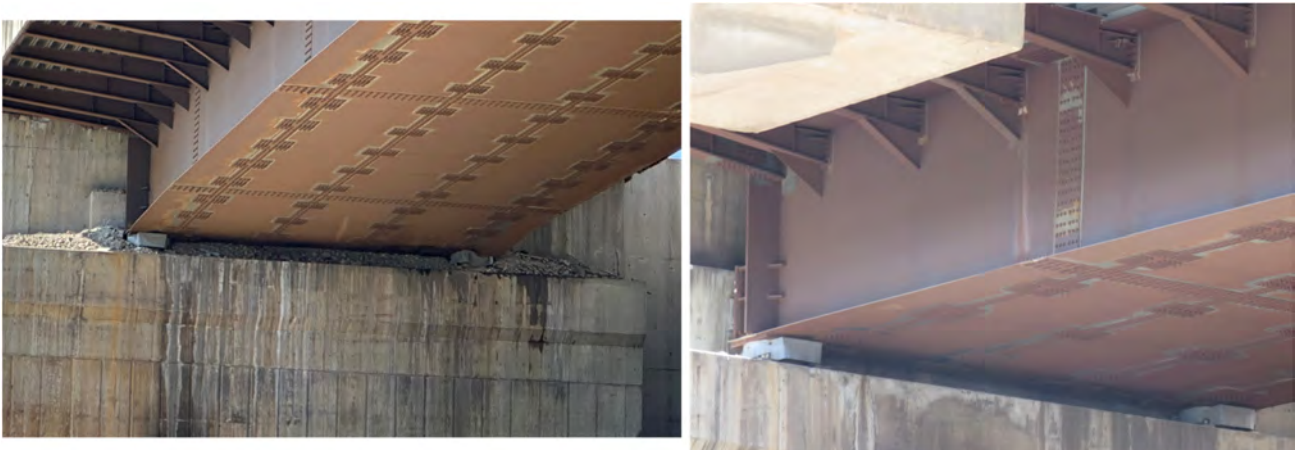
**Figure 2.3-23.** Abutments on Osmaniye side: Left = in-service side of bridge, Right = closed side of bridge

**Figure 2.3-23** shows the condition of the abutments on the Osmaniye side. The photos on the left and right show the girder on the in-service and closed sides of the bridge, respectively. The photograph on the left-hand side shows concrete debris accumulated on the bridge seating, that is, the in-service side of the bridge. This indicates that the expansion joint collapsed because of the collision of the box girder with the abutment during the earthquake.

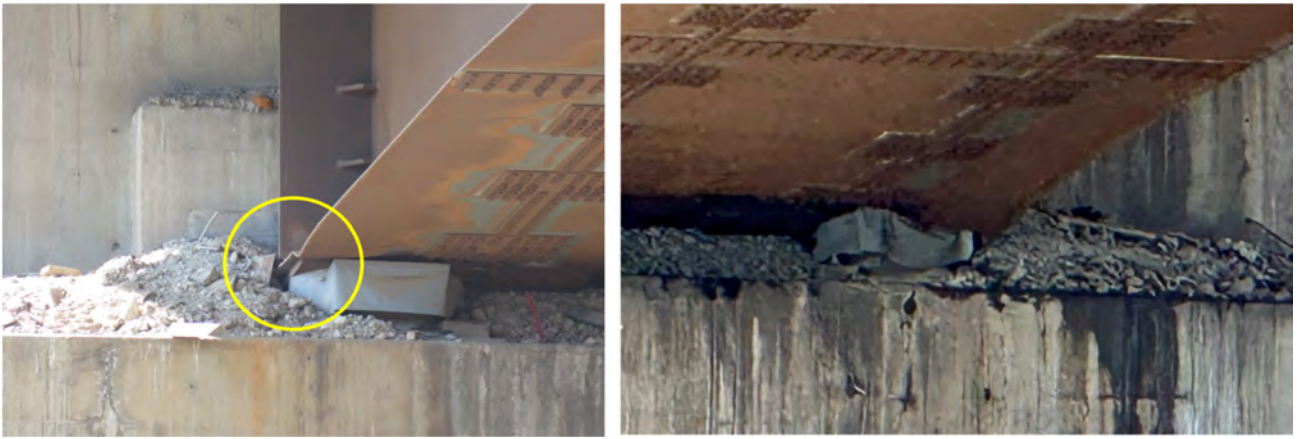
**Figure 2.3-24.** Local buckling of bottom flange above bearing on in-service side of bridge

**Figure 2.3-24** shows the surroundings of the bearings on the in-service side of the bridge. The bottom flange buckled above the bearings. In addition, the covers of the bearings were deformed, indicating bearing damage. **Figure 2.3-24** also indicates that the bearings could have been subjected to a large force during the earthquake and were probably deformed based on the deformation of the bearing cover and the girders. Additionally, no unseating prevention devices for failure safety were noticeable on the bridge.

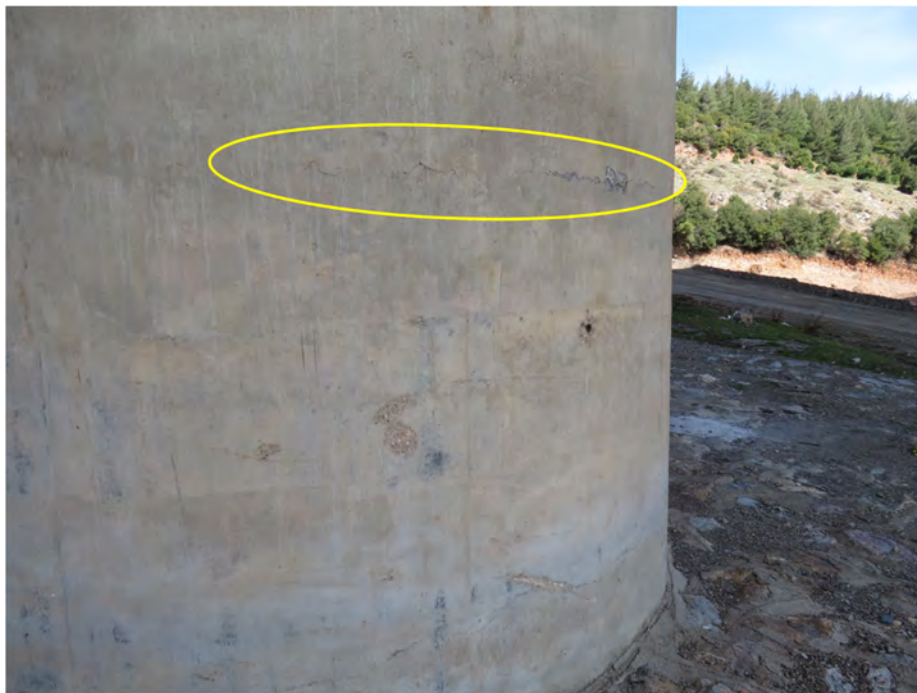
**Figure 2.3-28.** Horizontal crack in bridge column

As shown in **Figure 2.3-28**, one of the piers was approachable and minor cracks were observed.

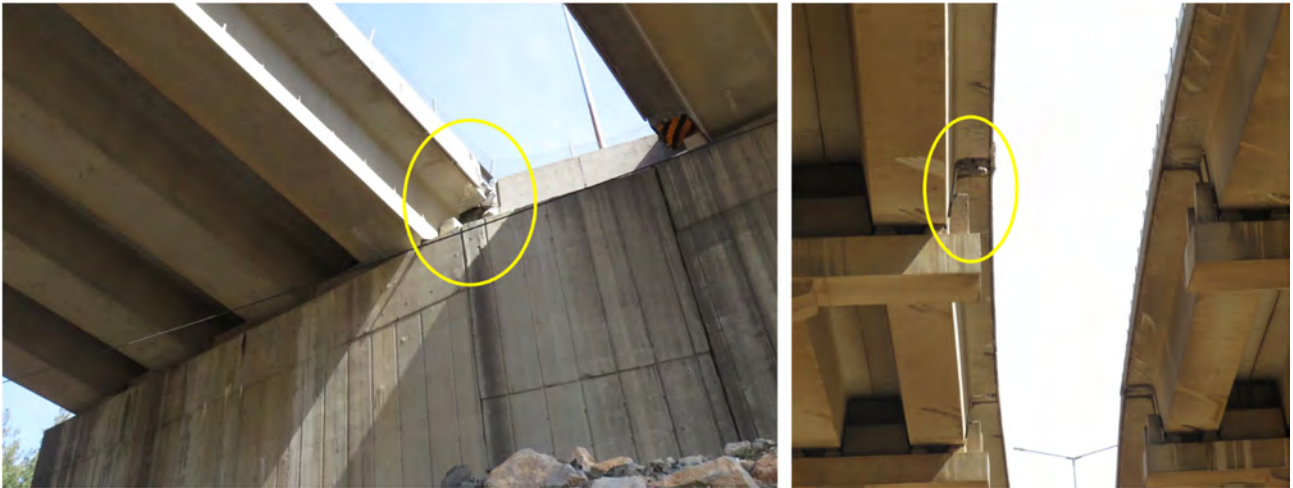
**Figure 2.3-29.** Examples of damage to expansion joint and link slabs

**Figure 2.3-29** shows that the superstructure collided with the abutment during the earthquake, which was also observed for the Başpınar viaduct. Damage to the link slabs was also observed.

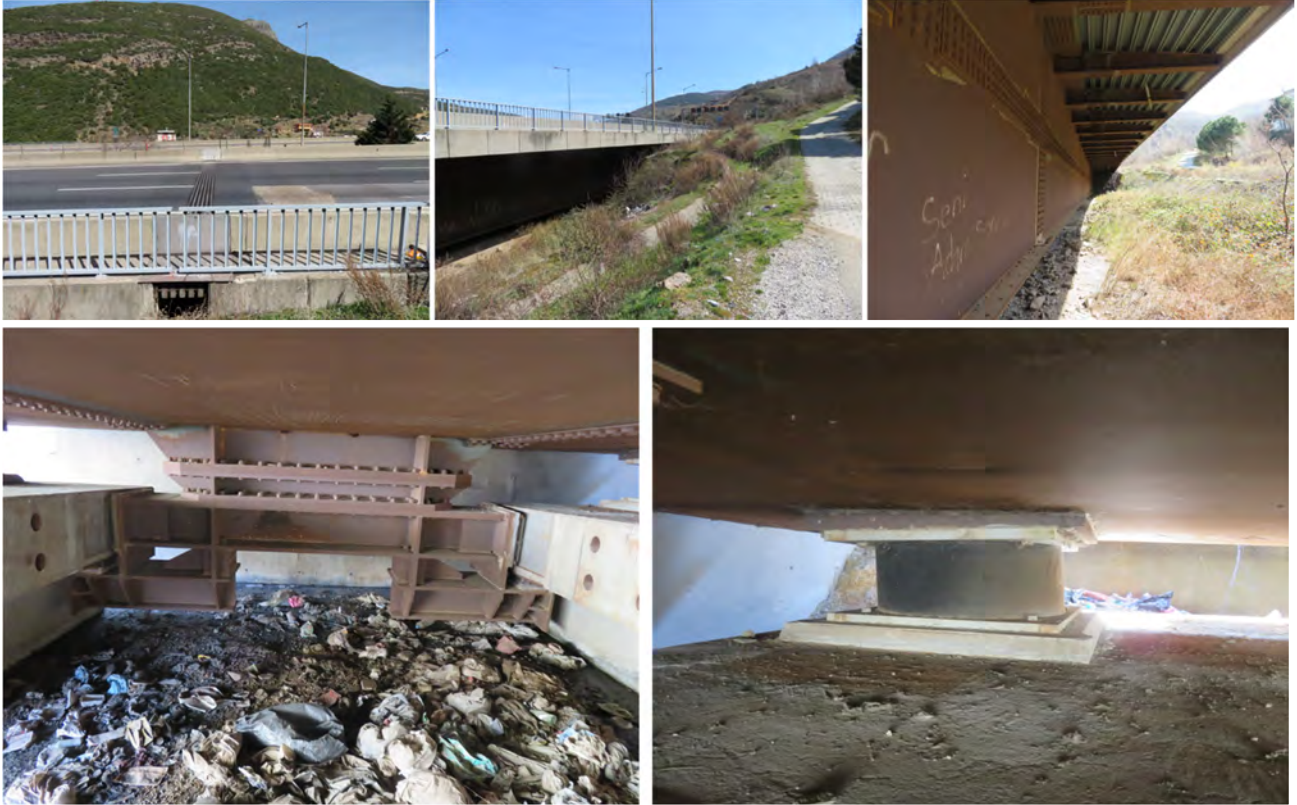
**Figure 2.3-33.** Photographs of expansion joint, bearing, and lateral displacement restrainer on Gaziantep-side abutment on mountain-side bridge

As shown in **Figure 2.3-33**, no distress was observed on the road surface above the Gaziantep-side abutment. A lateral displacement restrainer adhering to the bottom flange and sandwiched between two concrete blocks is present, with the concrete blocks also functioning as bearing pedestals. There was no indication of the lateral displacement restrainer having collided with the concrete blocks. The bearings on the concrete blocks exhibited no residual deformation.

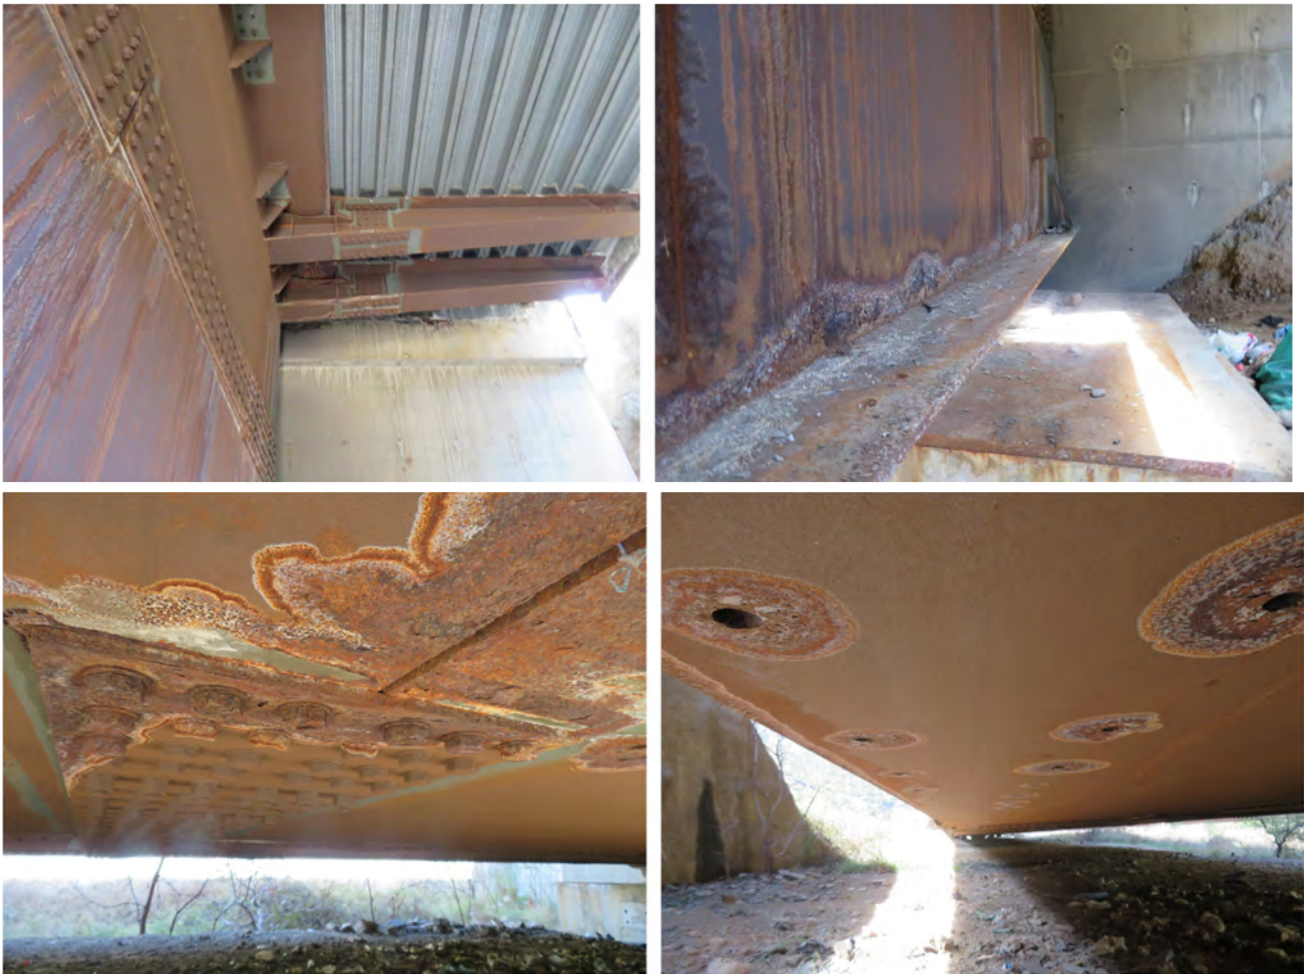
**Figure 2.3-34.** Nonuniform rust development in weathering steel girder

The clearance under the girder is very narrow on the Gaziantep side of the bridge. As shown in **Figure 2.3-34**, nonuniform rust developed in the weathering steel near the observed girder end.

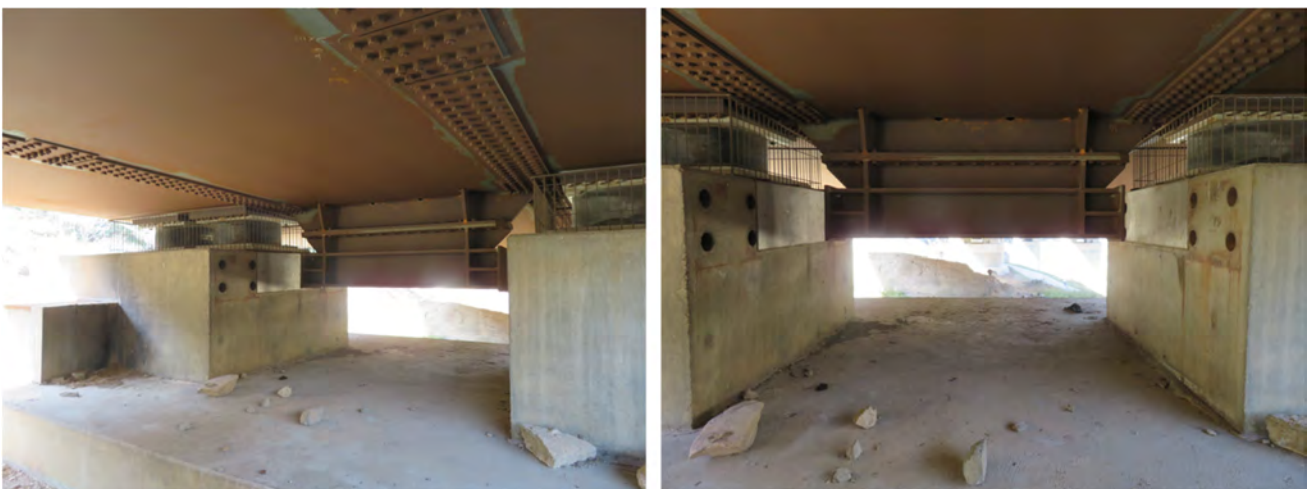
**Figure 2.3-35.** Horizontal displacement restrainer of girder and concrete blocks on column next to Gaziantep-side abutment

**Figure 2.3-35** shows the bearings and lateral displacement restrainer on the first column from the Gaziantep-side abutment. The column is very short and resembles a slab. The bearings are surrounded by steel cages. There are no traces of contact between the lateral displacement restrainer and the concrete blocks.

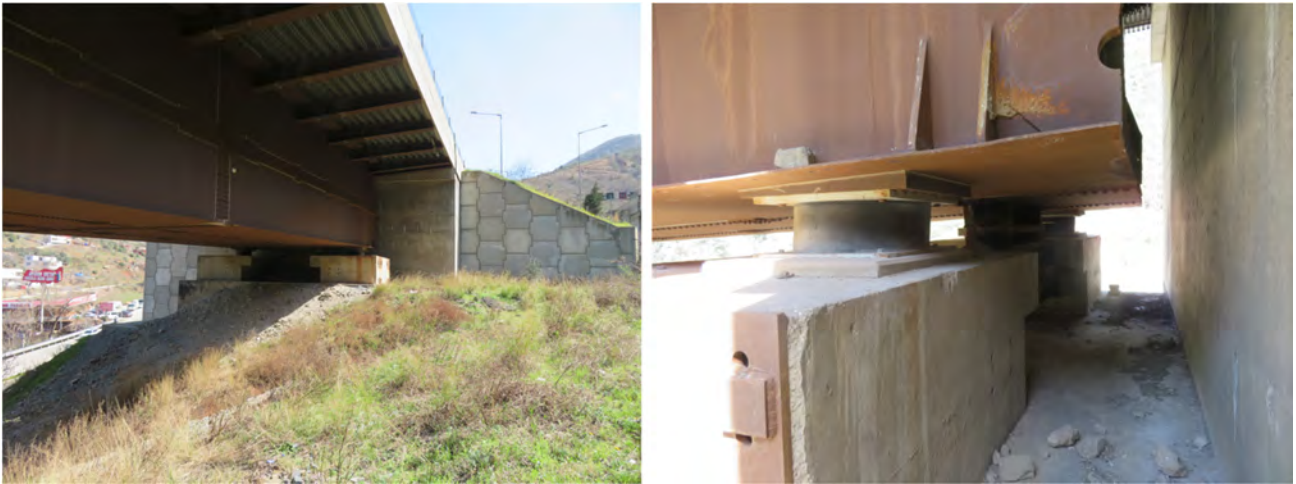
**Figure 2.3-36.** Superstructure and Gaziantep-side abutment on D400-side bridge

**Figure 2.3-36** shows the girder end near the Gaziantep-side abutment of the D400-side bridge. The superstructure details are the same as those of the mountain-side superstructure and nonuniform rust is not observed in the weathering steel. This could be attributed to the wider clearance between the girder bottom and the ground compared to that in the mountain-side superstructure.

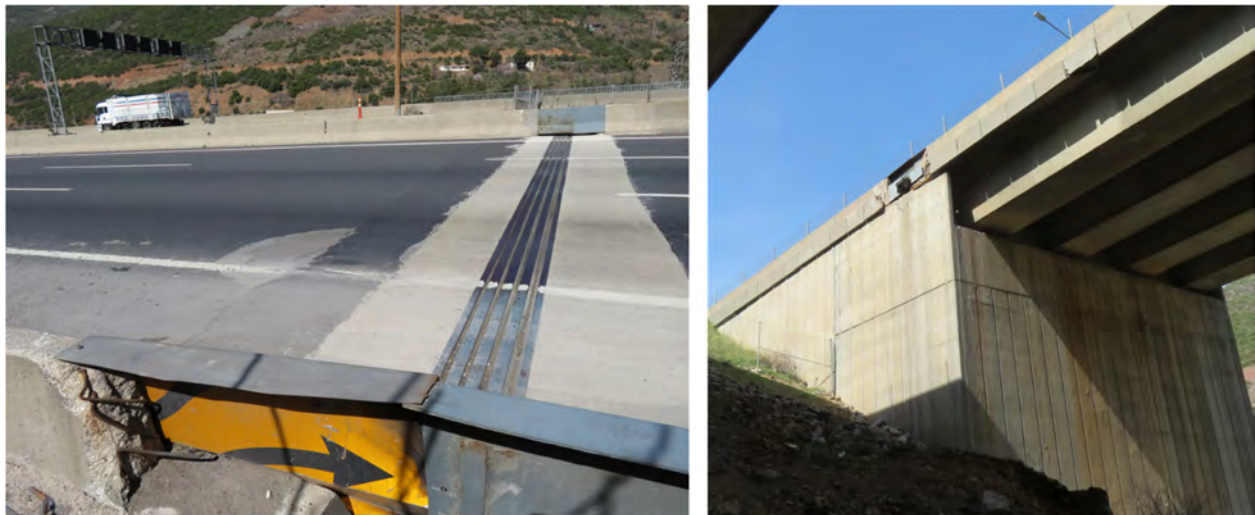
**Figure 2.3-37.** Deformed plates in transition section of parapet walls between bridge and backfill sections

**Figure 2.3-37** shows the expansion joint and the road surface behind the tunnel-side (or Osmaniye-side) abutment on the mountain-side bridge. The plates in the transition section of the parapet walls above the expansion joint between the bridge and backfill were deformed. The pavement behind the abutment appeared to have been repaired after the earthquake on both the mountain- and D400-side bridges. As shown in **Figure 2.3-38**, the shear keys were in contact with the adjacent girders; however, the superstructure did not appear to be offset to the left or right.

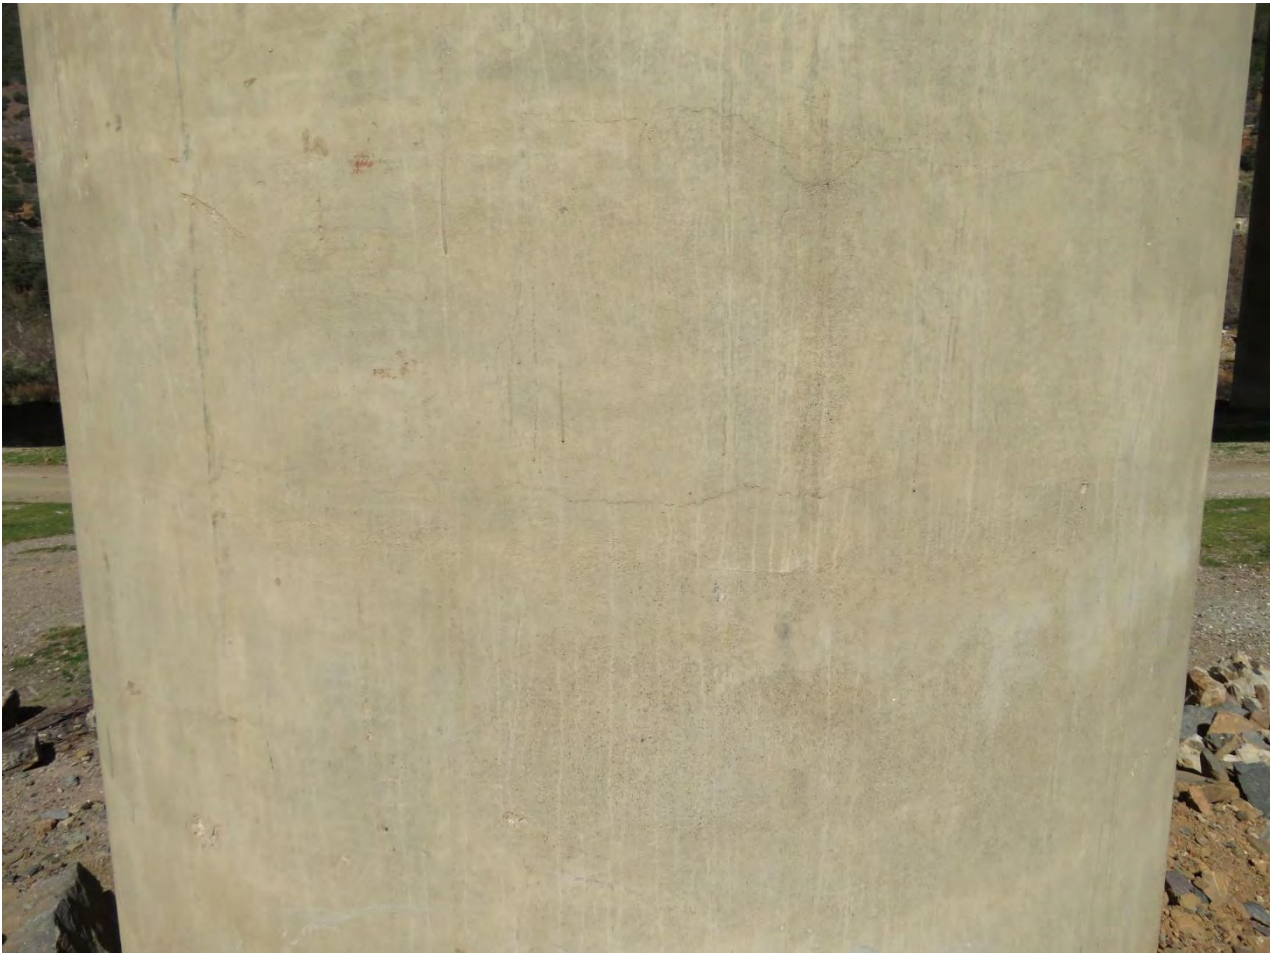
**Figure 2.3-39.** Horizontal crack in column

Minor horizontal cracks were observed in some piers, as shown in **Figure 2.3-39**.

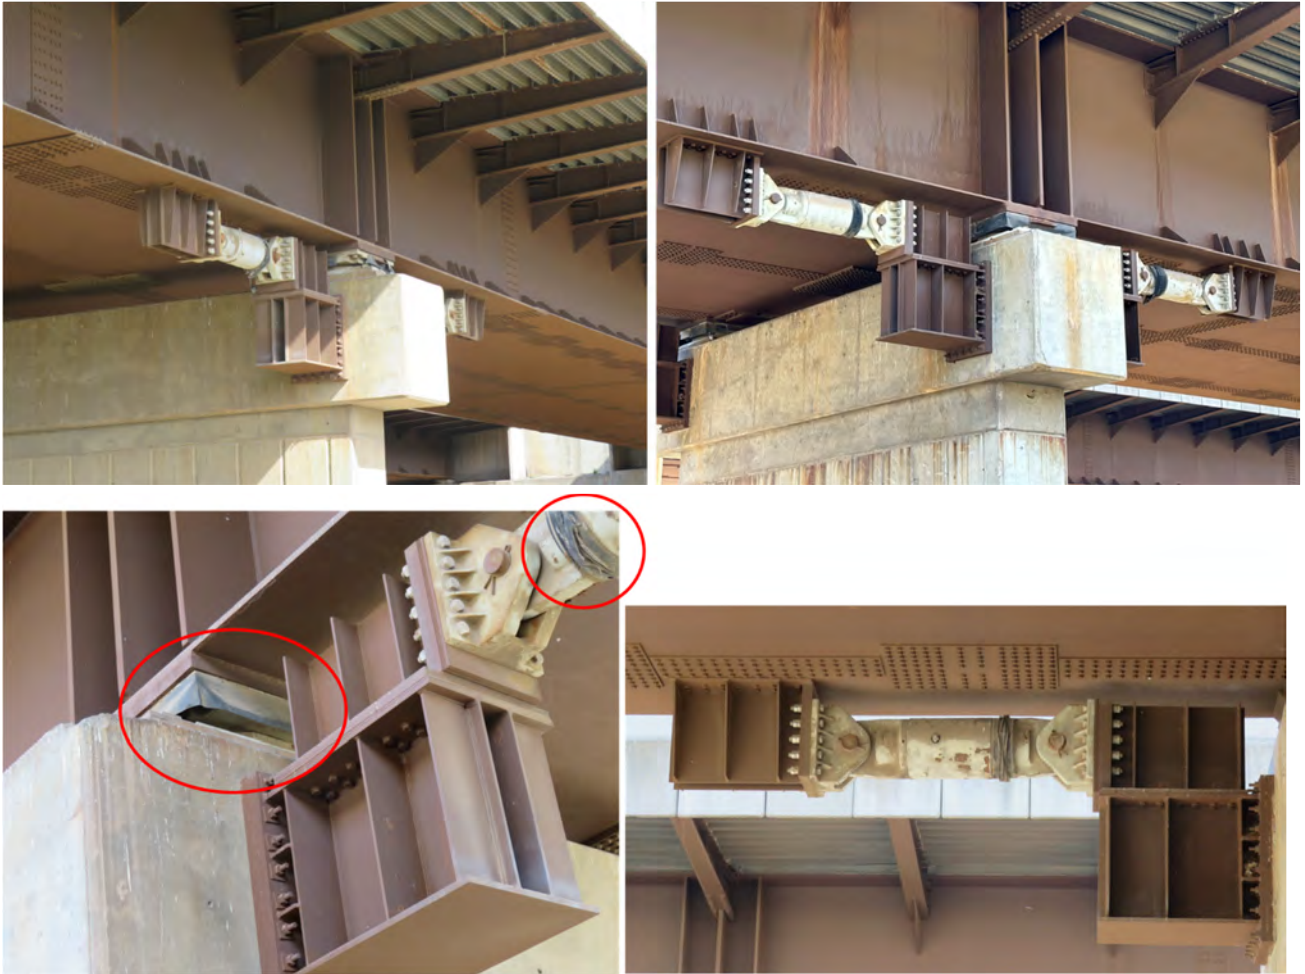
Figure 2.3-43. Dampers of Vecdi Diker viaduct

Figure 2.3-43 shows photographs of the dampers. No traits or signs indicated that the dampers functioned during the earthquake. Some bearings were covered with a black sheet, whereas others lost their covers.

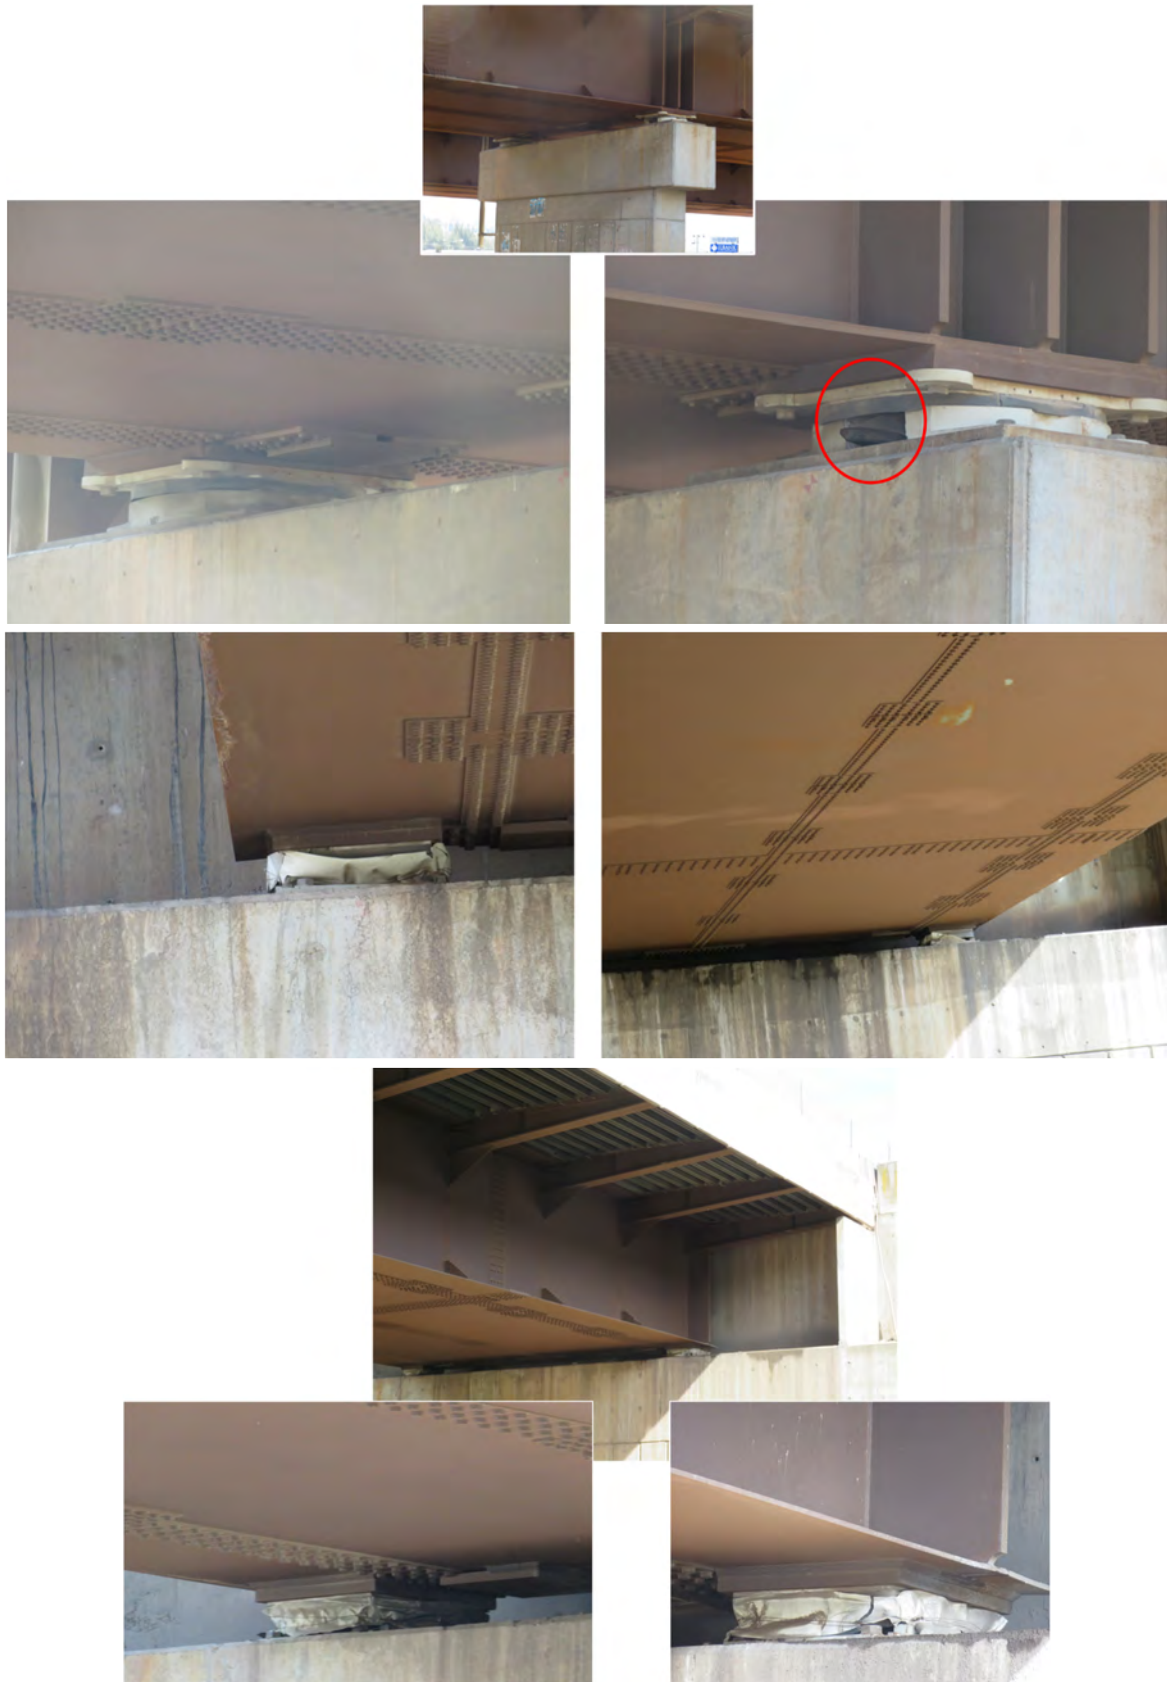
**Figure 2.3-44.** Examples of observed damage to bearing covers

As shown in **Figure 2.3-44**, the bearings are protected by cylindrical metallic covers. Some metallic covers were deformed, and black objects protruded internally from the metallic covers. These observations indicated that the bearings suffered large displacements, and therefore, the conditions of all bearings of this bridge must be checked.

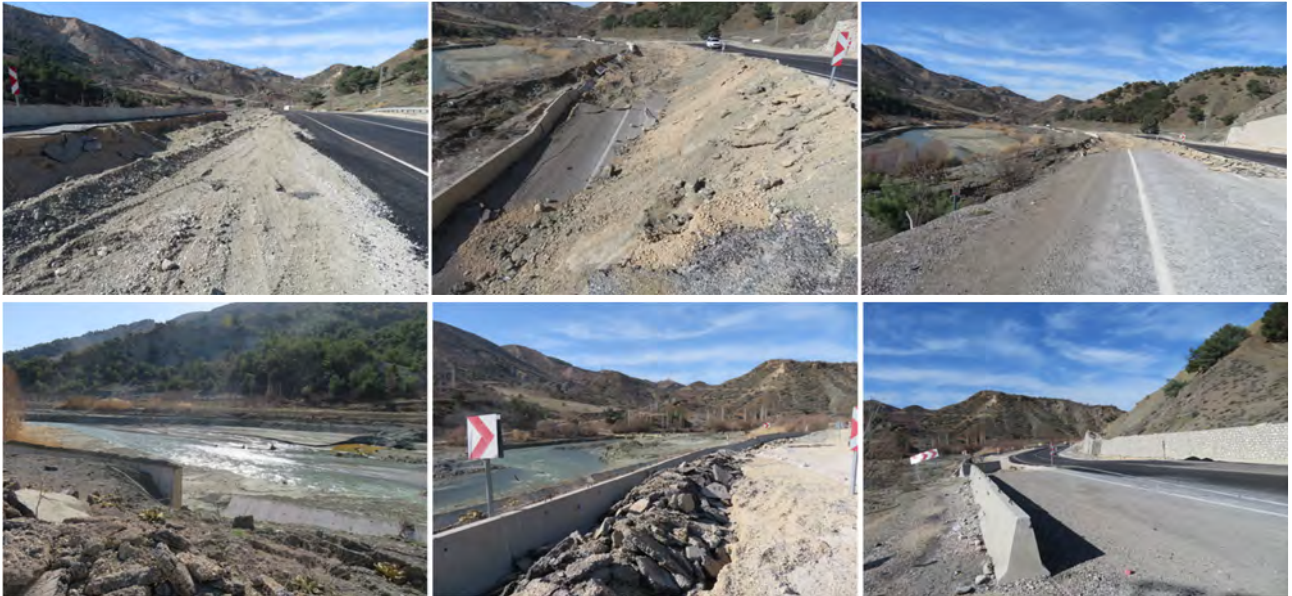
**Figure 2.4-3.** Examples of observed damage to road embankments

As shown in **Figure 2.4-3**, the surveyed section is a four-lane road, with the two lanes on the mountainside under repair and the other two in service.

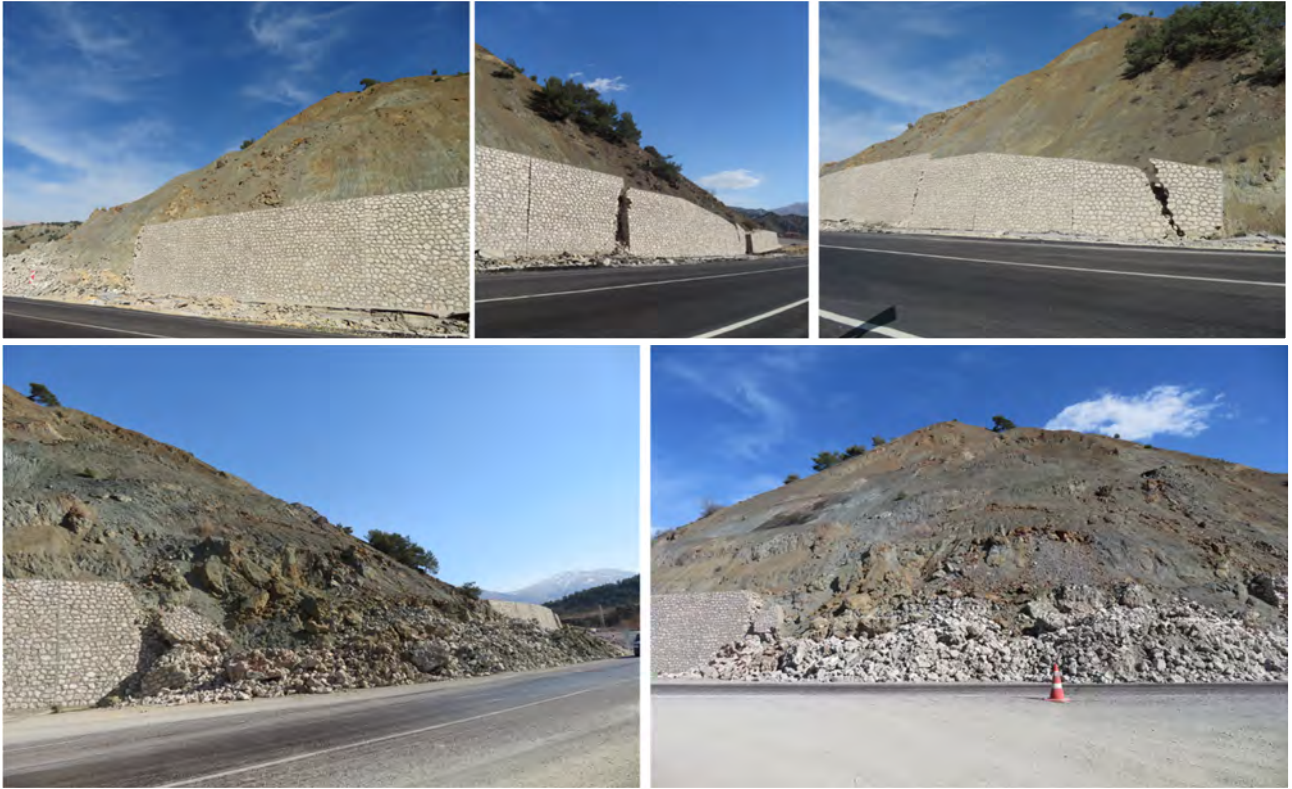
**Figure 2.4-5.** Cut-slope failure with collapse of retaining wall

Cut-slope failure with the collapse of the retaining wall was also observed, as shown in **Figure 2.4-5**.

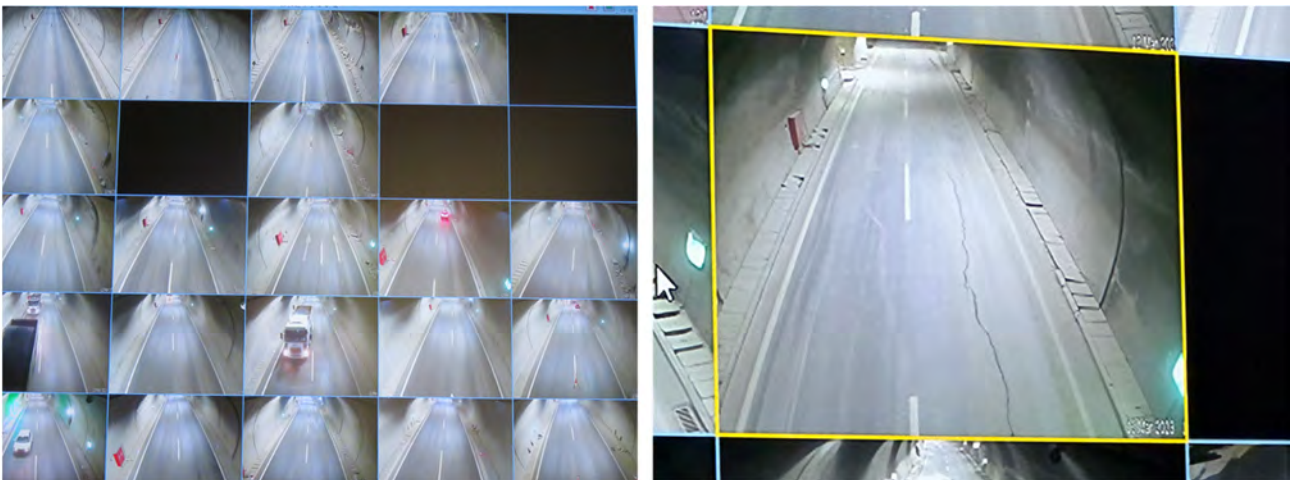
**Figure 2.4-8.** CCTV camera images of clearing work in Erkenek tunnel

**Figure 2.4-8** shows examples of CCTV camera images of the northbound tunnel. Traffic was closed for safety reasons, and entry into the tunnel was not allowed. In the tunnel, cracks were observed on the road surface in the longitudinal direction. In addition, the fallen concrete debris was being removed from the tunnel.
