## 2. Field scanning records

## 2.1. Antakya city and Hatay Airport Road

### 2.1.1. Viaduct on D817 near Saraykent, Antakya city

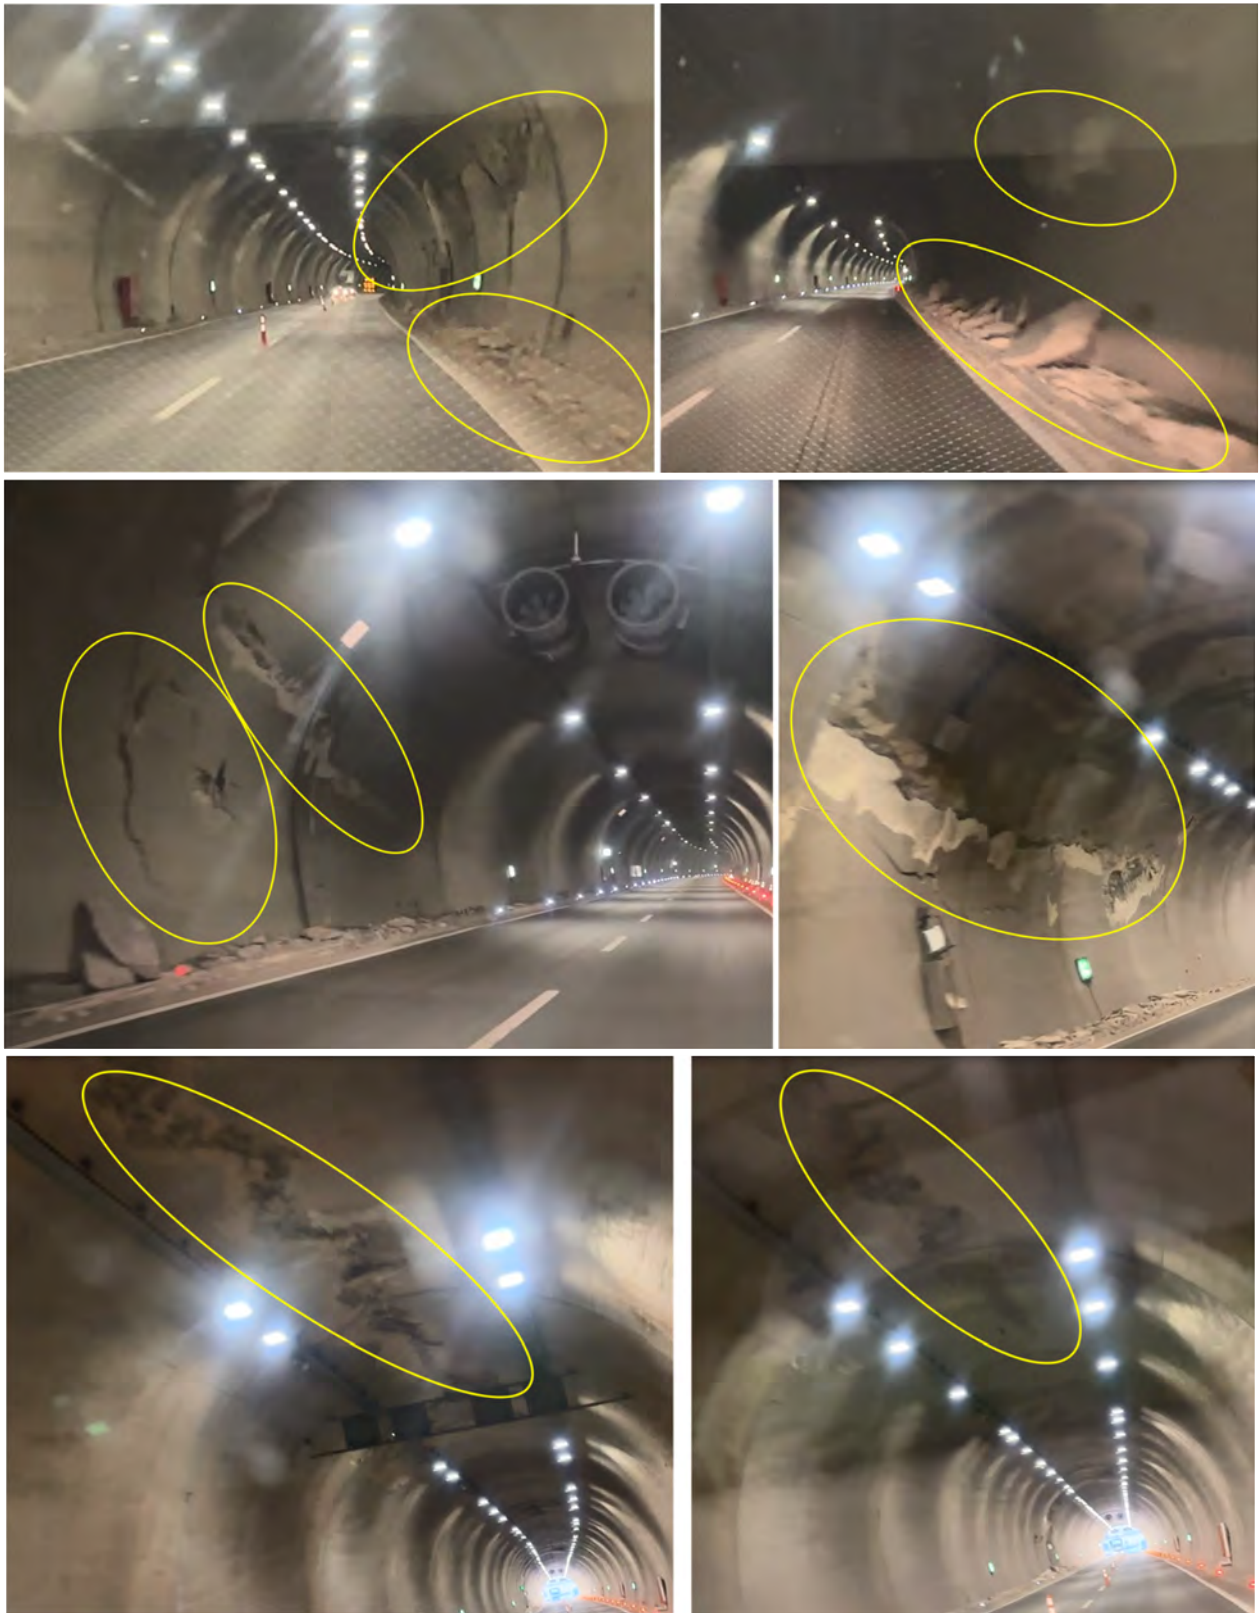
**Figure 2.4-9.** Examples of observed damage to Erkenek tunnel

Traffic was not allowed to enter the north tunnel. The south tunnel was open to traffic; however, there was a notable traffic safety concern for pedestrians because there were no sidewalks or decent shoulders in the tunnel. Accordingly, a video of the interior of the south tunnel was recorded from a car. **Figure 2.4-9** shows the damaged state inside the tunnel. The lining concrete had large cracks on its sides and top, and in some places the concrete blocks were probable to fall. This damage was similar to that observed during the 2004 Niigata Chuetsu Earthquake (Konagai et al., 2005; NILIM/PWRI, 2005a; NILIM/PWRI, 2005b) and the 2016 Kumamoto Earthquake (Fukuhara and Nakahara, 2018; NILIM/PWRI, 2017) in Japan. Given the location and direction of the lining damage, the lining concrete was subjected to complex stress conditions owing to the possible inward forces caused by the movement of the surrounding soil and rock toward the lining. Jet fans and information boards were anchored to the concrete lining; however, the condition of the concrete near the anchors could not be confirmed from the video.

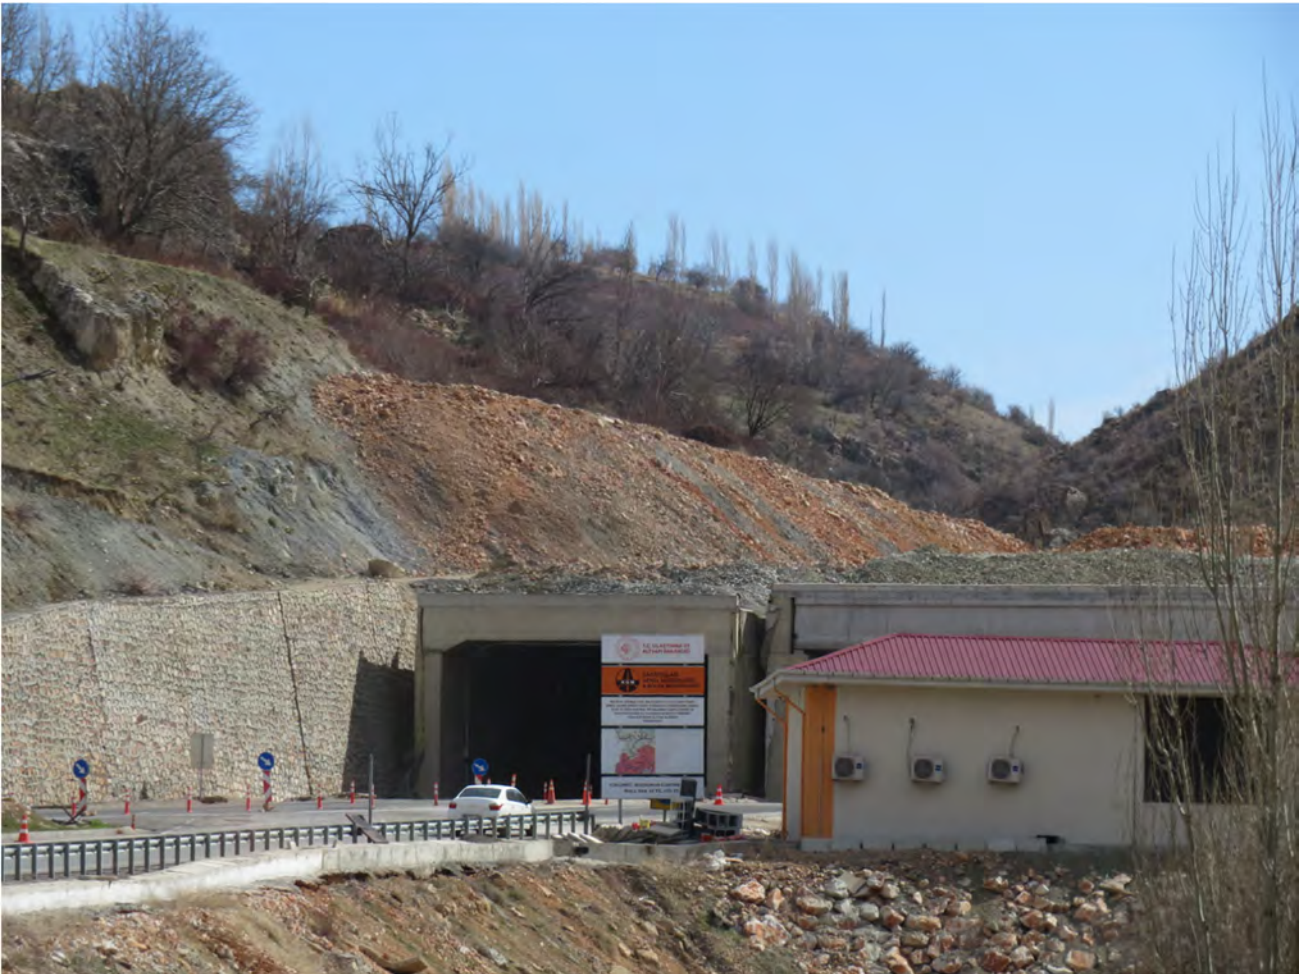
**Figure 2.4-10.** Rock shed adjacent to Erkenek tunnel

**Figure 2.4-10** shows a rock shed adjacent to the Erkenek tunnel. No particular damage was found from the moving-vehicle observations.

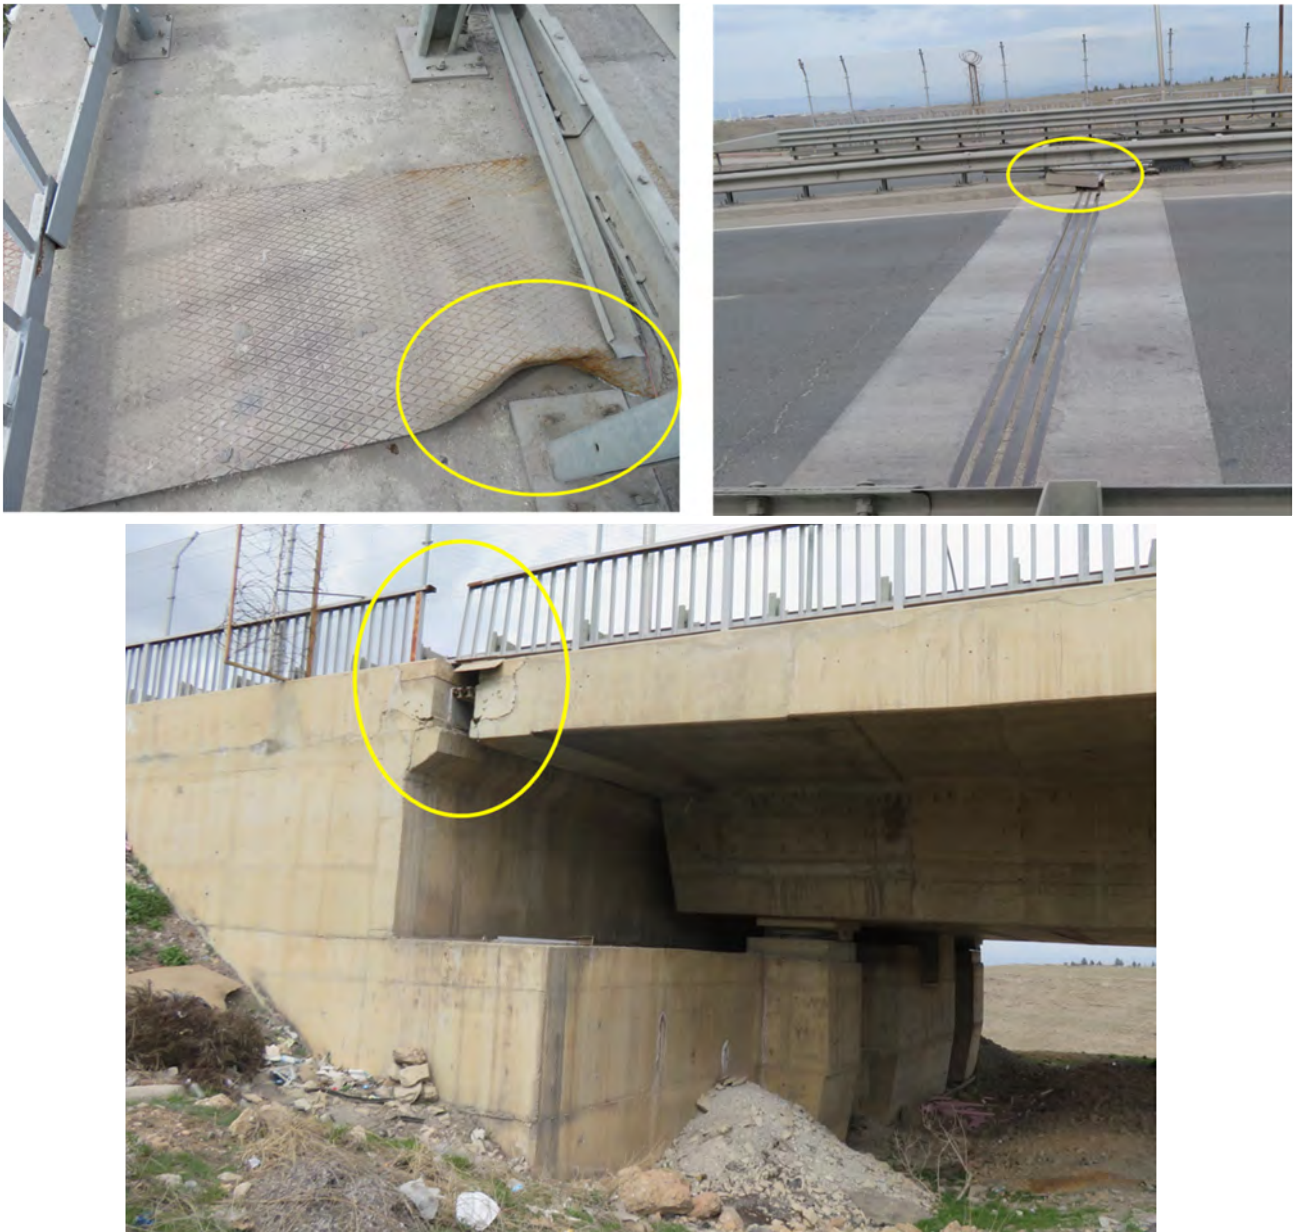
**Figure 2.4-15.** Examples of observed damage to girder-end and west-side abutment

**Figure 2.4-15** shows the damage around the west-side abutment. The damage indicated that the girder and the abutment collided.

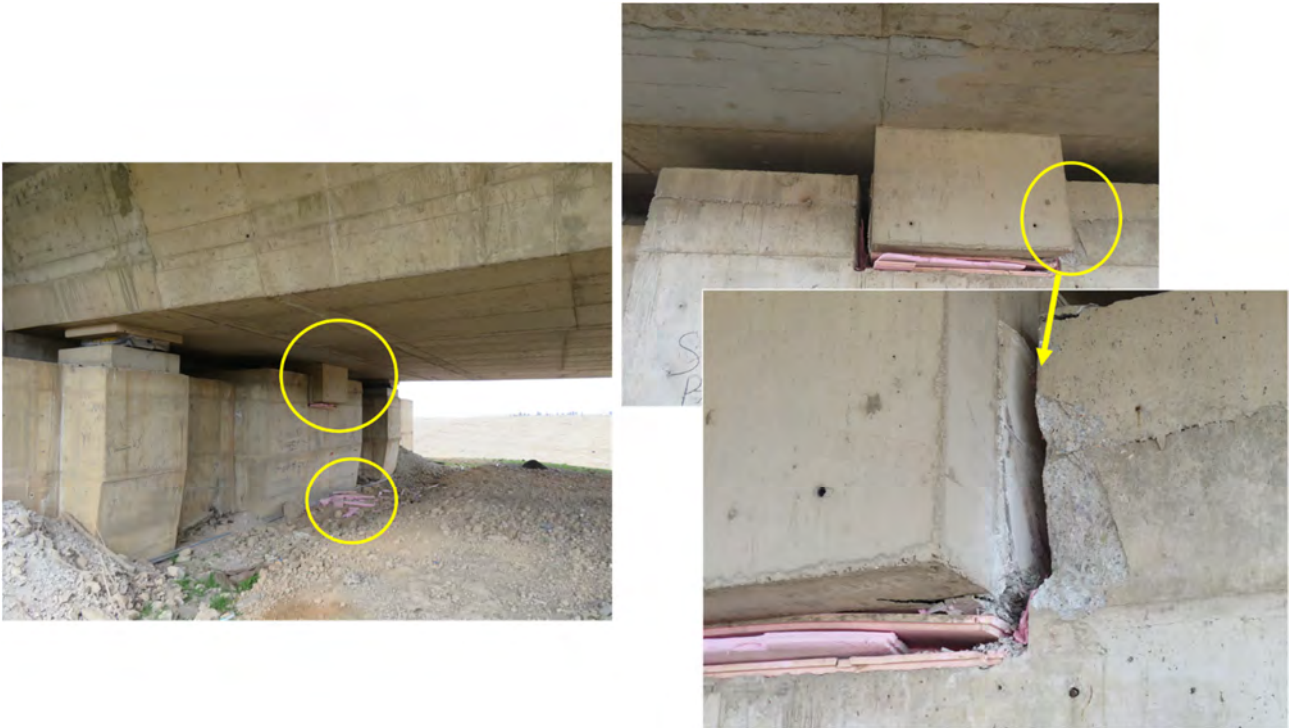
**Figure 2.4-16.** Examples of observed damage to shear key on west-side abutment.

As shown in **Figure 2.4-16**, the shear key concrete was damaged, indicating that the bridge was heavily shaken in a direction perpendicular to the bridge axis. The Styrofoam under the shear key was torn apart and fell to the ground in front of the abutment. The front face of the shear key was also positioned forward compared with the front surface of the abutment.

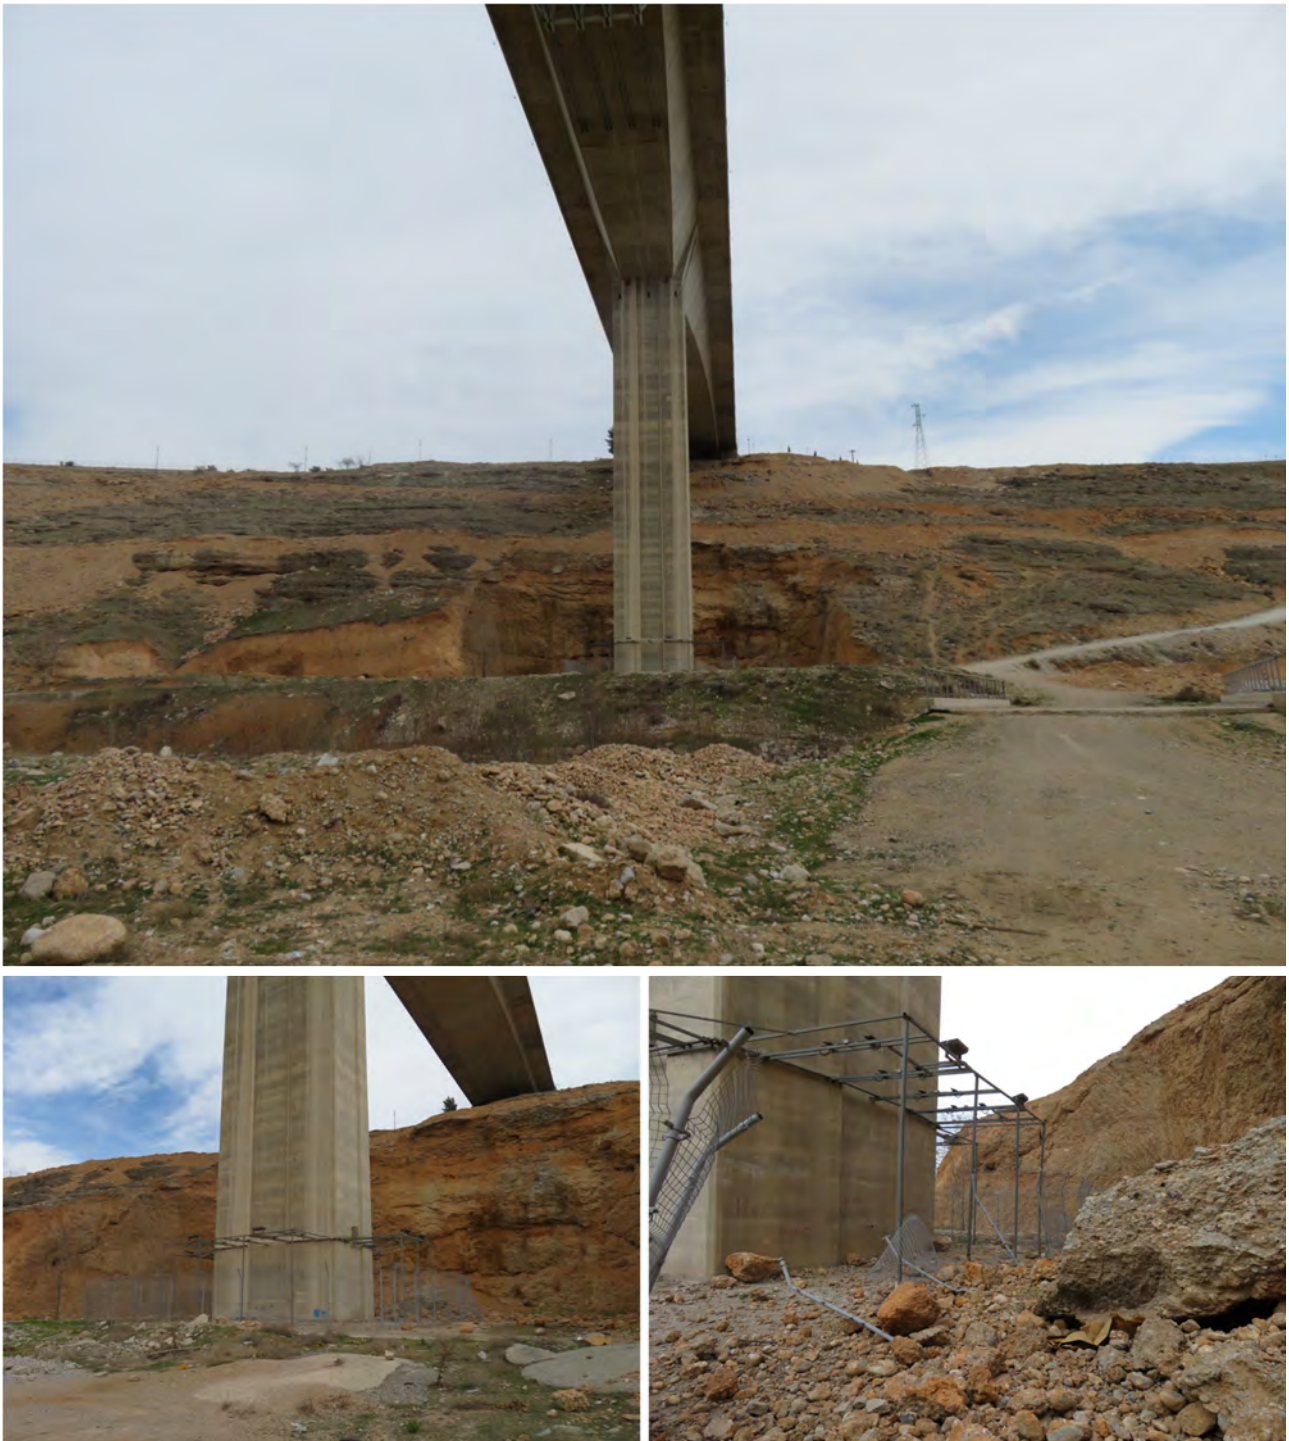
**Figure 2.4-18.** East-side pier and fallen rocks

**Figure 2.4-18** shows the east-side pier. A slope was behind the east-side pier and falling rocks were observed around the pier, indicating that some reached the pier during the earthquake. A frame was fixed to the pier and maintained its shape. As shown in **Figure 2.4-19**, no dents or cracks were observed in the column.

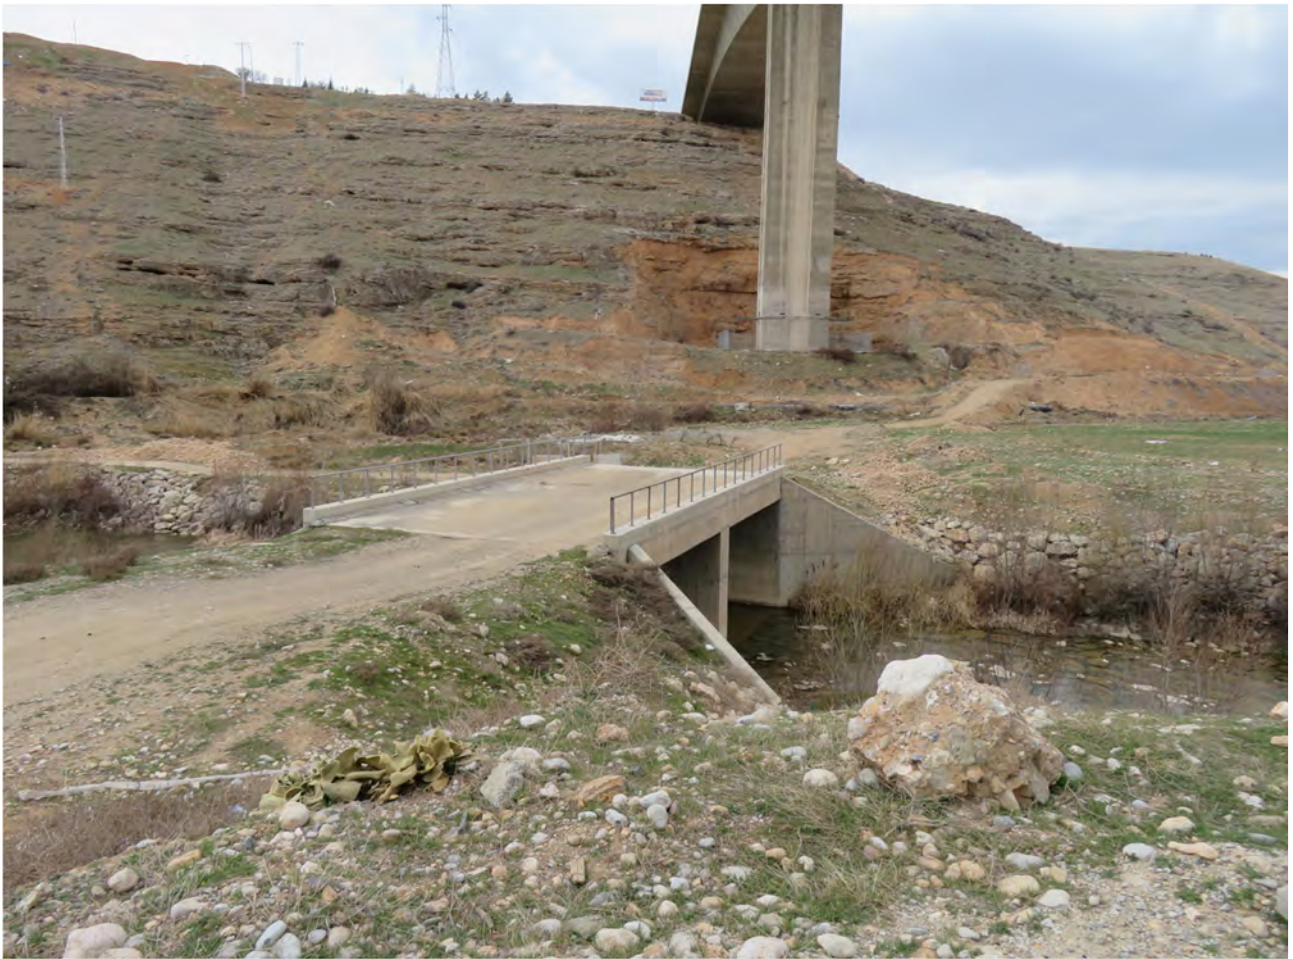
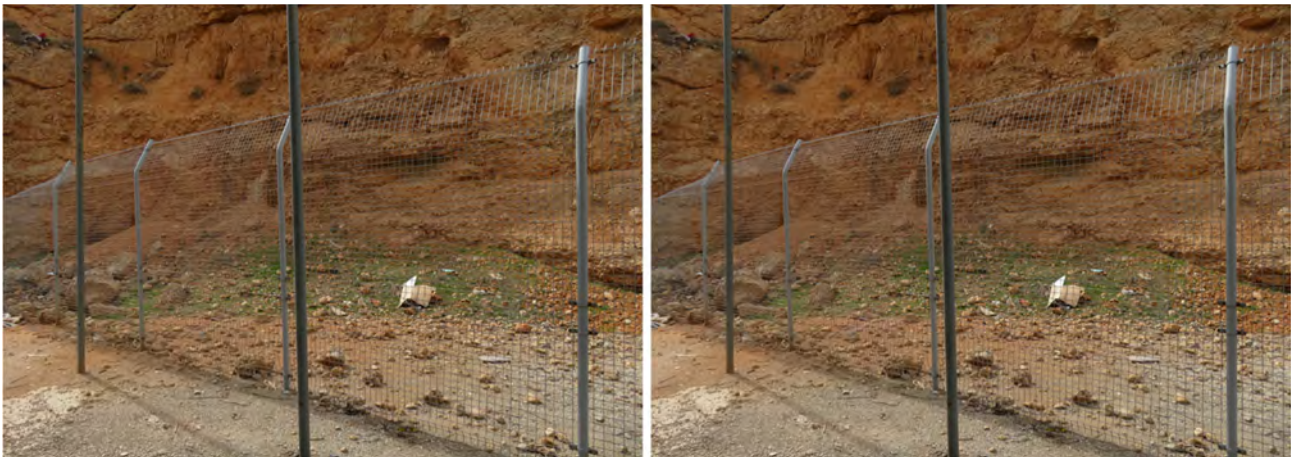
**Figure 2.4-20.** West-side pier and fallen debris around it

**Figure 2.4-20** shows the western pier. A few small fallen rocks were observed around the western pier. No damage was observed on the pier, as shown in **Figure 2.4-21**.

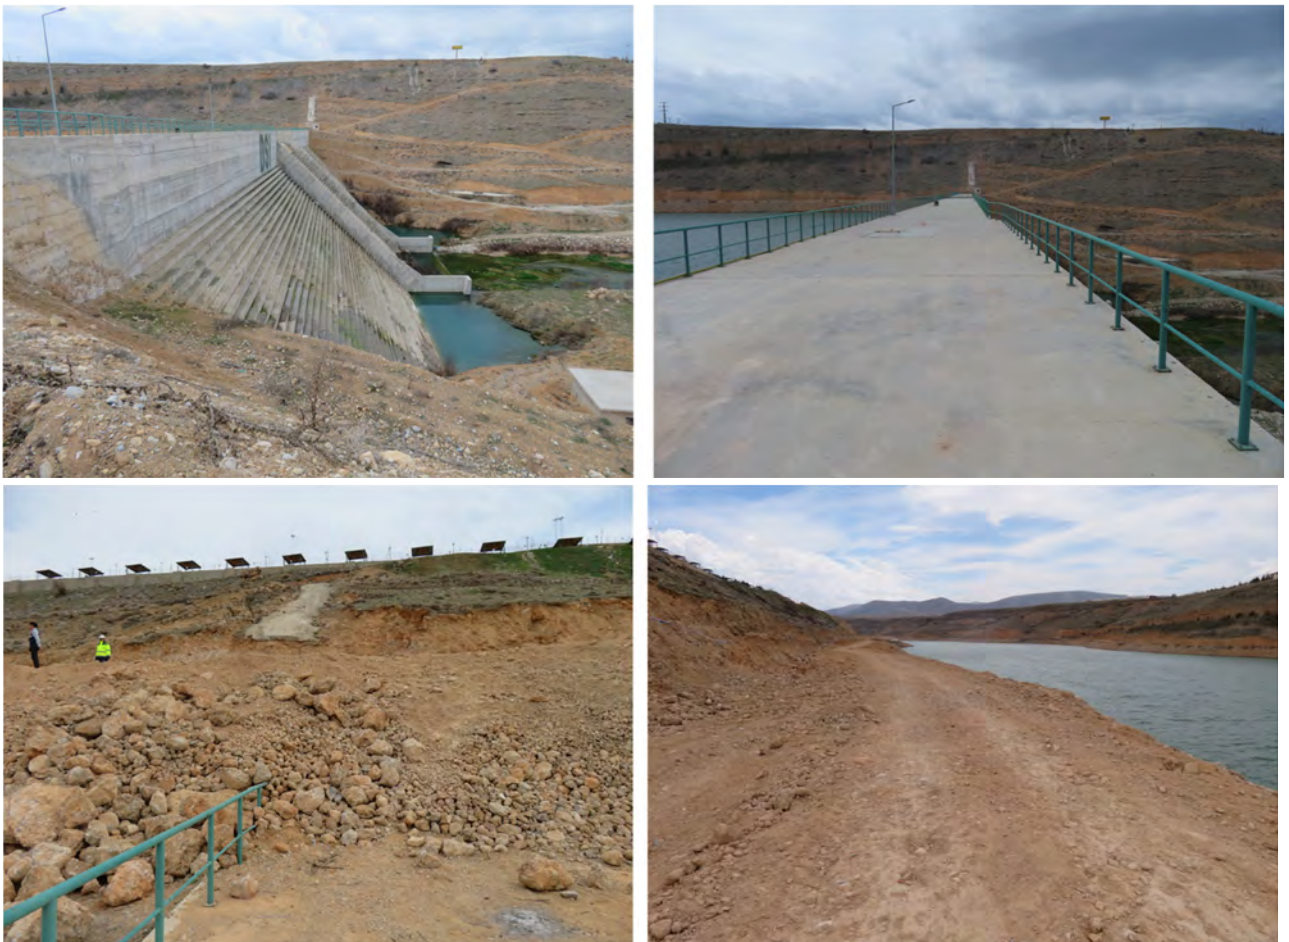
**Figure 2.4-22.** Beylerderesi dam and surrounding ground

**Figure 2.4-22** shows the Beylerderesi dam. No cracks, leaks, or other distresses were observed in the dam.

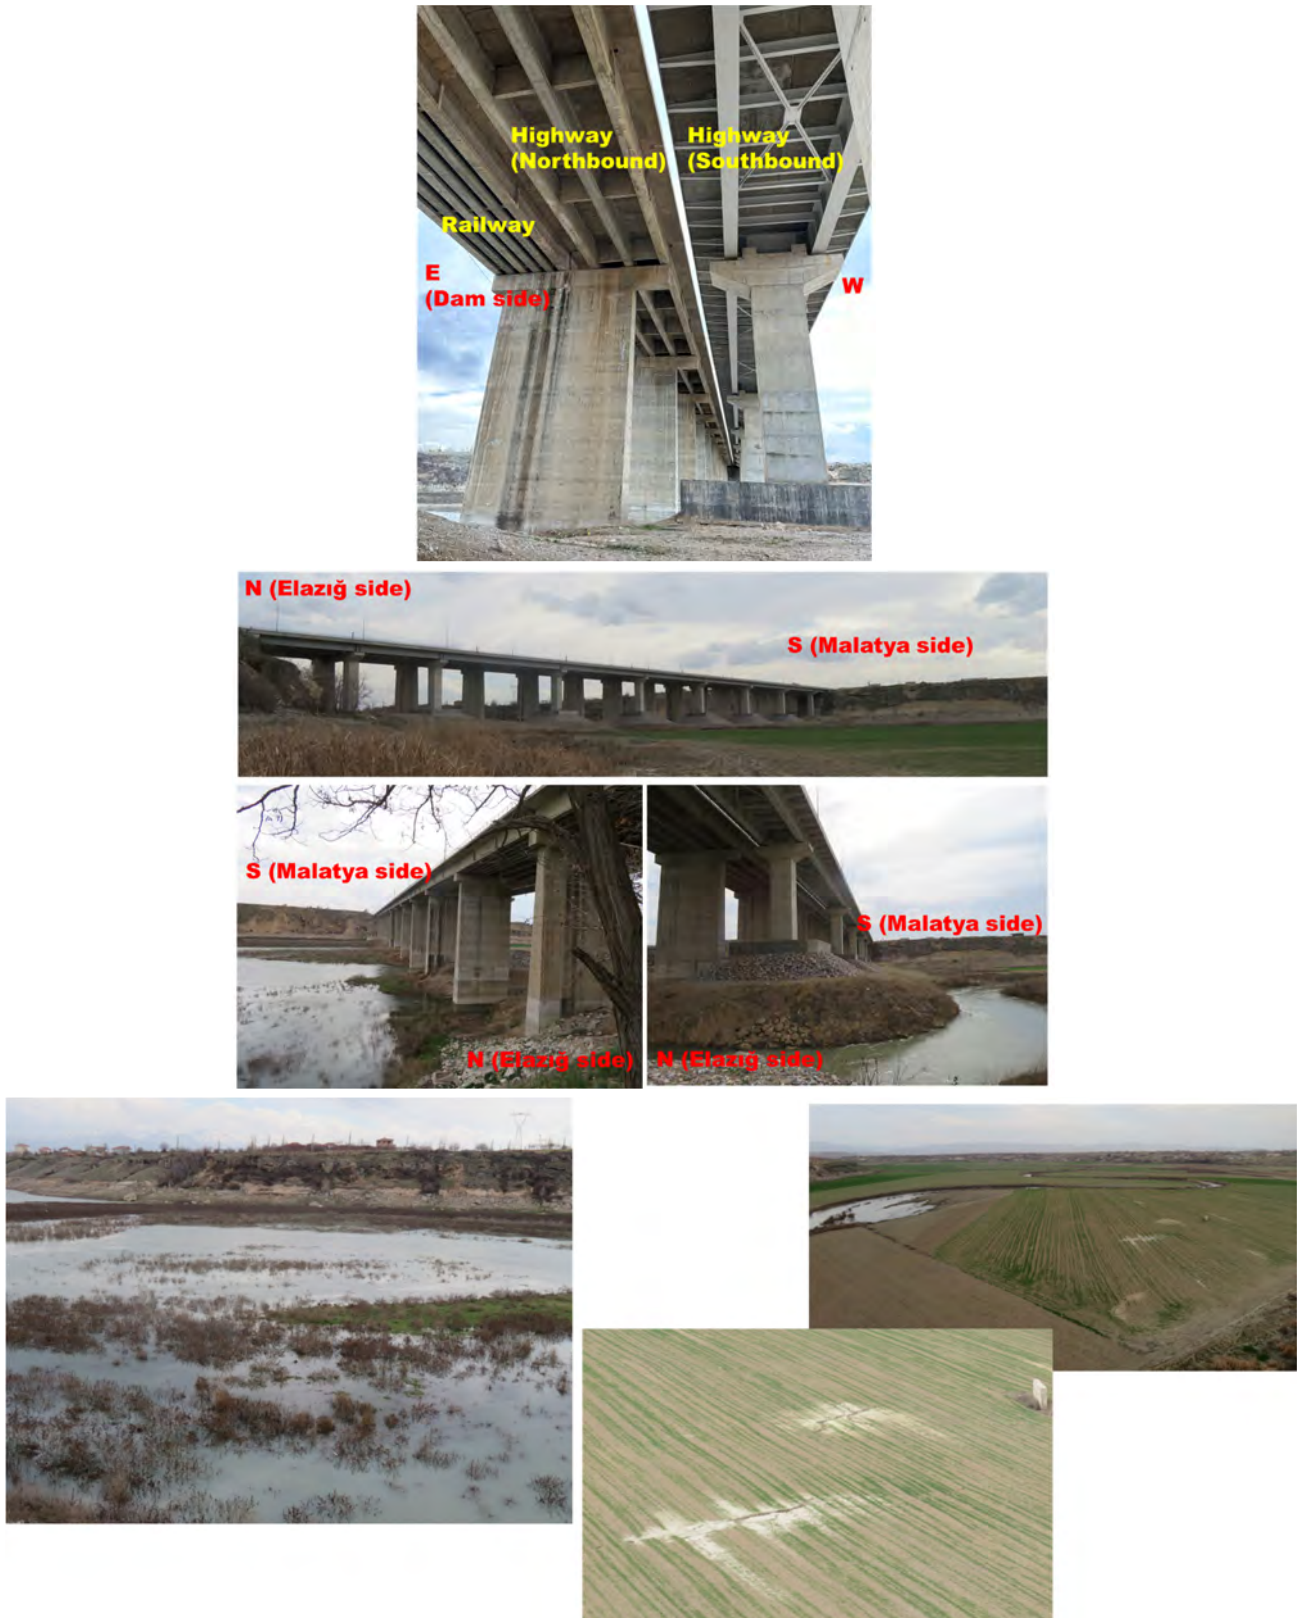
Figure 2.4-24. Tohma bridge on D875 Malatya/Keban highway

Figure 2.4-24 shows the Tohma bridge. The bridge comprises of old and new bridges. The old bridge consists of railroad and northbound road superstructures. Both bridges are concrete girder bridges. The southbound bridge is a steel girder bridge. The piers are located in a wetland. A train passed during the investigation; however, it was slow. Traits that looked like sand boils were observed on the ground surface near this bridge; however, it was unclear what they were because we did not approach them.

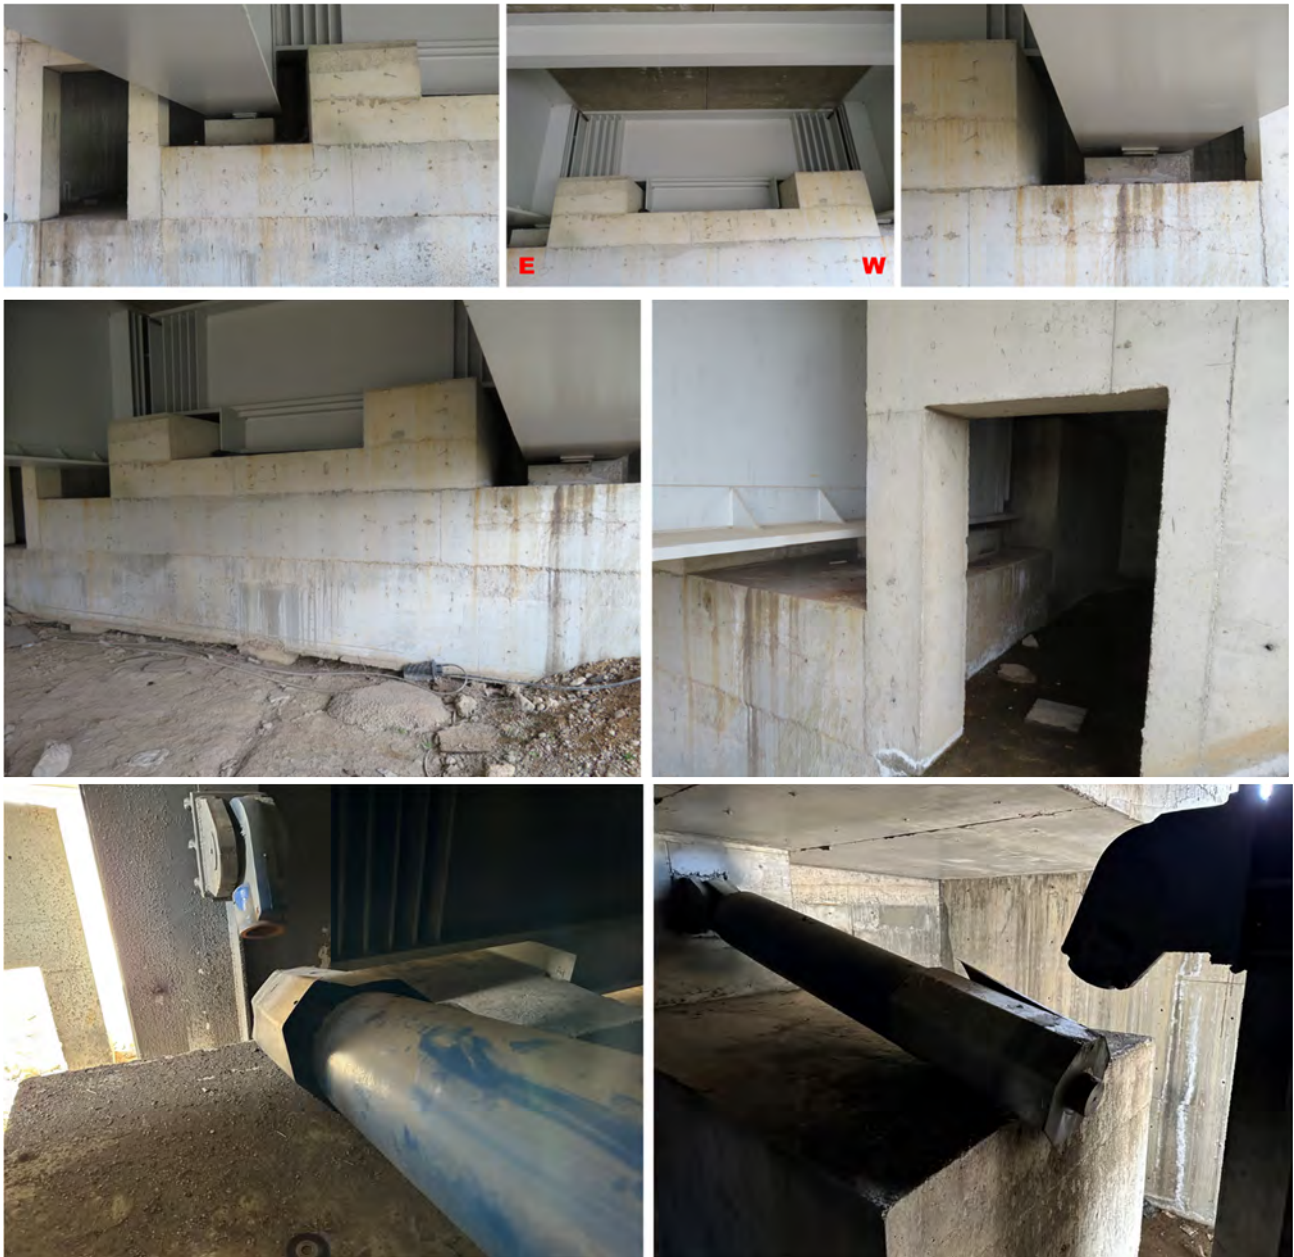
**Figure 2.4-26.** Damage to dampers

As shown in **Figure 2.4-26–Figure 2.4-28**, dampers were installed behind each steel girder of the new bridge; however, they were disconnected. The threads of the screw connections of the dampers were not stripped and the screw connections exhibited rust.

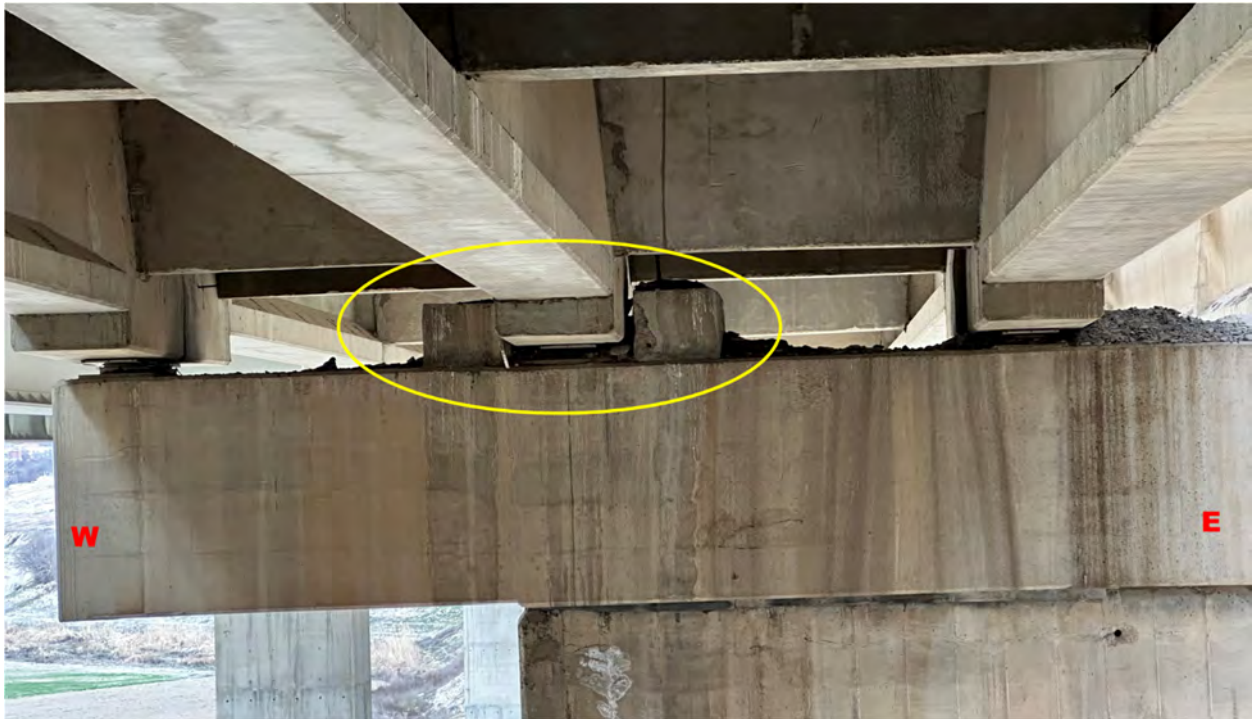
**Figure 2.4-30.** Damage to shear keys on pier of old bridge

**Figure 2.4-30** shows a photo of the seating of the pier of the old bridge, as seen from the abutment. The shear keys of the road girders were damaged, indicating that the superstructure had moved horizontally.

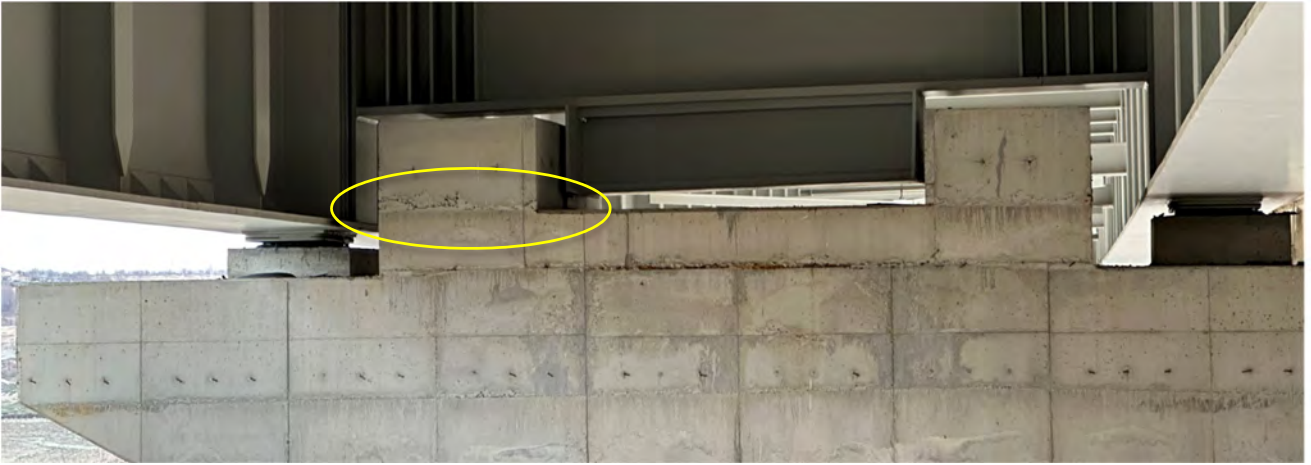
**Figure 2.4-31.** Damage to shear keys on pier of new bridge

**Figure 2.4-31** shows the seating of the pier of the new bridge, which was also seen from the abutment. Based on the distant view, it was unclear whether there was damage, but cracks appeared to develop at the bases of the shear keys.

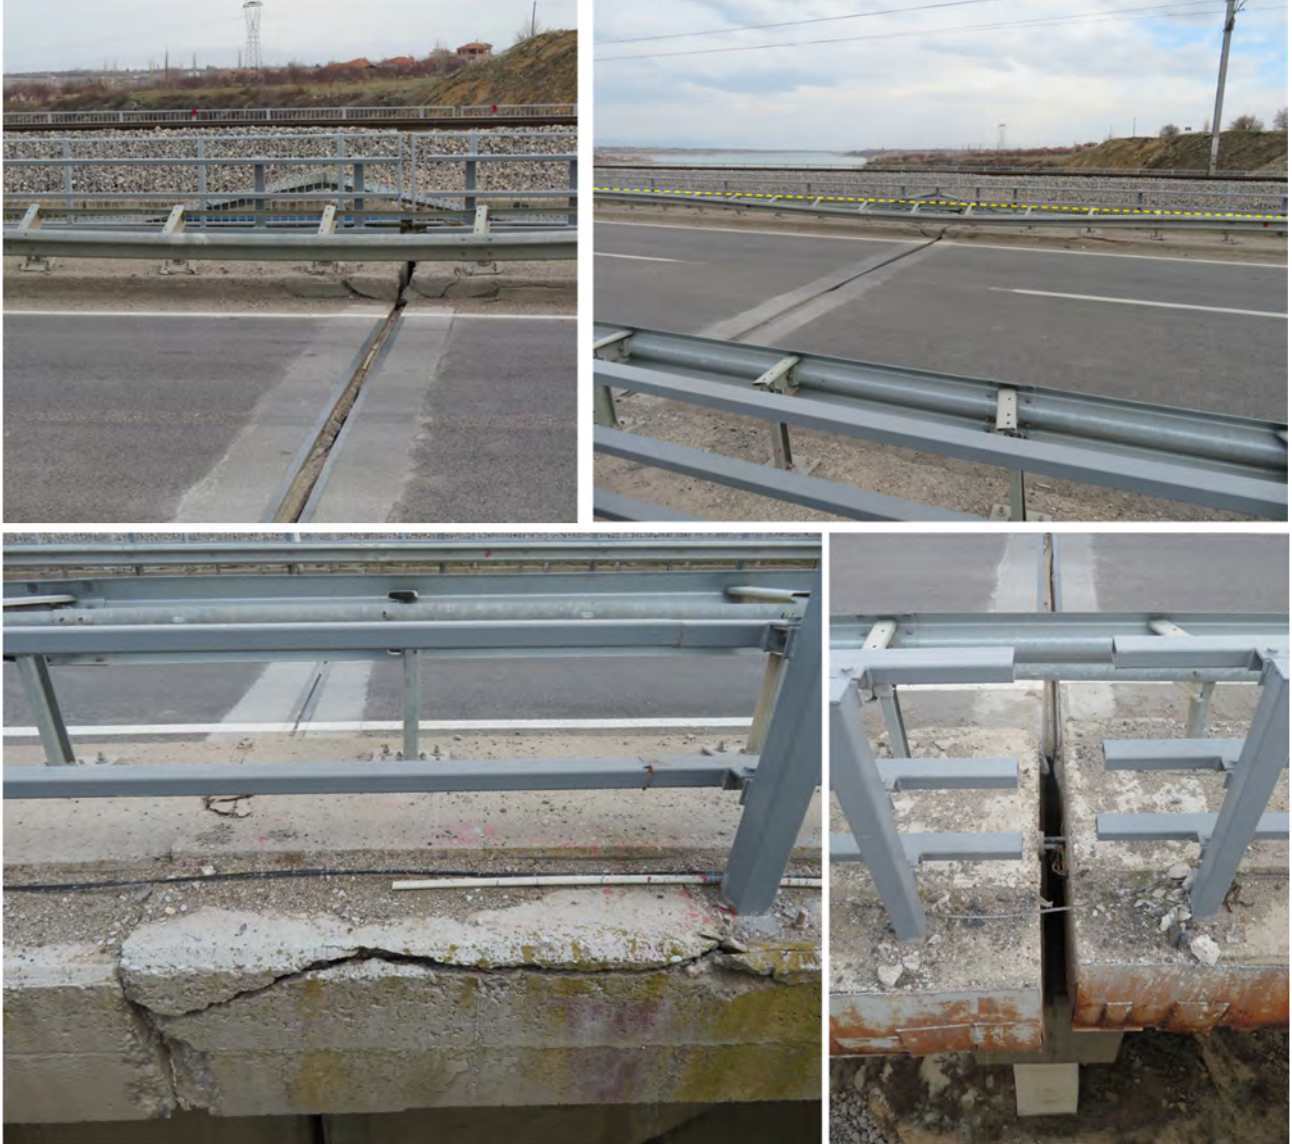
**Figure 2.4-32.** Dislocation of spans from each other over piers

The bridge surface was examined on foot. The floor slab was not continuous over the piers, and expansion joints were present between the spans. As shown in **Figure 2.4-32**, the superstructures were displaced from each other over the piers. Damage to the bearings and girder ends was presumed. Although inspection is necessary, the structure is not designed to allow easy access to the bearings. For example, no inspection facility was available for the superstructures. The superstructures were extremely close to each other horizontally to operate the inspection platform of a bridge inspection truck between them. As shown in **Figure 2.4-33**, soil deformation (cracking) was also observed around some piers.

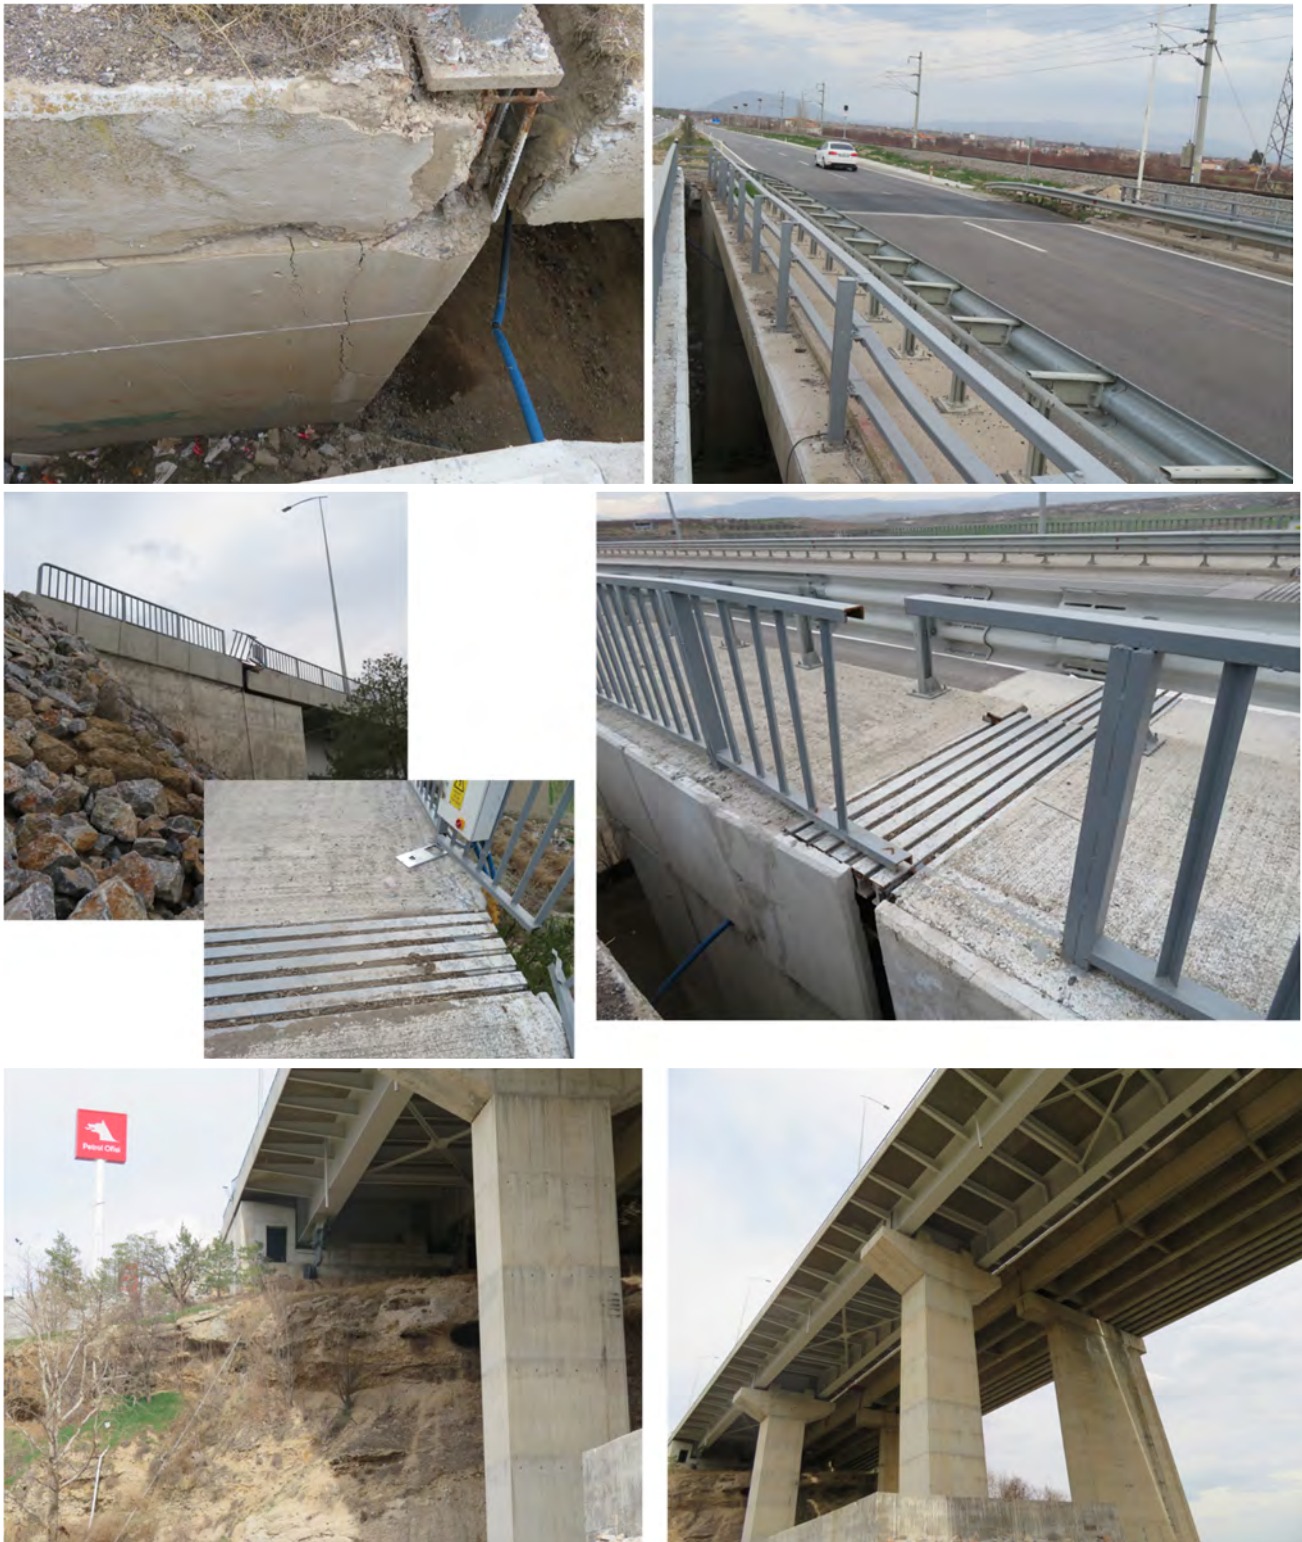
**Figure 2.4-34.** Northern (Elâziğ-side) abutment

**Figure 2.4-34** shows the north-side (Elâziğ-side) abutment of the new bridge. The pavement behind the old bridge was repaired. The abutment concrete fell off and the anchor bolts of the lighting pole foundation were exposed. The girder and the abutment appeared to have collided with each other.

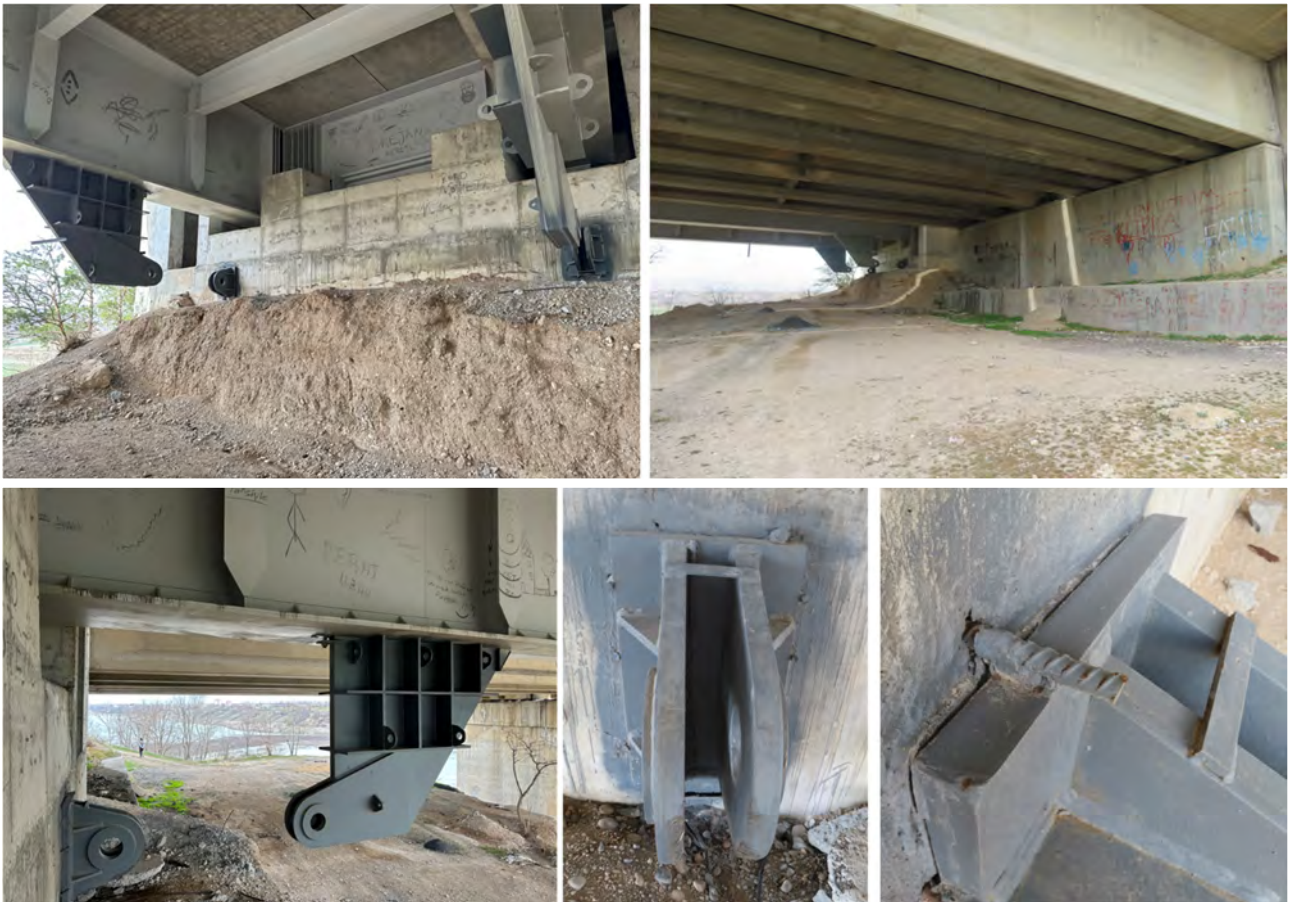
**Figure 2.4-35.** Close-up views of north-side abutments

**Figure 2.4-35** shows close-up views of the north-side abutments. No damage to the abutments of the new bridge was observed. In the new bridge, jigs were installed on the girders and the abutments. Installation of attachments to prevent the bridge from unseating seemed to be planned.
