## 2. Field scanning records

## 2.1. Antakya city and Hatay Airport Road

### 2.1.1. Viaduct on D817 near Saraykent, Antakya city

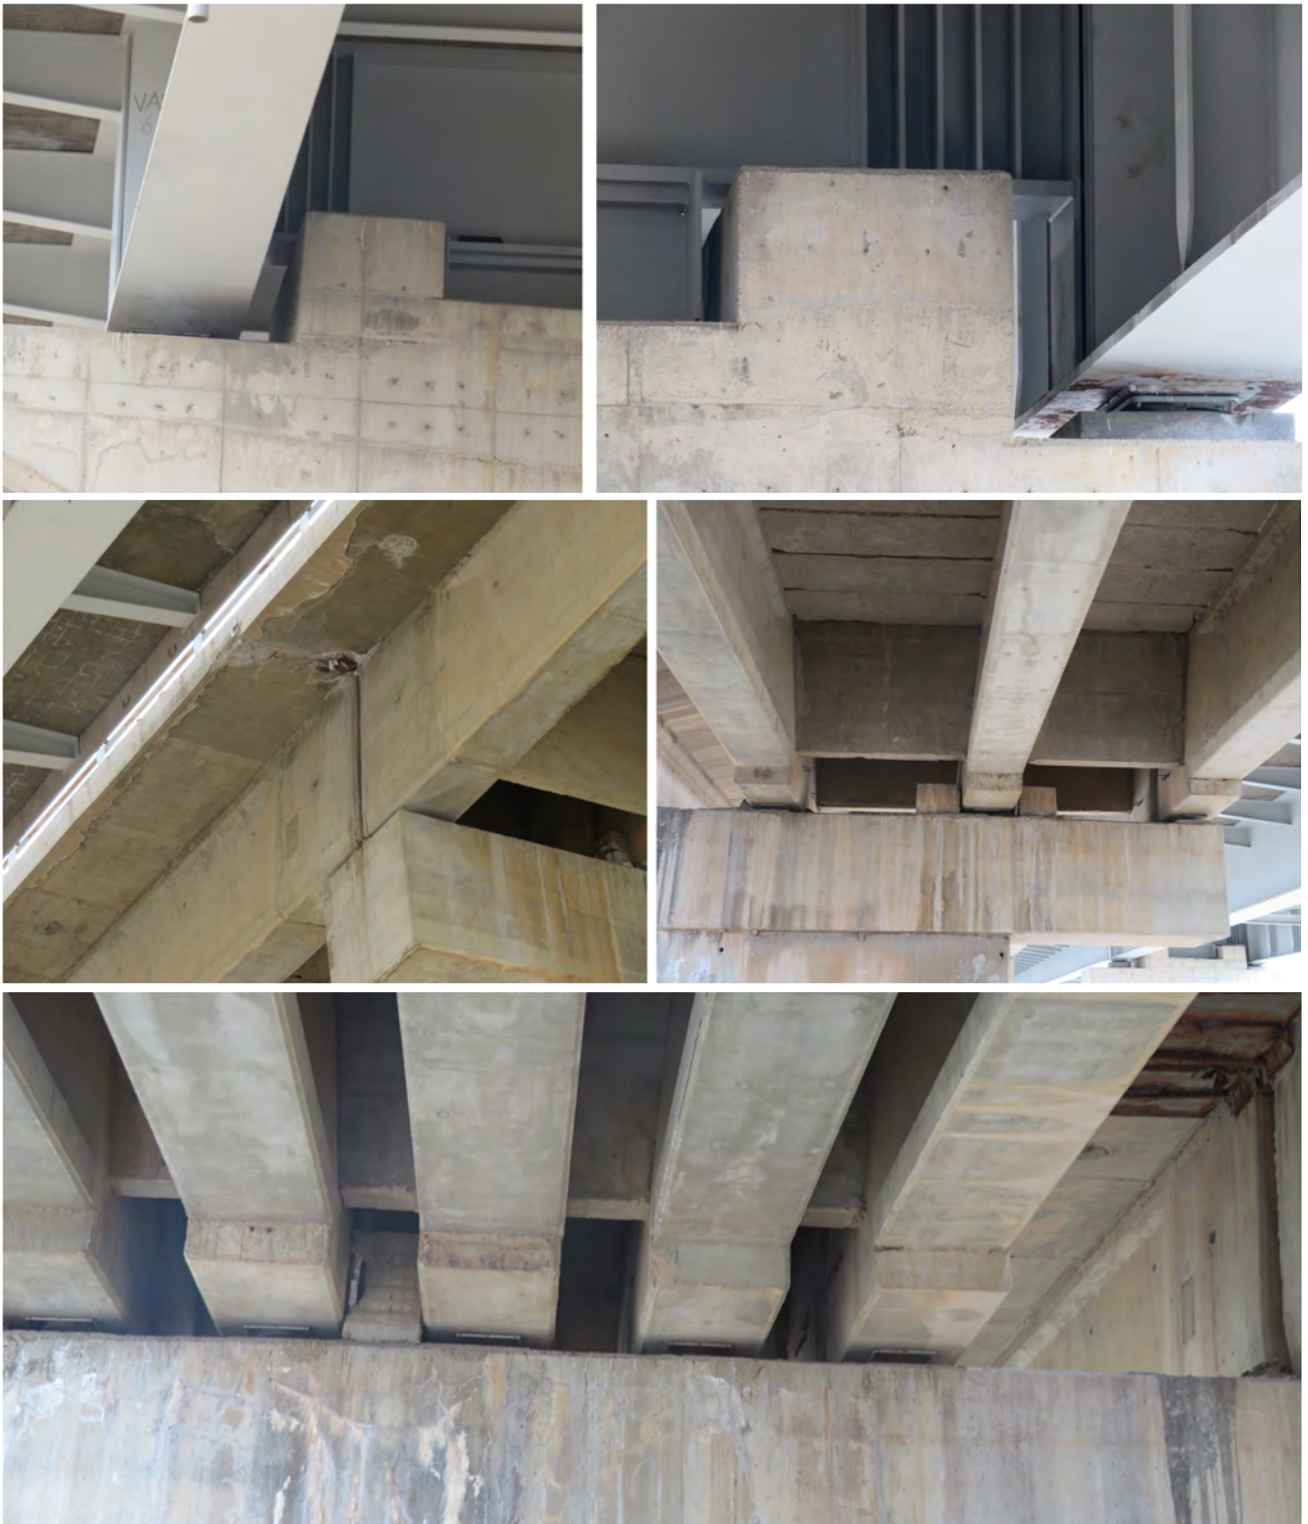
**Figure 2.4-38.** Shear keys on pier caps

**Figure 2.4-38** shows photos of the pier caps captured from the abutment. Based on these photos, it is uncertain that the girders and the shear keys were in contact with each other in the road bridges during the earthquake, whereas some shear keys were damaged in the railway bridge.

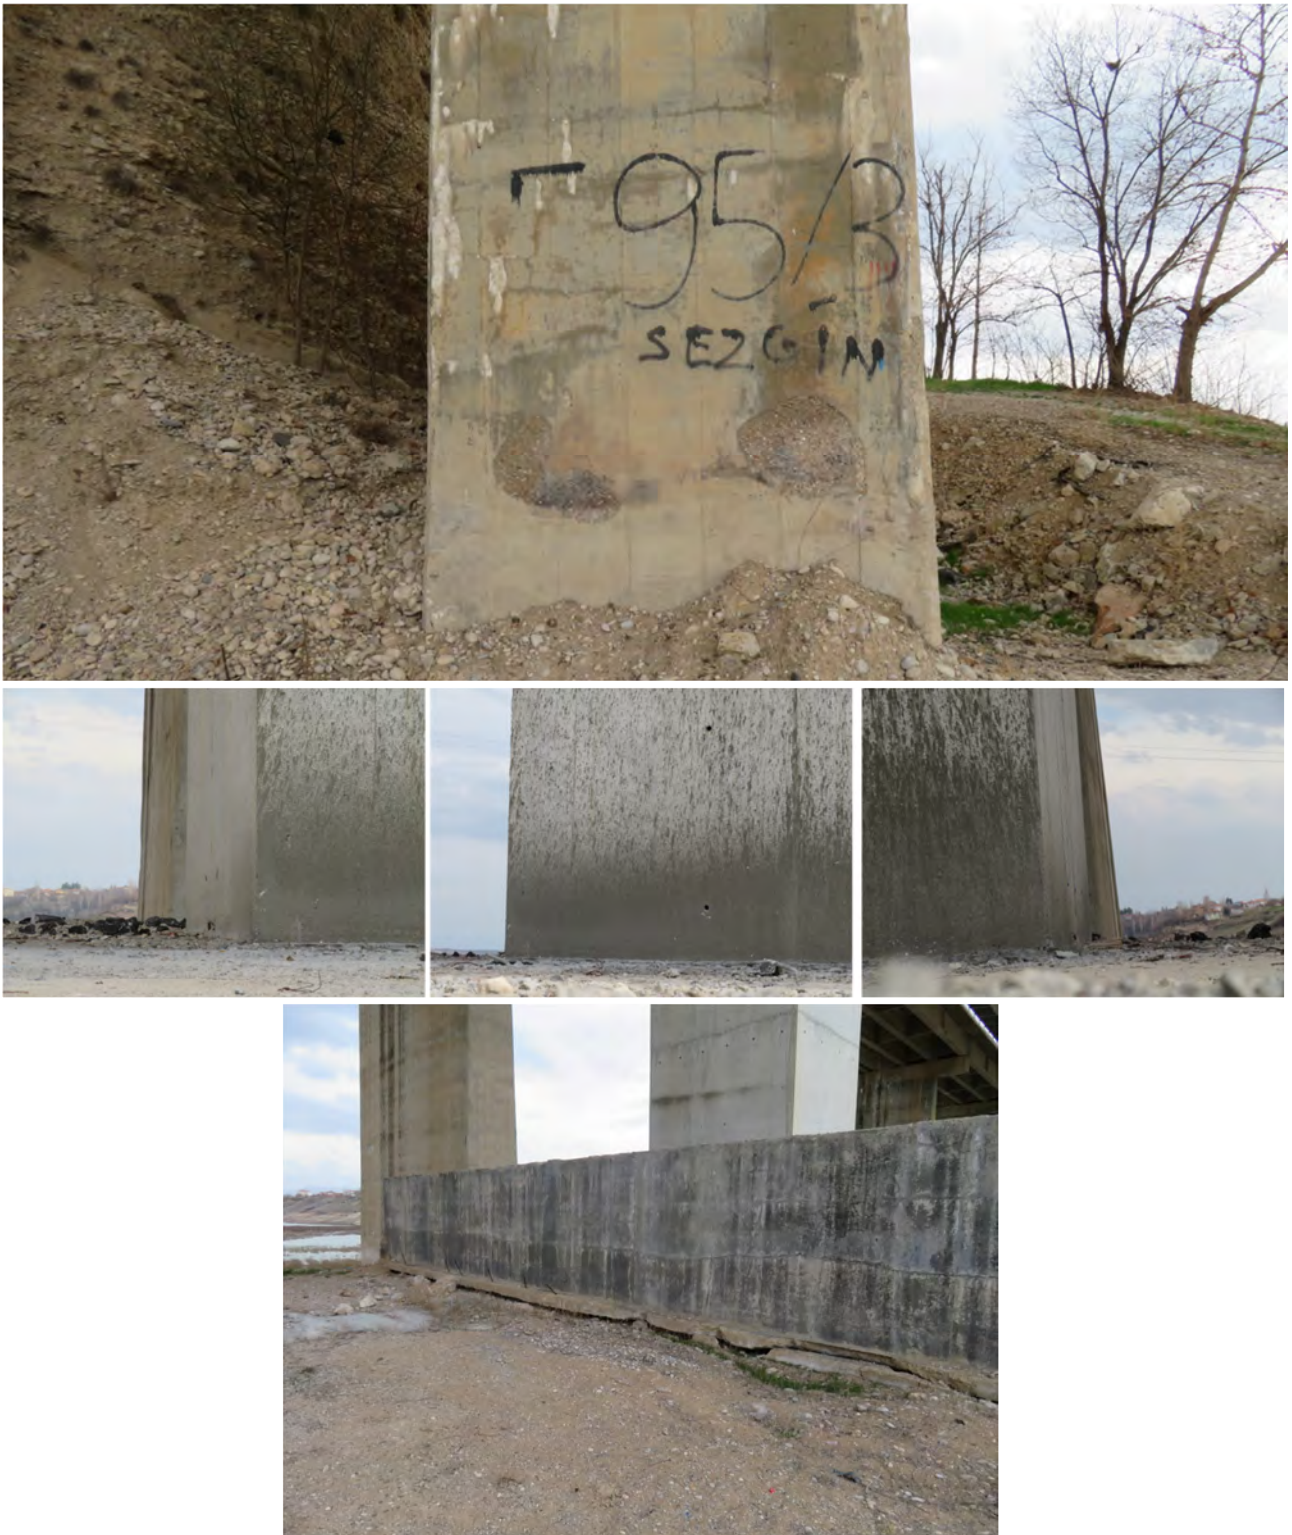
**Figure 2.4-39.** Bases of some piers and surrounding ground surface

The soil was considered to have subsided around some footings, as shown in **Figure 2.4-39**. Because the footings were extremely deep to climb, it was impossible to approach the bases of the piers. Photos taken from a distance indicated no significant damage, as **Figure 2.4-39** also shows.

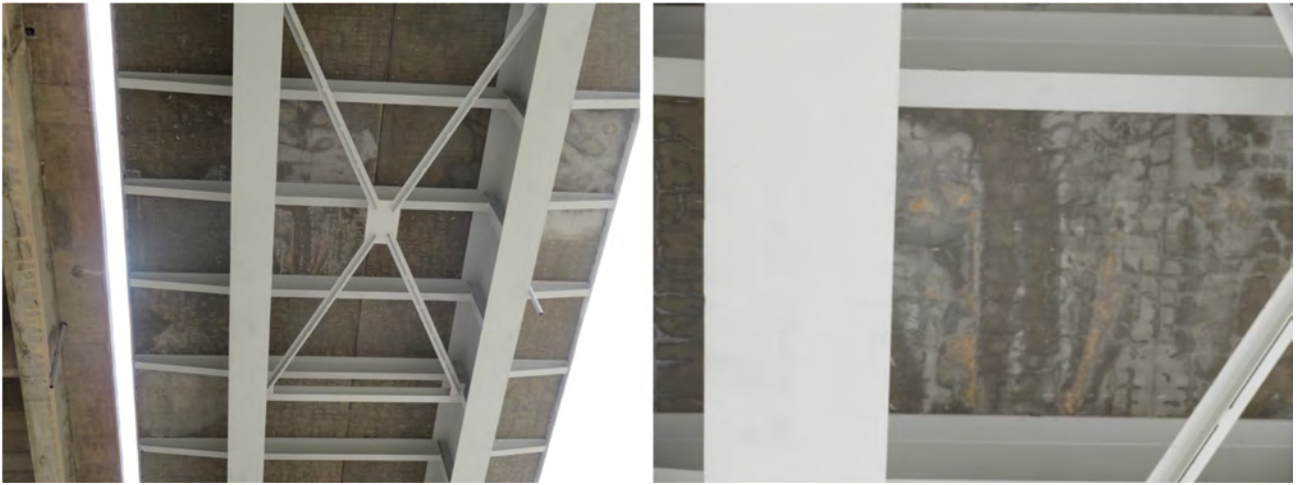
**Figure 2.4-40.** Deck slabs of new bridge

**Figure 2.4-40** shows photos of the deck slabs. There were white stains on the deck slabs, and, accordingly, the cause of these stains should be checked from the viewpoint of durability of the deck concrete.

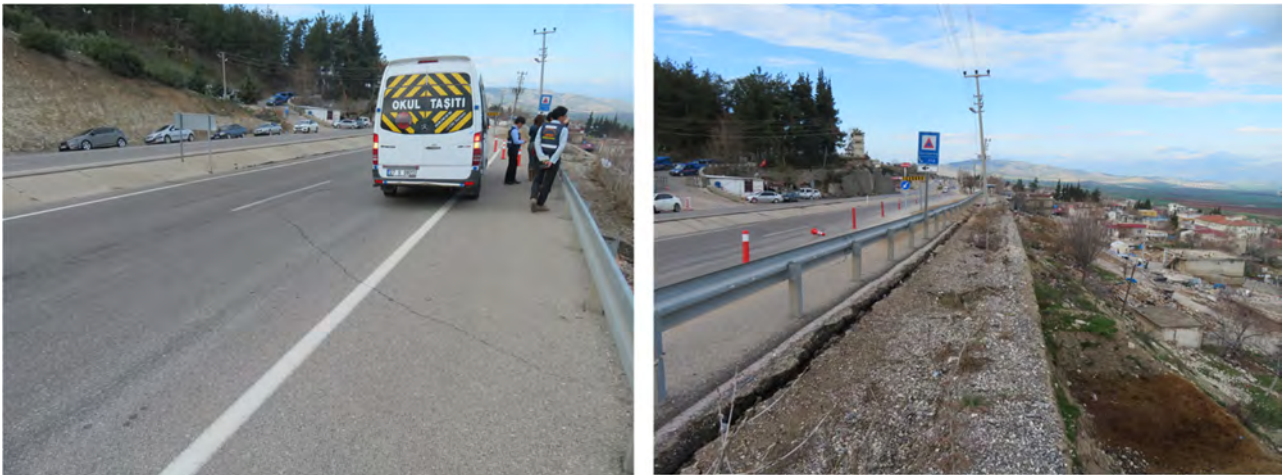
Figure 2.5-4. Traffic restriction on shoulder

During the survey, traffic on the shoulder above the retaining wall was restricted using lane separator pole cones, as shown in Figure 2.5-4. A separation crack was observed between the pavement and the retaining wall, indicating that the retaining wall moved forward during the earthquake.

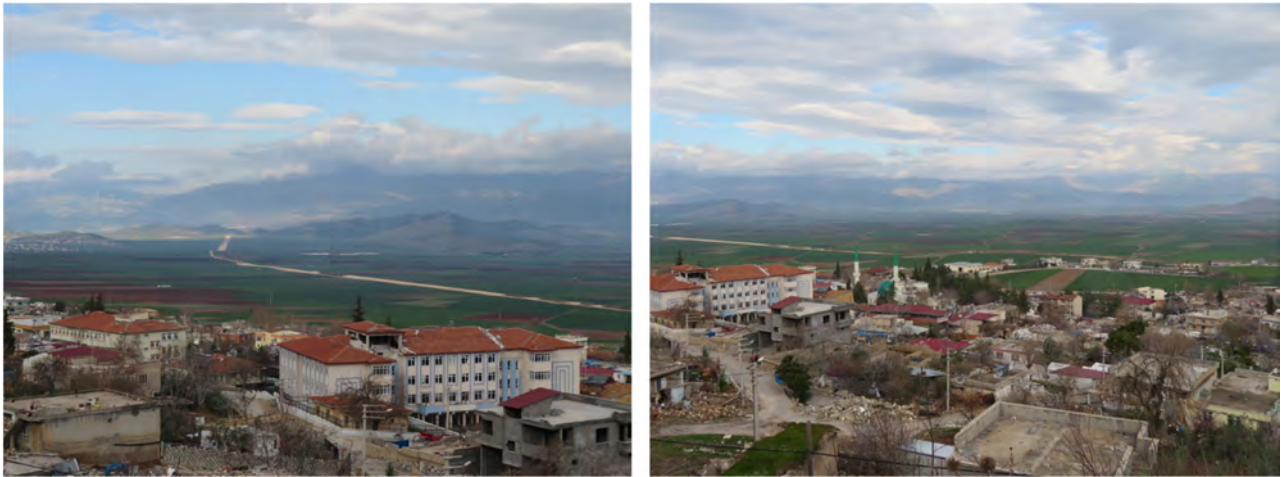
**Figure 2.5-5.** Buildings in Sakcagoz

Many buildings had also collapsed, as shown in **Figure 2.5-5**. A line earthwork was observed far from the town, but we had no time to visit and observe it.

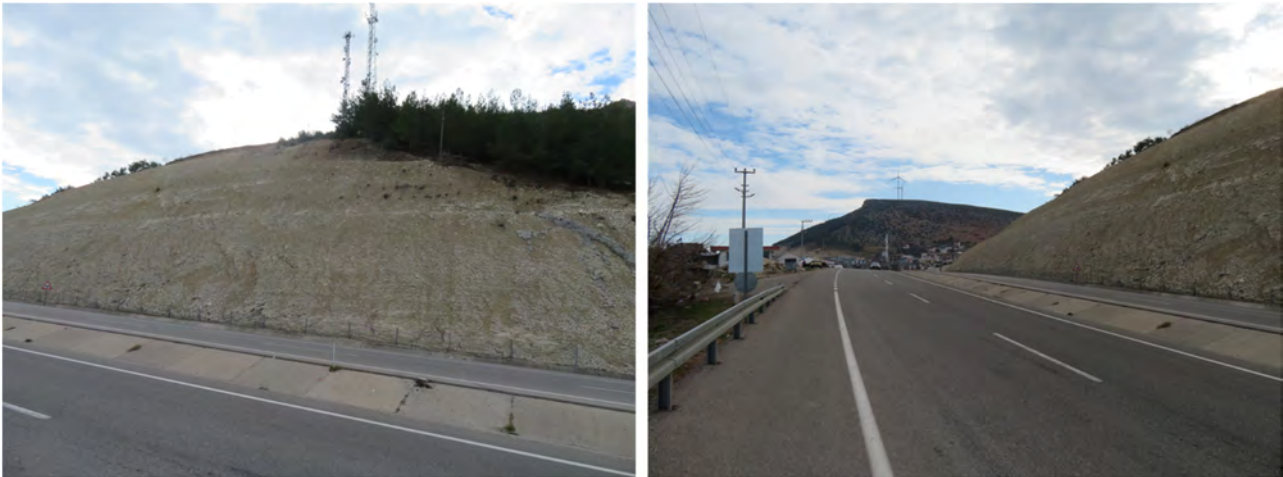
**Figure 2.5-6.** Example of cut slopes

**Figure 2.5-6** shows a cut slope example. No damage was observed.
