Support for restoration following the Kumamoto Earthquake in 2016 -Setting up laboratories at disaster recovery sites

1. Outline of Studies and Activities

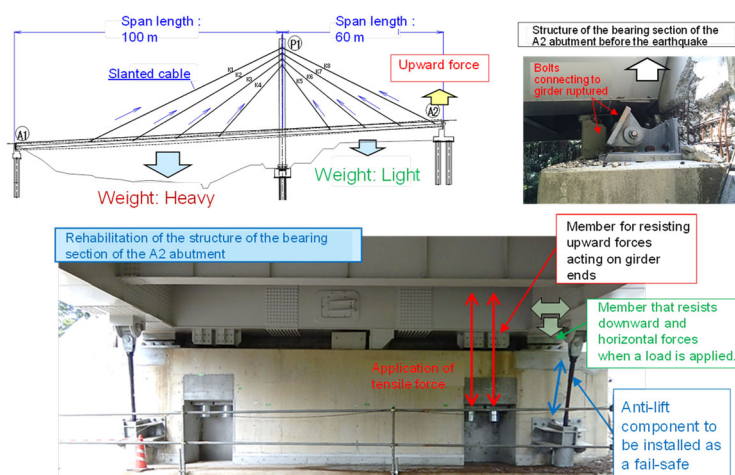
The Kuwatsuru Bridge, a cable-stayed bridge with unequal longitudinal slope, suffered a failure of its bearing that had resisted vertical upward and horizontal forces with the same member, causing the girder ends to lift up and hindering the early recovery of roadway functions. As a countermeasure to prevent serious damage due to the lifting of the girder ends, the NILIM proposed that the members resisting vertical upward forces be independent of the members resisting horizontal forces and that members of a different system be installed to prevent the girder ends from lifting easily even if these members should fail (Figure 3).

Figure 3 Structure of the fulcrum that prevents the girder end from

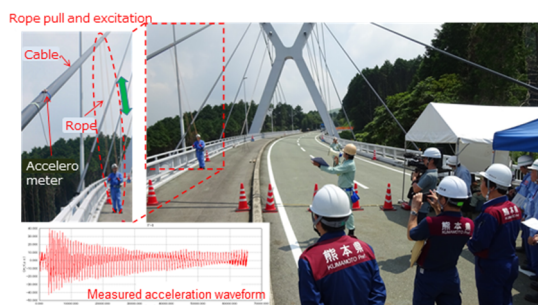
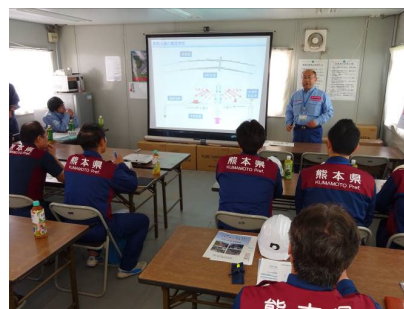
Figure 4 On-site briefing session at the Kuwatsuru Bridge for the administrator (Kumamoto Prefecture)

In addition, tests to obtain cable tension and the natural frequencies of the rehabilitated bridge were conducted at the on-site briefing held prior to the reopening of the bridge to hand over the bridge to Kumamoto Prefecture, which will be the administrator of the bridge. This process was held so that they could identify changes in the condition of the bridge in the event of another major earthquake while they are in charge of maintaining and administering the bridge after the reopening. This process was also done with an eye toward the fact that the local government, not the national government, which did the rehabilitation work, would be in charge of road administration. In order to facilitate the use of the test results in maintenance management, the test was designed to be as simple as possible in obtaining results so that the tests would not be a heavy burden on maintenance management. During the on-site briefing, the vibration characteristics of the bridge were explained, tests were conducted, and an explanation of how to use the test data for maintenance and management was provided (Figure 4).

(1) Status of cable tension verification testing

(2) Explanation to administrators regarding the use of data acquired during the construction phase for maintenance and management

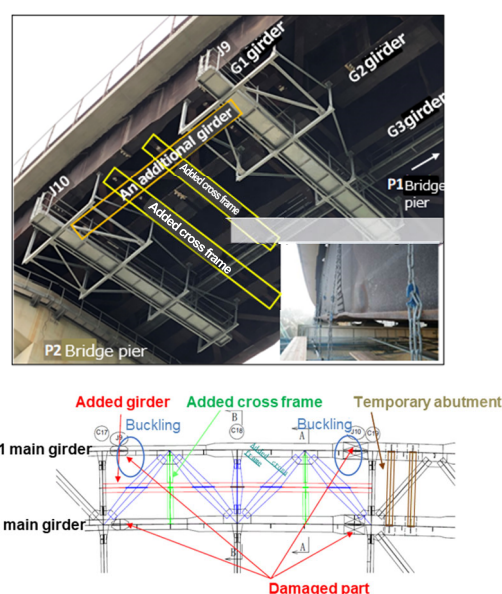
In the case of the Okirihata Bridge, a five-span continuous non-composite curved plate girder bridge, all but one of the bearings were damaged, causing the superstructure to shift and the main girder to buckle in the interstitial section. This kind of damage had never been observed in past earthquakes. The rehabilitation was conducted based on the basic policy of restoring the bridge as a whole to the same load-bearing capacity as before the disaster. From the viewpoint of recovering the load-bearing capacity of the superstructure, a strategy was devised to install a new girder and cross-frame within the damaged section, leaving the buckled main girder in place (Figure 5). The load sharing by the newly added girder was confirmed by monitoring the stress (strain) generated in the girder because the load acting on the superstructure changes from changes in the fulcrum conditions during the construction process and vehicle loading after completion.

Figure 5 The Okirihata Bridge repaired to recover the load-bearing capacity of the entire superstructure

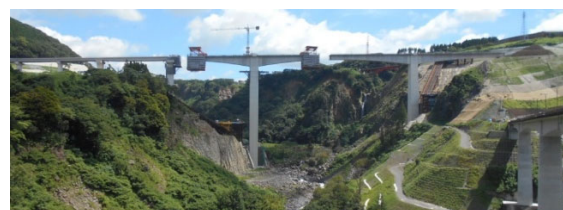
The New Aso Bridge was constructed approximately 600 meters downstream from the Aso Bridge (arch bridge) that collapsed because of the earthquake. In constructing the New Aso Bridge, the NILIM proposed various technical considerations at each stage of planning, design, and construction based on the lessons learned from the damage caused by the Kumamoto earthquake. For the crossing section, a bridge type (PC rigid-frame structure with cantilevered erection) was adopted so that the superstructure could stand on its own even if the substructure at the girder ends moved or settled from ground deformation (Figure 6). In addition, the section that straddles the fault where lateral displacement is anticipated is a single-diameter steel girder bridge, so that even if the girder moves due to movement of the substructure caused by displacement of the fault, it will not interfere with the superstructure of the adjacent section. The NILIM also proposed technical considerations for the span that crosses the fault line to make it more difficult for the bridge to fall and also to restore the road function as soon as possible. Details of the proposals are as follows: to design with differential load-bearing capacity at the bearings and their attachments so that the failure of the bridge is guided to the bearings when relative displacement occurs in the upper and lower structures due to ground deformation caused by faulting activities, to provide enough width of the pier top edge so that the bridge does not immediately fall from the top edge of the substructure if the bearing section were to fail (Figure 7), to secure space at the top end of the piers to facilitate temporary support of the girder if it were to move, and to arrange reinforcement within the top

Figure 6 The New Aso Bridge where the bridge girders remain without falling off even when the ends of the girders are not on the bridge piers (under construction) (Photo provided by the Kumamoto Reconstruction Project Office)

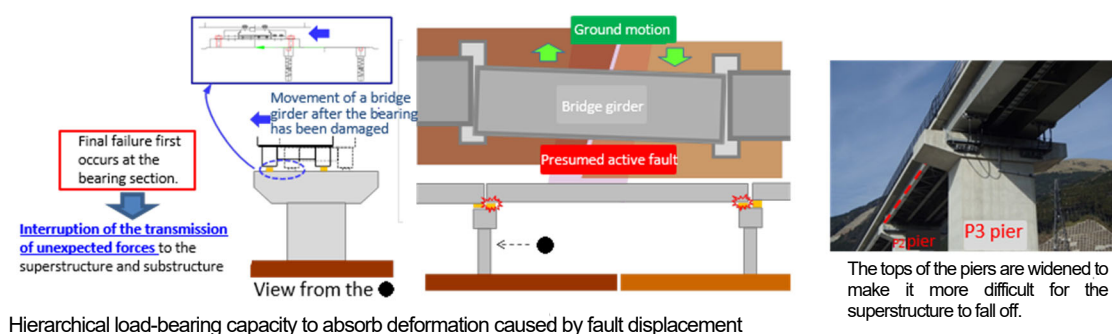
Hierarchical load-bearing capacity to absorb deformation caused by fault displacement

Figure 7 Structural plan to let go of fault displacement without resisting it by force (New Aso Bridge)

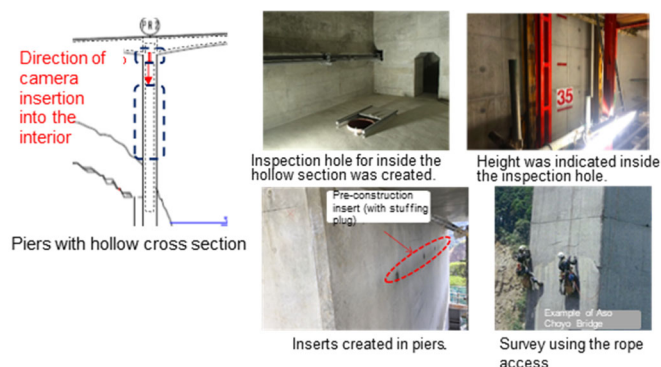
edge assuming the installation of anchor bolts in advance. In addition, the bridge has hollow piers at the crossing that reach 97 meters at their highest point. Therefore, the suggestion included installing inserts for rope access at the construction stage and creating inspection holes in the column heads to check inside the hollow section. These suggestions were to make it easy to monitor the bridge condition before damage occurs (Figure 8).

Figure 8 Considerations in maintenance to make bridge inspections easy

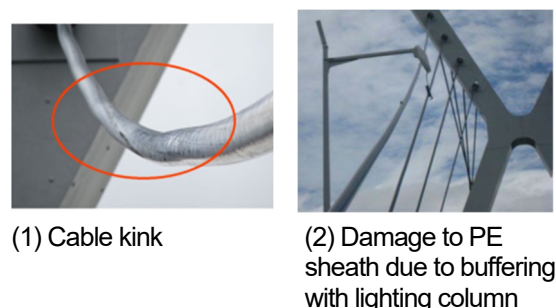
In the Kuwatsuru Bridge, which is a cable-stayed bridge, the earthquake caused cables to kink and the sheathing to be damaged from contact with lighting columns (Figure 9). A study of the cable integrity was conducted to contribute to future inspections and diagnostics utilizing the removed cables that had been replaced because of external deformities observed during repairs. Tensile tests were conducted on the steel strands of the cables used in this bridge for about 20 years. Findings from the tests were then obtained regarding corrosion protection, external deformation, and tensile strength. A method to check the humidity and other conditions inside the cable sheath, a method to repair the high-density polyethylene sheath, and a method to verify the water resistance were proposed. These were reflected in the restoration work (Figure 10).

Figure 9 Deformation of cables identified during visual inspection of the Kuwatsuru Bridge

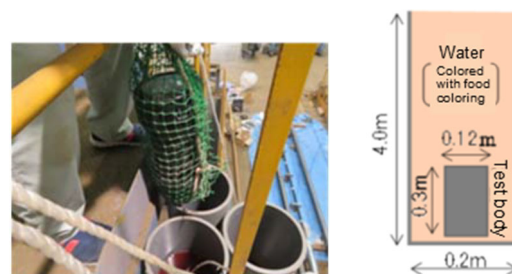
Figure 10 Water resistance verification test of cable sheath repaired by the proposed method (Condition in which a cable specimen is put into water with food coloring)

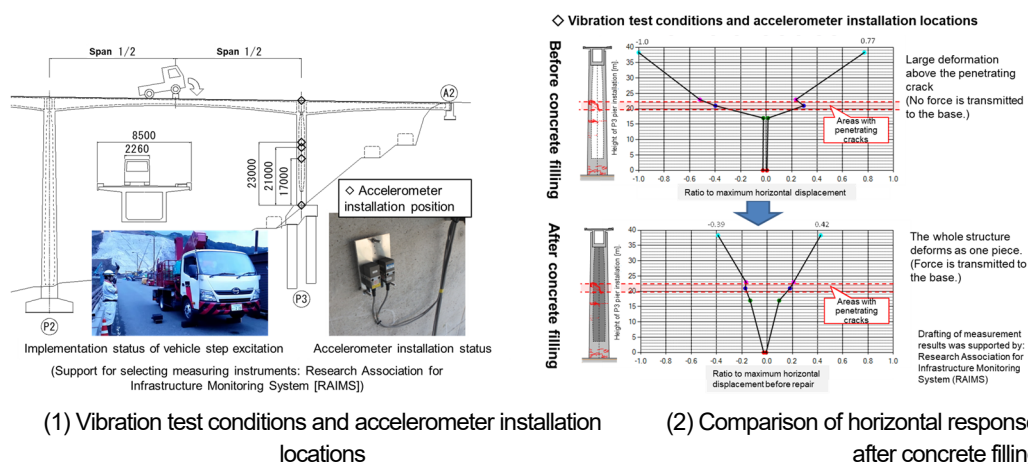
At the Aso Choyo Bridge, where resistance was reduced because of cracks penetrating the cross-section of the reinforced concrete piers with the hollow section, the hollow section was filled with concrete to regain resistance. Noting that the way the bridge shakes changes if this method is appropriate and effective, we proposed and implemented a method to confirm the effect of the repair by conducting a vibration test in conjunction with concrete filling and measuring the difference in the way the bridge shakes before and after the repair using an accelerometer (Figure 11).

Figure 11 Confirmation of repair effectiveness of the Aso Choyo Bridge using ICT technology

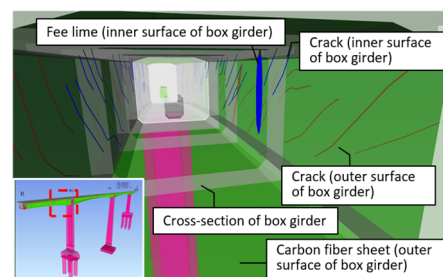
The maintenance and management of bridges that have been rehabilitated after an earthquake must take into account the various uncertainties that are not present in newly constructed bridges. Therefore, based on the damage caused by the earthquake, the characteristics of the type of repair work to be conducted and the concerns anticipated after the repair, information that should be obtained during the construction phase is extracted, taking into consideration how to utilize the information during the maintenance and management phase. In addition, we continue to research more versatile methods of recording and storing the data based on the experience gained through the Kumamoto earthquake restoration work. Among these, regarding the method of recording and storing information necessary for maintenance and management of rehabilitated bridges, we are researching methods that can be effectively used for maintenance and management by utilizing 3D models, taking into consideration the development of BIM/CIM in the maintenance and management phase (Figure 12).

Figure 12 Prototype example of a method for recording and storing information required for maintenance and management using a 3D model (Superstructure with cracks repaired and fiber sheeting applied)
