# Initiative to Increase the Efficiency of Levee Inspections Utilizing New Technologies, Including AI

(Research period: FY 2019–)

SASAOKA Shingo, Researcher; IMA Katsuaki, Researcher; FUKUSHIMA Masaki (Ph.D. in Engineering),  
Head, River Division, River Department

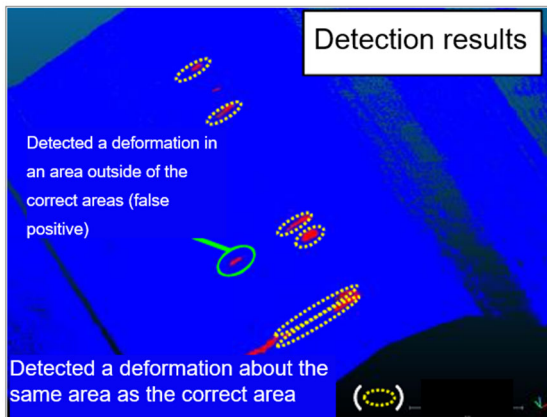
**Figure 1. Example of identifying deformations with AI**

Consequently, we have been researching and developing artificial intelligence (AI) technology to effectively identify levee deformations, aiming to resolve the issues mentioned earlier. This research is being carried out through the commissioned research program as part of the public recruitment program for the river erosion technological development project. Our research aims to achieve the automatic detection of embankment deformations through AI using point cloud data and image data. In prior studies, AI has been employed to successfully identify 12 types of deformations in embankments as outlined in the Guidelines for Inspection and Assessment of River Management Facilities and River Channels, including Levees. For instance, when specifically targeting erosion on an actual levee, the program successfully identified the majority of

deformations observed during visual inspections (**Figure 1**).

The AI program took approximately 10 minutes per kilometer (excluding measurement time) to identify deformations. This is shorter than the conventional visual inspection, which typically took around two hours, highlighting the potential for improved work efficiency with the AI program. Nevertheless, the AI-based deformity identification program exhibited instances of detecting deformations where none were present, known as "false positives." This suggests that further improvement is needed to enhance the accuracy of the program.

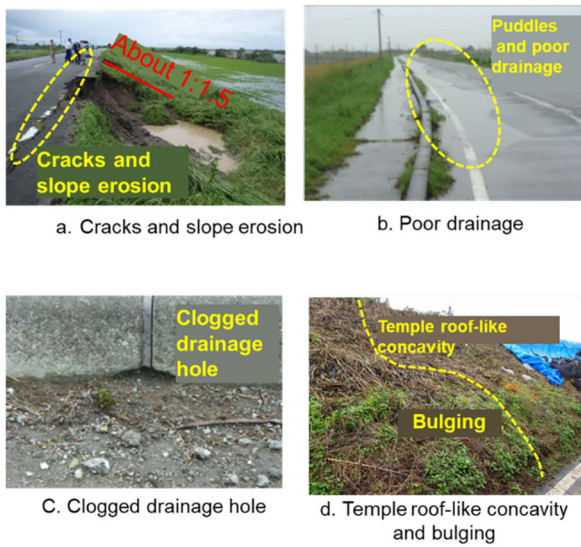
Figure 2. Deformation observed around the damaged area

For example, after examining cases where rainfall-induced erosion and infiltration were probable main causes of levee failure, we identified the following on-site conditions (**Figure 2**).

- The river level during the disaster was significantly below the planned high-water level, suggesting that the disaster was likely triggered by heavy rainfall over a short duration.

- The levee crown in the damaged area was the lowest compared to the upstream and downstream sections, creating a situation where rainwater drainage easily accumulated at the top of the levee in that specific section.

- We observed numerous longitudinal cracks in the slope at the top of the levee, along with erosion in the levee shoulder and the upper section of the levee slope. (a)

- A road was constructed on the crown of the levee, equipped with pedestrian/vehicle separation blocks. The top of the levee had a drainage structure designed to release water through a blocked drainage hole to the slope opposite the damaged side. Unfortunately, the drainage hole was obstructed, resulting in inefficient water discharge. (b, c)

- The repeated overlaying of the road on the levee crown has led to the slope taking on a concave shape, resembling the roof of a temple. (d)

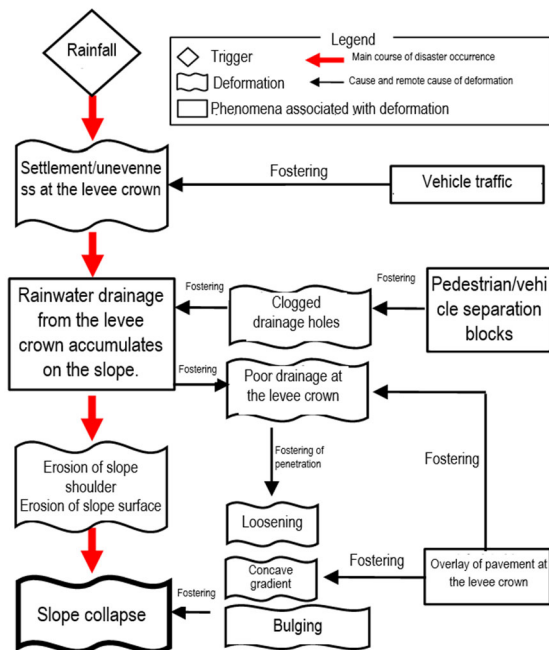
Figure 3. Chain of events leading to the slope collapse (estimated)

Based on the information above, the chain of events, from the formation of deformations found through the damage survey to the actual occurrence of damage, is organized as shown in Figure 3. We intend to employ the same process for other disaster cases and categorize them accordingly. The development of a successful AI model
