Analysis of the Causes of Damage to Building Structures in the 2024 Noto Peninsula

Building
Department

Research introduction

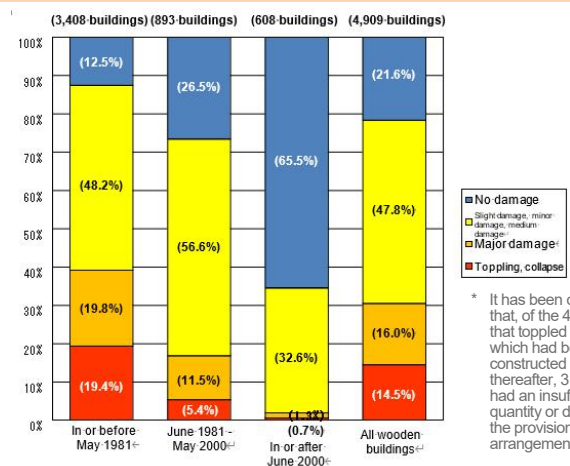
- The percentage of toppling of wooden buildings conforming to the former seismic standards was remarkably higher than that of wooden buildings after the introduction of the new seismic standards. In the wooden buildings after the introduction of the new seismic standards, the percentage of toppling was extremely low in 2000 and thereafter in which the specifications of joints have been clarified.

- The percentage of damage to wooden buildings that underwent seismic retrofitting was lower than that of the wooden building conforming to the former seismic standards that did not undergo seismic retrofitting, and damage was mitigated by seismic retrofitting.
- In houses that obtained seismic grade 2 or grade 3 under the Housing Performance Indication System and houses that obtained approval of a long-term excellent house, there were no houses that suffered toppling, collapse, or major damage, and most of them suffered no damage.

* It has been confirmed that, of the 4 buildings that toppled or collapsed, which had been constructed in 2000 or thereafter, 3 buildings had an insufficient wall quantity or did not meet the provisions of wall arrangement balance.

- Further facilitation of seismic retrofitting
 - Familiarization of the "Safety Ensuring Measures Manual for Wooden Housing" concerning wooden buildings conforming to the former seismic standards
 - Familiarization and propagation of the "Efficient Seismic Diagnosis Method" that are applicable to, of the wooden buildings conforming to the new seismic standards, those not conforming to the specifications that were clarified in 2000
 - Provision of support by means of the Housing and Building Safety Stock Formation Project, Etc

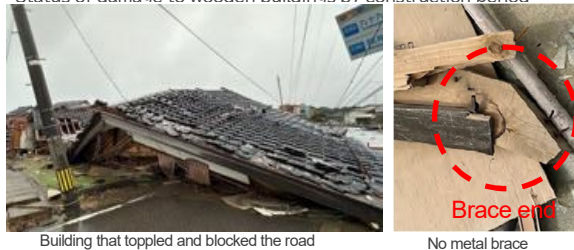
Status of damage to wooden buildings by construction period

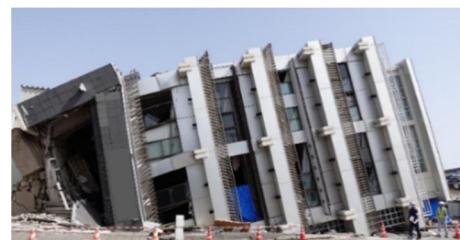
- Regarding reinforced concrete buildings supported on pile foundations, one of them toppled, and several of them were inclined. As for the factors of damage, a decline in supporting force of the piles due to damage, movement of the piles during the earthquake, but they are not clear at present.
- In the reinforced concrete buildings conforming to the former seismic standards, damage was identified such as shear destruction of columns, destruction of column-beam joints, and shear destruction of mullion walls.

Shear destruction of a column

- For buildings conforming to the former seismic standards, further facilitation of seismic retrofitting
- Analysis of the cause of inclination/toppling damage to reinforced concrete buildings supported on pile foundations

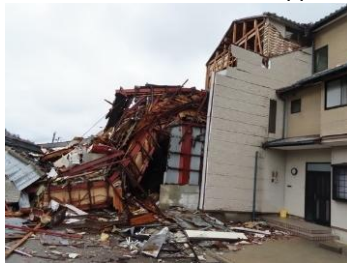
- Among steel frame buildings, 3 buildings conforming to the former seismic standards toppled or collapsed.

Collapse of 2nd and 3rd floors of a steel frame building

<Direction of the measures to be taken>
 • For buildings conforming to the former seismic standards, further facilitation of seismic retrofitting
