# Quick Report on Damage to Buildings by the Tornado on May 6, 2012 in Tsukuba City, Ibaraki Prefecture, JAPAN

National Institute for Land and Infrastructure Management (NILIM)  
Ministry of Land, Infrastructure, Transport and Tourism, Japan

Building Research Institute (BRI)  
Incorporated Administrative Agency, Japan

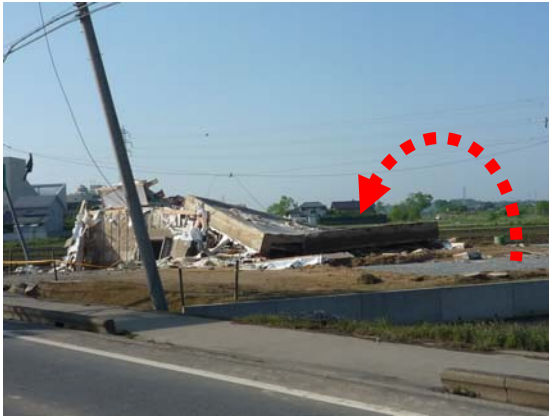
A wooden structure A (Photos 1, 2) completely turned over with mat foundation from ground.

Photo 1 Wood House A

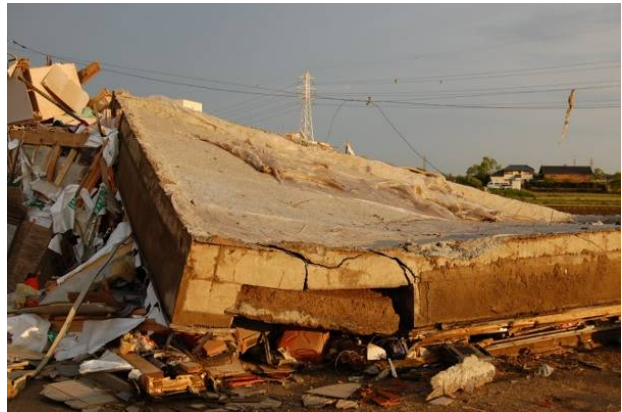
Photo 2 Turned mat foundation of Wood House B

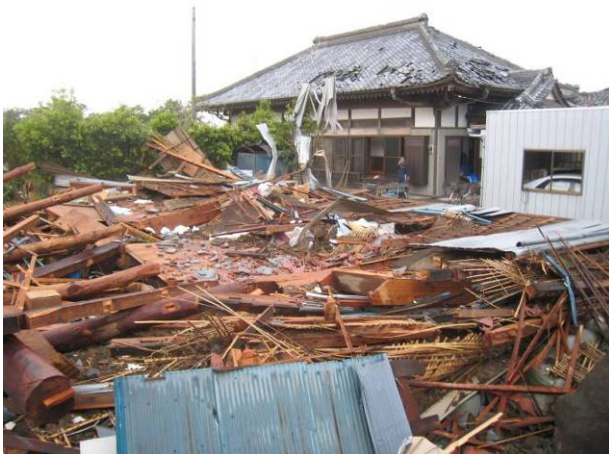
Though the details of the collapsed structure cannot be grasped, wood construction B (this side, Photo 3) and C (Photo 4) completely collapsed because tornado-induced wind force was estimated to surpass the lateral shear strength of these structures.

Photo 3 Wood construction B (this side, collapsed one)

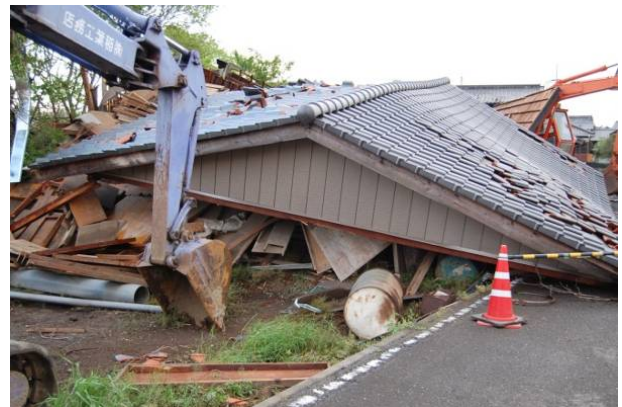
Photo 4 Wood construction C

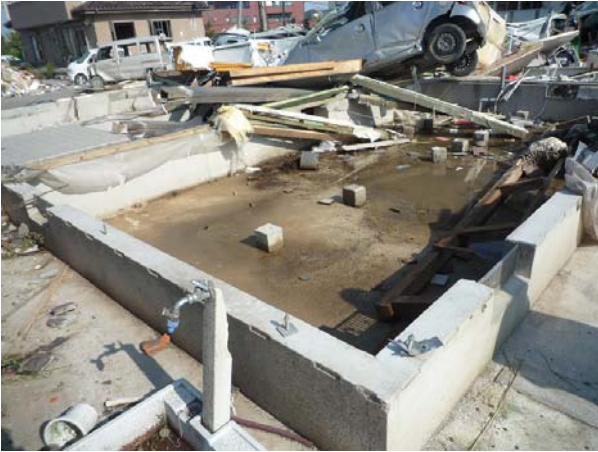
Whole wood construction without foundation (of wood houses D and E) were scattered. In the case of wood house D (Photo 5), the foundation remained (Photo 6) but most of wood construction were scattered. And, in the case of wood house E (Photo 7), sills, joists, and a part of floor board were remained.

Photo 5 Wood House D

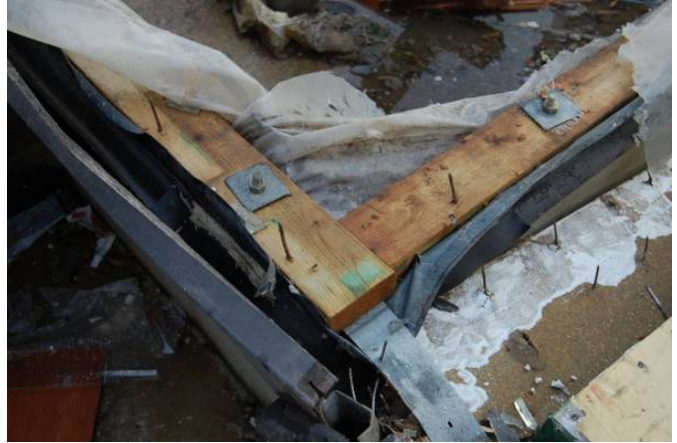
Photo 6 Remaining foundation of Wood House D

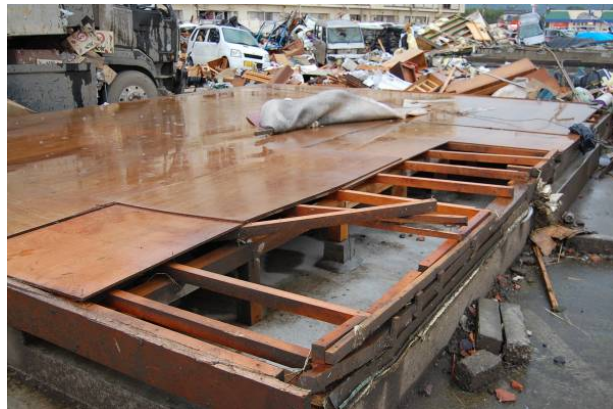
Photo 7 Wood House E

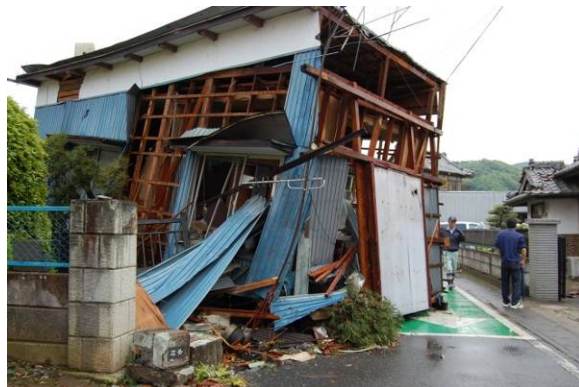
A case of horizontal movement of wood house to the road was observed (Wood House F, Photo 8). Anchor bolts or connection of columns and foundation might be failed by the strong horizontal force of tornado.

Photo 8 Wood House F which moved horizontally

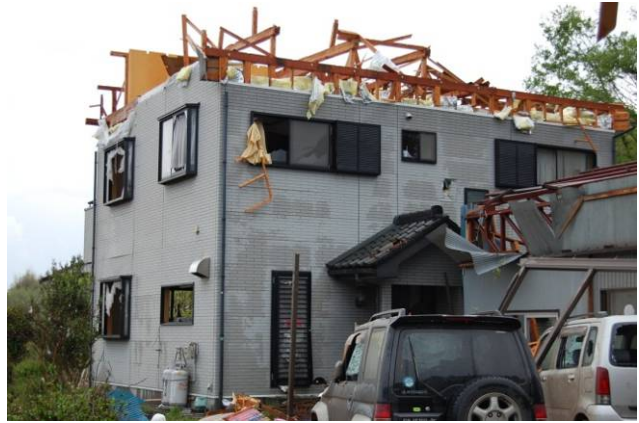
Many cases of damage on roof systems were observed. The damage cases are shown in Photo 9 of a gable roof (comparatively old house), Photo 10 of a gable roof (comparatively new house), Photo 11 of a hipped roof and Photo 12 of a shed roof, respectively.

Photo 10 Wood House H whose gable roof was scattered.

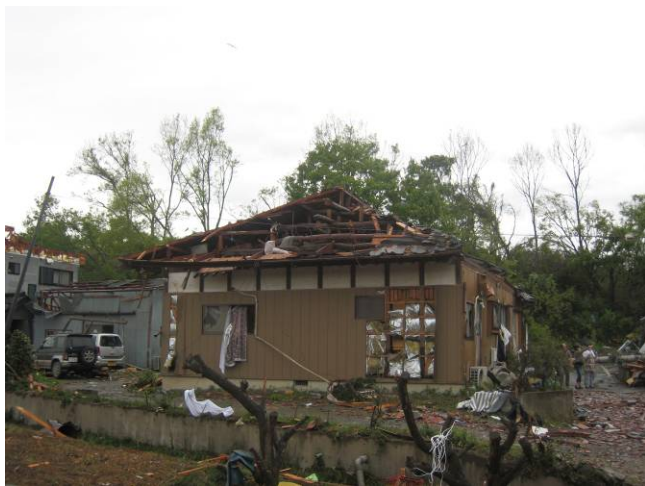
Photo 11 Wood House I whose hipped roof was scattered

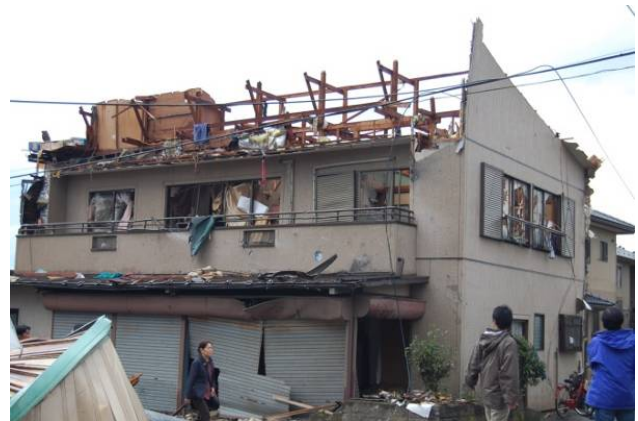
Photo 12 Wood House J whose shed roof was scattered

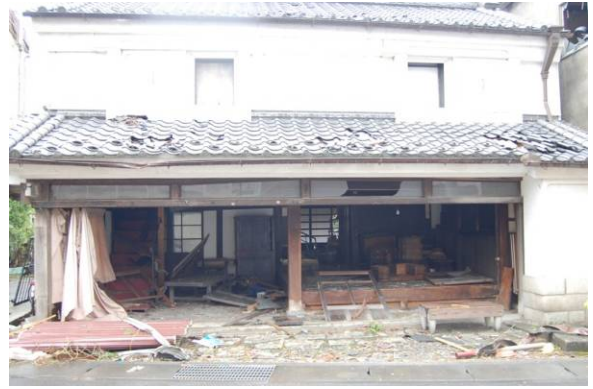
Openings are considered to have been broken due to out-of-plane wind pressure or collision of flying debris induced by the tornado.

The damage from out-of-plane wind pressure (Photos 13 and 14) caused failure of whole openings of outside in many cases, while partial damage of openings was seen in the case of collision of flying debris.

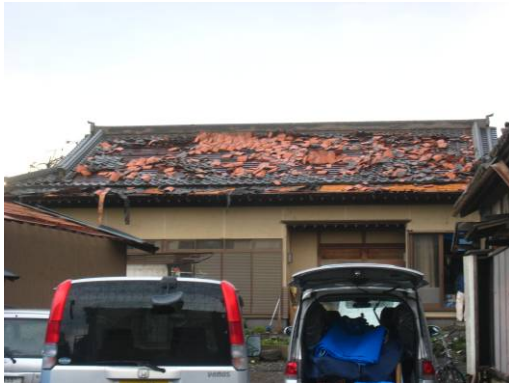
Photo 15 Wooden Building M

Substantial damage to roofing materials was observed (Photo 15). In addition, metal roofing materials were confirmed to have been scattered to considerable distances.

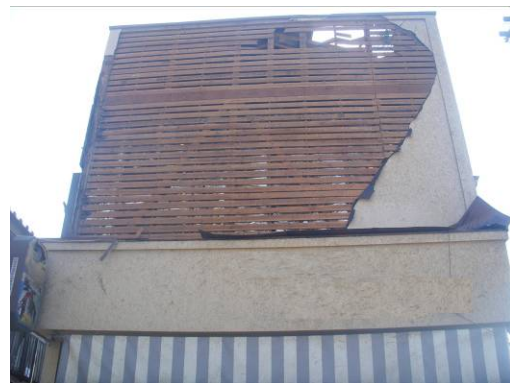
Photo 16 Wooden Building N

On the other hand, falling down of exterior materials was observed in exterior walls with mortar. In some cases, the wood laths of mortar wall were confirmed to be deteriorated. It is claimed that the mortared exterior walls will not collapse except the cases of structural shear deformation or out-of-plane forces, this cited failure is not determined to occur because of the reason of them.

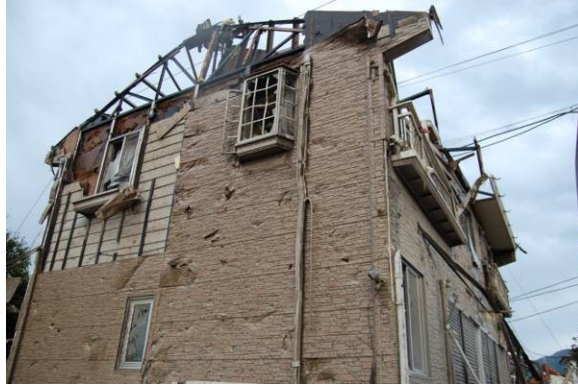
Photo17 Steel Framed Building A

The collapse and scattering of roof trusses with damage of exterior materials and windows were observed in a light-gauge steel framed house.

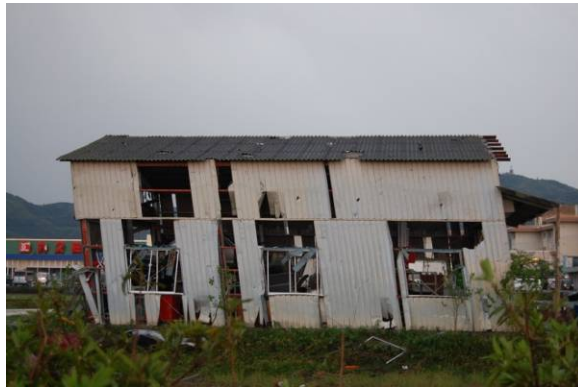
Photo 18 Steel Framed Building B

Residual deformation of structural frame was observed in a warehouse building.

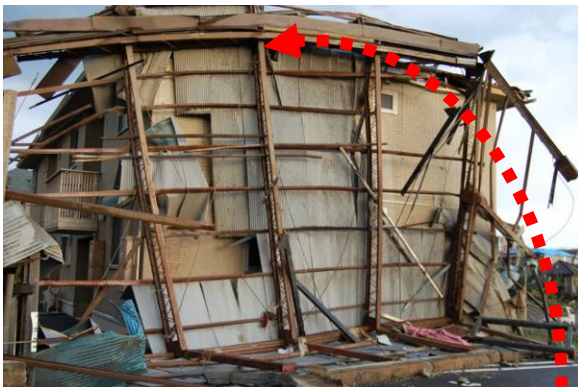
Photo 19 Steel Framed Building C

A steel framed building used as a garage fell down and turned sideways.

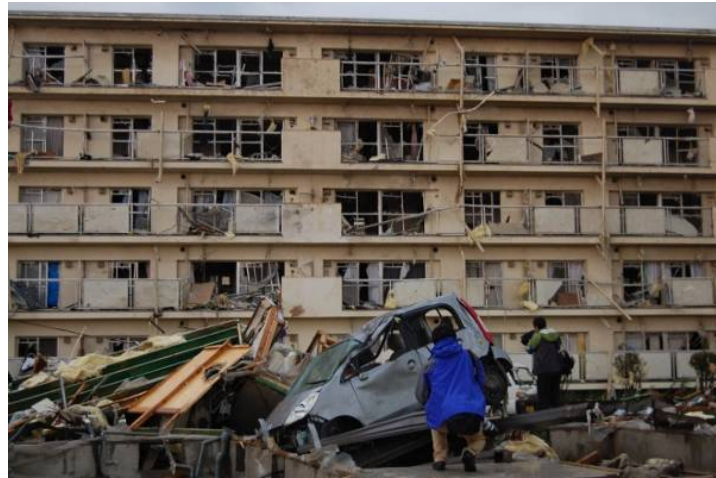
Window glass, frames, handrails of verandah etc. of a five-story multifamily housing were

significantly damaged on the south side. Similar damage was observed on the north side although the openings were small.

Photo 21 South side of a public multifamily housing

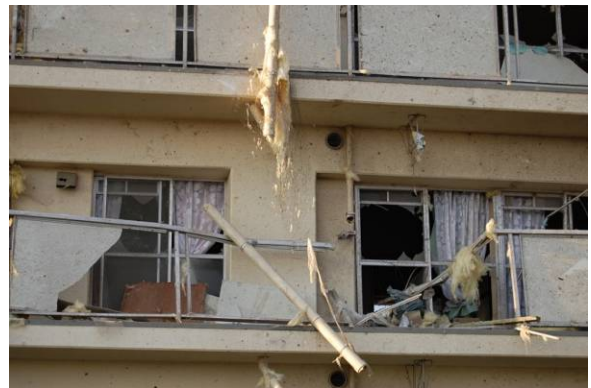
Photo 23 Windows and handrails 2

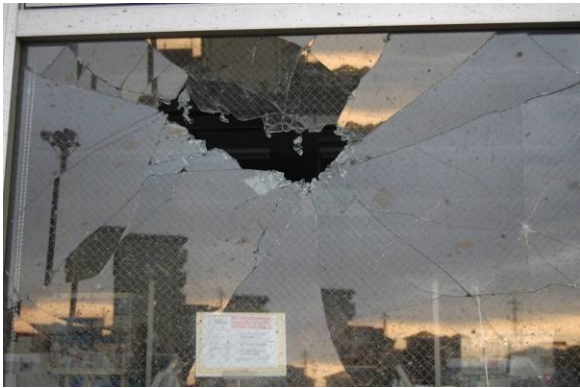
Photos 25 and 26 show traces of collision at an entrance of a shopping center, Photos 27 and 28 show the collision of flying roof/roofing materials and Photo 29 shows a flying roofing material hung at electric cables.

Photo 25 Evidence of collision to window

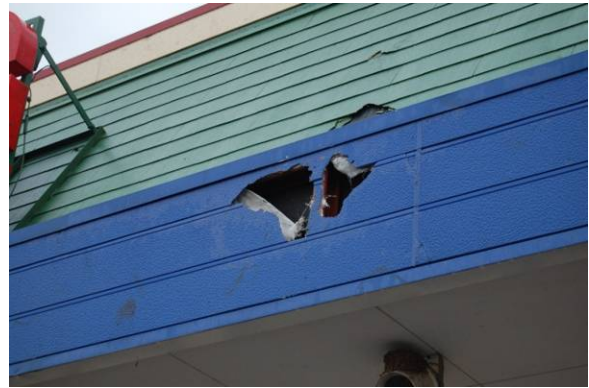
Photo 26 Evidence of collision to exterior material

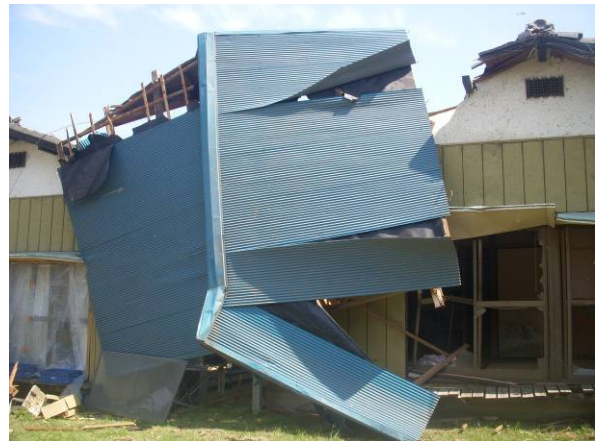
Photo 28 Collision of flying roof frame

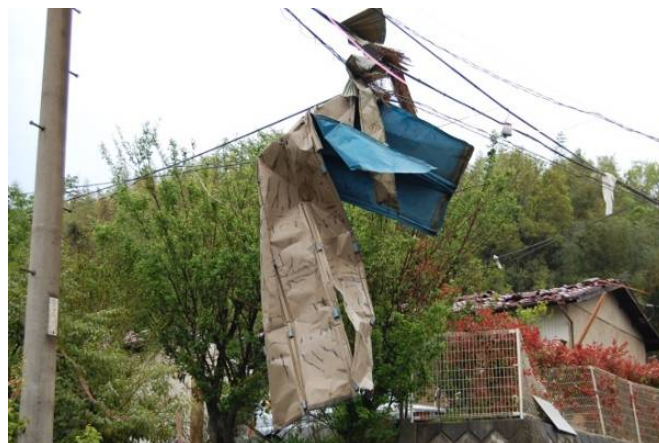
Photo 29 Roofing materials hung at electric cables

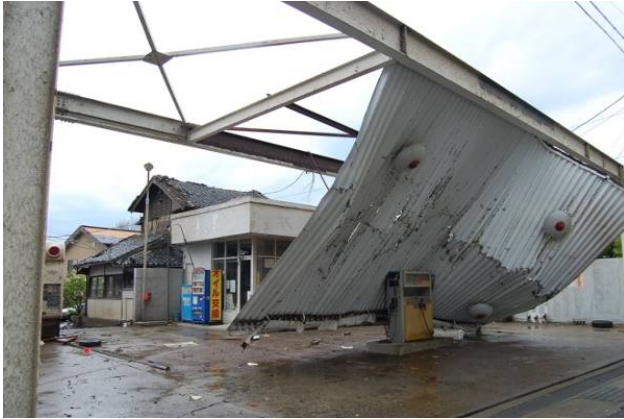
Photo 30 Collapse of a gas station roof

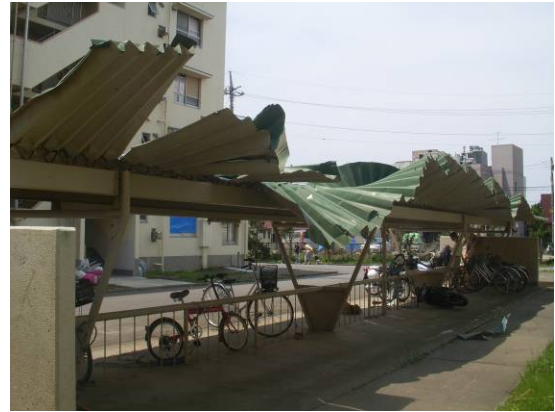
Photo 31 Heavy deformation of roof of a bicycle park

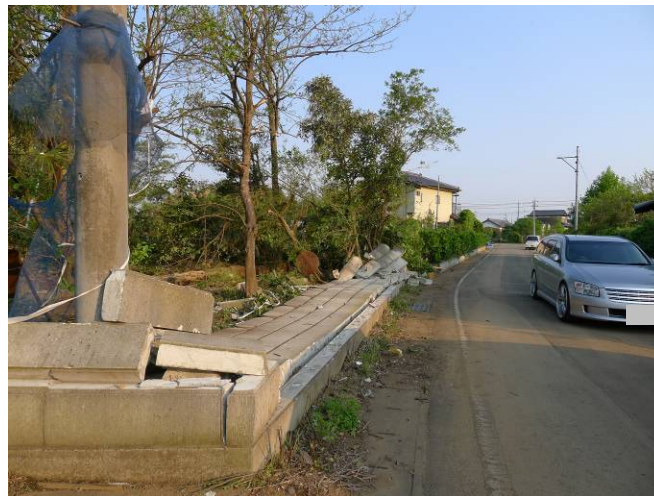
Photo 32 Collapse of stone fence

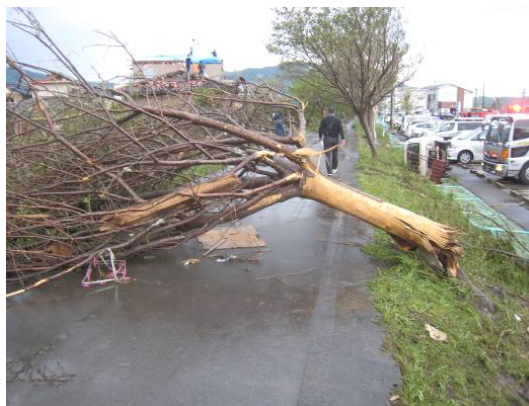
Photo 35 Broken tree

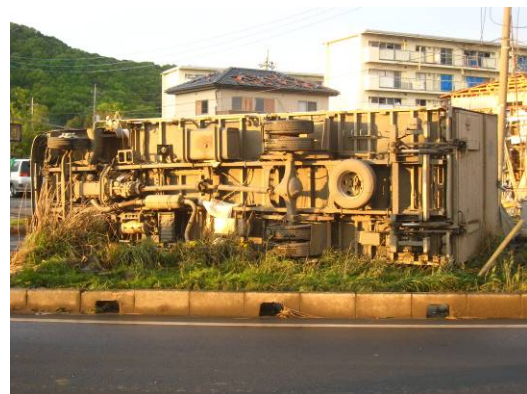
Photo 37 Rolling truck

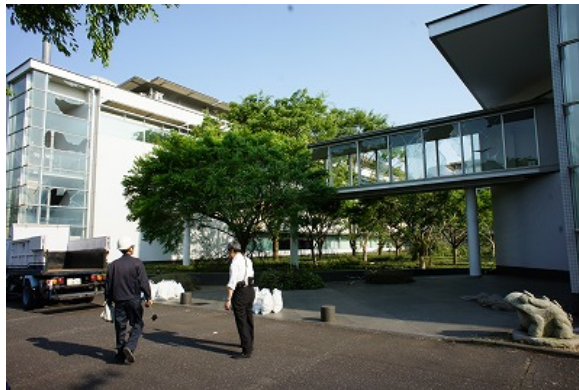
Window breakages were observed at exteriors and within roofed passages of reinforced concrete

or steel framed buildings.

Photo 38 Broken window of a roofed passage

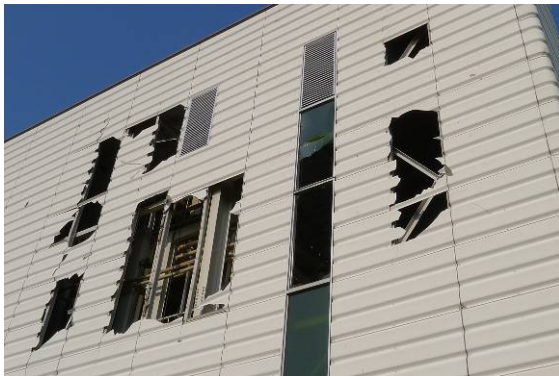
Damage to exterior materials and eave soffits was confirmed in steel framed buildings.

Photo 39 Breakage of exterior and windows

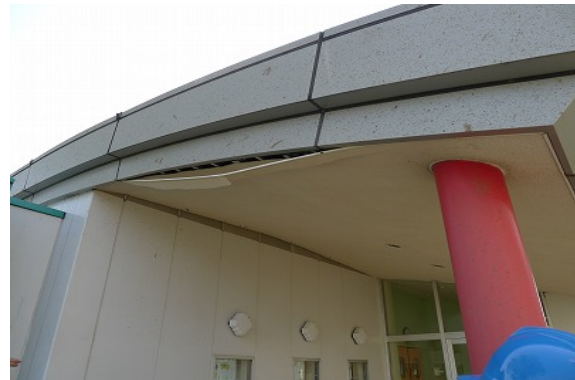
Photo 40 Breakage of eave soffits

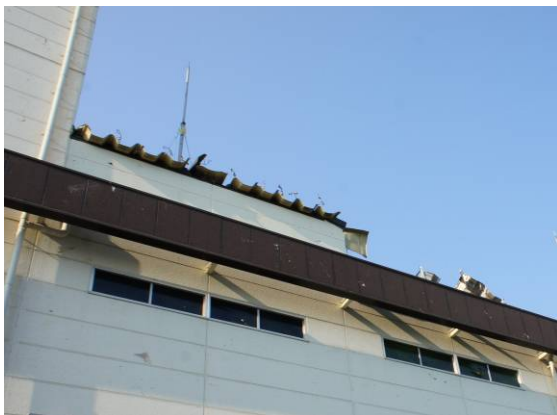
Damage to roofing materials of steel framed buildings was confirmed. Some roofing materials were scattered far to the next factory on the other side of the street more than several dozen meters.

Photo 41 Damage of roofing materials

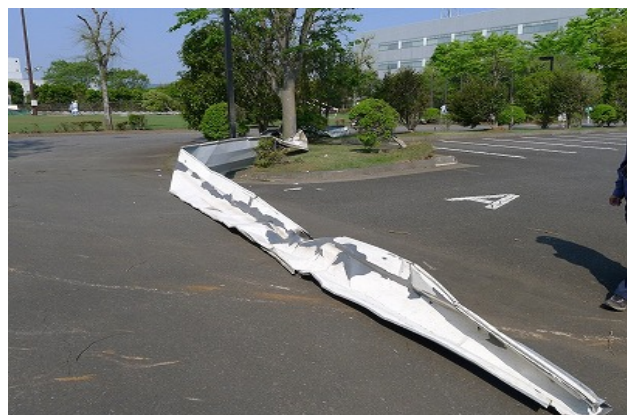
Photo 42 Scattered roofing materials
