3. Summary and suggested research topics to update seismic design practice and the Japanese Specifications for Highway Bridges

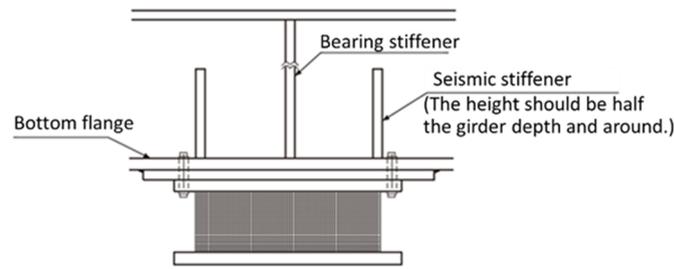
Figure 3-1. Present typical details of bearing stiffeners in Japan (JRA, 2021)

In the Nurdağı viaduct on motorway O52, the lower flanges buckled above the bearings. In Japan, similar insights from earlier earthquakes have improved the details of bearing stiffeners in steel girders. **Figure 3-1** shows a typical example of a vertical stiffener arrangement above a bearing in Japan. This is based on the repeated experiences of similar damage during earlier earthquakes. However, further studies are required to obtain better structural details.
