# Full-scale structural experiment of a partial frame reinforced concrete construction using fiber reinforced concrete on the nonstructural wall

SUWADA Haruhiko (Ph.D (Engineering)), Senior Researcher  
Structural Standards Division, Building Department

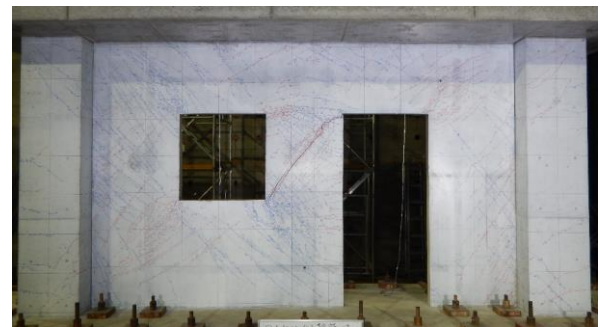
Photos 2 and 3 show the damage condition when the story deformation angle reached  $1/200\text{rad}$  and  $1/100\text{rad}$  respectively. At  $1/200\text{rad}$ , widening cracks in the wall (partial wall) between the window opening and door opening were found, although the same cracks were rarely found in other areas. As well, at  $1/100\text{rad}$ , widening cracks could be found on the corners of each opening, however, extensive damage like detached concrete could not be found. Furthermore, pressurization was finally conducted at  $1/50\text{rad}$ , however, the widening of cracks or detached concrete were likewise, not observed in other areas.

Photo 2: Damage conditions at story deformation angle  $1/200\text{rad}$

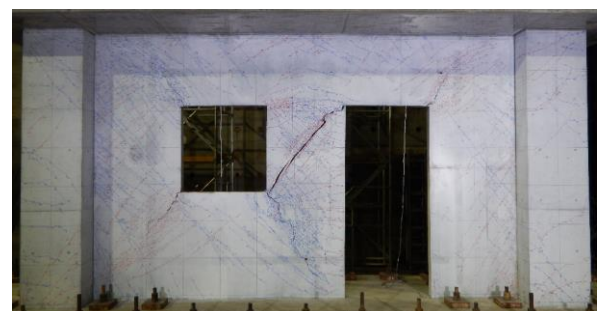
Photo 3: Damage conditions at story deformation angle  $1/100\text{rad}$
