A Case of Utilizing Results

Revision of Airport Pavement Design, Maintenance and Rehabilitation Manual

Airport Facilities Division, Airport Department

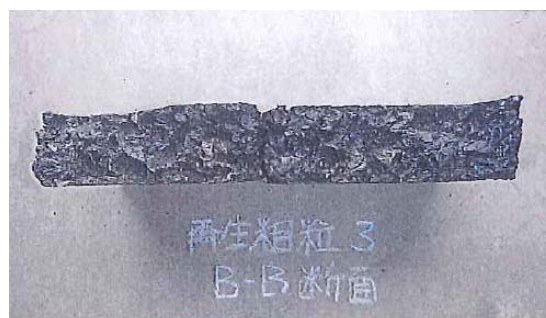
Photo 1 Specimen of asphalt concrete with recycled aggregate after immersed wheel tracking test

Related to above revision, the test condition of immersed wheel tracking test was revised. This test has been used to confirm the stripping resistance of asphalt concrete with recycled aggregate used in the binder course. In the new standard, water immersed depth for the test specimen in case the binder course with recycled aggregate is to be exposed to rain water temporarily must be deeper than that in case the binder course with recycled aggregate is not to be exposed to rain water.
