# Debris Flow Disasters Caused by Typhoon Wipha (T1326) on Izu-Oshima Island and Technical Support of NILIM TEC-FORCE

*(Key words) Izu-oshima Island, Debris flow, TEC-FORCE, Technical support*

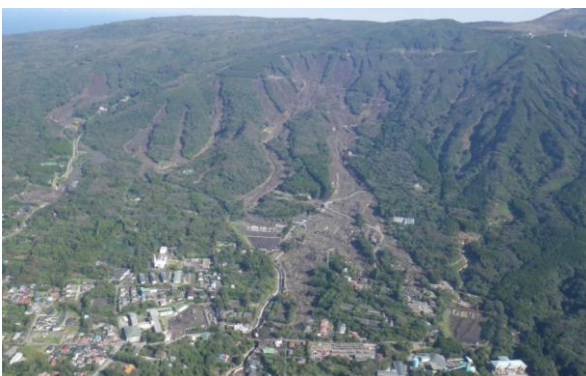
Photo 1 Debris flows on hillsides of volcano Mt. Mihara

On October 16, 2013, Typhoon Wipha brought precipitation exceeding 800 mm over a 24-hour period to Izu-Oshima Island, Tokyo. As a result, simultaneous debris flows occurred on hillsides of the volcano, Mt. Mihara, resulting in 36 deaths and 3 missing (as of Jan. 15, 2014; Photo 1). The SABO (Erosion and Sediment Control) Division of the Research Center for Disaster Management at the National Institute for Land and Infrastructure Management (NILIM) and the Erosion and Sediment Control Research Group of the Public Works Research Institute (PWRI) implemented technical support for the Tokyo Metropolitan Government and Oshima Town Office from the moments immediately after the debris flow disasters to early in November to prevent secondary disasters and to implement emergency recovery.

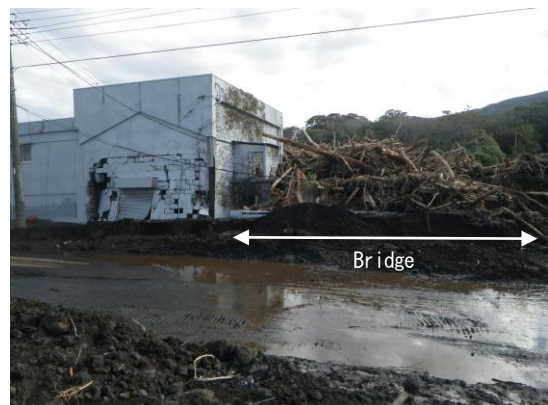
landslides of volcanic ash layer deposited on the hillsides. The ash was approximately 1 m deep and transformed into downhill debris flows. In addition, a huge number of trees, toppled by shallow landslides and debris flows, were carried downhill by the debris flows. The Motomachi-Kandachi district suffered serious loss of life and property damage from the direct impact of the debris flows. Downhill from the Motomachi-Kandachi district, blockage caused by driftwoods at bridges caused floods, resulting in more loss of life and property damage (Photo 2).

Photo 2 Blockage of driftwoods at Motomachi Bridge

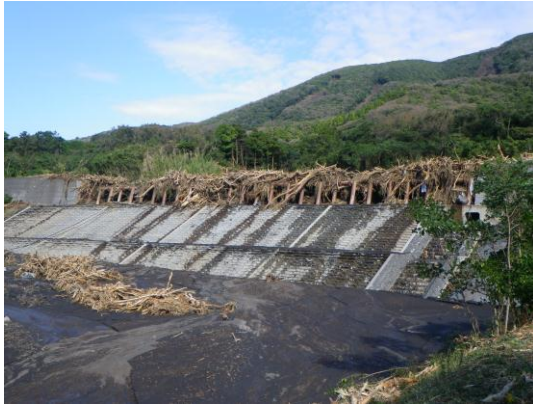
On the contrary, the Motomachi district has sediment-related disaster prevention facilities (i.e. check dam) and these facilities protected residents or reduced damage by capturing debris flows and driftwoods (Photo 3).

Photo 3 Capture of debris flows and driftwoods by a sediment-related disaster prevention facility along Okanesawa River

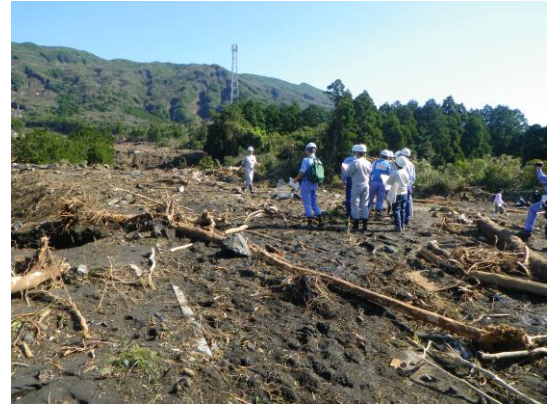
Photo 4 Emergency ground survey

- Emergency ground surveys to identify damage and prevent secondary disasters (Photo 4)
- Providing technical advice to the Tokyo Metropolitan Government on preventing secondary disasters and implementing emergency recovery activities
- Providing technical advice on selecting target areas and precipitation criteria for issuing evacuation advisories, orders and cancellation by the Mayor of Oshima
- Providing technical instruction to ensure safety during rescue activities
