Protect the Life from River Flood

ITO Hiroyuki, Head, YAMAMOTO Akira, Senior Researcher, YUASA Naomi, Researcher
Flood Disaster Prevention Division, River Department

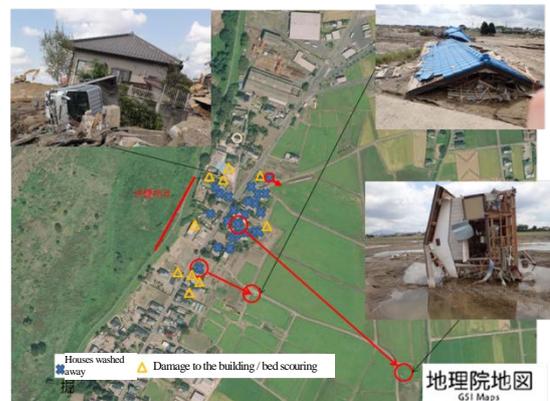
Figure 1: Washing-away of houses

At Kamimisaka, Joso-shi, the levee broke about 12:50 on September 10th due to overflow and the houses located at the front of the broken levee began to collapse or be washed away soon after the break. As a result of the investigation of the washing-away of the houses, etc., it was found that the flood flow caused by the break of the levee with the relative height of about 4 m or less washed away about 20 houses located in the area 150 m from the broken levee (see Figure 1). If levee break in a larger scale occurs, houses in a wider area are expected to be washed away, but it is difficult for local residents etc. to have an image in advance about the extent and area where such an event occurs. Therefore, guidelines for horizontal escape would be needed.
