Research of the Building Department to realize a safe, reliable, and comfortable living environment

SAWACHI Takao (Ph.D. in engineering)
Director of Building Department

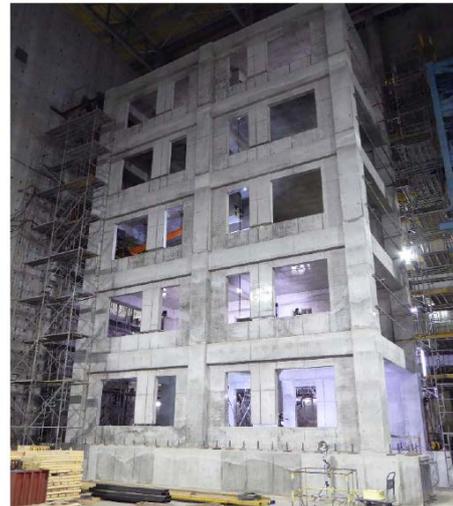
Photo 1. A test using an actual-scale five-layer reinforced concrete structure to propose structures that will not require repairing columns and beams after a massive earthquake

- Investigation and analysis of technologies to sustain the functions of facilities and systems
- Development of non-resonant ceiling materials
- Development of damage-controlling design method using non-structural walls (Photo 1 shows a test piece of load test using an actual-scale five-layer reinforced concrete structure.)
- Establishment of a design guideline for sustained use of buildings used as disaster response bases

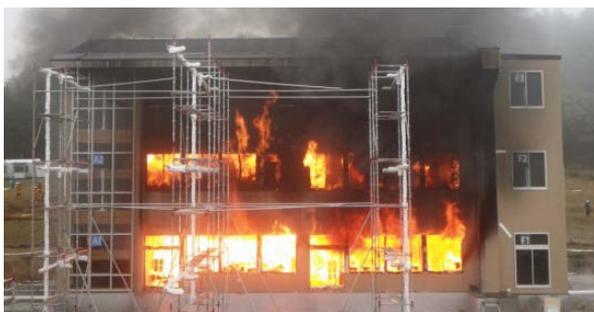
Photo 2. Actual-scale fire experiment to verify the adequacy of specifications to set standards for three-story wooden school buildings

The aim of this study was to enable the construction of wooden, three-story school buildings. The team gathered necessary technical perspectives for revising the Building Standards Act and prepared proposals for standards to ensure safety by ensuring safe evacuation from fire, low effect of fire to nearby areas, such as effects of heat, sparks, and collapsed buildings, and reduced number of obstacles, such as collapsed buildings that slow down firefighting activities. The team also prepared examples of specifications using parts with enough performance. (Photo 2 shows an actual-scale fire experiment to verify the proposed standards.)

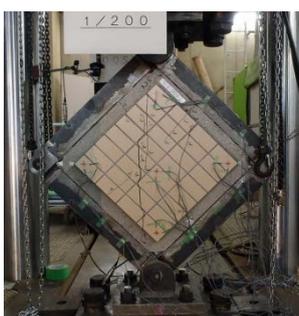
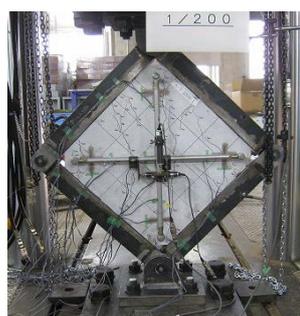
[Lined with tiles with two layers of mortar base layer]

[Concrete on the back side]

Photo 3. Diagonal evaluation test conducted for verification

intactness of wet-tile exterior materials after an earthquake. The study verified the effect of an evaluation and test method using two types of small test pieces (Photo 3) based on conditions of tile exfoliation caused by inter-layer displacement (deformation) using a test wall lined with large tiles.
