# Technical assistance upon bridge erosion damage in Hokkaido due to heavy rain by Typhoon No. 10

**Hideaki Nishida**, Senior Researcher, **Jun Nishifuji**, Researcher,

Foundation, Tunnel and Substructures Division, Road Structures Department

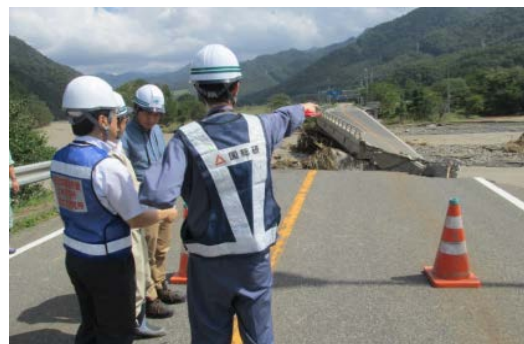
Photo 1: On-site study being conducted at Chiroro Bridge (National Route 274)
