# Verification of Disaster Process in the Bridge Exposed to a Large-scale Flood and Study of Disaster Reduction Measures based on Verification Results

(Study period: FY2016 to FY2017)

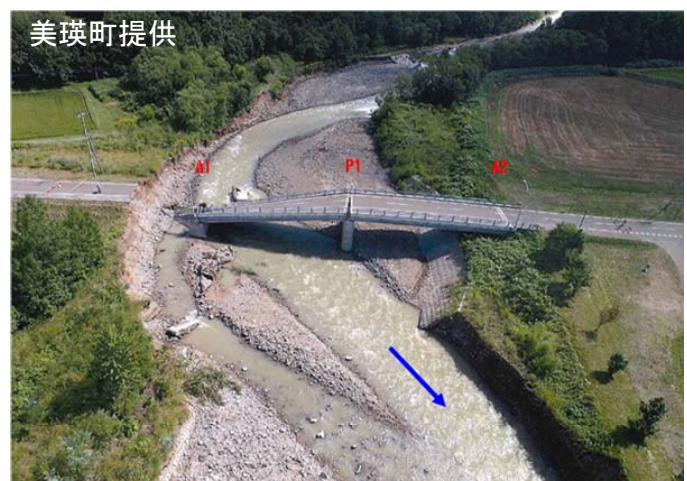
Fig. 1 Damage to Kyusen Bridge (Bebetsu River, Hokkaido)

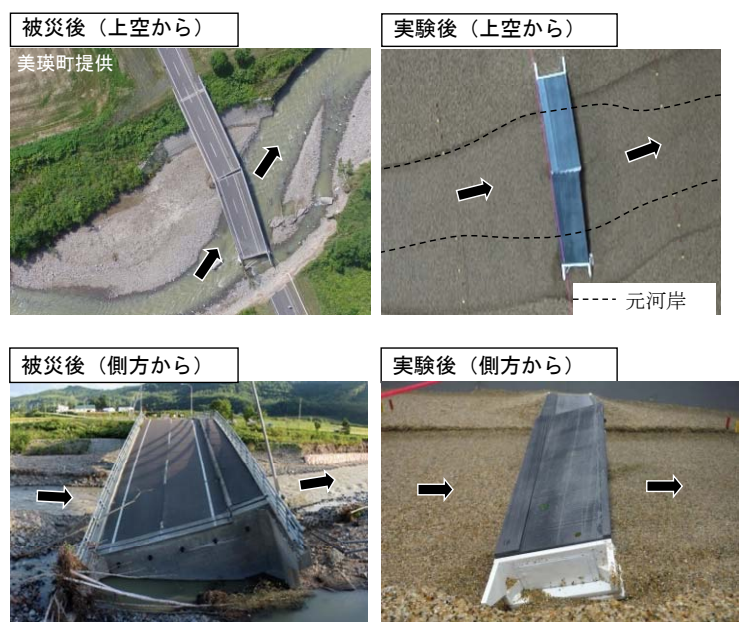
As a result of the model experiment, when bank erosion from the abutment upstream proceeded near the abutment, back fills of the abutment were lost and the abutment sank eventually (Fig. 2). It was confirmed that the bed height near the abutment changed in the following three conditions according to the elapse of time due to erosion / scour leading to abutment displacement and that the height decreased in each state (Fig. 3).

Fig. 2 Comparison of model experiment and site damage

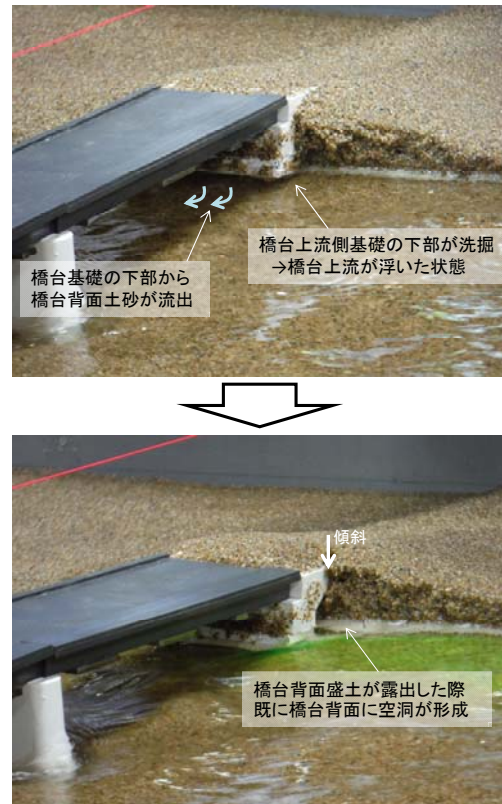
In addition, it was confirmed in the eroding process that when the bed height near the abutment is lower than the height of abutment foundation, back fills of the abutment are sucked out of the lower part of the abutment foundation in the channel direction and cavity is formed in the back fills (Fig. 3). This suggests necessity to stop traffic on the bridge quickly since damage may be proceeding in the channel even if the abutment seems sound in case of a flood.

Fig. 4 Cavitation of the abutment back by sucking from under the abutment
