Development of Resilient Levees That Are More Effective Than Crisis Management-type Structural Countermeasures

(Research period: FY2019 to FY2021)

River Division, River Department

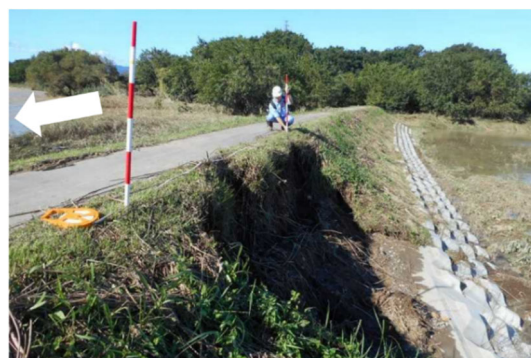
Photo 1: An example of back slope erosion at a site where crisis management-type structural countermeasures were used (left bank of 6.2 kp of the Toki River in the Arakawa River system)

In the 2019 Eastern Japan Typhoon, water overtopped at one of the sites where crisis management-type structural countermeasures were constructed. While the countermeasures were considered effective since the levee was not broken, erosion occurred on the back slope that was not covered with blocks (**Photo 1**), and the need for slope protection was recognized once again.

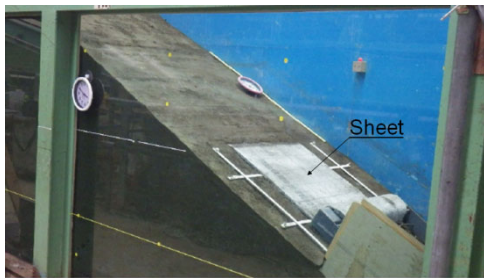
Photo 3: Pull-out resistance measurement experiment

When the back slope is long, it is difficult to cover the slope from the shoulder to toe with a single anti-absorption sheet, so a sheet seam is formed in the middle of the slope. Since these seams are weak areas and there is a concern that the sheets may shift or rise, we are considering inserting the sheets into the levee to hold them strongly. In examining the stability of sheets, since the pull-out resistance of the sheets was unknown, we conducted an experiment to directly measure the pull-out resistance (Figure, Photo 3). As a result, we found a relationship between the vertical load and the pull-out resistance of the sheet inserted into the levee, and obtained knowledge for determining the length of insertion of the sheet into the levee.
