Completed Recovery of Major Roads Damaged in 2016 Kumamoto Earthquake

Research Center for Infrastructure Management

NILIM established the Kumamoto Earthquake Recovery Division and provided technical support at the site of disaster recovery efforts in order to achieve the prompt recovery of roads that were severely damaged in the 2016 Kumamoto earthquake, thus contributing to the completion of recovery efforts on all roads where they were conducted as a project performed by the national government on behalf of the local government, six years after the earthquake.

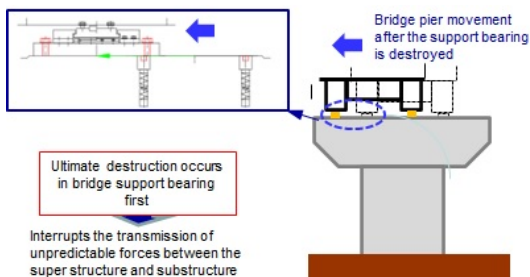
Design concept for a bridge support bearing that interrupts transmission of the unpredictable forces arising between the super structure and substructure with fault deformation

For the Shin-Aso Ōhashi, where the fault shifted horizontally, we proposed designs for the bridge support bearing and structural considerations that would reduce the risk of super structure falling, even if a fault shift occurred.

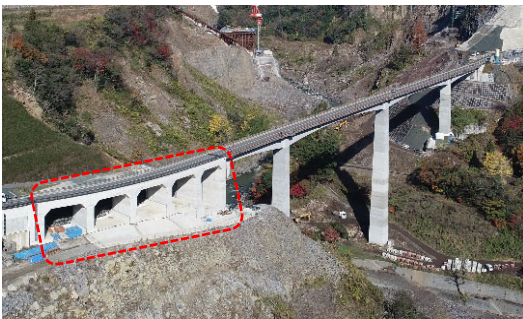
Aso Chōyō Ōhashi after completion of recovery

For the Aso Chōyō Ōhashi, we proposed using a strong rigid-frame structure to create a form that was less likely to sink over the structure as a whole, even if the slope collapsed in a large earthquake.

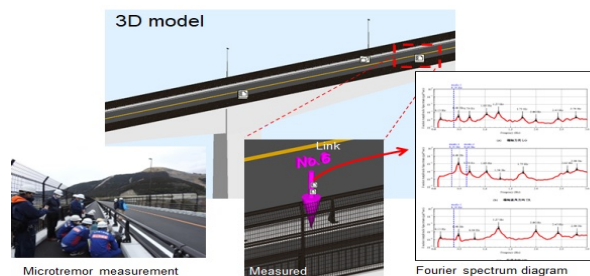
Acquiring information that is useful for maintenance and recording and storing it with BIM/CIM (Shin-Aso Ōhashi)

We also took certainty and ease of maintenance into account and proposed information acquisition leveraging ICT and recording and storage using BIM/CIM.
