No.6
September 2003

News Letter

A M7.0 Earthquake Hit Northern Japan on 26th May, 2003,

Earthquake Damages in Algeria

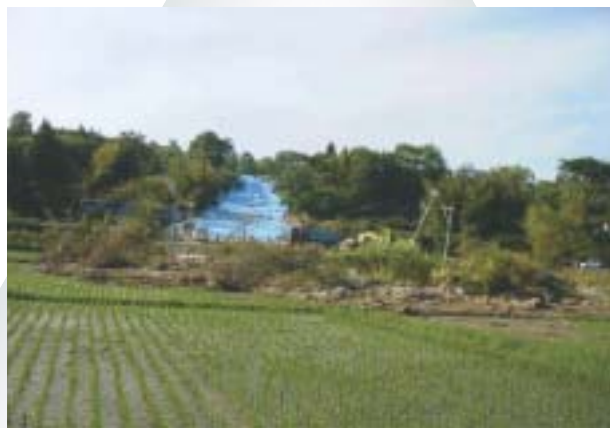
public research institutes. Photo1 shows the flow slide of a gently banked slope with an inclination of 11 ° for a width of 50 m where the soil travelled 160 m. It is inferred that the volcanic ash soil was liquefied. While road bridges did not sustain any significant damage, the cover concrete of several tens of piers of the Shinkansen railway line was peeled off.

Photo 1 Large-scale flow slide of a banked slope

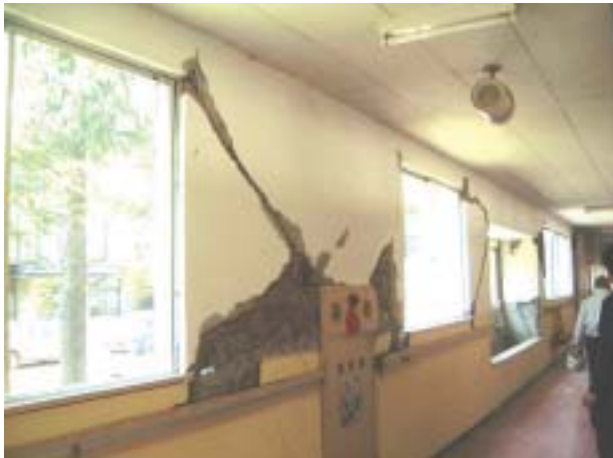
RC buildings, a municipal office building and a primary school building, etc.(see Photo3) sustained structural damage but other buildings sustained little damage. Steel framed gymnasiums suffered the rupture or buckling of its bracing members, buckling of the truss materials and damage to the anchor sections of the roof truss. In addition, damage possibly leading to the loss of the building functions and human casualties occurred, including the fall of exterior, interior and ceiling materials, damage to and the fall of smoke-proof glass, the fall of air-conditioning ducts and the fall of books.

Photo 3 Damage to the corridor wall of a primary school building

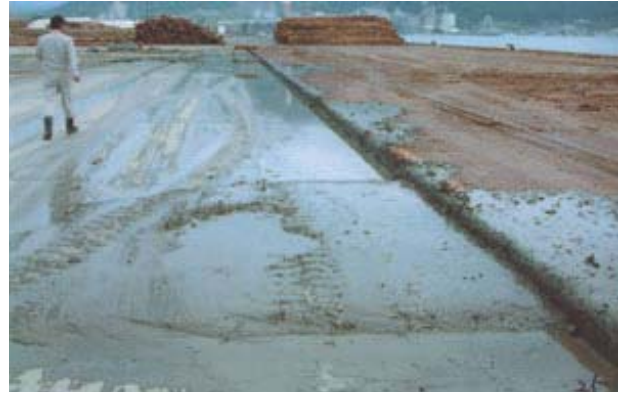
Port facilities did not sustain any functional damage. Nevertheless, a relatively large-scale phenomenon of liquefaction was observed in the Nonoda District of Port Ohfunato (Photo2). Traces of sand boil were observed from behind the open-type wharf on vertical piles and batter pile with sheet pile wall to some 60 m inland. The browed up sands in the inland area contained gravels as large as 5 cm in diameter. The earthquake caused subsidence of some 10-15 cm of the concrete paving at the cargo handling area. This figure represents approximately 1% of the entire thickness of reclaimed soil, which is deemed rather minor subsidence caused by liquefaction.

Photo 2 Deposit of silt erupted out behind a pier

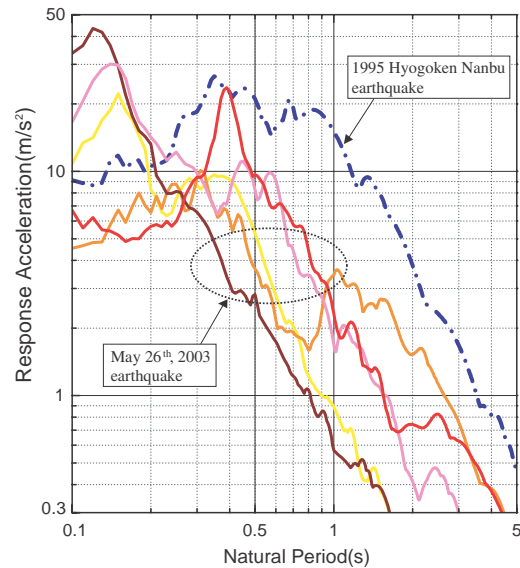
Figure 2 shows the acceleration response spectra of the strong motion records. One of major characteristics of this earthquake is that the short period component of ground motion is dominant compared to the 1995 Hyogoken Nanbu earthquake. This characteristics is believed to be the major reason for the light damage despite the large peak ground acceleration.

Figure 2 Acceleration response spectra (h = 5%)

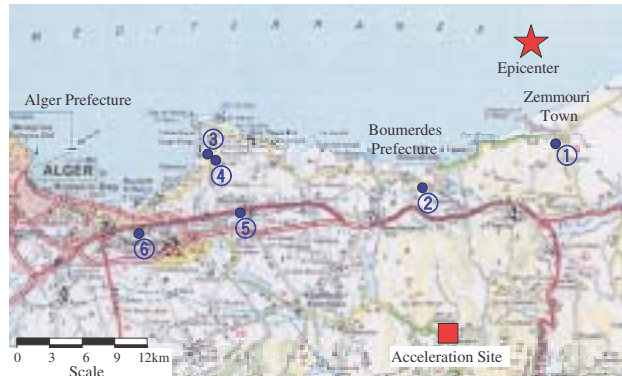
At 19:44 (local time) on 21st May, 2003, an earthquake measuring 6.8 on the Richter scale took place in Algeria and the epicenter was at the seabed some 7 km north of Zemmouri in the Boumerdes Prefecture. The maximum acceleration was approximately 580 gal observed in southern Boumerdes and considerable damage was caused in areas near the epicenter (Figure3 and Figure4).

After the earthquake and in response to a request made by the Algerian government, the Japanese government dispatched a team of experts to survey the damage in the disaster-hit areas for the evaluation of building safety and other matters (① ~ ⑥ in Figure3). The Algiers and Boumerdes Prefecture were the worst hit. According to a survey conducted by the Algerian government, more than 2,200 people were killed and more than 12,000 people were injured. Some 100,000 people were forced to live in tents in the aftermath of the earthquake. While 12,000 buildings collapsed or were otherwise seriously damaged, such infrastructure as roads, railway lines and ports sustained much less damage.

Figure 3 Map of damaged area and Survey points ①~⑥

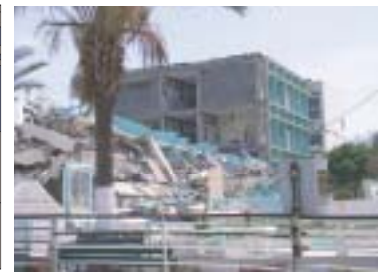
Many of the damaged buildings were low to medium height with RC frame structures and unreinforced brick walls. The entire storeys of some buildings collapsed. In the case of those buildings which had fewer walls due to the use of the ground floor for a shop or garage, etc., the damage appears to have been concentrated on the ground floor in many cases. Some of these buildings actually fell over. The photo7 shows the completely collapsed section of a three storey RC classroom building on the south campus of Boumerdes University located at survey point ②.

Photo 7 Boumerdes University
