Contents

No.38
Autumn 2011

Outline of and Technical Support for the Large-scale Sediment Disaster Triggered in the Kii Mountains by Typhoon 12

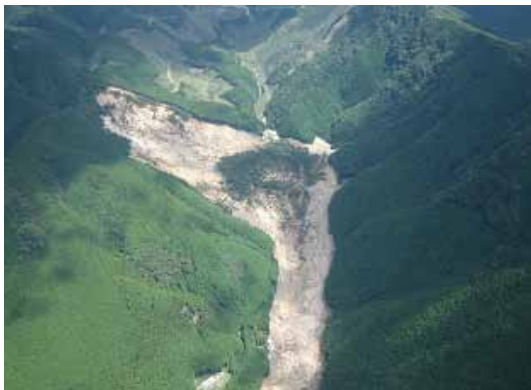
Photo 1. Blockage of River Courses by Typhoon 12 (Iya, Tanabe City, Wakayama Prefecture)

In cases where conditions stipulated under the revised Sediment-related Disasters Prevention Law enacted on May 1 of this year, the form of river course blockage, confirmation of ash fall accompanying a volcanic eruption, and so on, were satisfied, the regional development bureau conducted emergency inspections and issued emergency reports on the sediment disasters. Following typhoon 12, emergency inspections based on the same law were conducted for the first time to deal with the blockage of river courses.

An emergency inspection was started by the Kinki Regional Development Bureau on September 6 based on the results of the inspection by TEC-FORCE, with technical support from the NILIM and PWRI. The emergency inspection included measuring the assumed start points of overflows, the relative heights of the natural dams, the lengths of submerged ground, etc. using a portable laser range finder from a helicopter and GPS, clarifying the form of each natural dam. Based on the results, regions at risk of disasters caused by debris flows, etc. triggered by the overflow and collapse of a natural dam, and the estimated time of such disaster, were analyzed, and this emergency sediment disaster information was shared with local government bodies on September 8, two days after the start of the inspection (Fig. 1). Based on this information, each local government body issued evacuation orders on the same day so that residents could be properly evacuated.

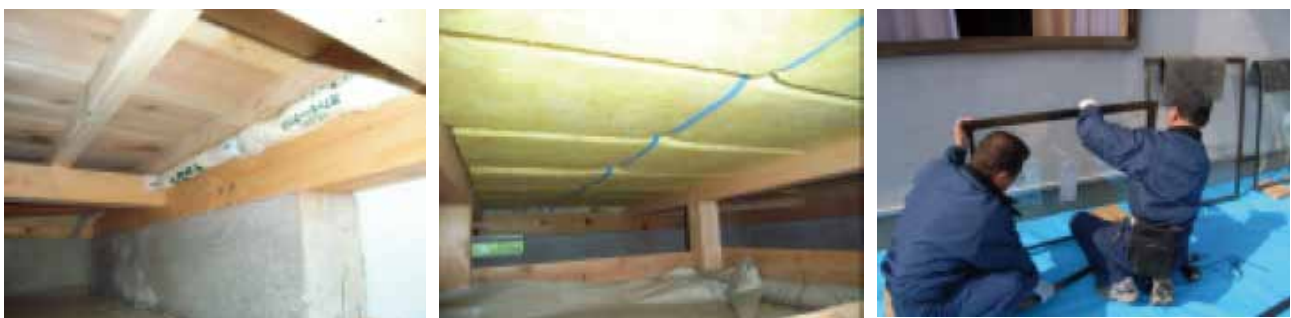
Examples of energy conservation renovation methods (from left, blocking air flow in walls, adding insulation below the floor, sash window attachment method)

Last year, cases of renovation for energy conservation were surveyed to compile suitable methods such as sun shading, insulating, and replacing equipment and appliances, etc. Renovation

only for energy conservation is rarely done, but is usually combined with other work not related to conserving energy (refurbishing the interior finishing, repairing the plumbing, placing waterproof materials in bathrooms, etc.). Before such renovations are carried out, it is necessary to decide how the energy conservation renovation methods surveyed will be combined and executed.

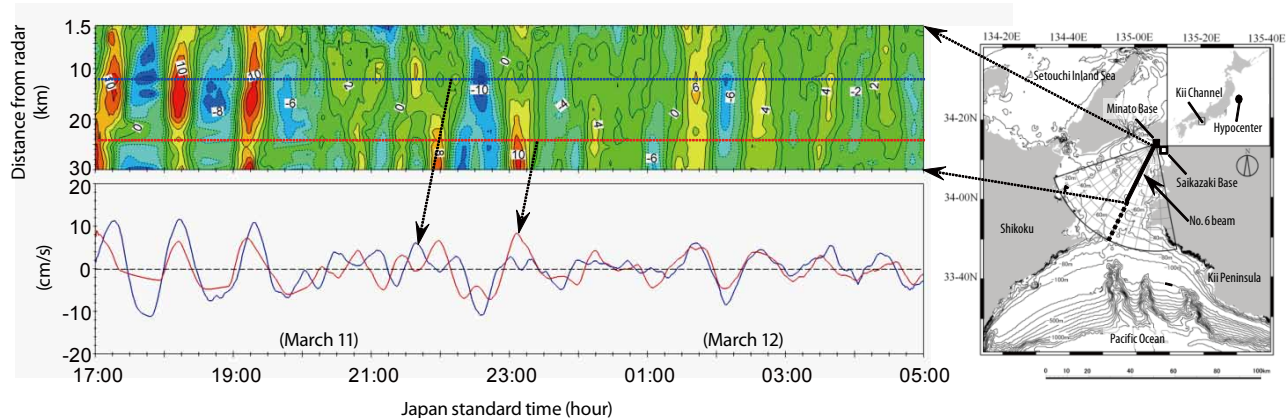
The figure shows the time series of radial velocity along the sixth beam. From the first to the third wave with larger velocity amplitudes, the phases in the distant ranges lead those in the closer ranges. The phase relationship gradually changed after the third wave and became out of phase from 20:00 to 23:00 followed by the establishment of an in-phase relationship throughout the range from 1.5 to 30 km along the beam due to resonance. We are now analyzing the radial velocities from the other radar beams to clarify the processes of tsunami propagation and excitation of the subsequent resonances in the channel.

The tsunami caused by the March 11, 2011 Magnitude 9.0 Tohoku-Oki earthquake reached the continental shelf south of the Kii Channel about 1.5 hours after the earthquake. At 5:00 p.m. on the day of the earthquake, we switched the observation mode of HF radars at two sites located on the eastern coast of the Kii Channel (Figure) from normal hourly observation to tsunami observation every two minutes. Signals from the tsunami waves induced by the earthquake and subsequent resonances were detected as radial velocity variability by the HF radar installed at the northern site.
