■ Activities of the NILIM after the 2016 Kumamoto Earthquake

No.57
Summer 2016

Edited and Published by National Institute for Land and Infrastructure Management

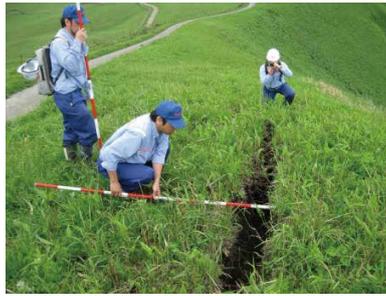
Photo 1. Surveying cracking caused by the earthquake

The Sabo Department dispatched personnel to the region on April 15, immediately after the foreshock of April 14. As a result, after the main shock struck on the 16th, they were able to quickly confirm the state of many landslides, cracks, and large debris flows that occurred along the caldera wall and near the central volcanic cone of the outer rim of Mt. Aso.

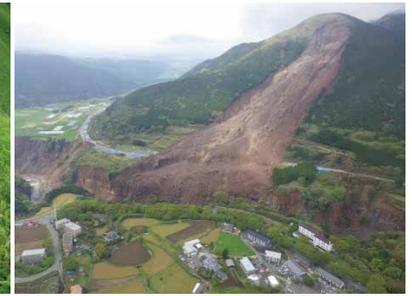
Photo 2. Large-scale collapsed slope near Aso Bridge

On slopes near Aso Bridge, where countermeasures using advanced technologies were necessary, large-scale collapsed ground, or where a national highway or railway track at the foot of a collapsed slope had to be restored, for example, they gave technical support by attending technology study meetings held by the Kyushu Regional Development Bureau.

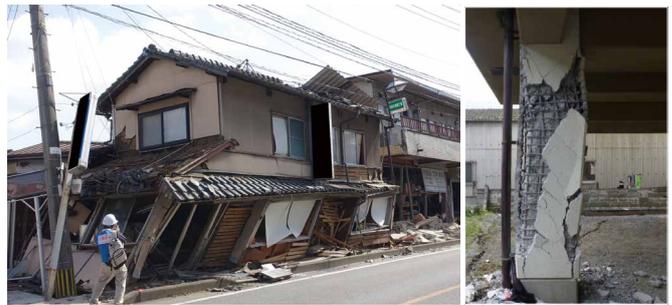
Photo State of damage to buildings (left: wooden, right: RC)

After the Kumamoto Earthquake, the Building Department carried surveys 1 to 13 centered on Kumamoto City and Mashiki Town, etc. in Kumamoto Prefecture where many buildings had been damaged, in collaboration with the Building Research Institute (at the end of July 2016). To carry out the survey, experts on wooden construction, steel frame construction, reinforced concrete construction, non-structural
