NILIM's disaster prevention, disaster mitigation and crisis management initiatives

■ Initiatives for advancement of disaster response based on NILIM's mission and recent R&D

NILIM's activity report on the heavy rain of July 2018

NILIM’s disaster response to the 2018 Hokkaido Eastern Iburi Earthquake

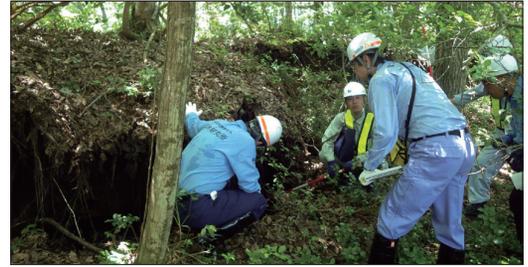
On Matsue Expressway (Shobara City, Hiroshima Prefecture), where the a cut slope was damaged by a landslide, in response to a request from Chugoku Regional Development Bureau, we conducted an on-site survey on July 14 and provided technical assistance on safety check methods and restoration toward the resumption of traffic.

Survey conducted in the vicinity of Takano IC of Matsue Expressway

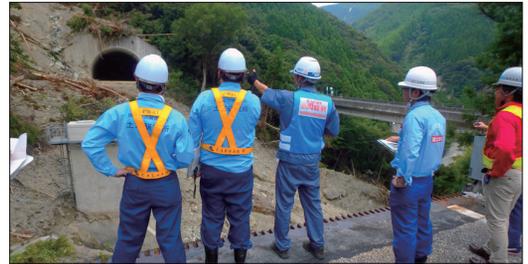
We also dispatched our staff to Tajikawa Bridge, where the upper part had broken away due to the collapse of a mountain slope (Otoyo Town, Kochi Prefecture) on July 20, and we carried out a damage survey and provided the expressway company with advisory points to consider in the restoration procedures from a technical point of view.

Damage survey on Tajikawa Bridge of Kochi Expressway

Even after dispatching our staff, we are continuing to provide technical assistance, including participation in the “Technical Examination Committee for the Restoration of Kochi Expressway”.

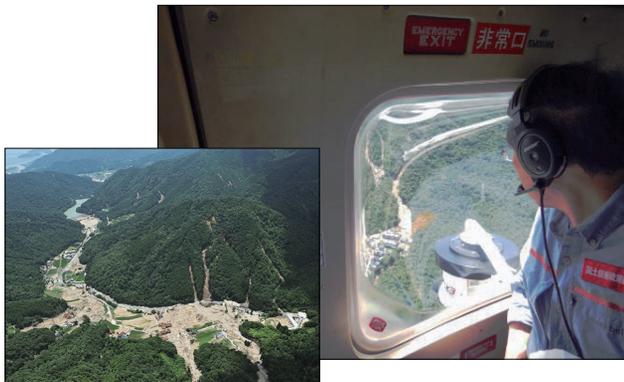
On July 10, immediately after the disasters began, the NILIM dispatched staff to the sites in cooperation with the Public Work Research Institute. We conducted a survey using a helicopter in 3 affected prefectures: Hiroshima; Ehime, where 200 or more sediment disasters occurred; and Kyoto, where natural dams were formed. We provided technical advice to regional development bureaus and the relevant prefectural institutions regarding the extracted points that needed to be focused on, urgent examinations, emergency response measures, precautions against the continuous rain, and evacuations. We also carried out a survey of the actual status, including debris/water flooding and measurement of peak debris flow rate, etc. We will continue to research this disaster through extraction/classification of technical subjects based on the actual damage.

Conducting a survey using a helicopter, and the disaster-affected area seen from above

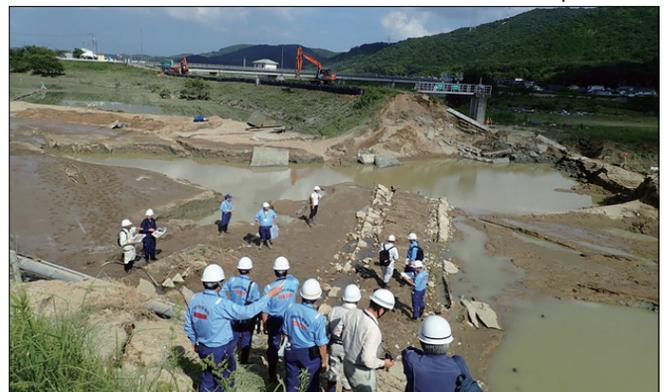
The NILIM dispatched its staff to the area on July 8, the very next day after the disaster occurred. Together with the Water and Disaster Management Bureau of the Ministry of Land, Infrastructure, Transport and Tourism, and the Public Work Research Institute, we surveyed the damage conditions of the breach points of the river levees.

Field survey

From the middle of July to the end of August, after holding four sessions of meetings, the Committee concluded that the principal cause of this damage was an overtopping of water. In addition to carrying out a measure to counter overtopping, a restoration method in consideration of seepage was to be examined, since the Committee could not rule out the possibility that the seepage had weakened the levees.

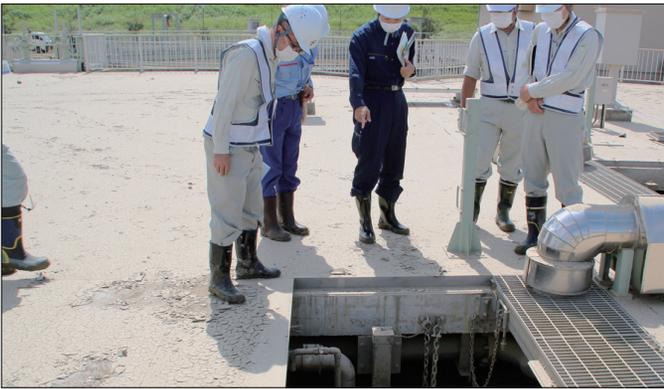
Conducting a damage survey of Mabi Purification Center

During the heavy rain of July 2018, river levee failures led to flooding with a depth of 4.2 meters, causing Mabi Purification Center in Kurashiki City to suffer a functional breakdown. In the sewer system of the Mabi area, two spans of sewer pipe (approx. 20 meters) were flown out due to scouring.

On July 11, the next day after entering into the disaster area became possible, in cooperation with the Sewerage Department of the Water and Disaster Management Bureau of the Ministry of Land, Infrastructure, Transport and Tourism, the NILIM surveyed the damage situation, and provided advice regarding emergency restoration and gradual restoration, as well as water quality monitoring, etc.

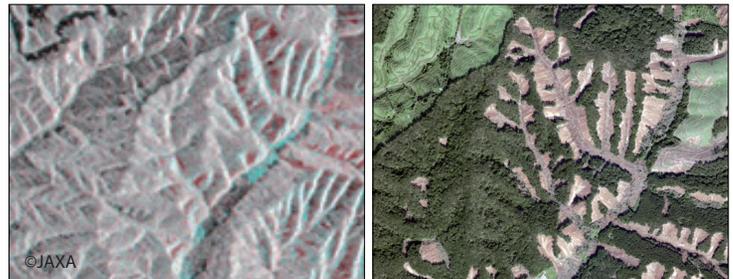
With regards to the 2018 Hokkaido Eastern Iburi Earthquake, the NILIM analyzed the state of slopes around the focal region of the earthquake based on satellite SAR image taken both before and after the occurrence of the earthquake. As a result, we grasped the fact that a high density of ground deformations that are presumed to be denudation of mountain forests or sedimentation from collapsed slopes occurred on the day of the earthquake, which struck on the evening of September 6. These observations showed the possibility that a significant number of slope collapses had occurred across an extensive area. We provided this information to the institutions concerned through the Water and Disaster Management Bureau of the Ministry of Land, Infrastructure, Transport and Tourism.

SAR image (left) and an image provided from the Geographical Survey Institute (right)

disaster, and advice regarding warnings/evacuations. We also advised Hokkaido Regional Development Bureau regarding risk assessment of secondary disasters, development of warning/evacuation systems, and emergency response to the natural dam formed in Hidaka-Horonai River.

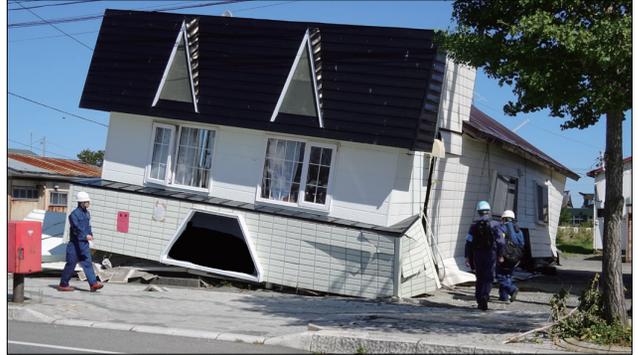
Based on the results of quick post-earthquake inspections of damaged buildings provided by each town office, we implemented the survey in various ways, determining which buildings were damaged, carrying out visual inspection, measurement and photography, and interviewing local residents, etc. We also carried out confirmation of the locations and the installation conditions of seismometers in the vicinity in order to analyze the relationship between the seismic motion and the damage caused to the buildings. We responded to media inquiries in our survey location, and an overview of the survey results was reported on TV within the day. Also, we made the survey report public on our website on October 2. In this survey, we often observed that relatively old two-story houses combined with stores were particularly susceptible to collapse or significant deformation. We will continue to analyze the damage to these buildings.

A collapsed dwelling combined with store (Mukawa Town)

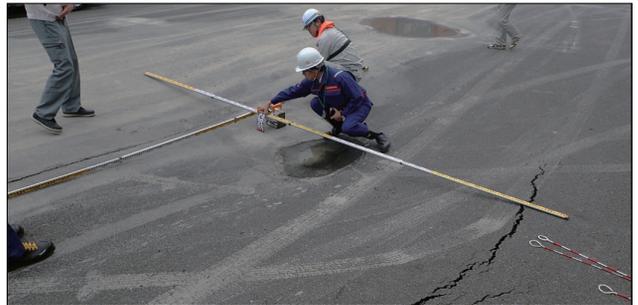
As a result of an on-site survey, we observed many cases of sand jet traces, inundation and subsidence, etc. that are thought to have resulted from the liquefaction of the ground.

The state of on-site survey

Based on this survey, we conducted technical assistance including providing advice on the survey policy for the cavities formed in the liquefied ground, restoration methods, and regarding the progression of liquefaction.
