No.65
2018

NILIM's disaster prevention, disaster mitigation and crisis management initiatives

Disaster response measures during FY2018

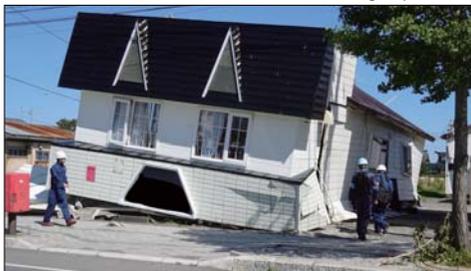
A collapsed dwelling combined with store (Mukawa Town)

Concerning the 2018 Hokkaido Eastern Iburu Earthquake, the NILIM conducted a building damage survey on September 11 in three towns where the earthquake intensity reached upper 6 on the scale, causing considerable damage to buildings in Mukawa Town, Abira Town, and Atsuma Town.

Based on the results of quick post-earthquake inspections of damaged buildings provided by each town office, we implemented the survey in various ways, determining which buildings were damaged, carrying out visual inspection, measurement and photography, and interviewing local residents, etc. We also carried out confirmation of the locations and the installation conditions of seismometers in the vicinity in order to analyze the relationship between the seismic motion and the damage caused to the buildings. We responded to media inquiries in our survey location, and an overview of the survey results was reported on TV within the day. Also, we made the survey report public on our website on October 2. In this survey, we often observed that relatively old two-story houses combined with stores were particularly susceptible to collapse or significant deformation. We will continue to analyze the damage to these buildings.

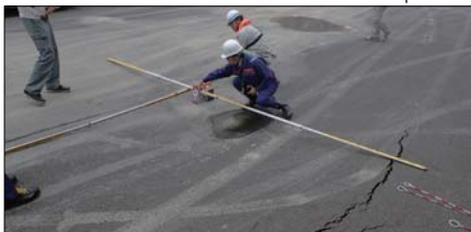
The state of on-site survey

As a result of an on-site survey, we observed many cases of sand jet traces, inundation and subsidence, etc. that are thought to have resulted from the liquefaction of the ground.

Due to the liquefaction caused by the 2018 Hokkaido Eastern Iburu Earthquake, the port and harbor facilities of Tomakomai Port, including the container yard of the central pier in Tomakomai East Port, were damaged.

Based on this survey, we conducted technical assistance including providing advice on the survey policy for the cavities formed in the liquefied ground, restoration methods, and regarding the progression of liquefaction.

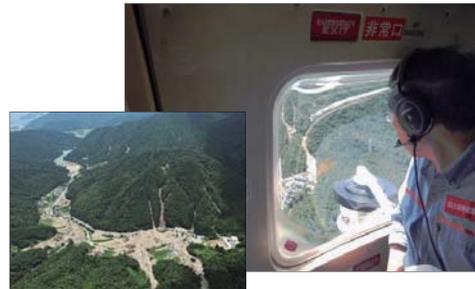
Conducting a survey using a helicopter, and the disaster-affected area seen from above

Due to the heavy rain of July 2018, 2,512 cases of sediment disasters occurred in 31 prefectures.

On July 10, immediately after the disasters began, the NILIM dispatched staff to the sites in cooperation with the Public Work Research Institute. We conducted a survey using a helicopter in 3 affected prefectures: Hiroshima; Ehime, where 200 or more sediment disasters occurred; and Kyoto, where natural dams were formed. We provided technical advice to regional development bureaus and the relevant prefectural institutions regarding the extracted points that needed to be focused on, urgent examinations, emergency response measures, precautions against the continuous rain, and evacuations. We also carried out a survey of the actual status, including debris/water flooding and measurement of peak debris flow rate, etc. We will continue to research this disaster through extraction/classification of technical subjects based on the actual damage.

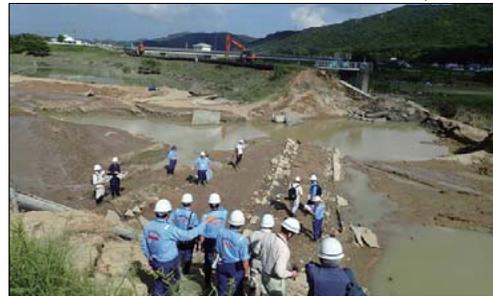
Field survey

In the heavy rain of July 2018, Mabi Town, Kurashiki City, located along Oda River in the Takahashi River-System, suffered considerable damage due to a river overflow, with the flooded surface area reaching approximately 1200ha.

The NILIM dispatched its staff to the area on July 8, the very next day after the disaster occurred. Together with the Water and Disaster Management Bureau of the Ministry of Land, Infrastructure, Transport and Tourism, and the Public Work Research Institute, we surveyed the damage conditions of the breach points of the river levees.

From the middle of July to the end of August, after holding four sessions of meetings, the Committee concluded that the principal cause of this damage was an overtopping of water. In addition to carrying out a measure to counter overtopping, a restoration method in consideration of seepage was to be examined, since the Committee could not rule out the possibility that the seepage had weakened the levees.

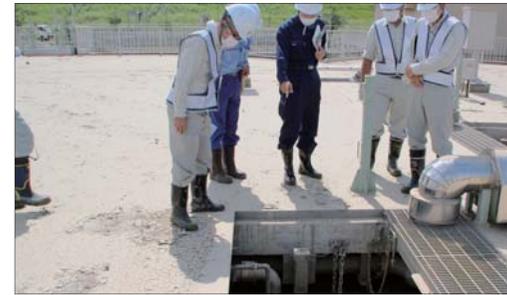
Conducting a damage survey of Mabi Purification Center

During the heavy rain of July 2018, river levee failures led to flooding with a depth of 4.2 meters, causing Mabi Purification Center in Kurashiki City to suffer a functional breakdown. In the sewer system of the Mabi area, two spans of sewer pipe (approx. 20 meters) were flown out due to scouring.

On July 11, the next day after entering into the disaster area became possible, in cooperation with the Sewerage Department of the Water and Disaster Management Bureau of the Ministry of Land, Infrastructure, Transport and Tourism, the NILIM surveyed the damage situation, and provided advice regarding emergency restoration and gradual restoration, as well as water quality monitoring, etc.
