# 国土技術政策総合研究所資料

TECHNICAL NOTE of  
National Institute for Land and Infrastructure Management

## QUICK INSPECTION MANUAL FOR DAMAGED REINFORCED CONCRETE BUILDINGS DUE TO EARTHQUAKES

Based on the Disaster of  
1999 Kocaeli Earthquake in Turkey

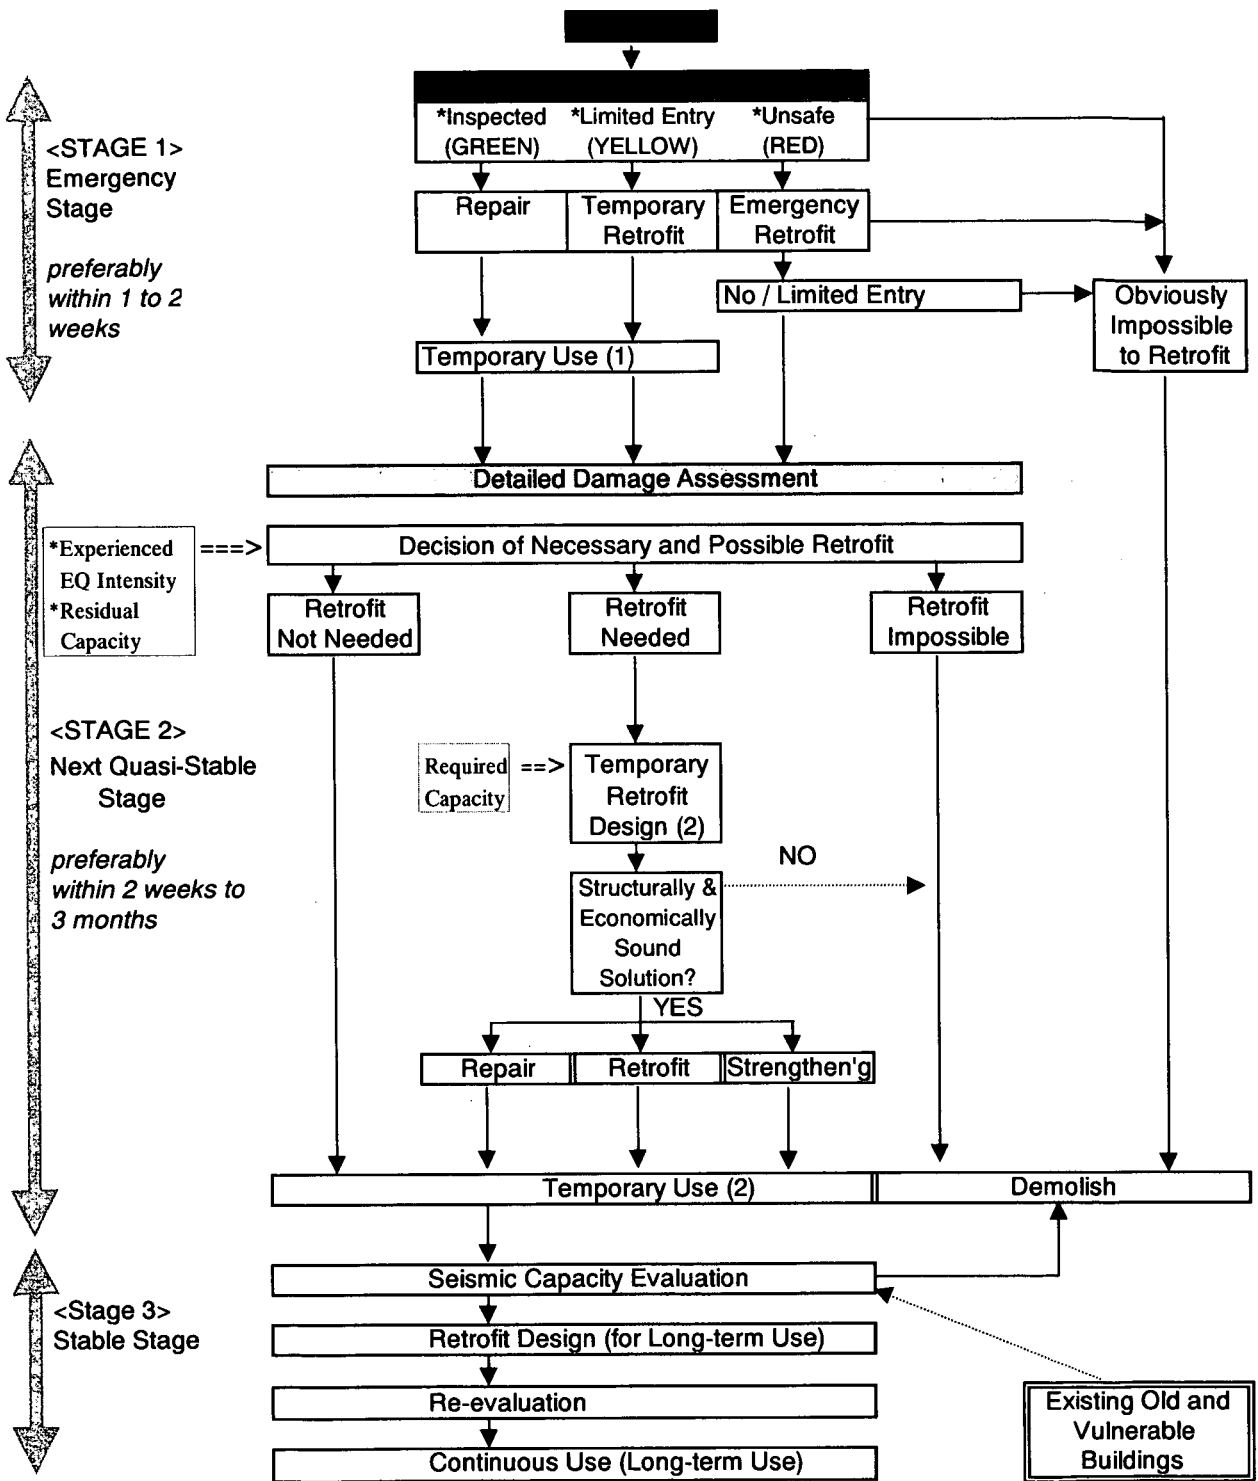
Figure 2.1: General Flow of Reconstruction Strategy

As can be found in the flow chart, it is recommended to perform stages 1 and 2 within “1 to 2 weeks” and “2 weeks to 3 months”, respectively, but it is highly dependent on the disaster scale. It may be informative that quick inspections could not be completed in Japan even 1 month after the 1995 Hyogo-ken Nambu (Kobe) Earthquake due to the huge scale damage, although quick inspectors system had been already established in several prefectures at the time of the quake. Considering the lessons learned from such evidence, nationwide quick inspectors system was developed to mutually cooperate in case of emergency.

To restore a damaged community as early as possible, well-prepared reconstruction strategy, which needs deep and wide discussions among engineers and governmental personnel prior to disaster, is most essential. Figure 2.1 shows an example of reconstruction strategy for earthquake damaged buildings, which is under discussion in Japan. As is shown in the figure, there may be several stages chronologically after the event in general. Although the detailed and practical flow should be determined after further discussions considering wide array of issues related to earthquake disaster planning and social system in each country, local authority and community, a quick inspection can be definitely the first action to be taken immediately after a major earthquake.

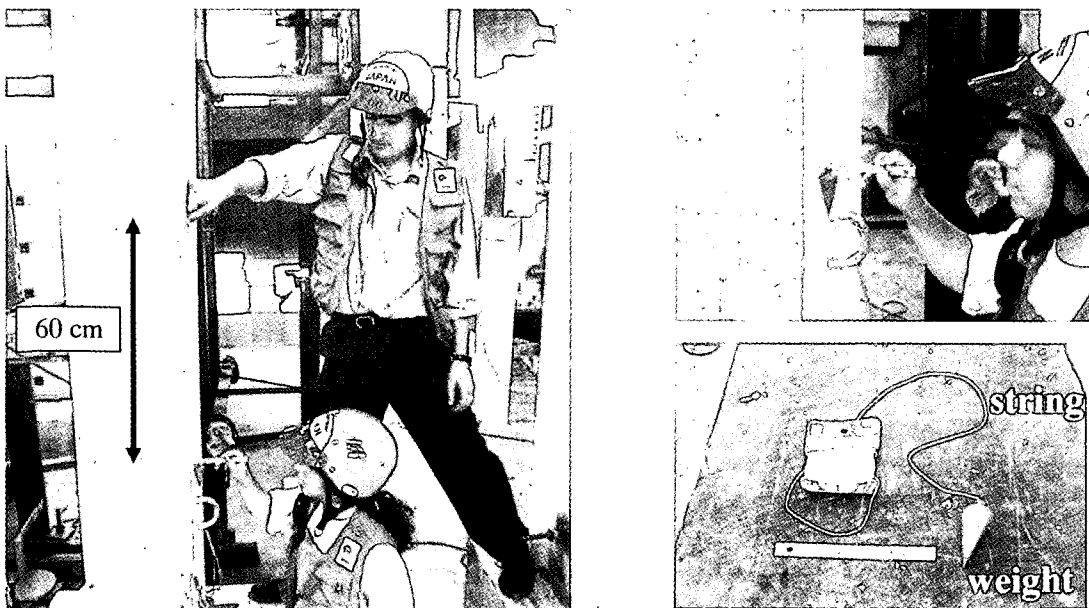
1. When some damage around or to the building is found, check as such in questions a. through c. Ordinarily noticeable inclination may be larger than 2 degrees ( $1/30$  rad.) and rank C would be appropriate, while unnoticeable inclination may be smaller than 1 degree ( $1/60$  rad.) and rank A would be appropriate. If the building is seemingly inclined but the degree is uncertain, inclination measurement is recommended. Inclination can be easily noticed with a pendant-type measurement as shown below.

note: If the string is adjusted 60 cm long, inclination can be easily measured by the distance from the column surface to the string. (e.g. 1 cm :  $1/60$  rad. and 2 cm :  $1/30$  rad. )

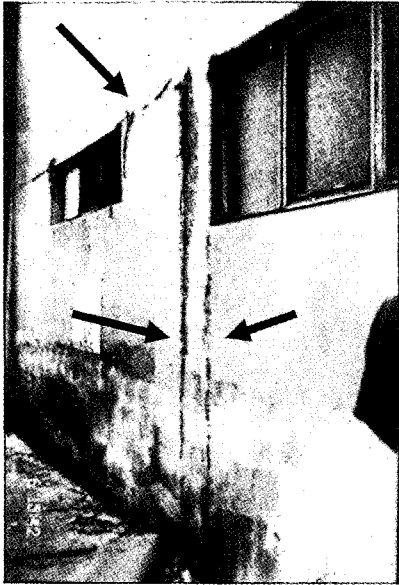
2. Identify the most seriously damaged story and inspect column damage in the story. Note that it is essential to identify structural and nonstructural members to assess structural safety. Column surface is often flush with nonstructural (ordinarily brick) walls but vertically or horizontally continuous cracks can be a sign of border between structural and nonstructural members.

Cracks along interface between structural members (column and beam) and nonstructural wall are clearly observed.

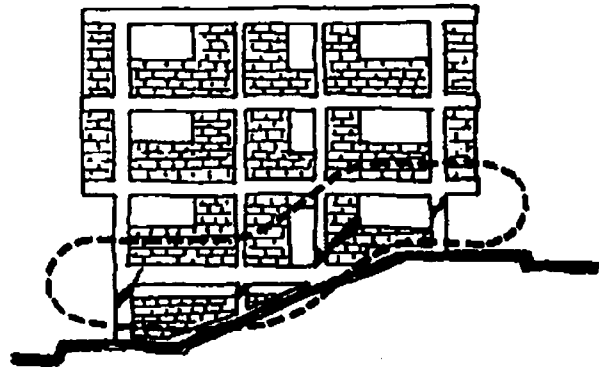
4. It is often found that a building is located on the slope and damage to columns in two adjacent stories is observed. In such a case, it may be a solution to allow for both stories and to take heavier damage into account as shown below.

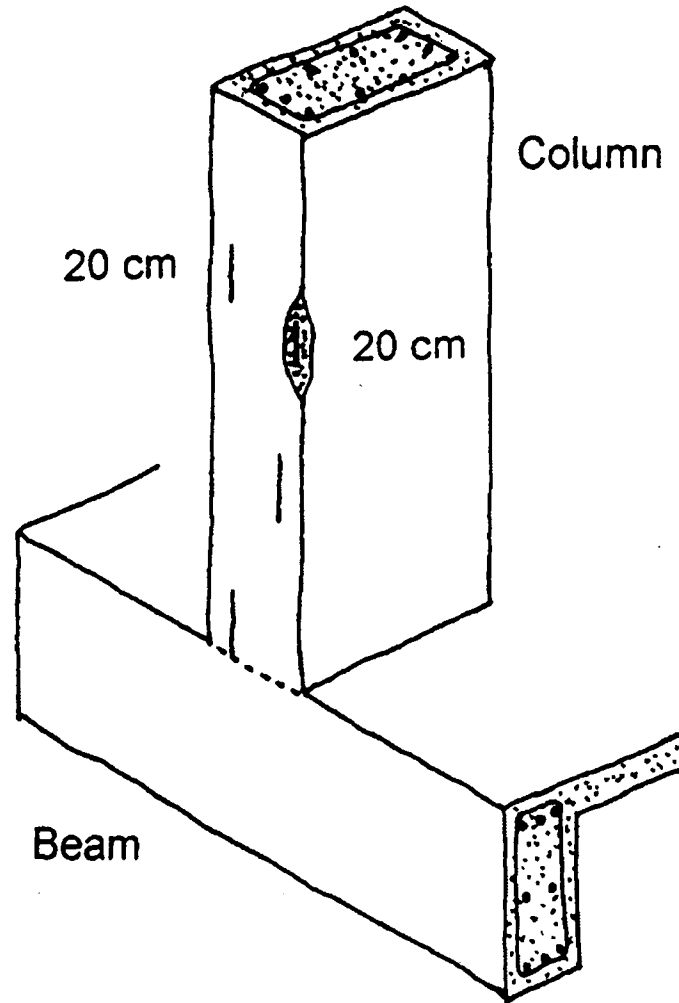
Fig.4.1.1.2 Negligible Cracks and Spalling of Concrete in Damage Rank Evaluation

If the length of longitudinal cracks along the structural member is less than 20cm, the cracks are negligible in the damage rank evaluation. (Fig.4.1.1.2)

The structural members are usually covered by mortar and/or finishings. If the damages of structural members are not visible because of mortar and/or finishings, take away the mortar and/or finishings and observe the damage, or evaluate the damage rank by the damage of the mortar and /or finishings

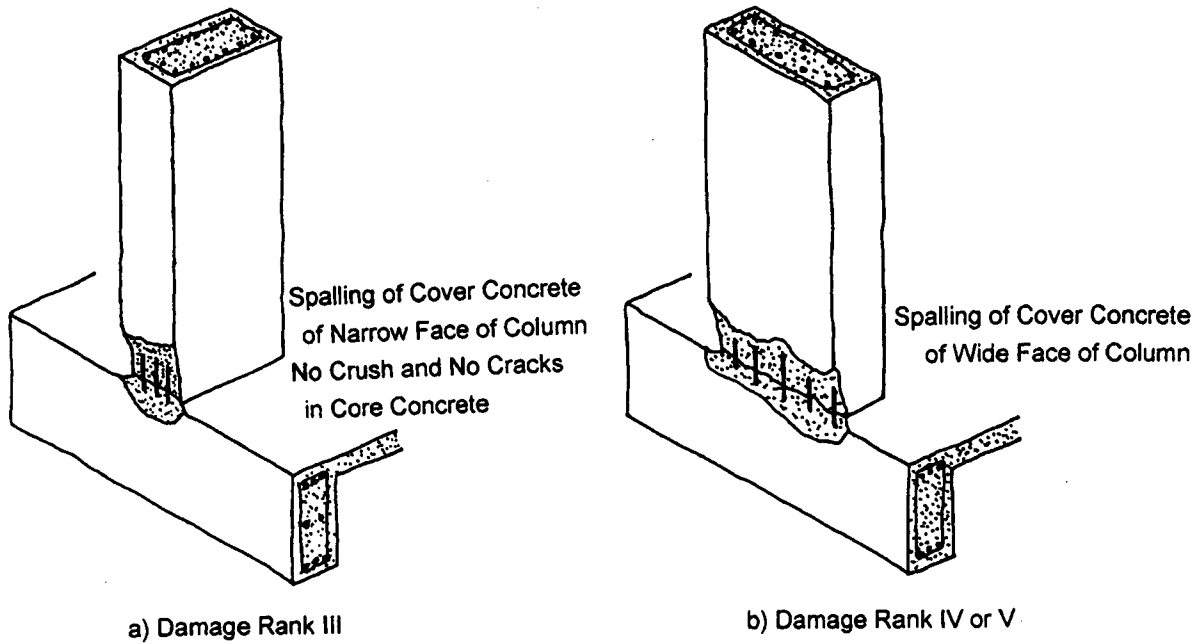
Fig.4.1.3.1 Damage Rank of Columns,  
the Cover Concrete is Spalled off Locally at the Bottom of columns

The columns are evaluated in damage rank III in case that the cover concrete of bottom and narrow face of columns is spalled, but there is no crush and no cracks in the core concrete. (Fig.4.1.3.1 a))

But the spalling of cover concrete occurs at the wide face of columns, the damage rank should be IV or V. (Fig.4.1.3.1 b))

This column is Rank III as Fig.4.1.3.1 a)

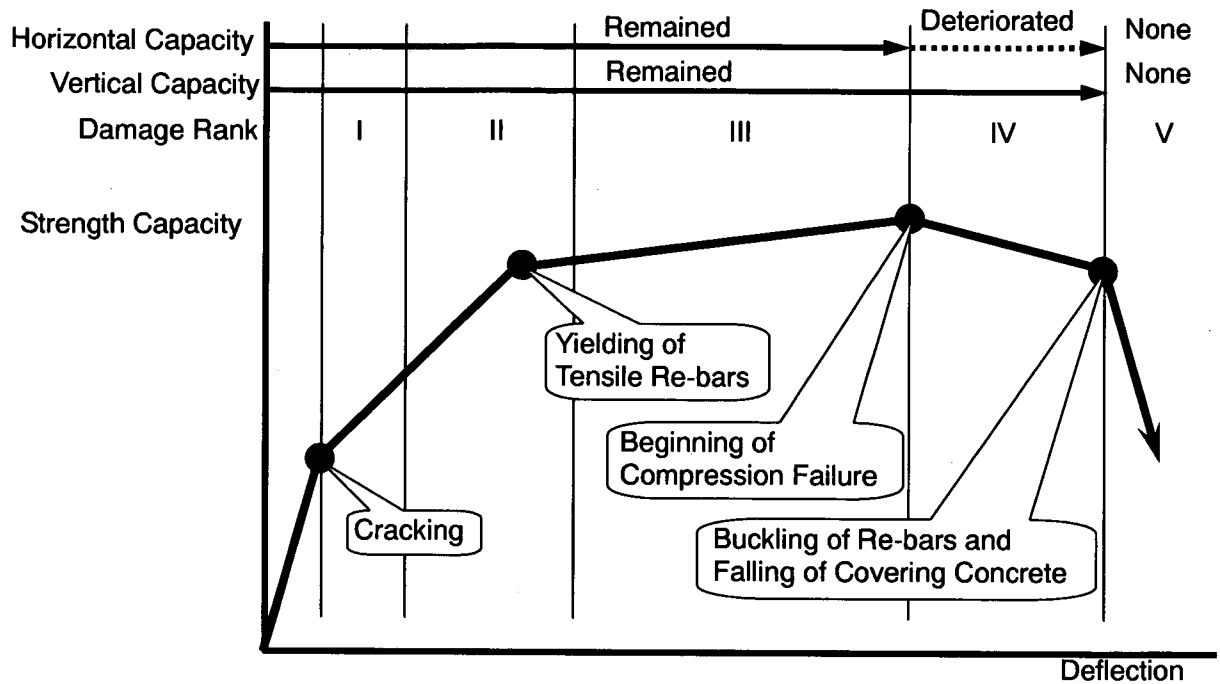
Fig.4.1.4.1 Concept of Damage Rank and Structural Performance of Ductile Members

Following figures, Fig.4.1.4.1 and 4.1.4.2, show the concept of damage rank and structural performance of structural members.

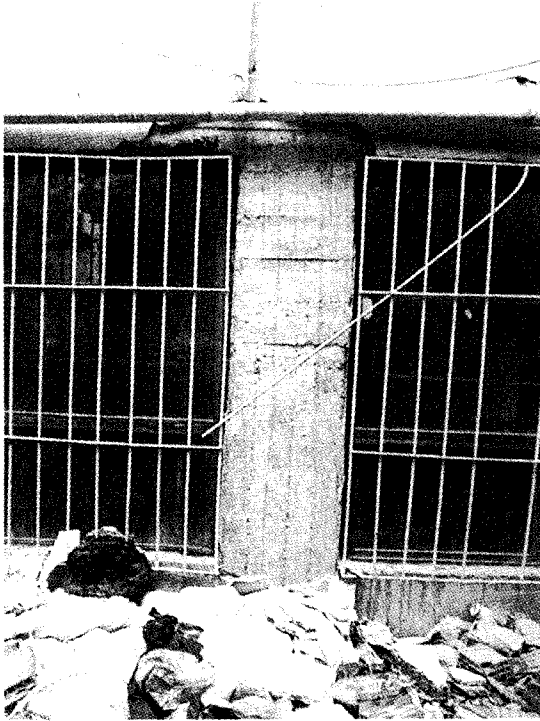
1) Mortar is separated and fallen down, and No shear cracks are observed.

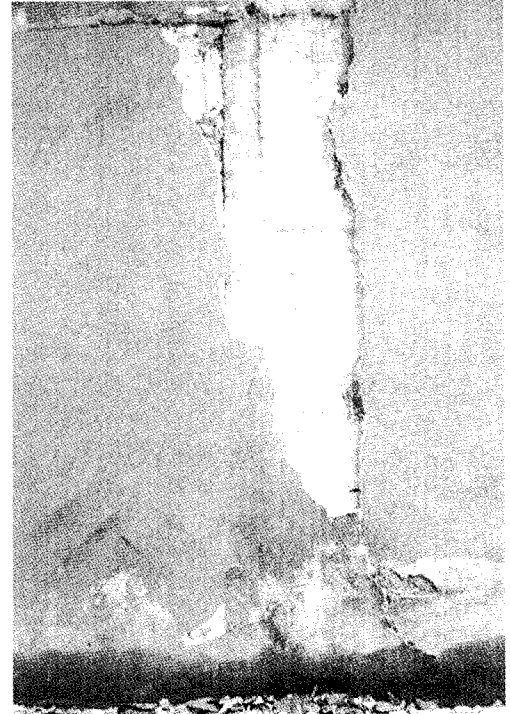
2) Mortar is separated and fallen down, and No shear cracks are observed.

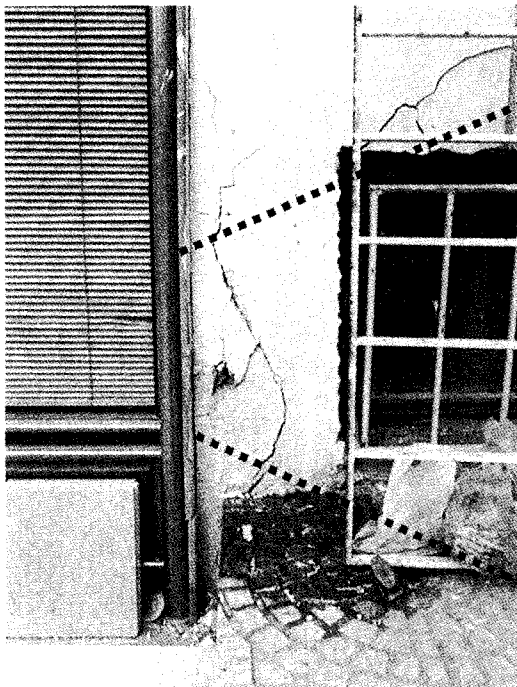
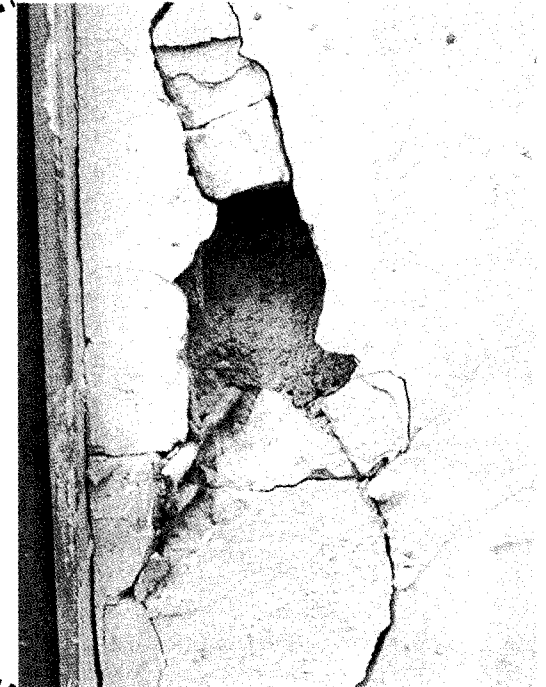
3) Big crack is observed on mortar. But take the mortar away, no crack is observed on the face of concrete.

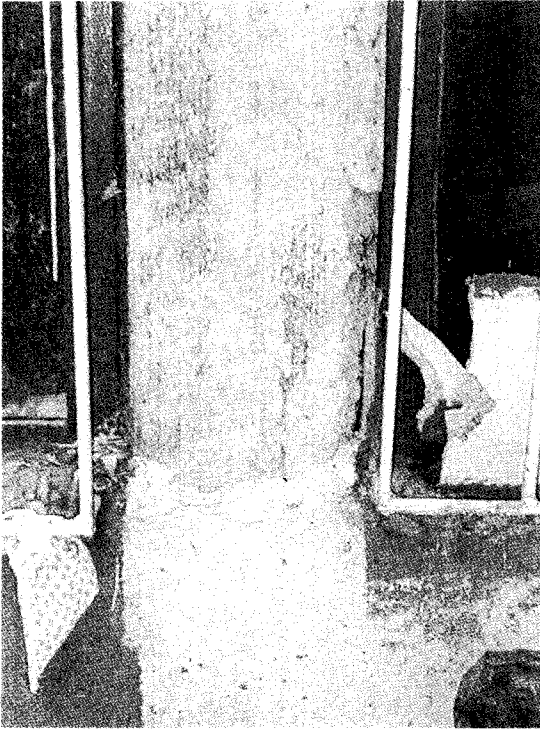
4) Corner cover concrete is spalled off.  
But shear cracks are not observed.

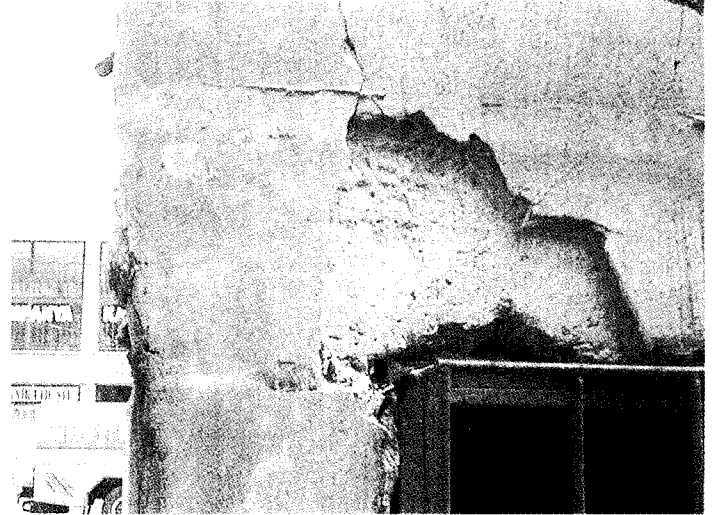
5) Only flexural cracks occur in beam

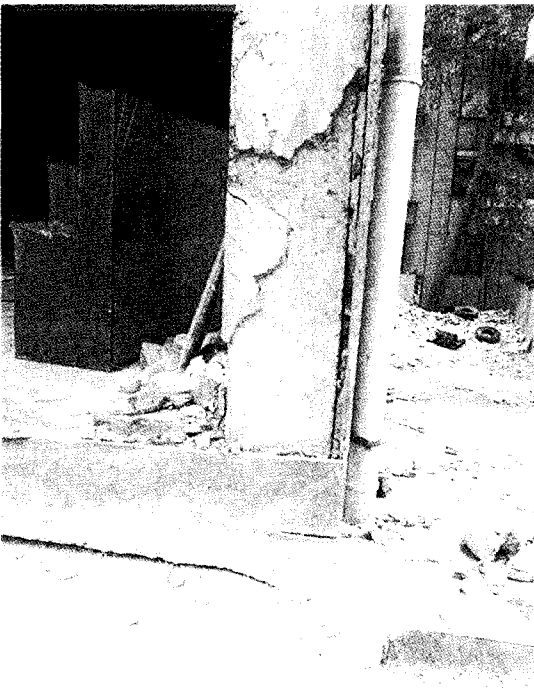
6) Corner cover concrete is spalled off.  
But shear cracks are not observed.

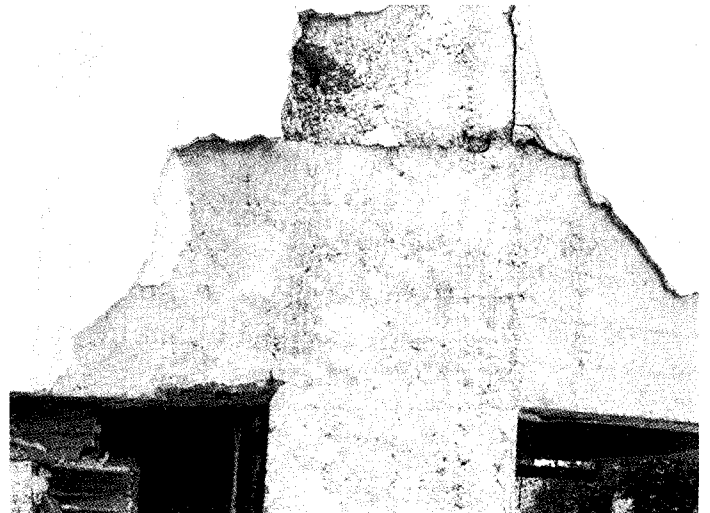
7) Visibly narrow shear crack and flexural crack occur  
in beam. No shear cracks are observed in the beam-  
column joint.

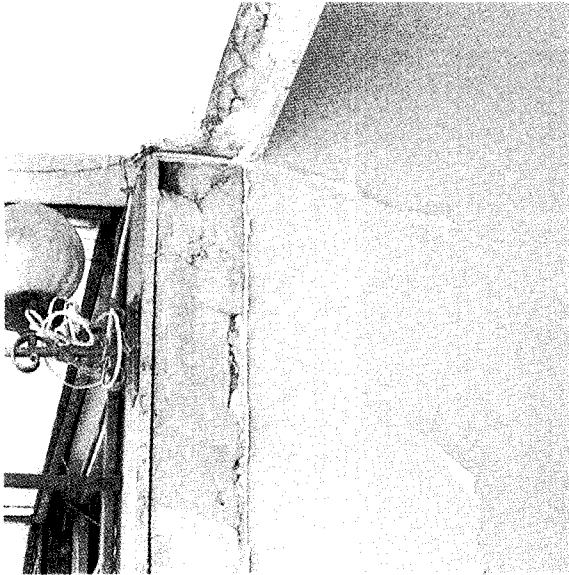
1) Mortar does not fall down, and only small cracks are observed on mortar.

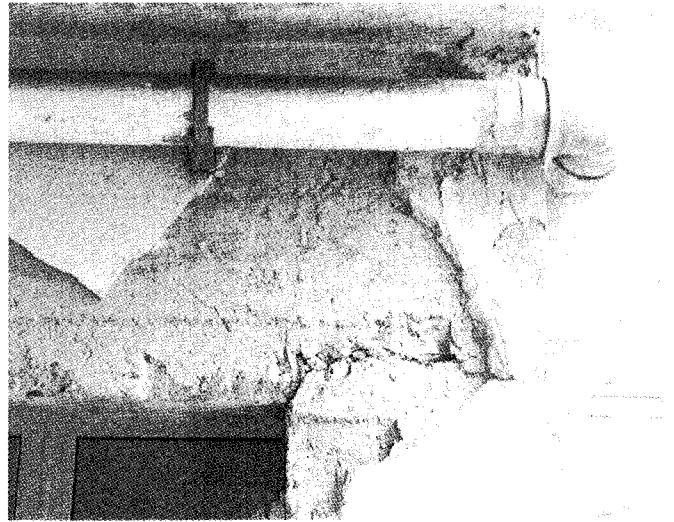
2) Construction joint is observed but negligible.  
Visible clear shear crack in the beam is observed.

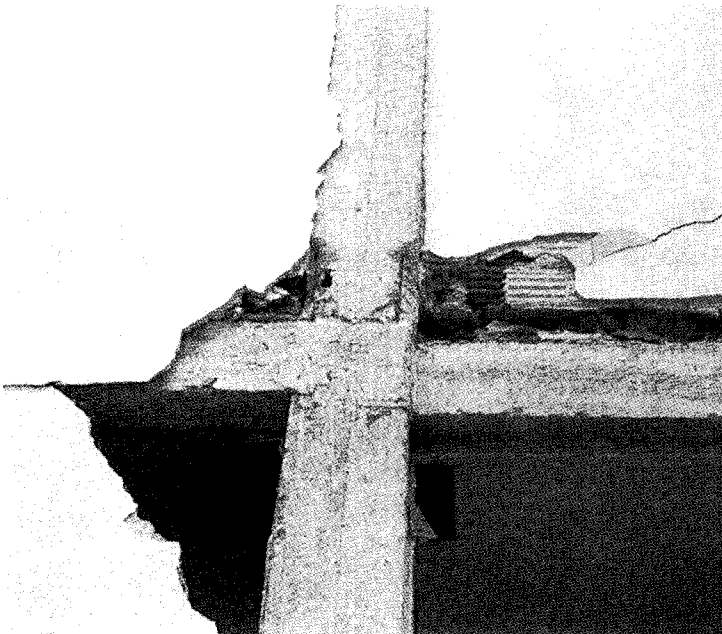
3) Beam has a visible clear crack. (Rank II)  
Beam-column joint has no cracks. (Rank I)  
Spalling of corner cover concrete of column is negligible.  
So, totally the column is Rank II.

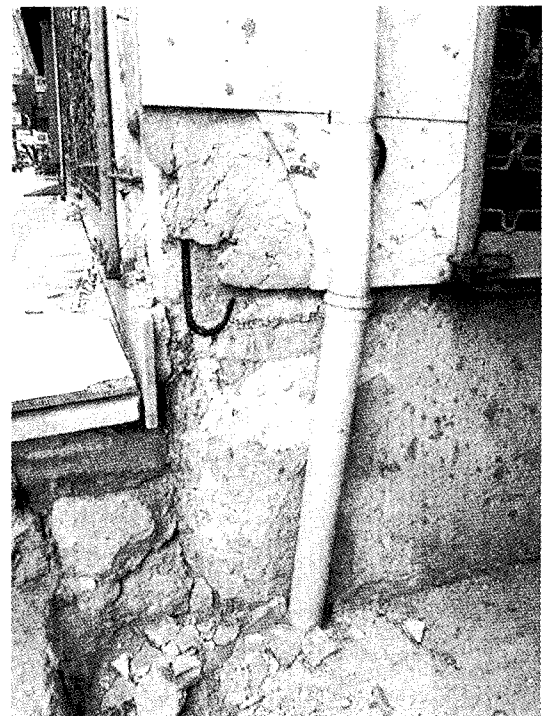
4) Evaluation of damage of this column is difficult. Spalling of cover concrete occurs at only corner. So, damage rank is II.

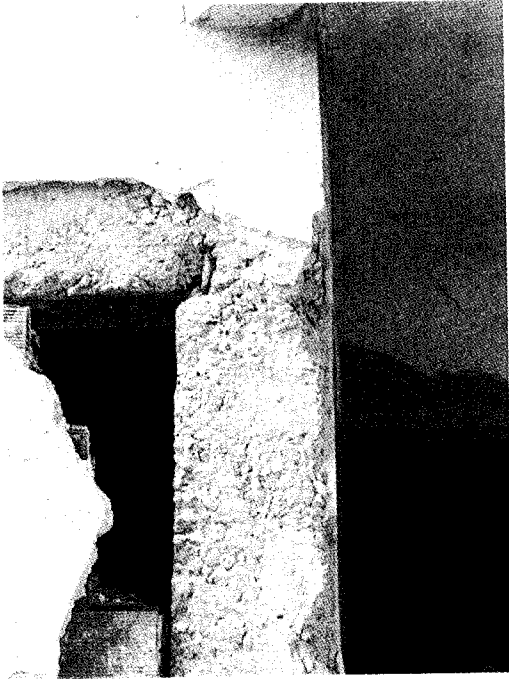
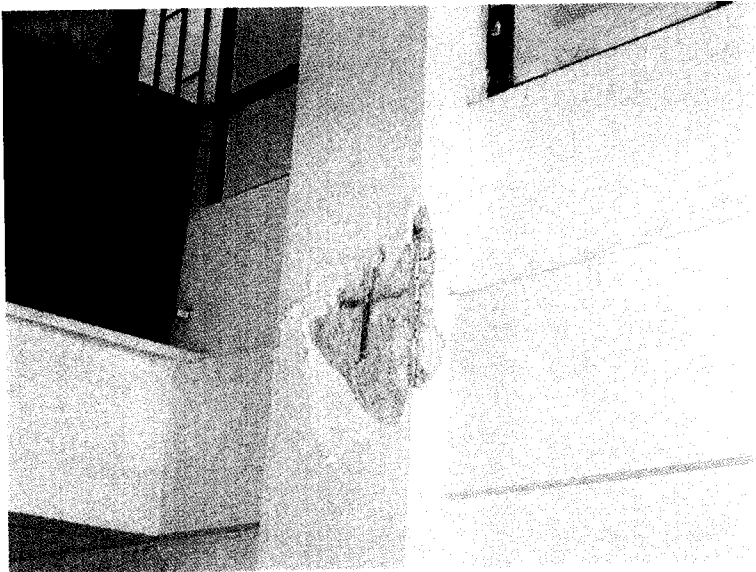
5) Construction quality is not so good.  
But almost no damage is observed  
in structural members.

6) Mortar is fallen down. There was no cover concrete  
initially, so the reinforcing bars are exposed easily, but there  
is almost no cracks in concrete. So, damage rank is II

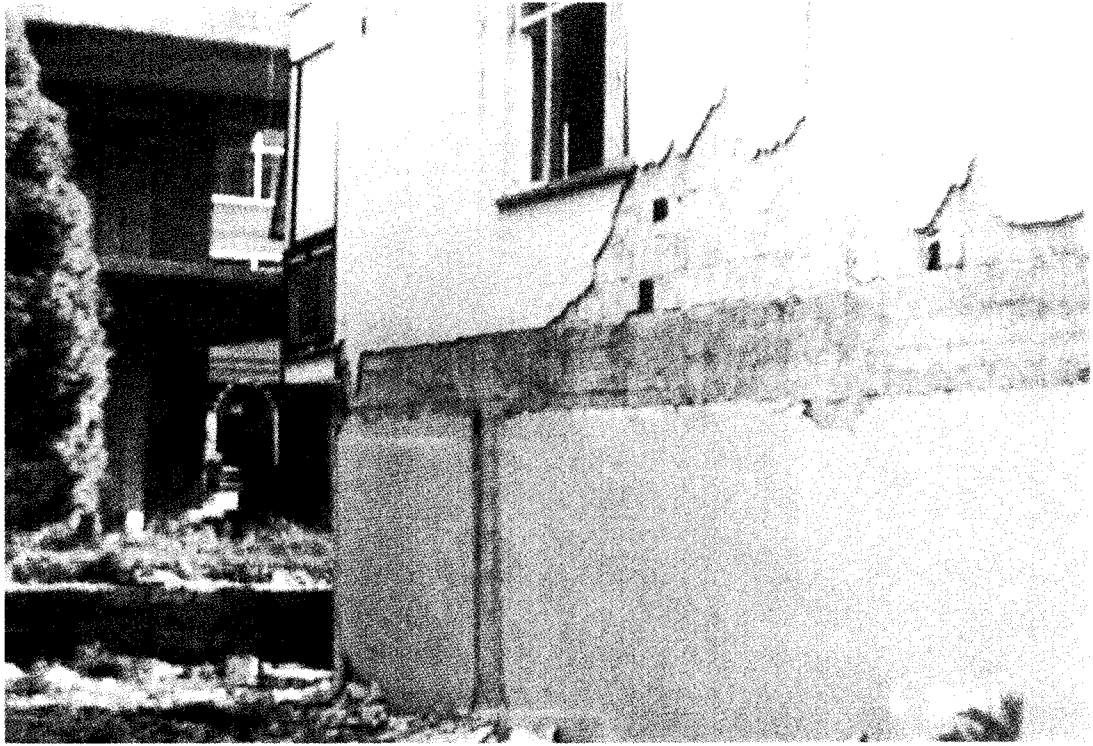
- 7) Mortar is fallen down extensively, but no severe damage and no wide cracks are observed.  
So, the inner two columns are estimated as Rank II.

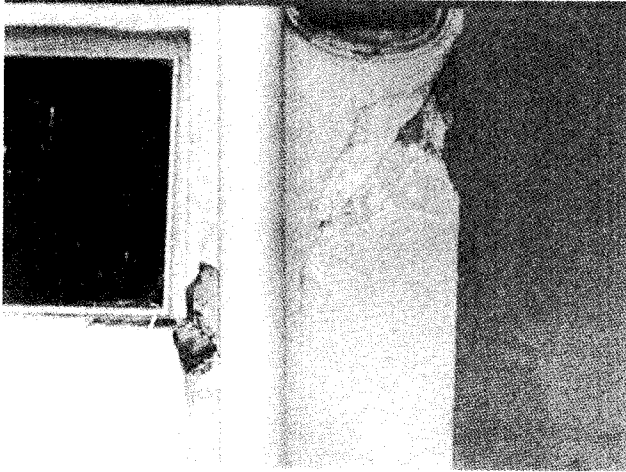
1) Wide shear cracks and local crush of cover concrete are observed at the upper part of column.

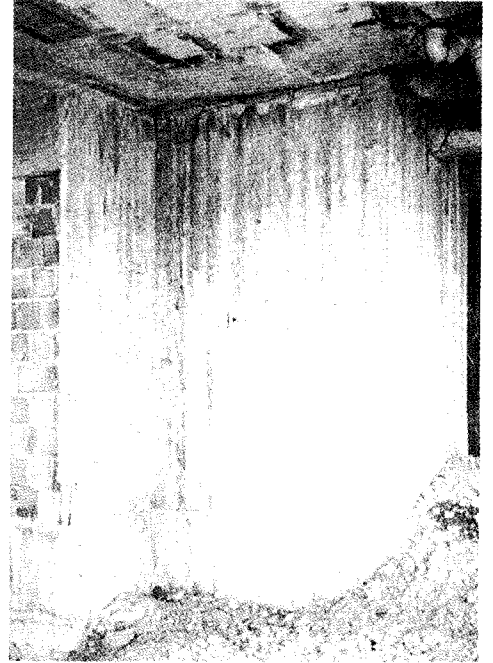
2) Wide shear cracks, local crush of cover concrete and small exposure of reinforcing bars may be observed are observed.

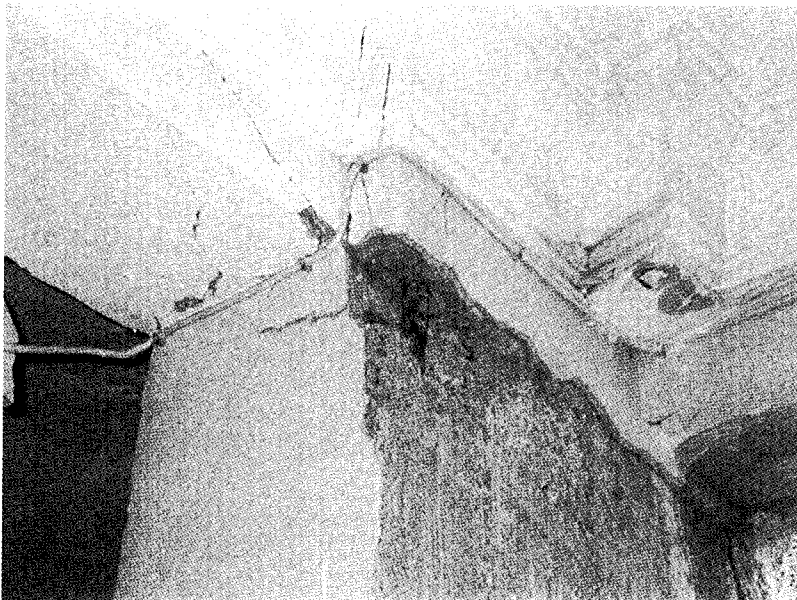
3) Wide flexural crack and local crush of cover concrete and small exposure of reinforcing bars are observed.

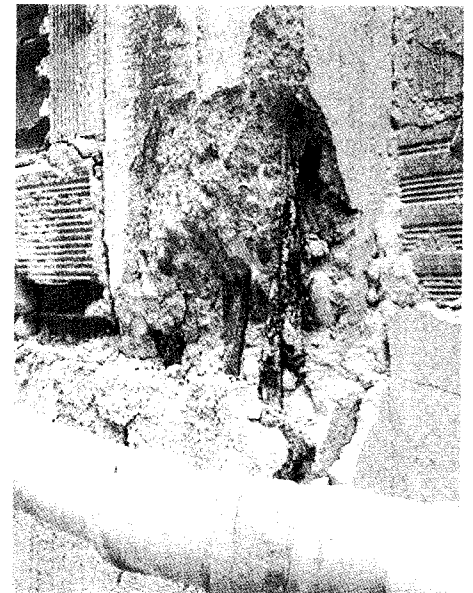
4) Local crush of cover concrete and exposure of reinforcing bars are observed. But no cracks are observed in core concrete.

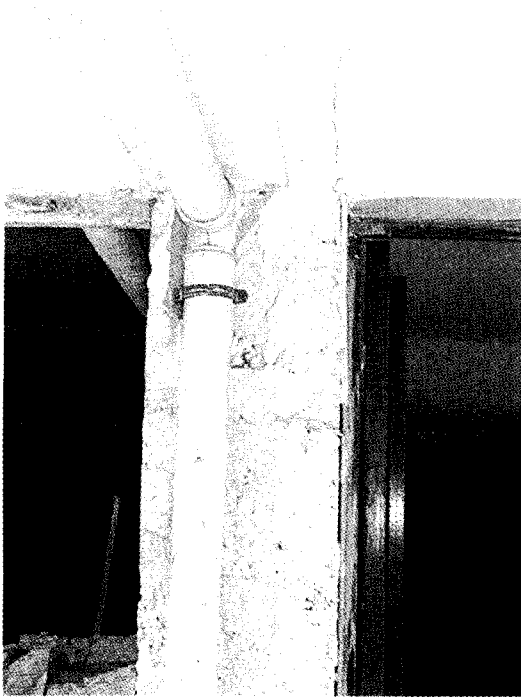
5) Visibly clear shear crack occurs at the top of the narrow face of the column.

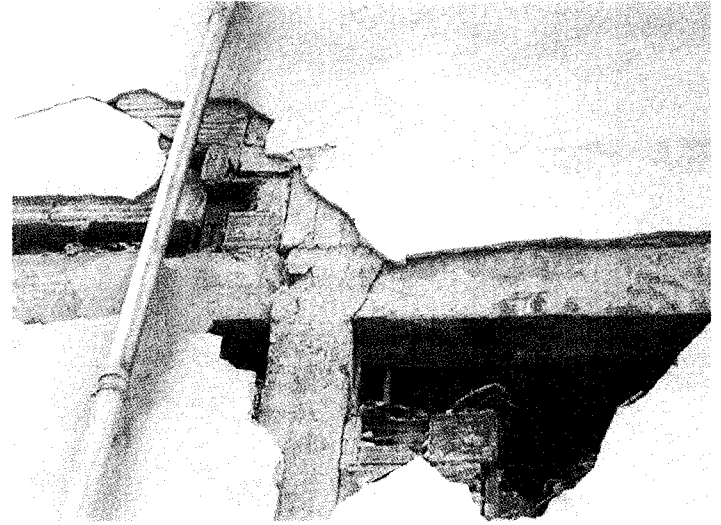
6) Wide shear crack and big flexural crack occur at beam end.

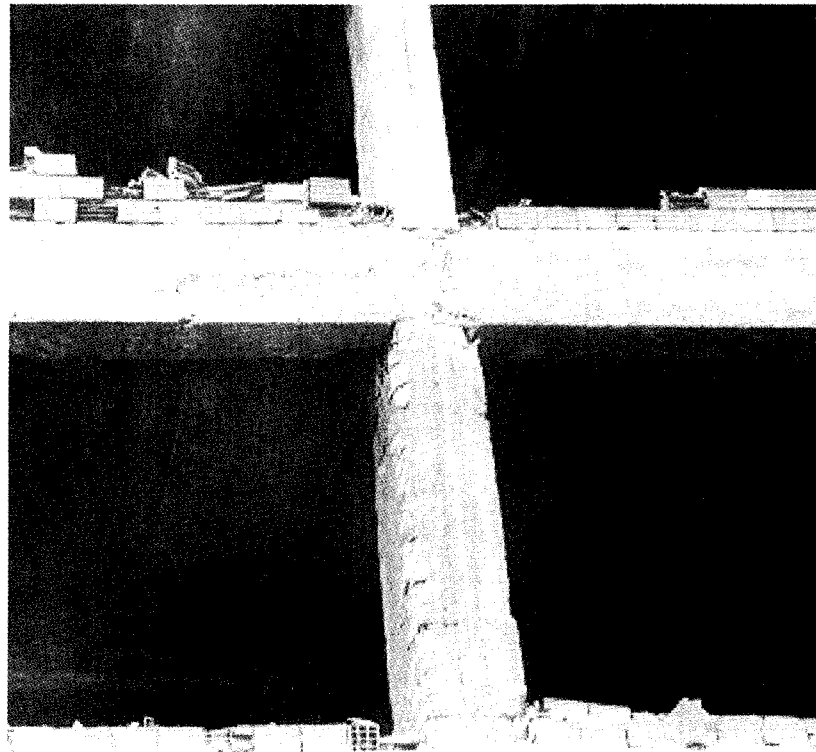
7) Some corner cover concrete are spalled off in the column damage, but damage mainly occurs beam-column joint. Cover concrete is spalled off but no diagonal shear cracks are observed.

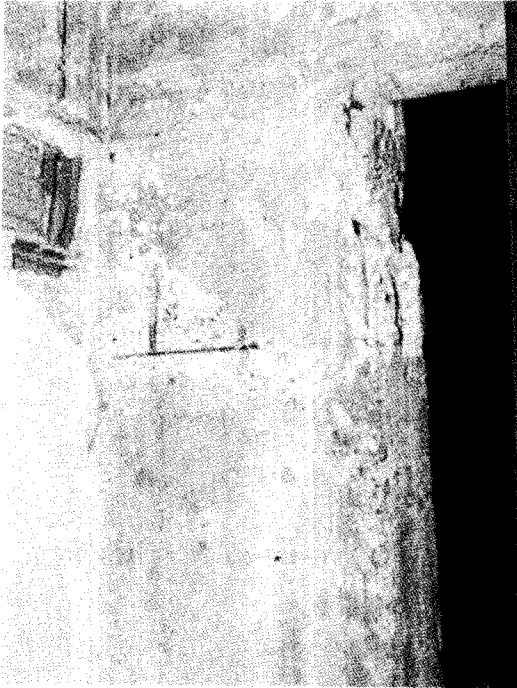
1) Big cracks, Massive Spalling of cover concrete and extensive exposure of reinforcing bars are observed. But buckling of the reinforcing bars is not observed.

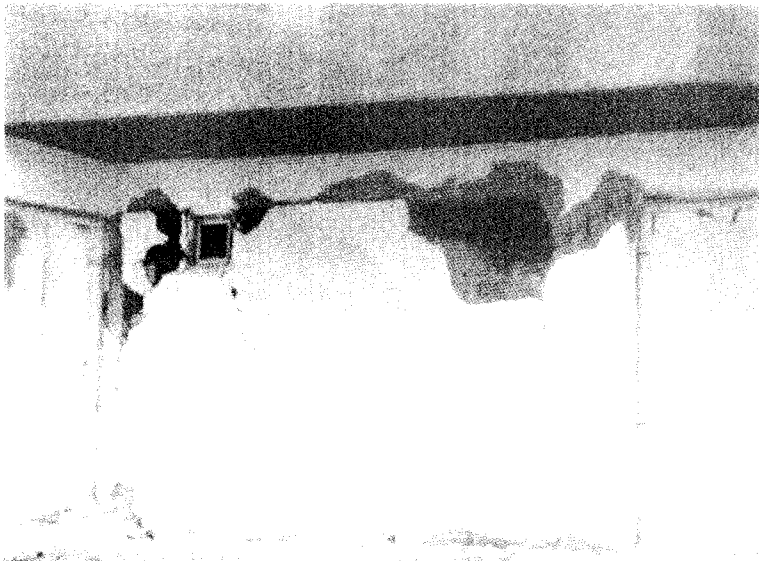
3) Big cracks, Massive Spalling of cover concrete and extensive exposure of reinforcing bars are observed.

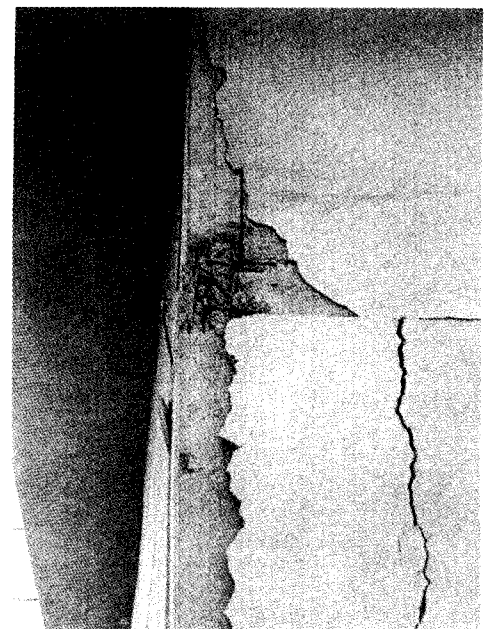
4) Diagonal shear crack is observed in beam-column joint.

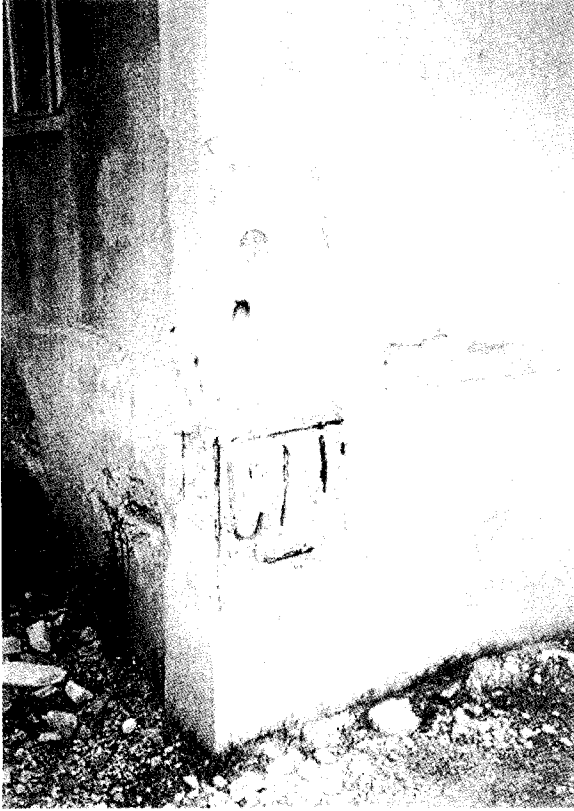
5) Massive Spalling of cover concrete and extensive exposure of reinforcing bars are observed, but buckling of the reinforcing bars is not observed.

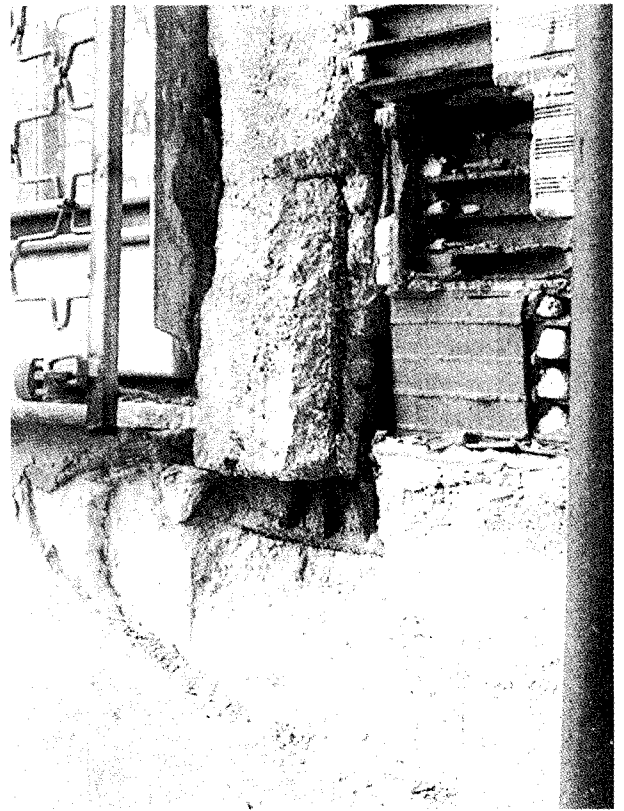
6) Damage is almost same as Fig.4.1.3.1 a).  
But the damage is heavier and there are cracks in core concrete.

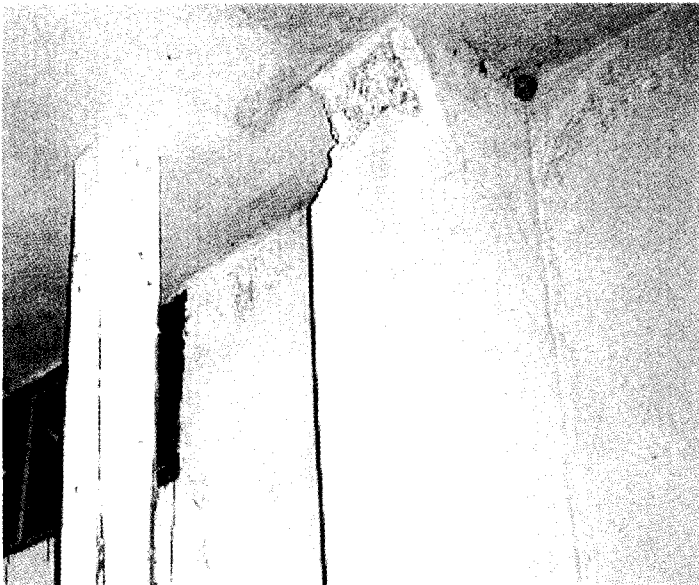
7) Big shear crack and spalling of cover concrete is observed at the top of column.

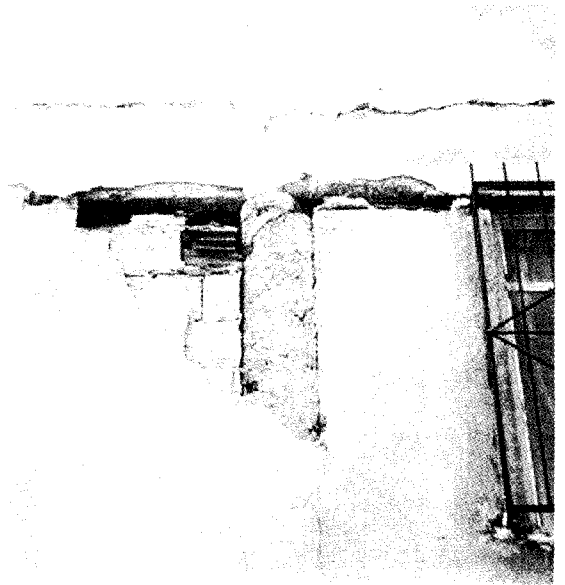
8) Big shear crack is observed at the top of the narrow face of column.

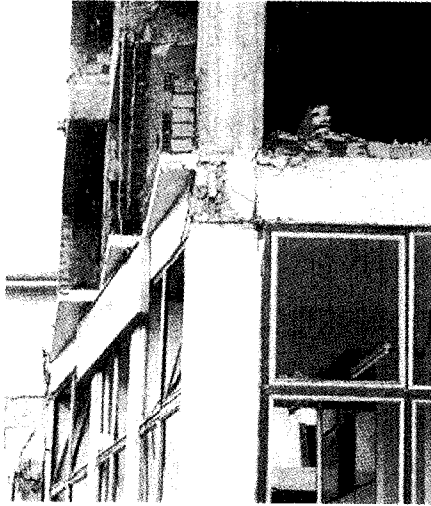
Diagonal shear cracks at the beam-column joint

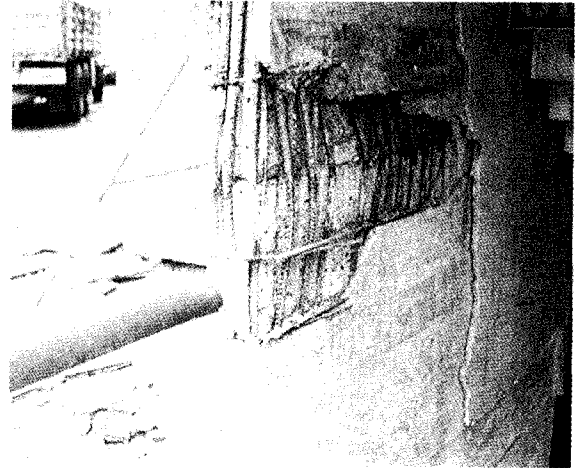
Tensile crack at the middle height of column

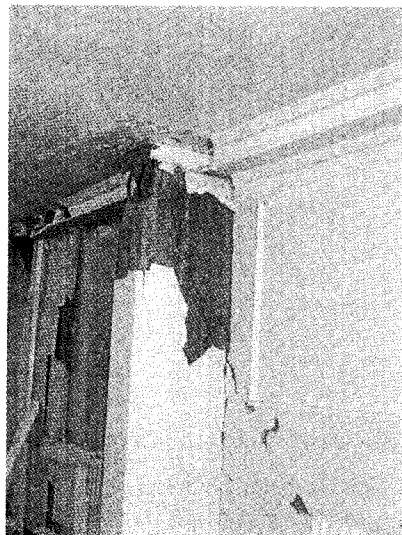
Big shear crack at the top of column

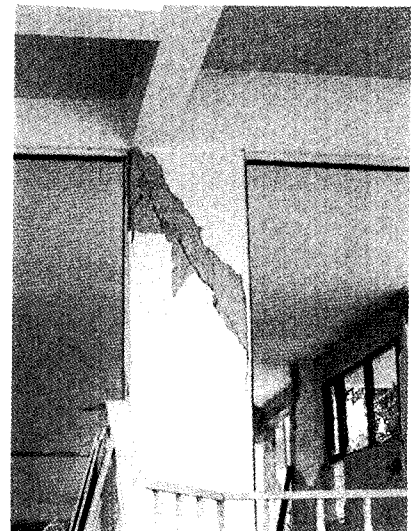
Big shear crack at the top of column

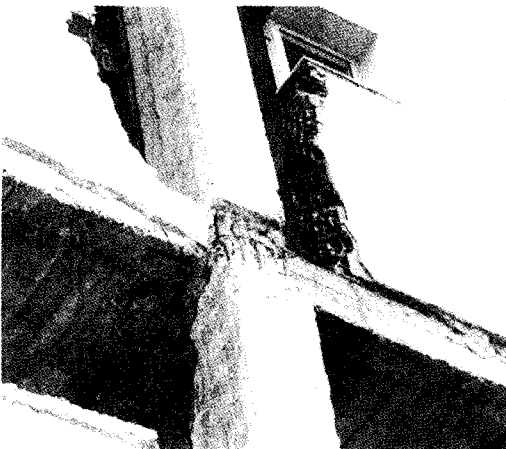
9) Heavy damage at beam-column joint

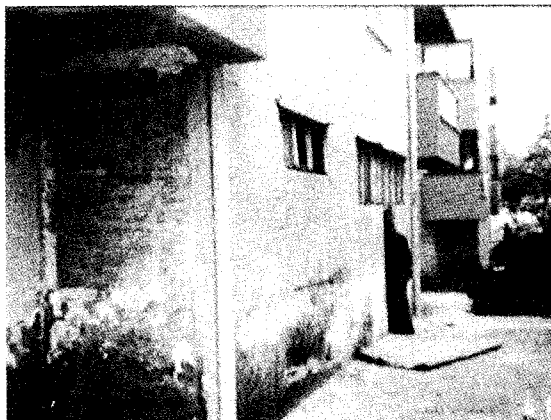
1) Rank A: Local crack and cracks at the  
boundary between wall and RC frame

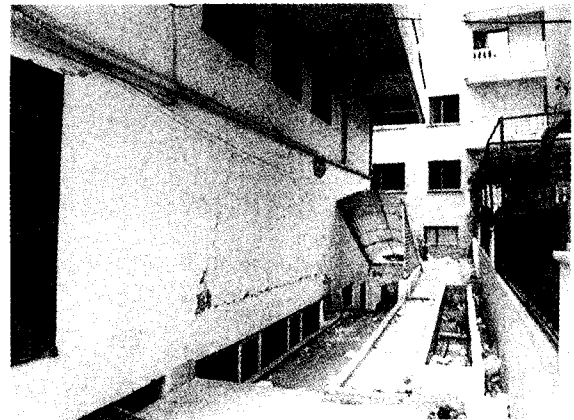
2) Rank B: Cracks observed  
but no out-of-plane deformation

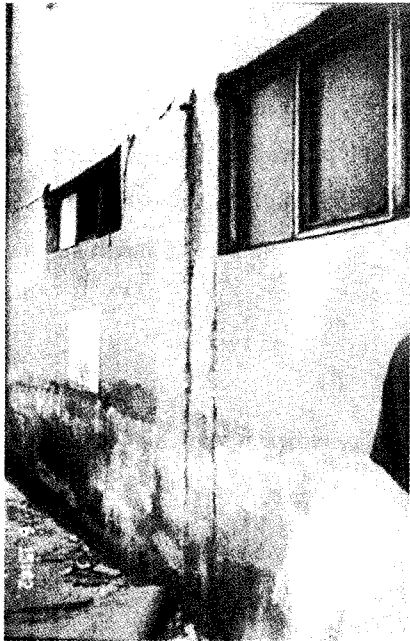
3) Rank C: Offset from RC frame

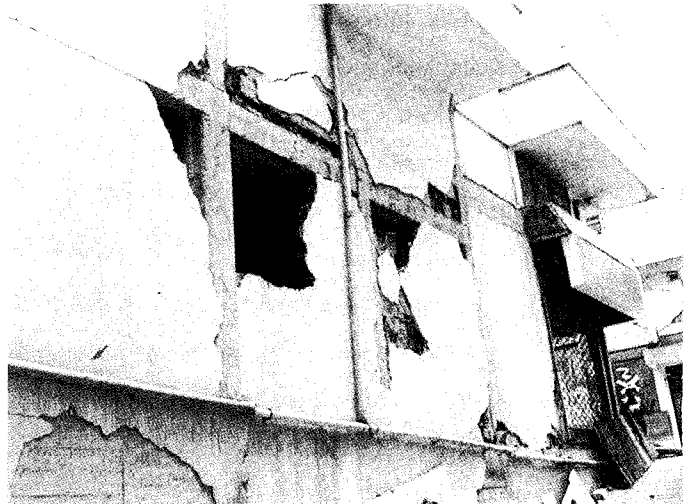
4) Rank C: Extensive cracks penetrated

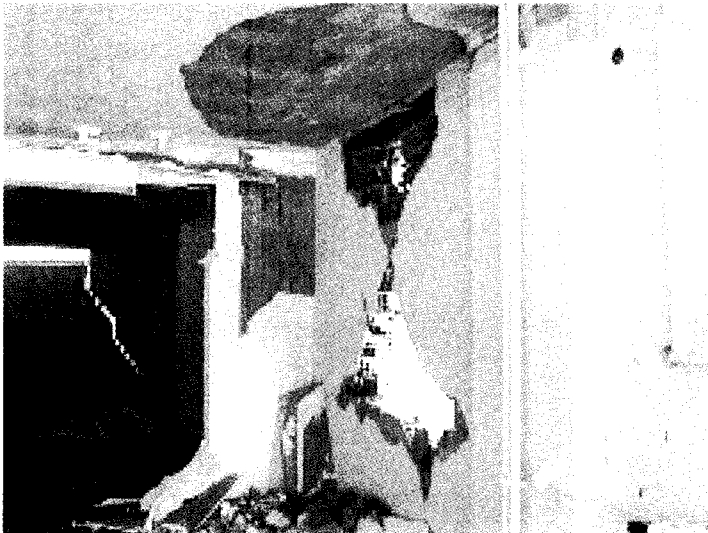
5) Rank C: Extensive diagonal cracks penetrated and  
Offset from RC frame

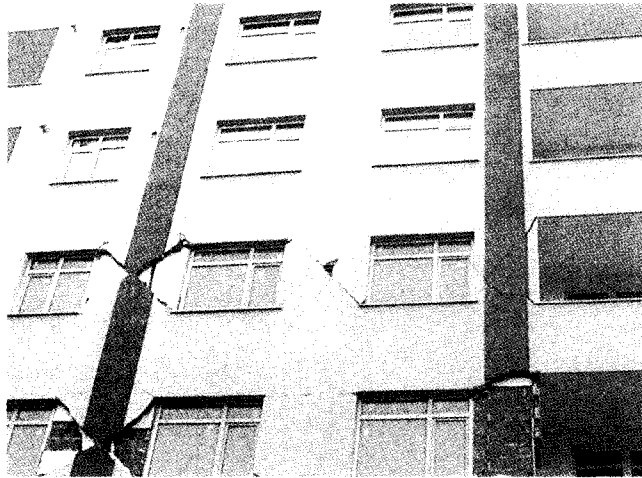
**1) Rank C: Diagonal cracks observed**

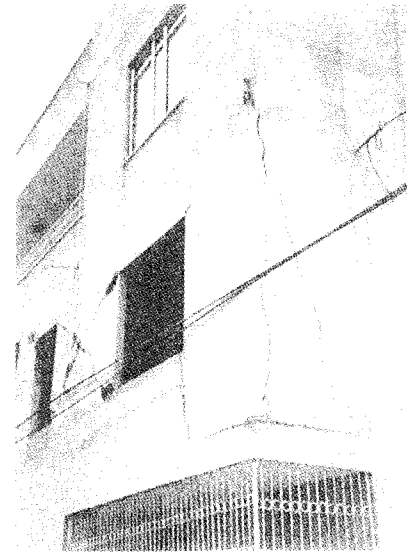
**2) Rank C: Diagonal cracks observed  
and offset from RC frame**

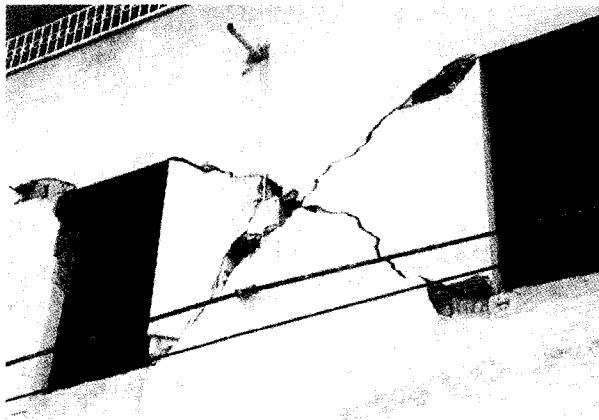
**3) Rank C: Diagonal cracks observed**

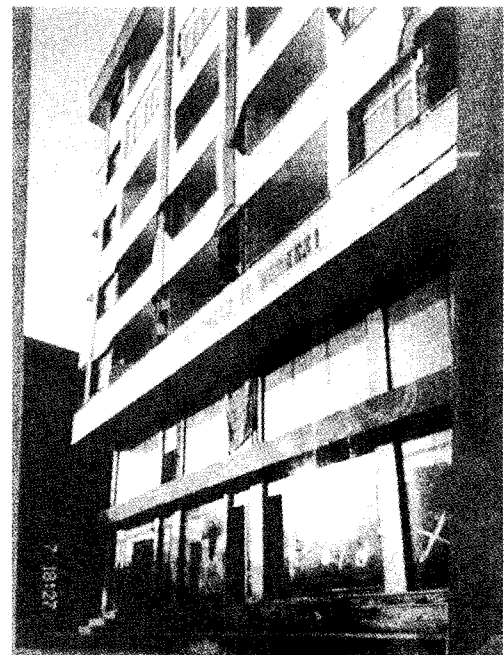
**4) Rank C: Diagonal cracks observed in  
upper stories. Keeping out is  
needed near the building.**
