# 国土技術政策総合研究所資料

TECHNICAL NOTE of  
National Institute for Land and Infrastructure Management

## QUICK INSPECTION MANUAL FOR DAMAGED REINFORCED CONCRETE BUILDINGS DUE TO EARTHQUAKES

Based on the Disaster of  
1999 Kocaeli Earthquake in Turkey

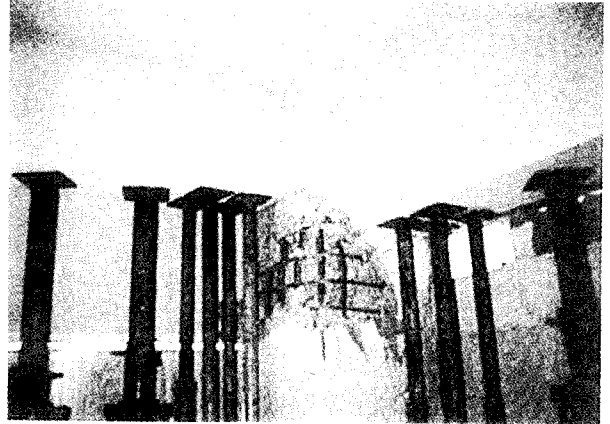
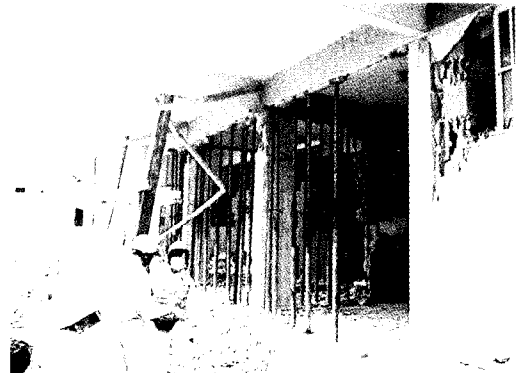
(4) Shoring with steel pipes or screw jacks around heavily damaged column

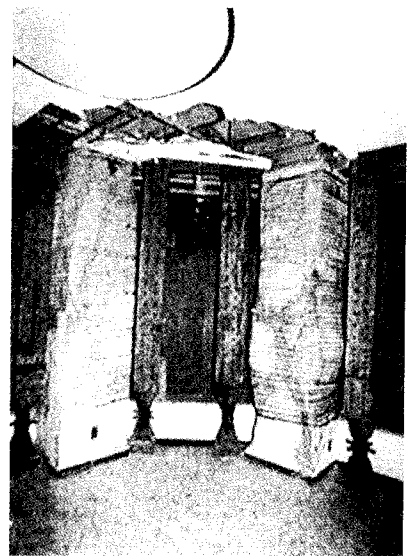
(5) Jacketing of damaged column with steel wires

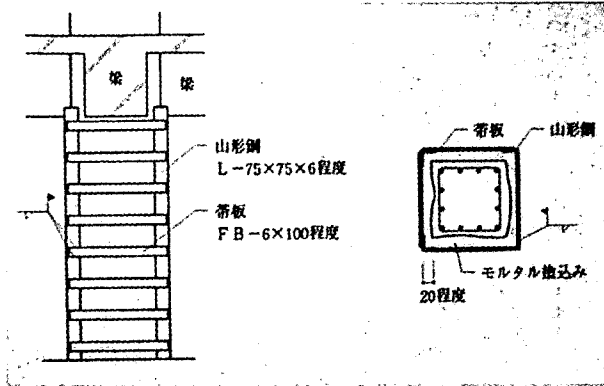
(6) Jacketing of damaged column with steel sections

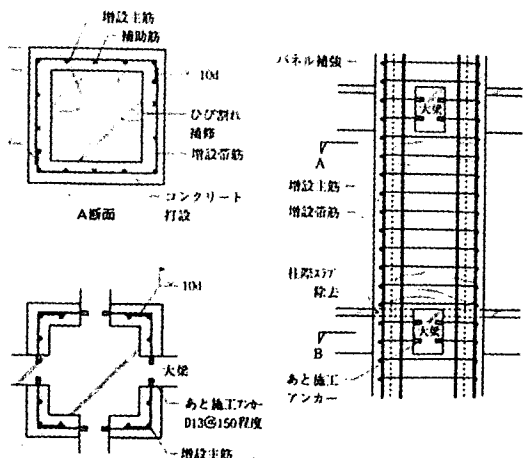
(7) Jacketing with newly cast RC section

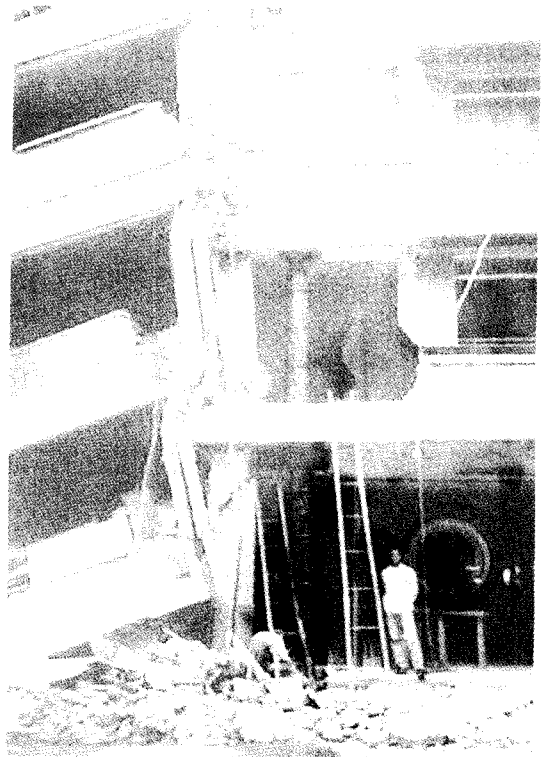
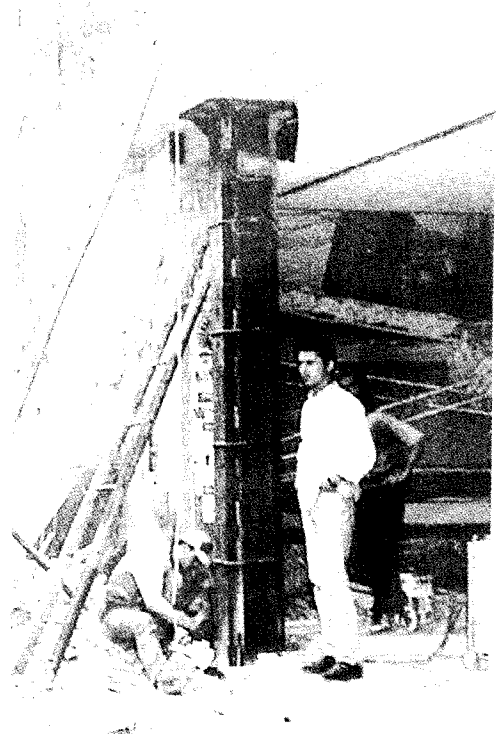
(9) Shoring with steel sections around a column damaged due to pounding  
(left: before retrofit / right: after retrofit)

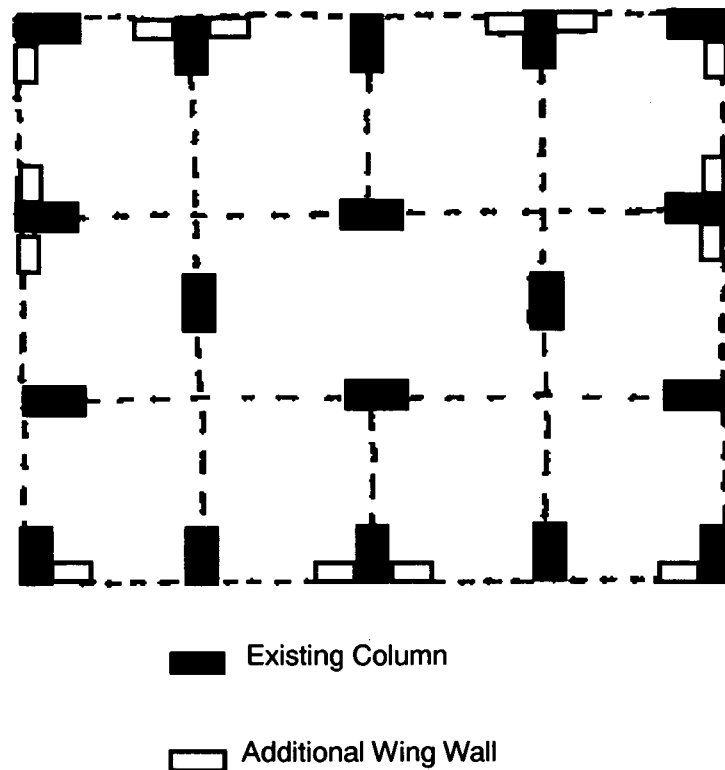
(10) Conceptual temporary retrofit design of damaged columns with wing walls

The most conventional retrofit strategy applied to existing reinforced concrete buildings, both for emergency or temporary use and long-term use, can be installation of new RC shear walls within bare frames. The scheme described above can be a primary candidate for damaged buildings.

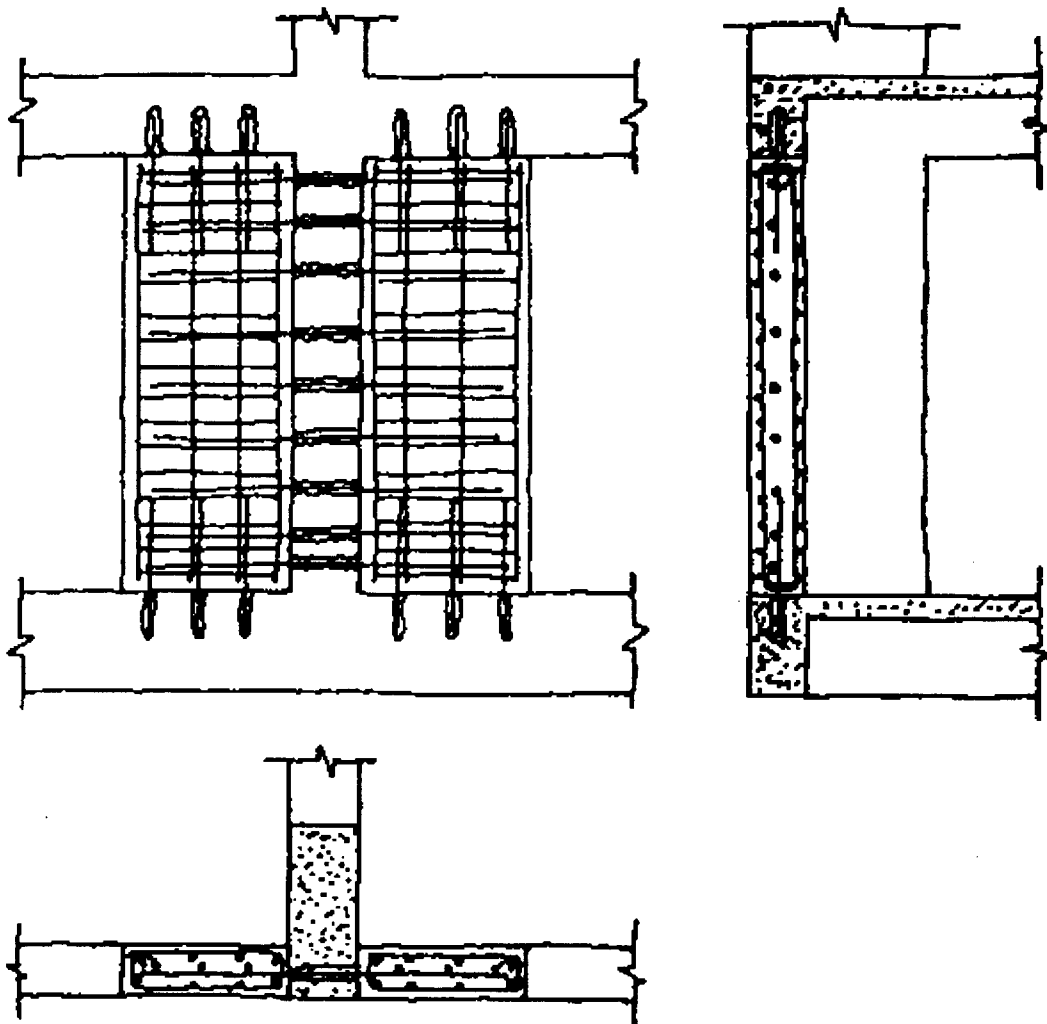
Although the detailed arrangement of reinforcement is not explicitly determined yet, it is strongly emphasized that the following general remarks should be carefully taken into account when this scheme is applied in practice.

1. Re-bars should be deformed bars. They would be placed through drilled holes in existing columns, and epoxy mortar should be injected into gaps around re-bars for smooth action transfer.
2. Longitudinal bars in wing walls should be properly confined with lateral reinforcement having 135 degree hooks. They should be jointed (lap splice joint) with anchoring bars embedded in upper and lower beams at the top and bottom of the wall. Bonded anchors (epoxy adhesive anchors) may be most preferable to connect anchoring bars with existing RC members. When honey-combs are found in existing members, repair them before installing anchors. It should be also noted that embedded length of anchors should be deeper than usual.
3. Quality of concrete for new wing walls should be carefully controlled.
