## **Measures for recovery against seismic damage to wastewater systems**

### **TANAKA Shuji**

Director, Water Quality Control Department, National Institute for Land and Infrastructure Management, Ministry of Land, Infrastructure and Transport, Asahi 1, Tsukuba, Ibaraki 305-0804, Japan. tanaka-s92ta@nilim.go.jp

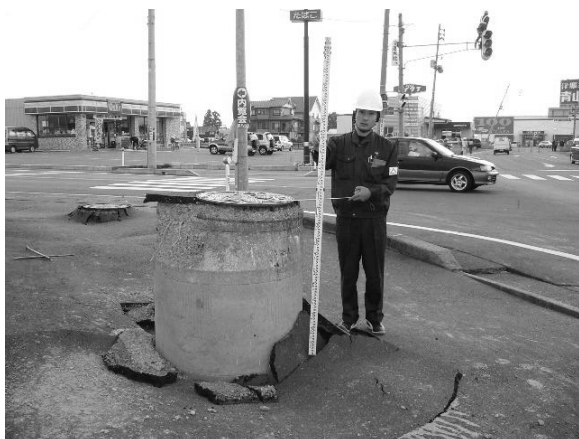
Photo1. A lift-uped manhole in Niigata-ken Chuetsu Earthquake

Damage to sewers differed greatly between the Hyogo-ken Nanbu Earthquake and the Niigata-ken Chuetsu Earthquake. The Hyogo-ken Nanbu Earthquake caused permanent strain of the ground that shifted pipelines and its earthquake motion caused cracking, but a large part of the damage by the Niigata-ken Chuetsu Earthquake was lifting up of pipes and manholes by liquefaction of backfill soil around pipelines. The lifting up of manholes blocked traffic. Damage to the sewers caused problem for draining from homes.

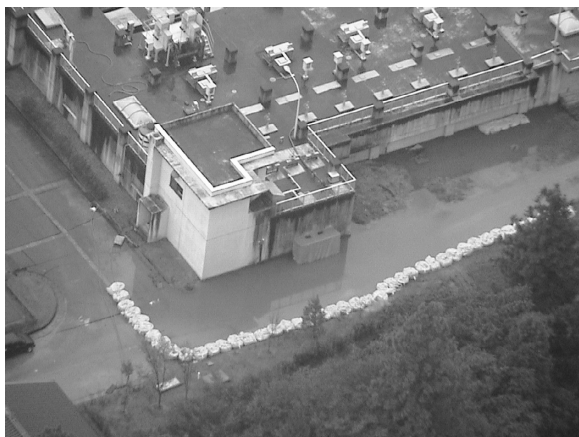
Photo2. A temporary settlement pond and a disinfection plant in Horinouchi Treatment Plant

The Niigata-ken Chuetsu Earthquake shut down the Horinouchi Treatment Plant of a river basin sewerage system in Niigata Prefecture, allowing polluted water flowing into the plant to overflow, inundating with incoming wastewater around the plant. This was caused by damage to the inlet, but the treatment systems were also severely damaged as well. As emergency measures, a temporary settlement pond and a disinfection plant were installed to prevent the discharge of untreated polluted water to nearby river.

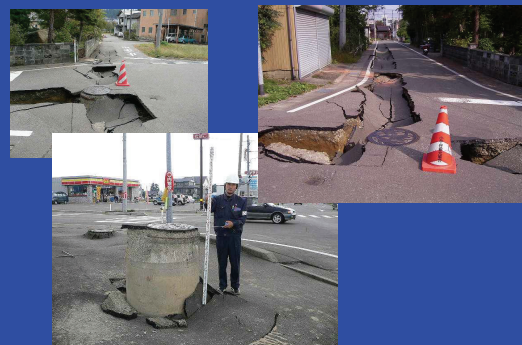
## Typical damage types in Niigata-ken Chuetu EQ

- Hyogo-ken Nanbu EQ:
  - Difficulty of finding of damages in sewers
  - Cracks caused by shaking of manholes and permanent strains of grounds
  - Relatively small damage-ratio: Ave. 1.7%, Max. 9.7%
- Niigata-ken Chuetu EQ:
  - Surfaced up of manholes and lifted up of sewers
  - Sinking of ground surfaces six months later
  - High damage-ratio: Ave. 4.6%, Max. 21.7%
