「日本の砂防事業について」

## SABO Administration in JAPAN

**Dr. Noriyuki MINAMI**

Director-General, Sabo Department,  
Ministry of Land, Infrastructure, Transport and Tourism, JAPAN

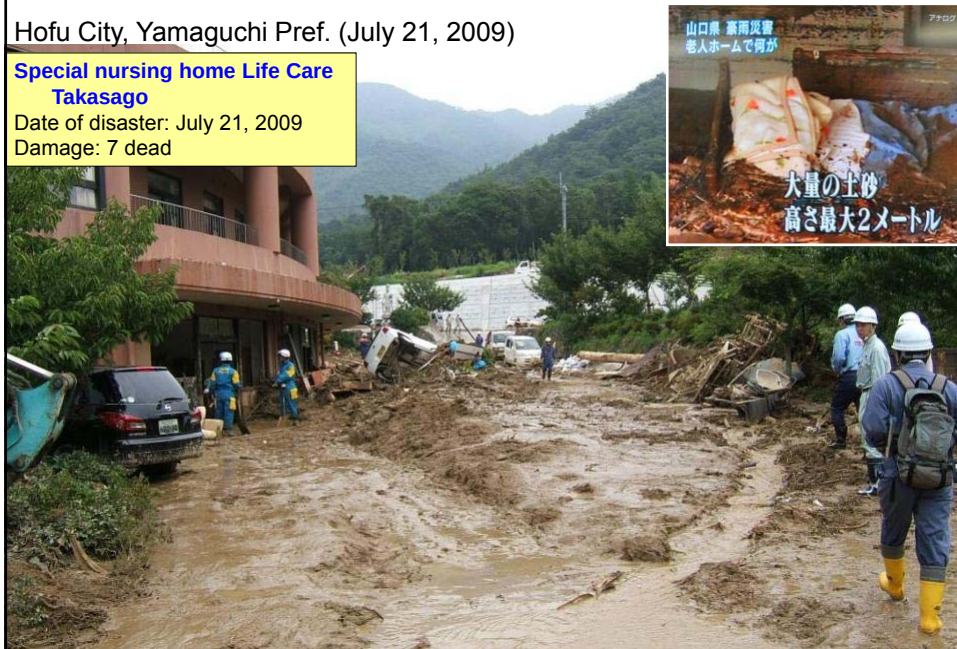
## Disasters at Facilities for Persons Requiring Assistance During Disasters

Hofu City, Yamaguchi Pref. (July 21, 2009)

**Special nursing home Life Care  
Takasago**

Date of disaster: July 21, 2009

Damage: 7 dead

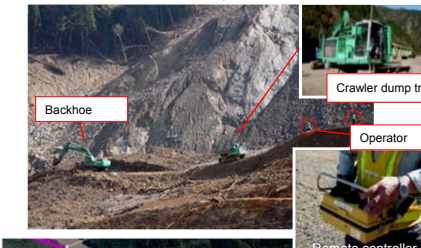
**Akatani** Constructing a bank    • Length : 200m  
 • Period : Nov. 17~Nov. 18, Nov. 28~Dec. 3  
 • Machines : Backhoe (1.6m<sup>3</sup> class)  
 Crawler dump truck (10t class)

Backhoe    Crawler dump truck    Operator    Remote controller

Access road    Bank    Drainage hose    Drainage pump    Front apron    Tentative drainage channel    Unmanned construction work

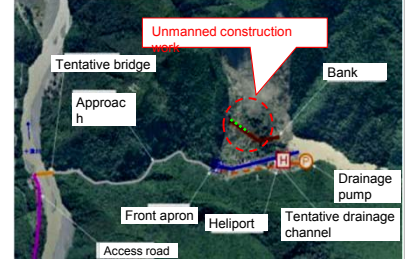
**Nagatono** Constructing a bank    • Length : 75m  
 • Period : 11/16~11/18  
 • Machine : Dismantled type backhoe (1.0m<sup>3</sup>Class)

Excavating at the dangerous steep slope    Air transport    Remote control    Antenna for operating    Antenna for camera    Camera Monitor    Power supply(generator)

Tentative bridge    Bank    Drainage pump    Front apron    Heliport    Tentative drainage channel    Access road    Unmanned construction work

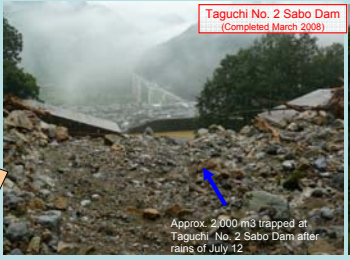
Example of effective facility: Kuma River , Kawabe River Water System (Taguchi No. 2 Sabo Dam, Taguchi Sabo Dam)

**Dates of disasters:** July 12, 2012 [max. hourly rainfall 68 mm (12 July, 11:00), continuous rainfall 322 mm (12 July, 01:00–13 July, 14:00)]  
 June 24, 2012 [max. hourly rainfall 31 mm (24 June, 09:00), continuous rainfall 274 mm (23 June, 08:00–24 June, 21:00)]  
**Disaster location:** Itsuki Village, Kumamoto Pref.  
**Damage:** Debris flow occurred because of a rain season rain front, but sabo dams had been provided and trapped the debris (approx. 7,600 m<sup>3</sup>).  
 Damage to the area downstream was prevented.

Taguchi No. 2 Sabo Dam (Completed March 2008)  
 Approx. 2,000 m<sup>3</sup> trapped at Taguchi No. 2 Sabo Dam after rains of July 12

Taguchi Sabo Dam (Completed May 2002)  
 Approx. 5,100 m<sup>3</sup> trapped at Taguchi Sabo Dam after rains of July 12

2 dams trapped debris and prevented debris flow disaster
