3.6 「日本における豪雨に起因する土砂災害」

Sediment-related Disasters induced by Heavy Rainfall in Japan

November 30, 2012

Head of Sabo Division,
Research Center for Disaster Management,
National Institute for Land and Infrastructure Management, MLIT

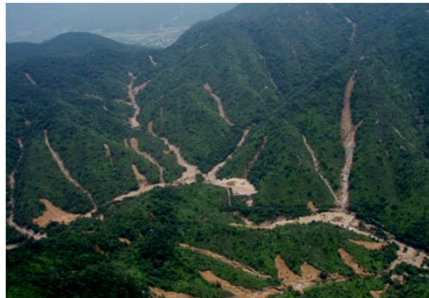
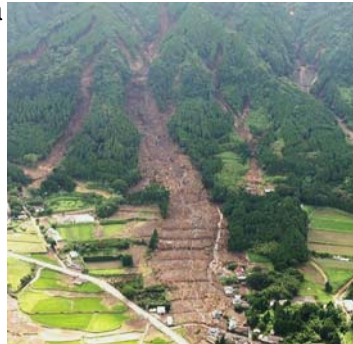
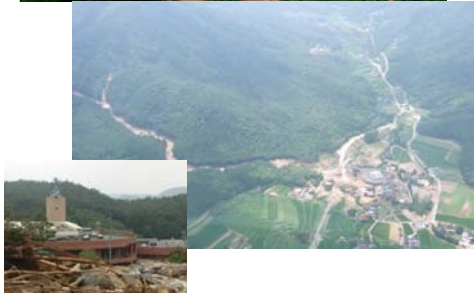
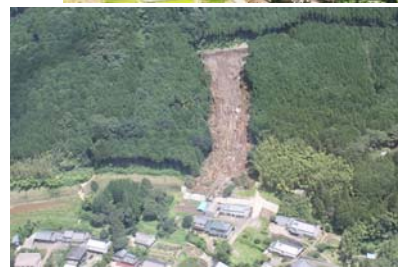
Example of debris flow and slope failures due to torrential rainfall in Japan

Yamaguchi Prefecture / July 21, 2009

Kumamoto Prefecture / July 12, 2012

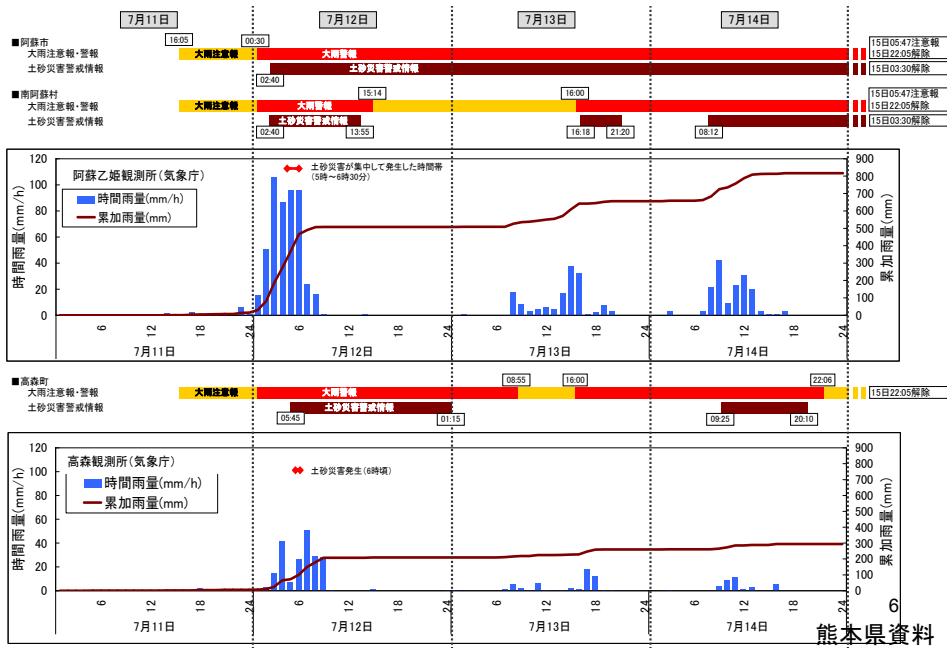
Time Table of Rainfall and Early Warning Information

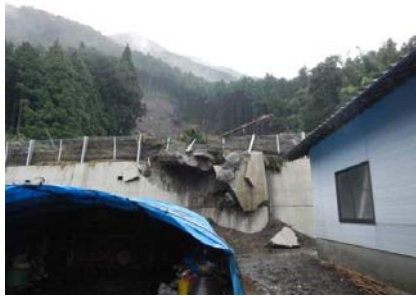
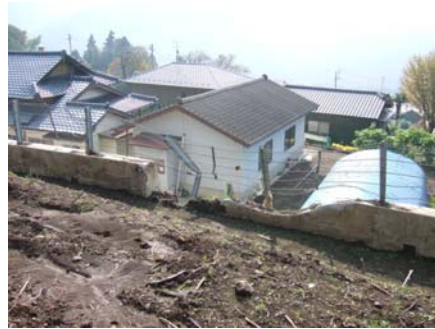
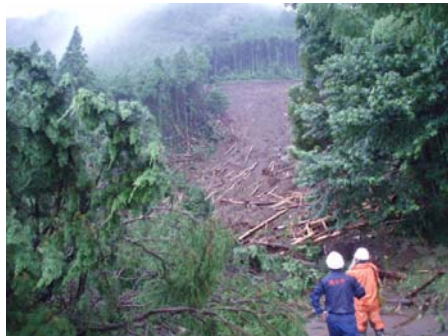
Slope Failure at Sinsyo District, Minami-aso Village

- Slope Failure Size (approx.); width 40m, length 150m, height 60m, depth 1m
- Collapsed sediment deposited behind the retaining wall, thus preventing house damage.
- Retaining wall and stone-guard were partially broken.

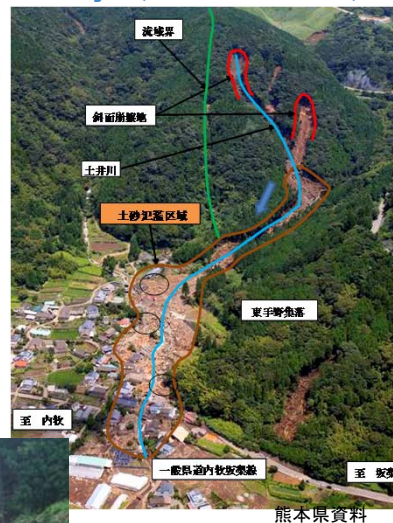
Doi River in Ichinomiya Town, Aso City (Ca:0.35km²)

- 14 houses were totally or partially destroyed by the debris flow.

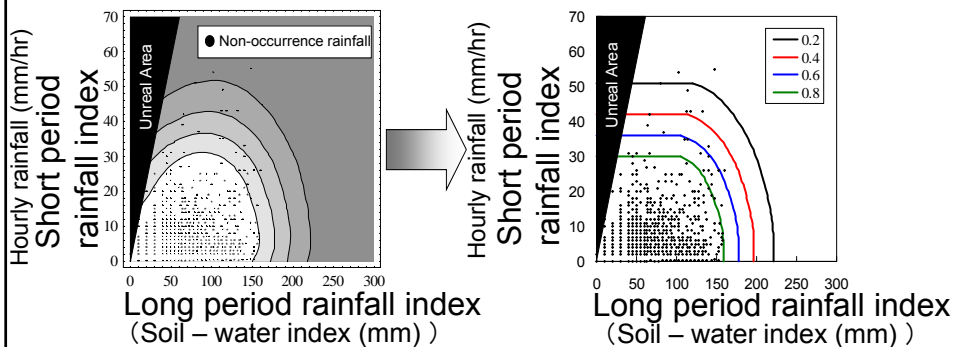
Study of a new CL setting method

From the response curved surface set based on non-occurrence rainfall, an optional same probability value line is abstracted (slightly corrected to prevent contradiction with phenomenon)

An same probability value line judged to be suitable according to its relationships with the false alarm rate, frequency warnings are issued, and rainfall warnings is set.

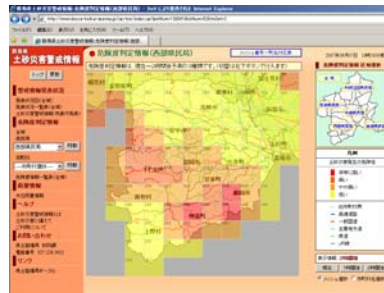
Procedure for Issuing Sediment Disaster Warning Information

Detailed Information of rainfall forecast and the warning level of the 5 × 5km mesh

Information of rainfall forecast and the name of region (city, town or village) which exceeds the warning level

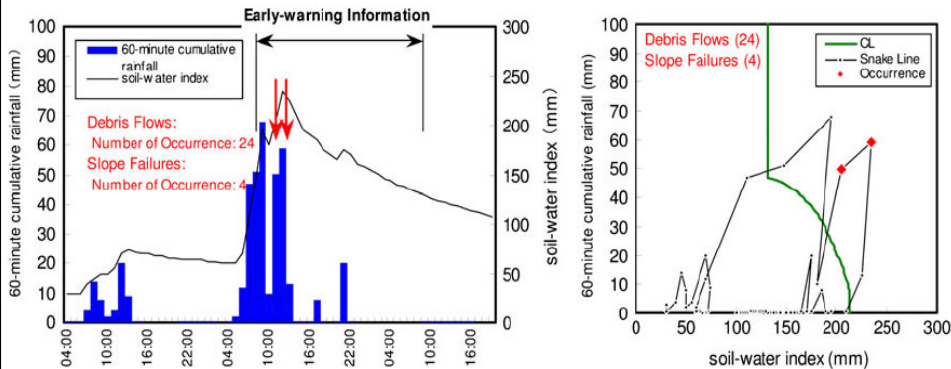
Example of snake line progress using RBFN

- On 21st July 2009, 65 debris flows and 105 slope failures occurred in Yamaguchi Prefecture.
- 14 people died as a result of these mass movements.
- The time series of 60-min rainfalls and soil-water index, the timings of occurrence of debris flows and slope failures, and the period of early-warning information issue are shown in the left figure.
- The progress of the snake line and the timing of the disasters (red box) in the damaged area are shown in the right figure.

→CL adequately captured the timing of these disasters occurrences
