Disaster prevention, mitigation, and risk management of road structures

1. Outline of Studies and Activities

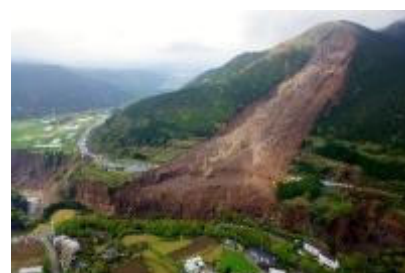
Photo 1: Damage from the Kumamoto earthquake

such as bridges, earthworks, and tunnels, the Bridge and Structures Division, the Foundation, Tunnel, and Substructures Division, the Pavement and Earth Structures Division, and the Earthquake Disaster Prevention Division. The Earthquake Disaster Management Division is conducting research from the viewpoint of seismic motion. In addition, as a new initiative, the Kumamoto Earthquake Recovery Division (Research Center for Infrastructure Management) was established in April 2017 to accelerate recovery and reconstruction projects from the damage caused by the 2016 Kumamoto earthquake (Photo 1). Infrastructure Management was established in April 2017 to accelerate recovery and reconstruction projects from the damage caused by the Kumamoto earthquake (Photo 1) in 2016.

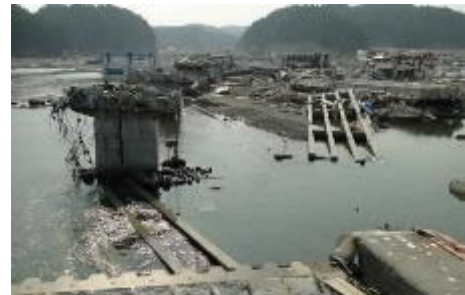
Photo 2: Damage to bridges damaged by the tsunami (Tohoku Earthquake out at Pacific Ocean)

In the Tohoku-Pacific Ocean earthquake, damage to bridges caused by seismic motion was limited as described above, but the tsunami caused such damage as bridge washouts (Photo 2). In light of this, the 2012 revision of the JSHB stipulates that structural planning for bridges must take into account local disaster prevention plans and other factors related to tsunamis.

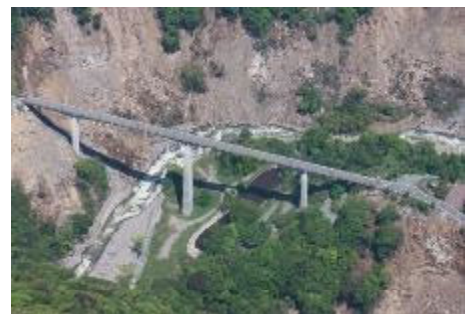
Photo 3: Damage to a bridge that sustained ground deformation (Kumamoto Earthquake)

The Kumamoto earthquake caused damage to bridges due to ground deformation, such as fault displacement and slope collapse (Photo 3). In addition, the superstructure supported by rocking piers suffered damage that resulted in the bridge falling (Photo 4). Based on the experience of these damages, the 2017 revision of the JSHB stipulates that the standard is to select bridge locations or bridge types that are not affected by large-scale ground deformation. It was also stipulated that the substructure must be stable and support the superstructure. In addition, although seismic motion exceeding the design spectrum was observed in some of the period bands of the Kumamoto earthquake, it was evaluated to be at the same level as the design spectrum established based on the seismic motion of the Hyogo-ken Nanbu Earthquake, and based on various engineering judgments, the characteristic values of Level 2 seismic motion considered in the previous specifications are to be retained.

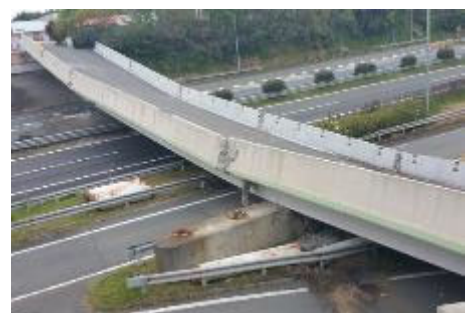
Photo 4: Damage to bridge with locking piers (Kumamoto Earthquake)

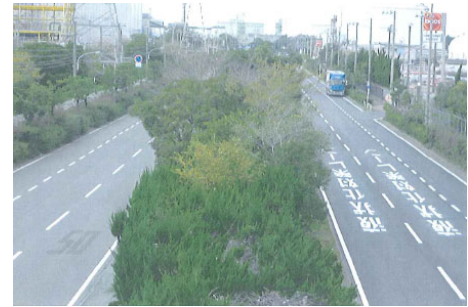
Photo 6: Liquefaction Countermeasure Pavement (Takaishi City, Osaka Prefecture)

In the Tohoku Pacific offshore earthquake, liquefaction damage was also observed in the Kanto region. The NILIM collected liquefaction damage cases in various regions, organized and analyzed the relationship between various conditions, such as road structure, buried objects under the road, and ground conditions, and the damage situation. Based on the results, pavements with liquefaction countermeasures were constructed by local governments (Photo 6).

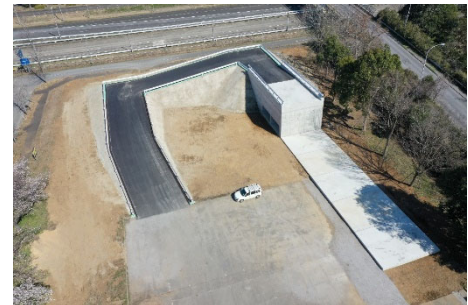
Photo 7: Experimental facility for road base structure

In 2020, a road base structure experiment facility was constructed on the premises of the NILIM in order to reproduce ground deformations that may cause road bumps and sinking and to verify the passability of roads when deformations occur (Photo 7). This facility is designed to reproduce ground deformation during earthquakes by installing jacks on the experimental slab, constructing an embankment and pavement on top of the jacks, and inducing

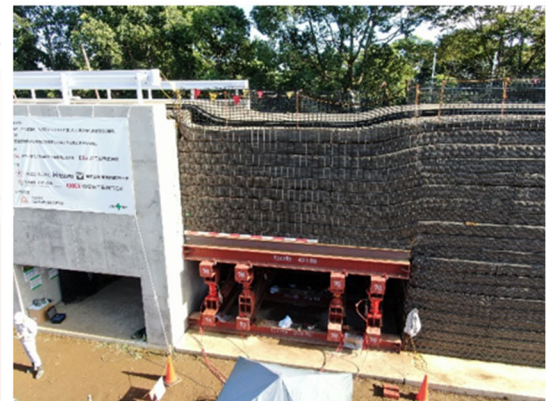
Figure 3: Test to confirm resistance of pavement structure with geogrid to deformation caused by ground deformation

forced displacement of the embankment by the ups and downs of the jacks. In the same year, we conducted a confirmation test of the resistance of the pavement structure with geogrid inside to deformation caused by ground deformation (Figure 3).

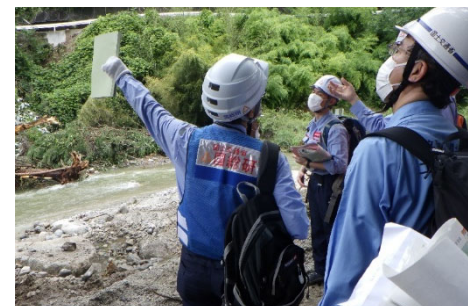
Photo 8: Local assistance for damaged roads

In addition to the above, NILIM has also visited disaster-stricken sites of earthwork structures to accumulate knowledge and provide technical support. In recent years, NILIM has provided technical support to local governments on restoration policies for slope collapse in the Kumamoto earthquake and landslide and river flooding in the East Japan typhoon of 2019. Most recently, we conducted on-site surveys and provided advice on restoration methods after a landslide occurred on national and prefectural roads managed by Nagano Prefecture during the torrential rains in July 2020 (Photo 8).

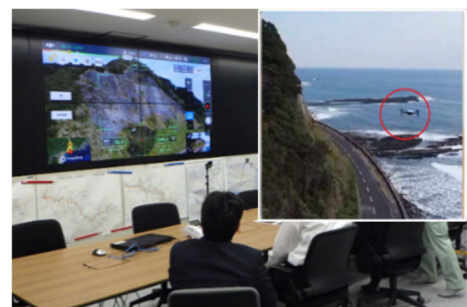
Photo 9: Experiment of information acquisition by an auto-navigating UAV

In the future, we will study the possibility of utilizing information collection by automatic navigation UAVs and satellites (Photo 9) and
