Establishment of emergency response methods in the event of a large-scale landslide disaster such as a river channel blockage

1. Outline of Research and Activities

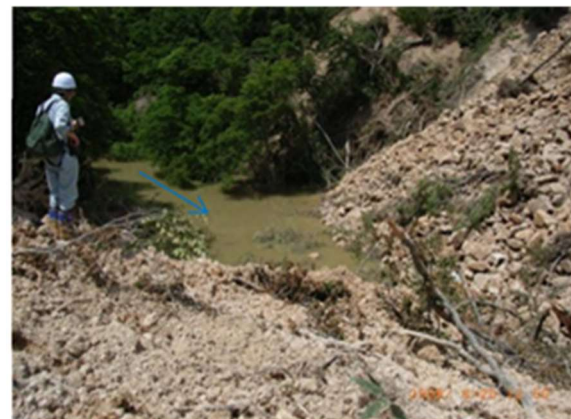
Figure-2 Field survey of river channel blockage (natural dam) by the Landslide Research Department (Iwate-Miyagi Nairiku Earthquake in 2008)

Field survey of collapsed sediment accumulation and upstream waterlogging at a natural dam that formed a channel blockage

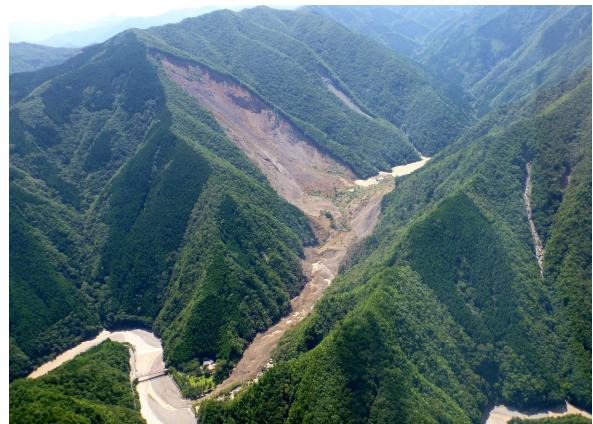
Figure-3 River channel blockage (natural dam) caused by heavy rainfall from Typhoon No. 12 in 2011 (Kumano River Basin, Gojo City Akaya, photographed by the Sediment Control Research Group, PWRI on September 6, 2011)

The guidelines and programs prepared by the Sabo Department of NILIM, and others were actually utilized when the government conducted an emergency survey based on the Landslide Disaster Prevention Act for the first time in Japan, targeting five large-scale river channel blockages in Akadani (Figure-3) and other areas after Typhoon No. 12 in September 2011 caused deep channel failures in the Kii Peninsula. In this disaster, the Sabo Department of NILIM and the PWRI Sediment Management Research Group dispatched a number of researchers to provide technical support for the Kinki Regional Development Bureau’s response (Figure-4).

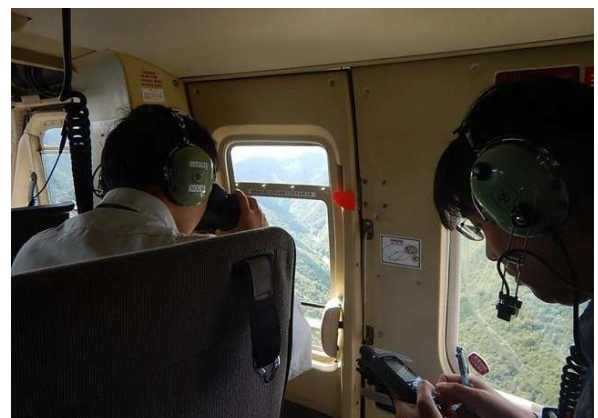
Figure-5 Training support program for local development bureau staff members engaged in advanced landslide countermeasures

past disaster responses (Figure-5). Under this program, staff members at the rank of section chief of the Regional Development Bureau are concurrently assigned to the Sediment Hazard Research Department of NILIM and PWRI from April to December to disseminate knowledge obtained by the Sabo Department of NILIM and the PWRI Sediment Management Research Group on how to respond to sediment-related disasters such as river channel blockages. By FY2020, a total of 65 people had participated in the program.
