Efforts for Technical Development of Base Building for Post-disaster Operation (Research and Development Project)

1. Damage to government buildings and others by recent natural disasters

2. Development of base building for post-disaster operation

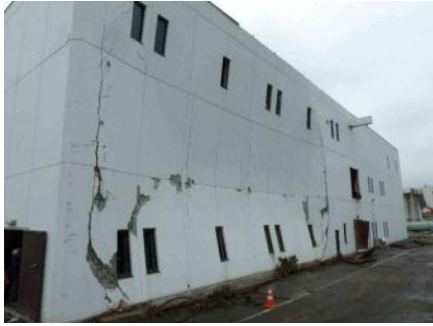
Photo 1 Damages on building by tsunami

In the Great East Japan Earthquake, (1) structural damages by tsunami (photo 1) and (2) functional loss from damage of nonstructural members (nonstructural walls, ceiling and others) (photo 2) occurred and the damage was observed also in the government buildings which should have been base buildings for post-disaster operation. A tornado in Tsukuba City in May 2012 caused flying debris leading to massive damage to the windows and doors of a reinforced concrete building. This kind of damage may lead to the functional loss of base buildings.

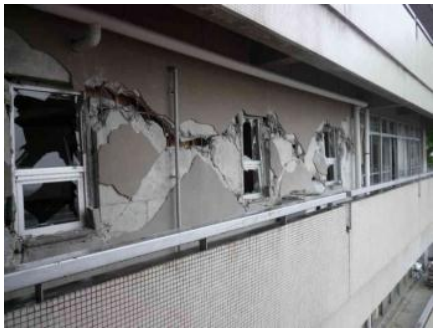
Photo 2 Damages on non-structural wall by earthquake
