Feature Article

Response to the Noto Peninsula Earthquake - Activities Related to Road Structures -

Road Structures Department

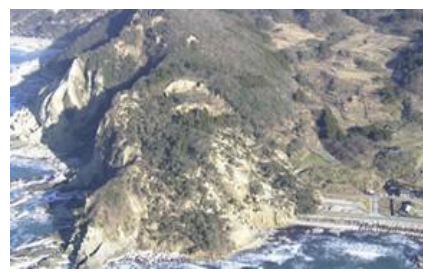
Photo-1 Investigation by flying overhead over the areas where large-scale slope failures occurred

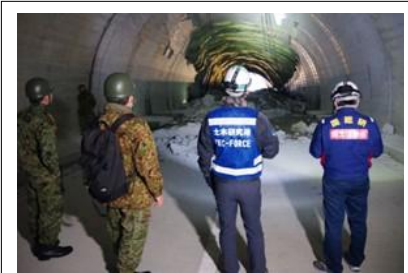
Photo-2 Investigation of the tunnel where the large-scale liner spalling occurred

In cooperation with the Hokuriku Regional Development Bureau, the Public Works Research Institute, etc., the statuses of damage in a wide range were grasped through investigation, etc. by means of a helicopter flying overhead, and at the same time advice was provided to the road administrator, concerning technical evaluation of various types of structures that suffered large-scale damage, such as the Otani Tunnel where the tunnel liner spalling occurred, and risks of secondary disasters.

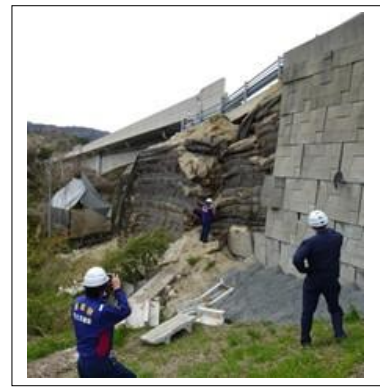
Photo-3 Investigation of mechanisms of disaster damage in the connecting section on the abutment back face

On the other hand, mechanisms of disaster damage were analyzed concerning characteristic damage to various types of structures such as that in the connecting section on the abutment back face, and new problems related to a review of the technical standards, etc. were grasped.
