TECHNICAL NOTE of
National Institute for Land and Infrastructure Management

No.1110

Guideline for the interpretation of sediment-related disasters by synthetic aperture radar (SAR) images

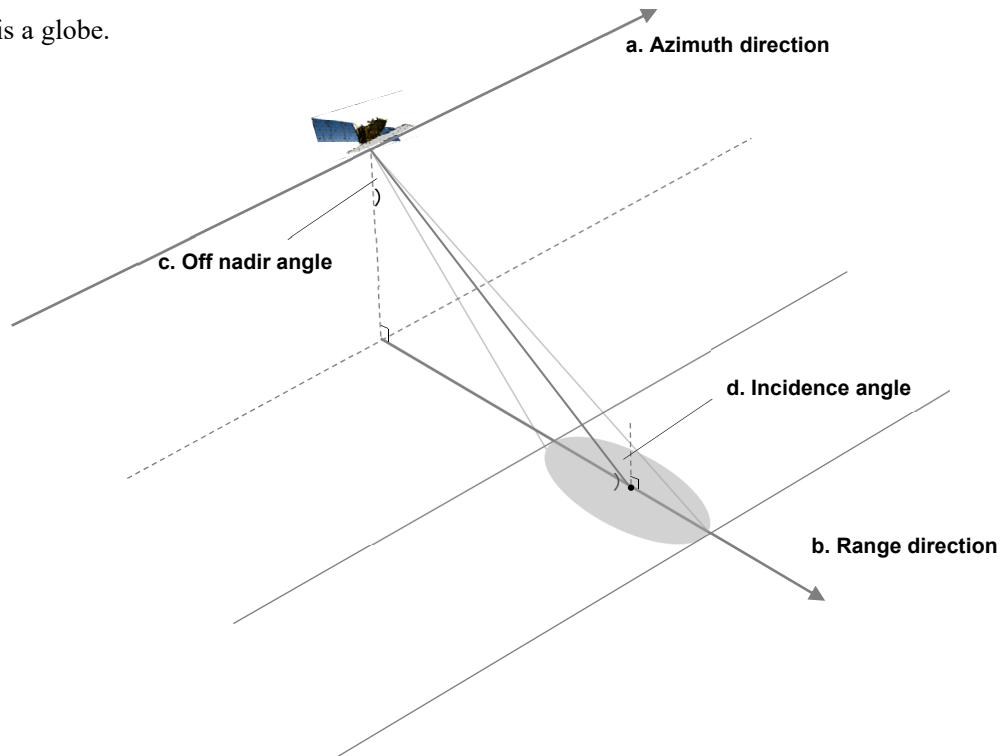
The angle formed by the vertically downward direction of the satellite and the direction of microwave irradiation of the satellite is called the "off nadir angle," and the angle formed by the direction of microwave irradiation of the satellite when viewed from the direction of the apex of the target is the "incidence angle" (Fig.-1.1.1). Many satellites make the off nadir angle during observation variable, and on a inclined land, as shown in Fig.-1.1.2, the angle formed by the normal to the slope and the direction of microwave irradiation is called the "local incidence angle." Note that the relationship of "Off nadir angle < Incidence angle" holds even on a flat land because the Earth is a globe.

Fig.-1.1.1 Terms and a schematic diagram related to SAR observation

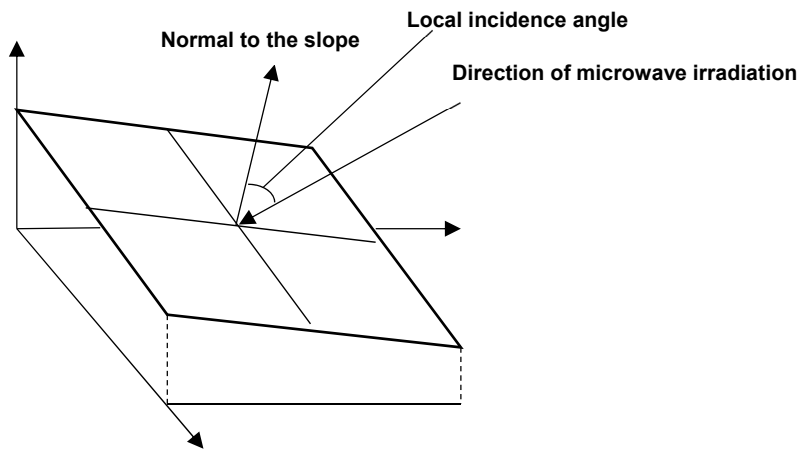
Fig.-1.1.2 Local incidence angle

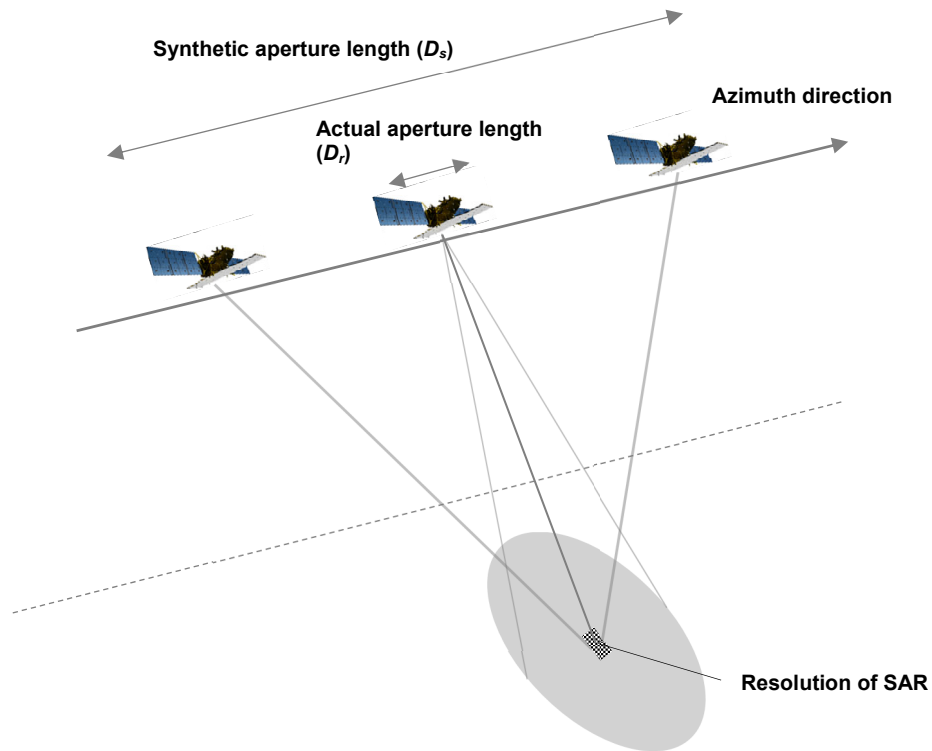
Fig.-1.1.3 Principles of the synthetic aperture technique

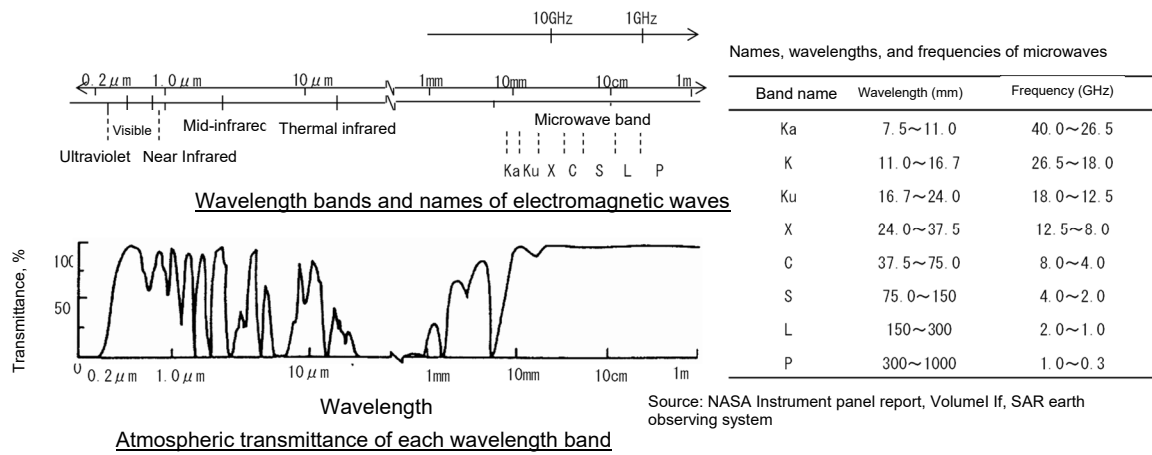
Thus, SAR has an advantage of "all weather capability," thereby providing the merits of performing observation without depending on the time zone or meteorological condition.

Fig.-1.1.4 Relationships between microwaves and atmosphere/cloud/rain

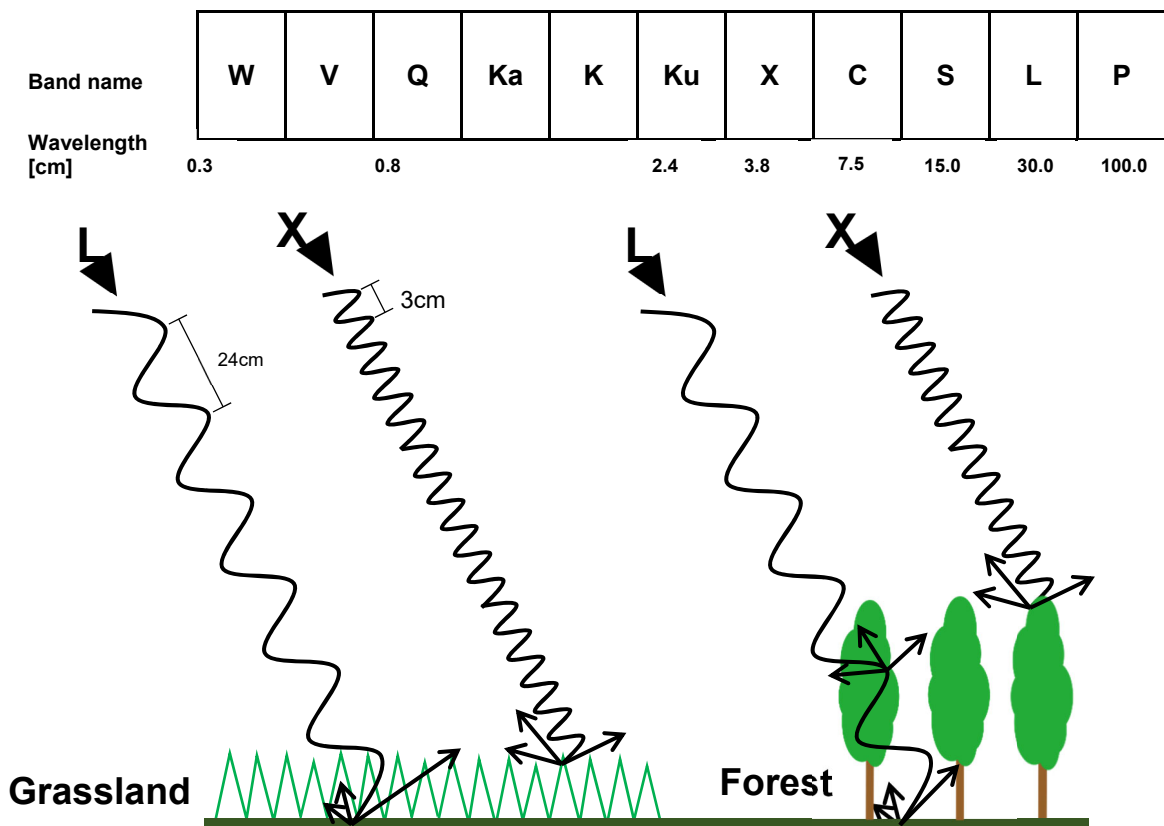
Microwaves with a relatively short wavelength such as those of the X band are scattered on a grassland, tree canopy, or on the surface of a leaf of a tree. On the other hand, if the wavelength is great such as that of the L band, the microwaves are transmitted through the grass land or tree canopy, and are scattered on the tree trunk or ground surface. Differences in the scattering characteristics depending on the wavelength will be described in "Part 1, 1.4 Scattering characteristics."

Fig.-1.1.5 Band names as well as classification and features of wavelengths

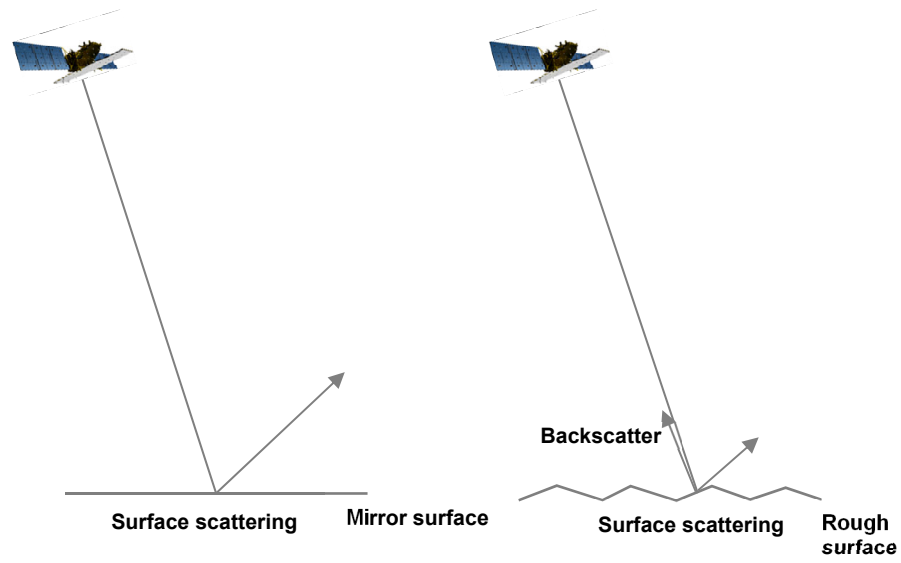
The scattering of microwaves irradiated from SAR on the border surface such as the ground surface is called "surface scattering." Surface scattering is affected by the roughness on the border surface. There are characteristics such that, when the microwaves are irradiated to a smooth surface, scattering toward the side opposite to the direction of irradiation (forward scatter) increases, and when irradiated to a rough border surface, scattering toward the side of the direction of irradiation (backscatter) increases (Fig.-1.1.6).

Fig.-1.1.6 Schematic diagram of surface scattering

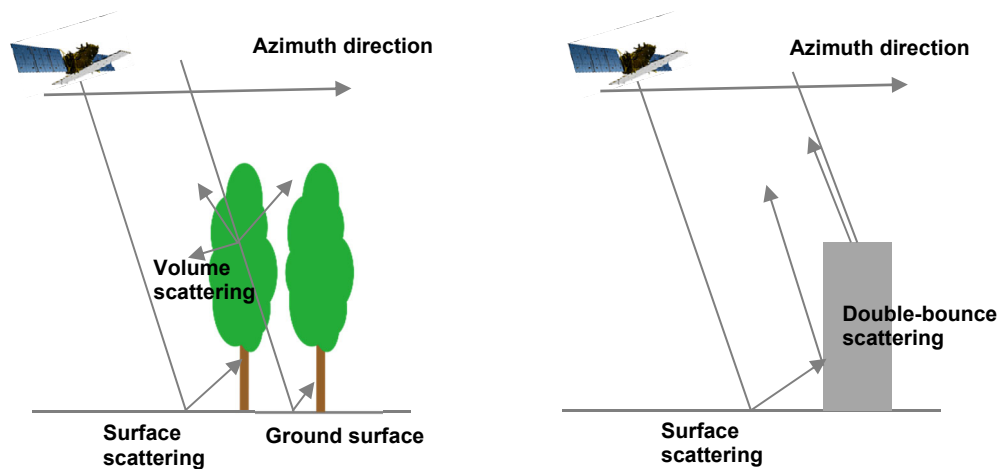
As shown in Fig.-1.1.7 on the right, there is a phenomenon called "double-bounce scattering" in which backscatter increases as a result of recurrence of scattering after surface scattering has occurred. It may occur strongly in cases such as those where the direction of microwave irradiation comes face-to-face with a building, structure, etc.

Fig.-1.1.7 Schematic diagrams of volume scattering and double-bounce scattering

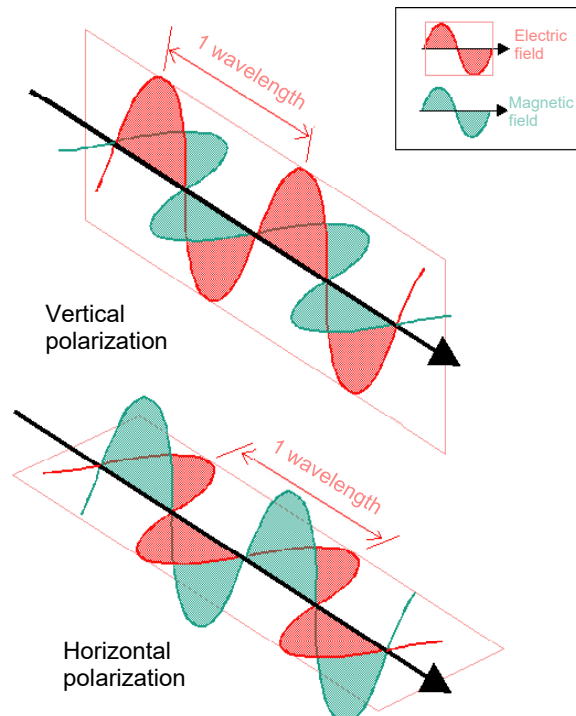
The characteristics are such that, when horizontal polarization (H) has been irradiated to a target having a cubic structure like a forest, part of it rotates and is reflected as vertical polarization (V), and in the case of vertical polarization (V) having being irradiated as well, part of it is reflected as horizontal polarization (H). HH and VV are called "like-polarization," and these polarization characteristics reduce backscatter of the observation target whose volume scattering is dominant such as a forest. On the other hand, HV and VH are called cross-polarization, which increases backscatter of a forest, etc.

Fig.-1.1.8 Schematic diagrams of horizontal polarization and vertical polarization

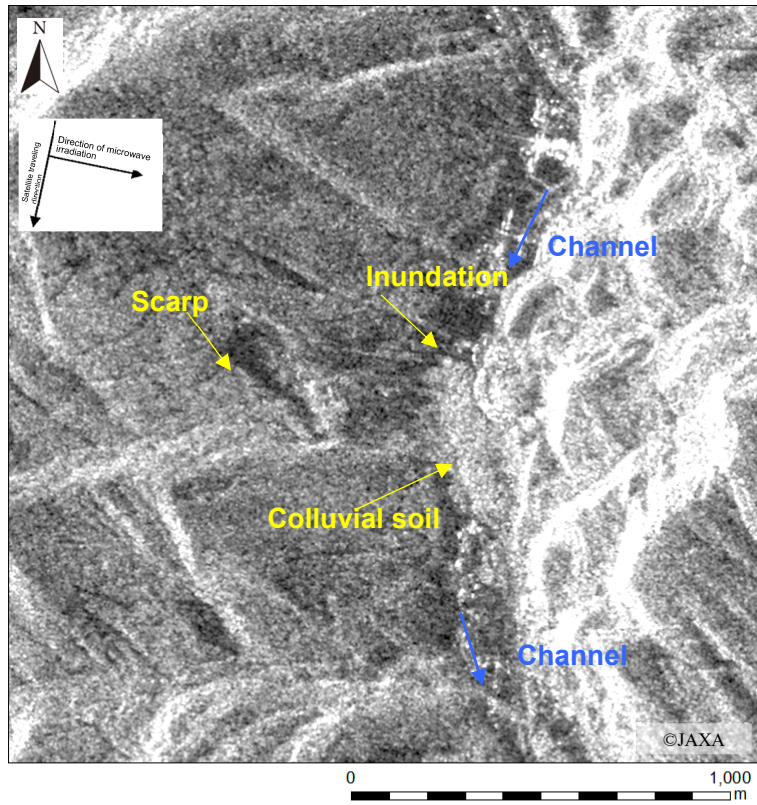
Fig.-1.2.1 Example of a single-polarized SAR image (Hita City, Oita Prefecture)

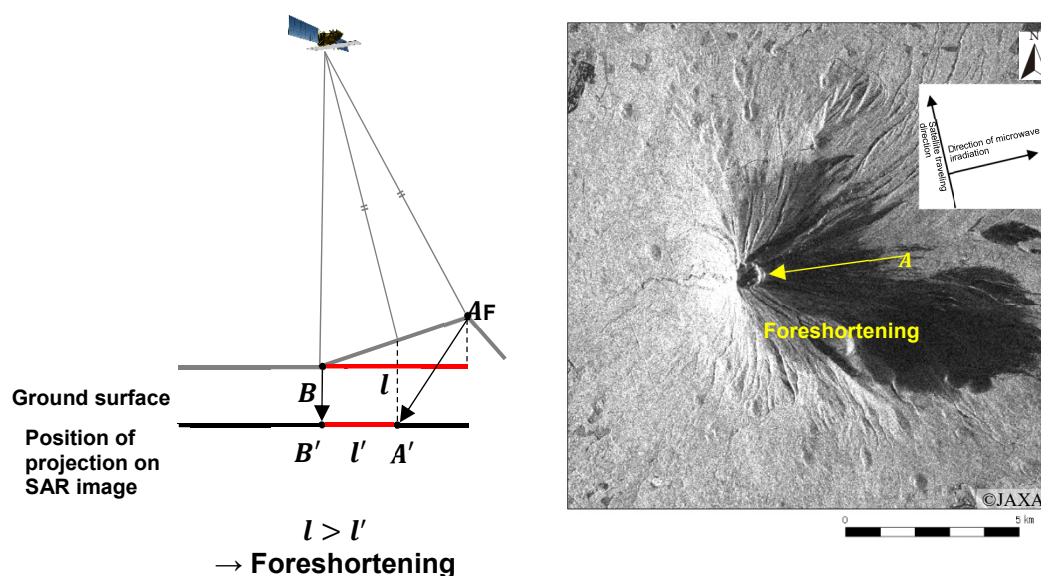
When an explanation is given by taking Mt. Fuji shown in Fig.-1.2.3 as an example, Point A that shows the mountain top of a mounting having a high altitude is projected as though falling down to the position of Point A' at the side of the direction of microwave irradiation (west side) as compared with the actual position. On the other hand, a place with a low altitude is affected little by foreshortening, and the actual position of Point B is almost the same as the position of the projected Point B'.

Fig.-1.2.3 Schematic diagram of foreshortening and an example by means of a single-polarized SAR image (around Mt. Fuji)

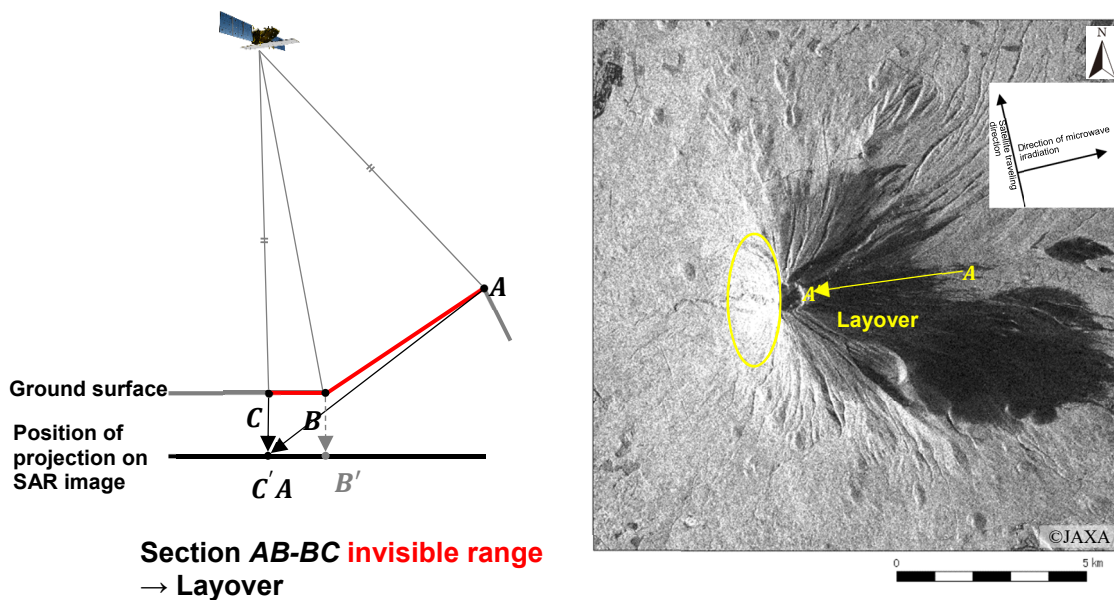
When an explanation is given by taking Mt. Fuji shown in Fig.-1.2.4 as an example, Point *A* at the mountain top of Mt. Fuji is greatly subjected to foreshortening toward the west side, and is projected to Point *B* on the slope at the west side as though covering Point *B*, and the slope at the west side (section *AB-BC*) becomes an invisible range widely. Also, since scattering is dense on the slope at the west side where layover occurs, SAR images are featured by being displayed in conspicuously light colors as though there are great backscatter intensities.

Fig.-1.2.4 Schematic diagram of layover and an example by means of a single-polarized SAR image (around Mt. Fuji)

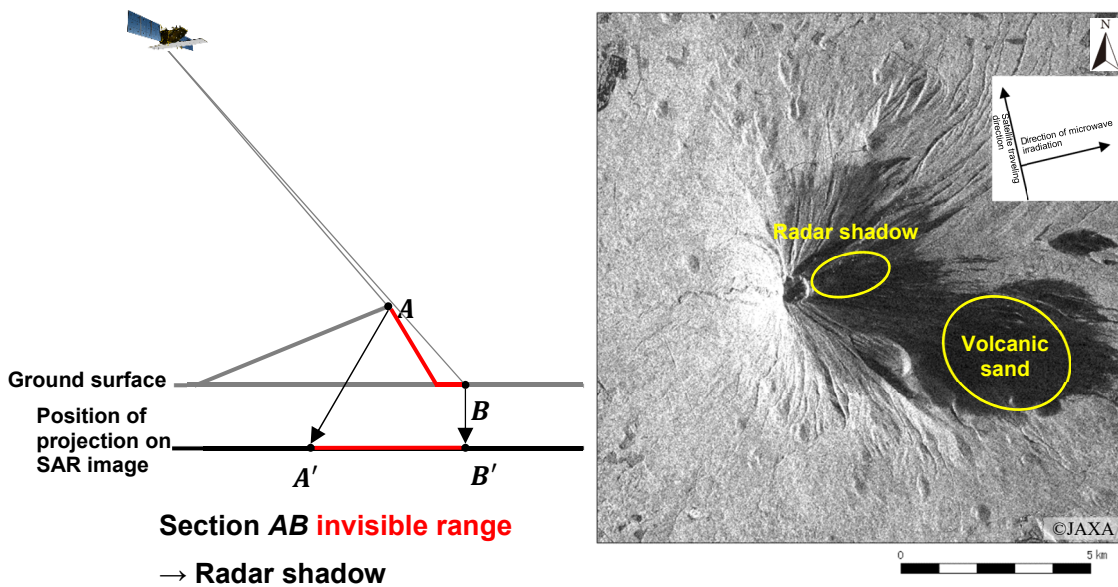
When an explanation is given by taking Mt. Fuji shown in Fig.-1.2.5 as an example, on the slope at the east side from mountain top *A* of Mt. Fuji, microwaves do not reach the ground surface, and radar shadow occurs. Since there are no scattered microwaves in the radar shadowed part, on SAR images, backscatter is shown in dark colors where the backscatter is considerably low. Since its visibility is similar to surface scattering that occurs on a smooth, flat land area such as water surface, attention should be paid to its distinction.

Fig.-1.2.5 Schematic diagram of layover and an example by means of a single-polarized SAR image (around Mt. Fuji)

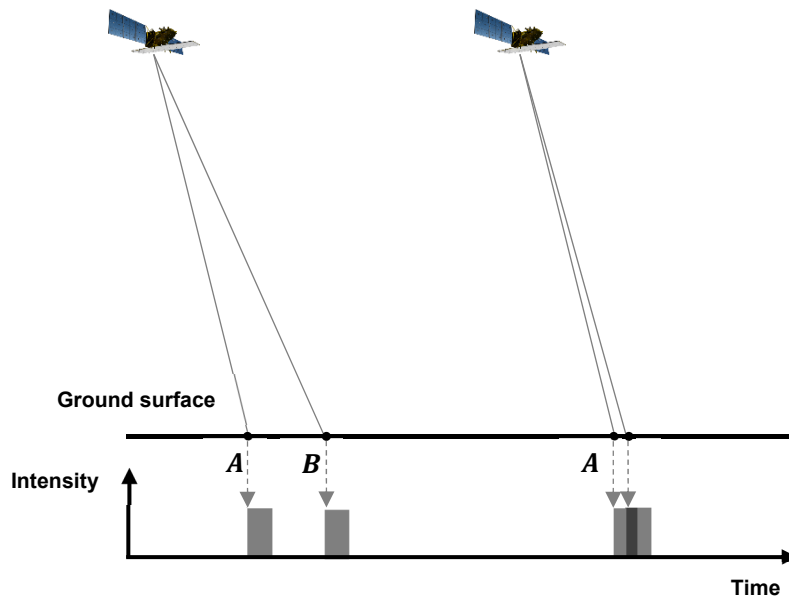
However, the resolution of SAR images and the size of the target of observation that can be distinguished are different from each other, and generally it is considered that in order to visually identify a specific target, its size needs to be 10 - 20 times the resolution.

Fig.-1.2.6 Schematic diagram of resolution

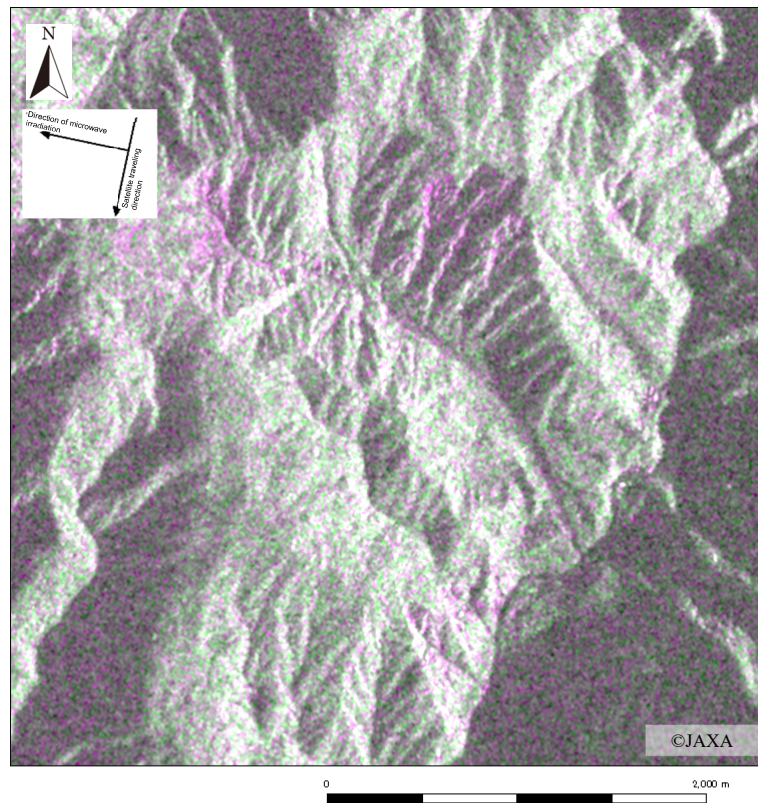
Fig.-1.2.7 shows dual-polarized SAR images that have been created by RGB color synthesis processing with R (red): HH polarization, G (green): HV polarization, and B (blue): HH polarization, according to NILIM Technical Note No. 791. The forest areas are expressed in green, and bare land without forests is expressed in purple red, thereby making it possible to distinguish forests and bare land including failure areas based on the image color.

Fig.-1.2.7 Example of a dual-polarized SAR image (Aoi Ward, Shizuoka City, Shizuoka Prefecture)

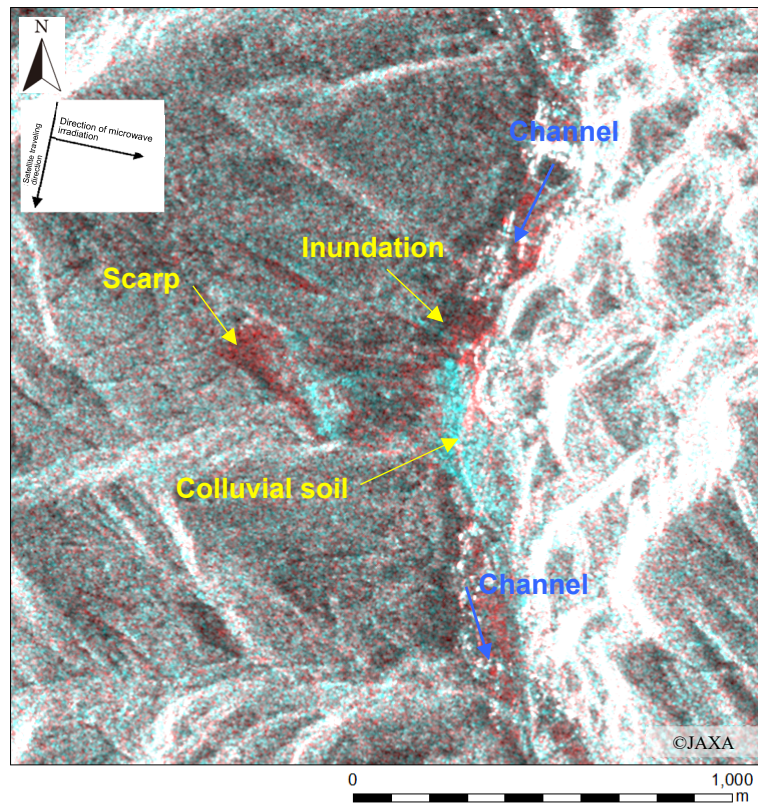
In this material, intensity difference SAR images are created by assigning R (red): archive images, G (green): new observation images, and B (blue): new observation images (Fig.-1.2.8). In the 2 periods, the place where the backscatter intensity decreased is expressed in red, and the place where the backscatter intensity increased is expressed in cyan (greenish-blue close to light blue), thereby making it possible to distinguish the situation of occurrence of a sediment disaster based on the change in image color.

Fig.-1.2.8 Example of an intensity difference SAR image (Hita City, Oita Prefecture)

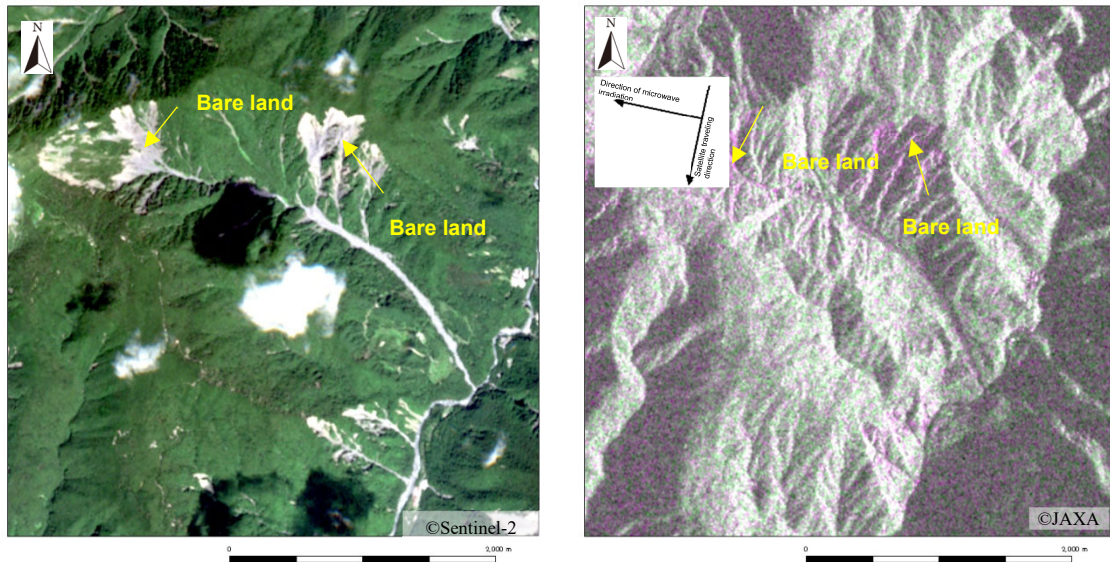
With dual-polarized SAR images, it is difficult to distinguish the places with sediment disasters from bare land such as deforested area or land where a failure already occurred (Fig.-1.3.2), and with intensity difference SAR images, attention needs to be paid to artificial modification (deforestation, topography modification, etc.) and seasonal changes (inundation of farmland, etc.) in the 2 periods (Fig.-1.3.3). Interpretation of changes in intensity difference SAR images will be described in detail in Part 2.

Fig.-1.3.2 Appearance of bare land in dual-polarized SAR images
(Aoi Ward, Shizuoka City, Shizuoka Prefecture)

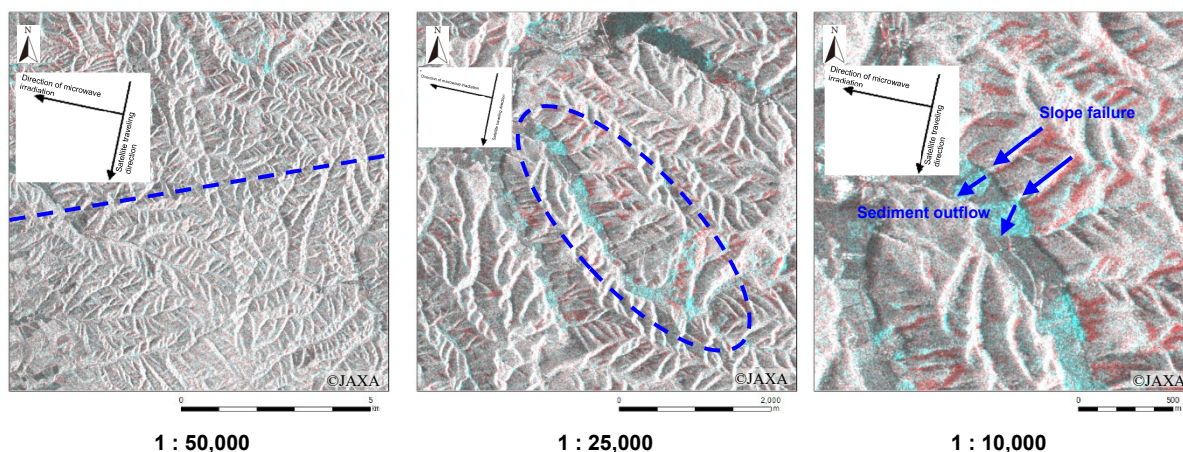
Lastly, an intensity difference SAR image is displayed in scale of about 1:10,000, and judgment is made on each slope unit (Fig.-2.3.4, right). It is recommended to use a judgment method to be described later.

Fig.-2.3.4 Intensity difference SAR images displayed in each scale and how to view the images (Atsuma Town, Hokkaido Prefecture)

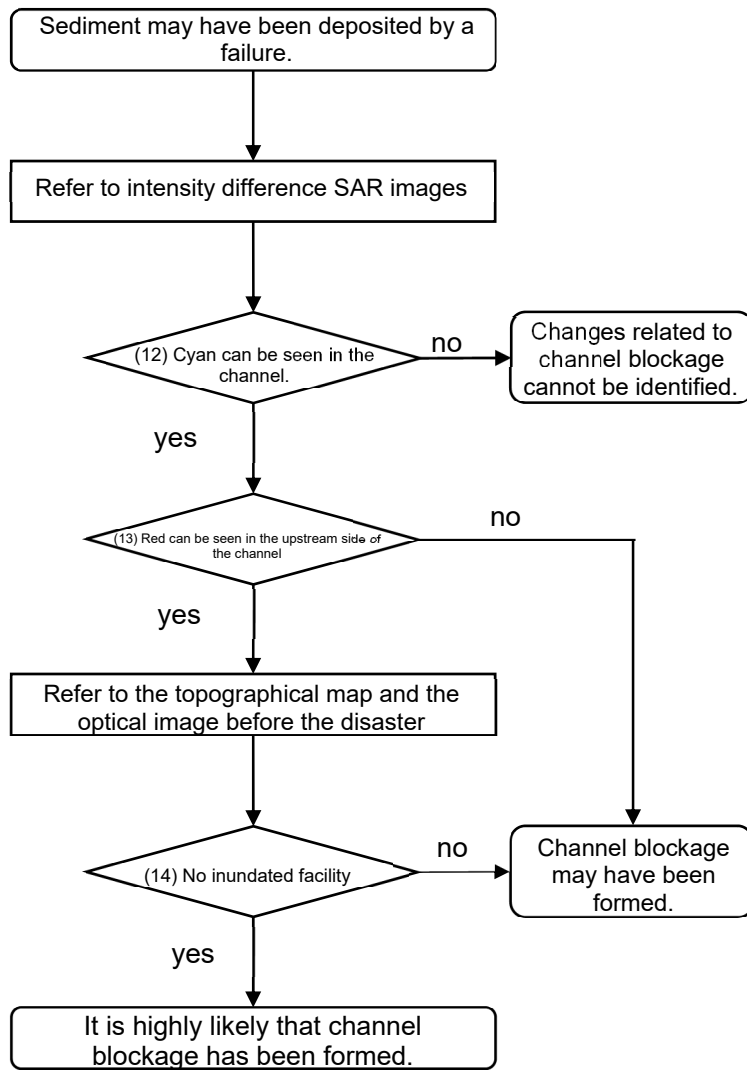
From the intensity difference SAR images, check whether changes in cyan can be seen in the channel, and whether ranges in red can be seen in the upstream side of the channel, and when falling under both of these, refer to the topographical map and the optical images before the disaster, to ensure that such changes or ranges are not existing dams, reservoirs, etc. that have been misinterpreted. If all the conditions stated above are met, it is determined that "It is highly likely that channel blockage may have been formed." Also, when SAR images that were observed in the initial response period are used, it is expected that the scale of inundation is small as a result of channel blockage, and therefore it is desirable that monitoring and additional survey be carried out for places in which it has been determined that "Channel blockage may have been formed." as well.

Fig.-2.3.7 Viewpoints of whether channel blockage has been formed by means of intensity difference SAR images (Step 3)

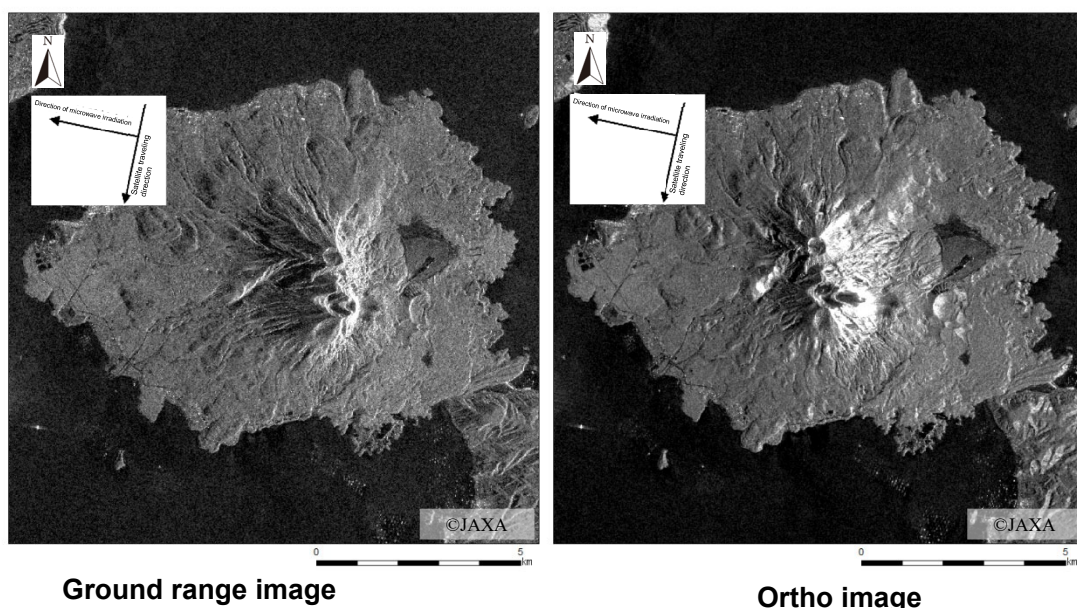
Use SAR images in the ground range in which the distance from the target object has been projected by SAR to the ground surface (Fig.-2.4.1). By performing ortho processing (orthographic projection) of the image, it can be overlapped accurately with GIS data such as topography or administrative boundaries, but as a result of distortion of the image, the visibility of a failure area, channel, etc. decreases. On the other hand, since a ground object is photographed as an image like that of an oblique photo, its intuitive interpretation can be performed easily. Moreover, since ortho processing takes a lot of time, when speedy image interpretation is required, the use of ground range images is recommended that provides data quickly.

Fig.-2.4.1 Comparison of ground range image and ortho image (Sakurajima, Kagoshima City, Kagoshima Prefecture)

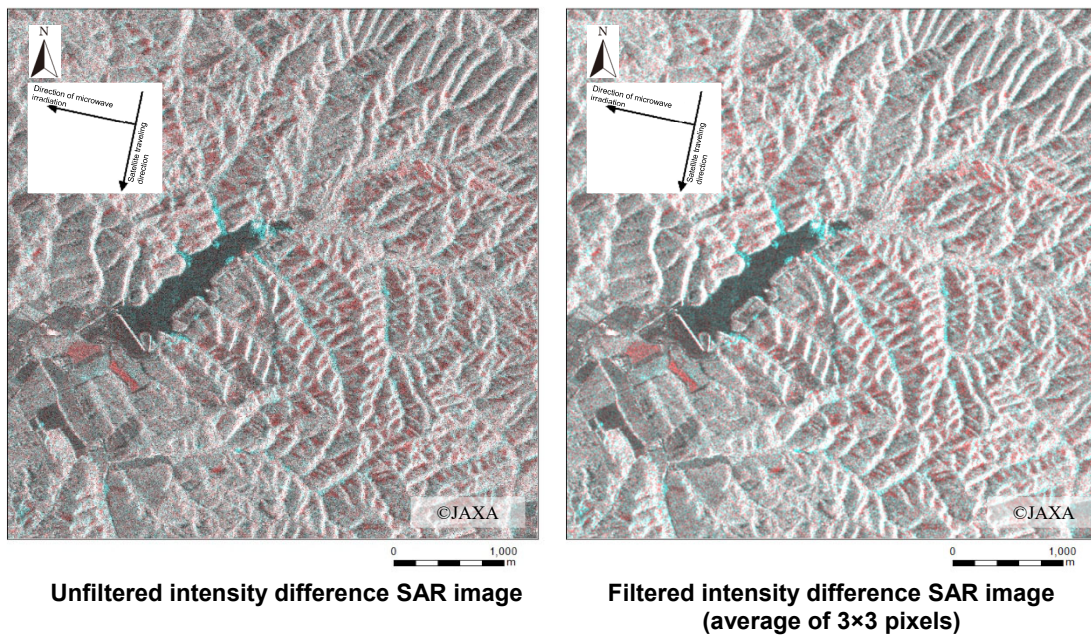
Fig.-2.4.3 Comparison of intensity difference SAR images between filtered and unfiltered ones (Abira Town, Hokkaido Prefecture)

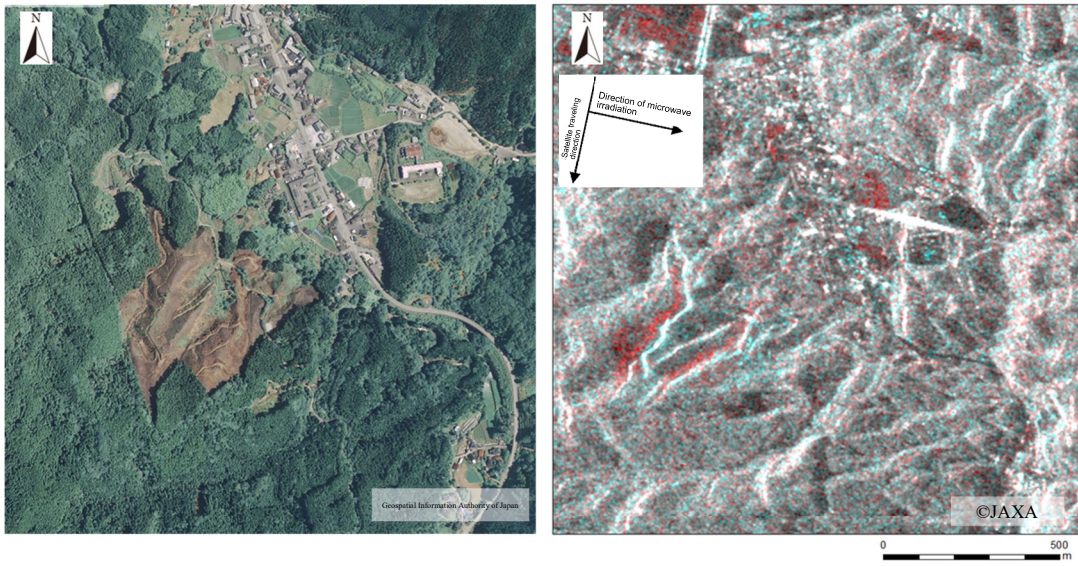
Fig.-2.5.2 Example in which changes in backscatter caused by deforestation appeared (Toho Village, Fukuoka Prefecture)

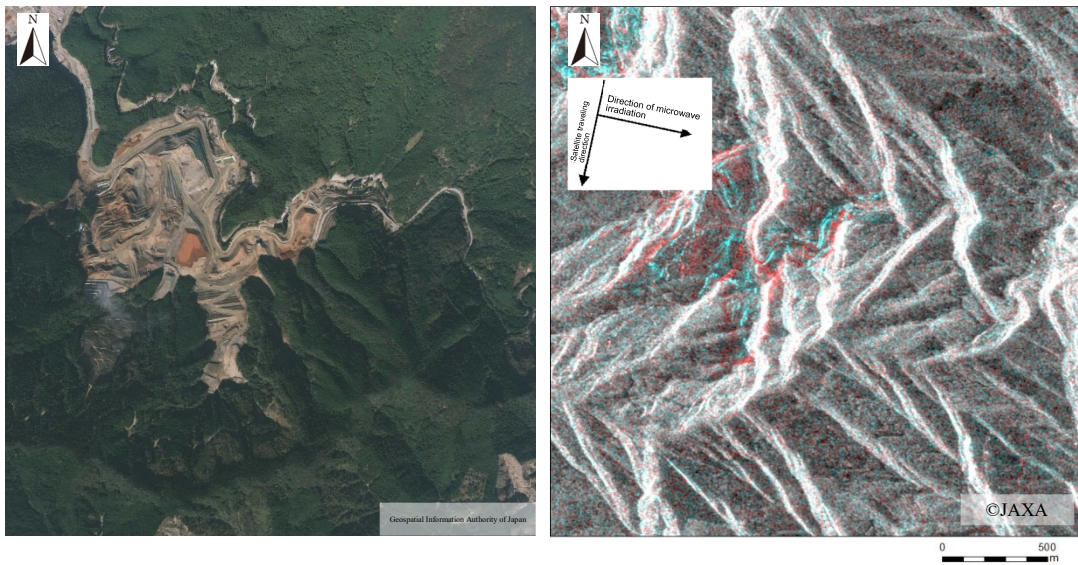
Fig.-2.5.3 Example in which changes in backscatter caused by quarrying appeared (Asakura City/Toho Village, Fukuoka Prefecture)

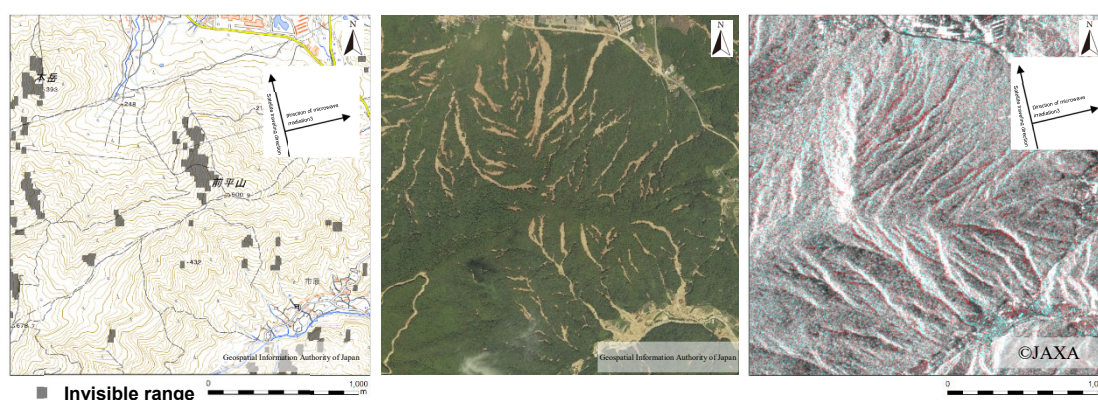
Fig.-2.5.4 Comparison of visibility in invisible ranges (Higashihiroshima City/Yasuura Town, Hiroshima Prefecture)

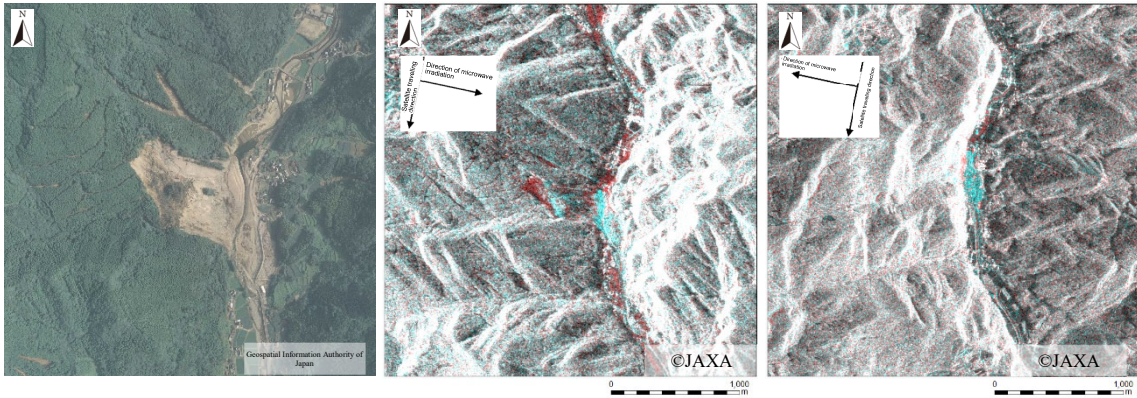
Fig.-2.5.5 Comparison of visibility depending on the direction of microwave irradiation
(Hita City, Oita Prefecture)

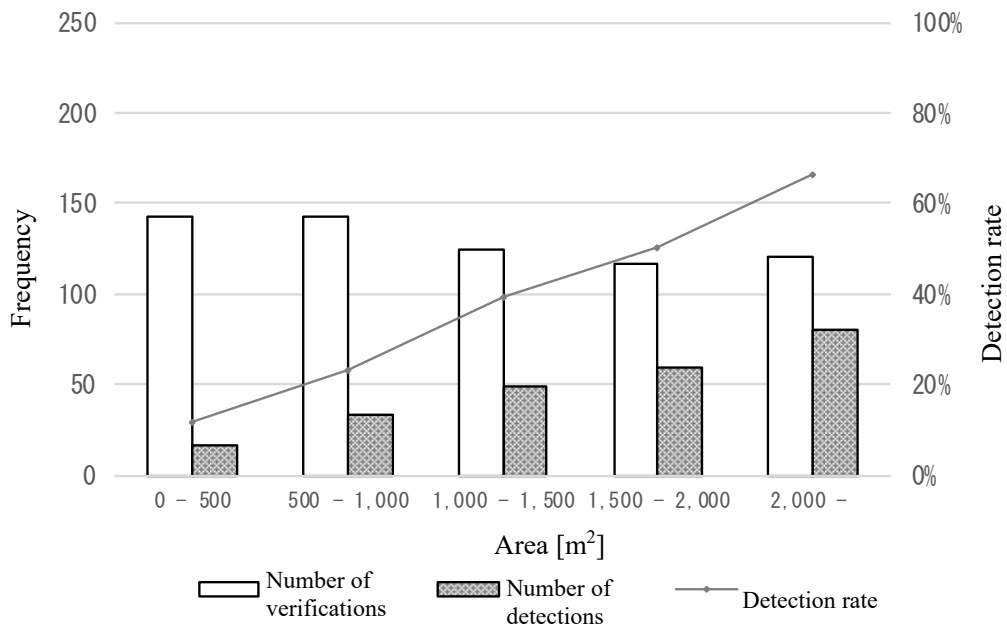
Fig.-3.2.2 Detection rate in the image interpretation survey of sediment disasters by means of intensity difference SAR images (area)

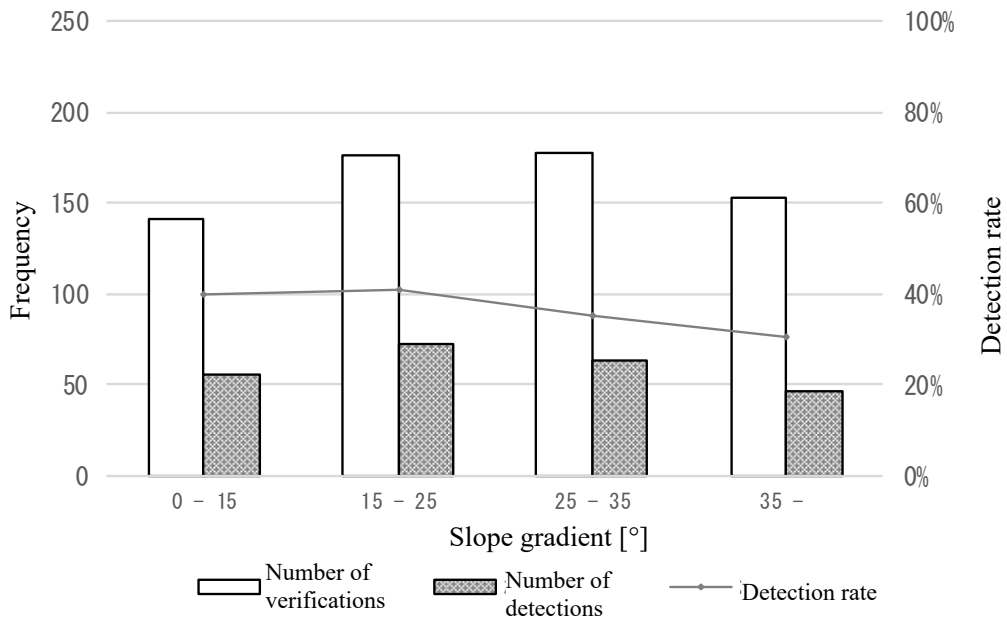
Fig.-3.2.3 Detection rate in the image interpretation survey of sediment disasters by means of intensity difference SAR images (slope gradient)

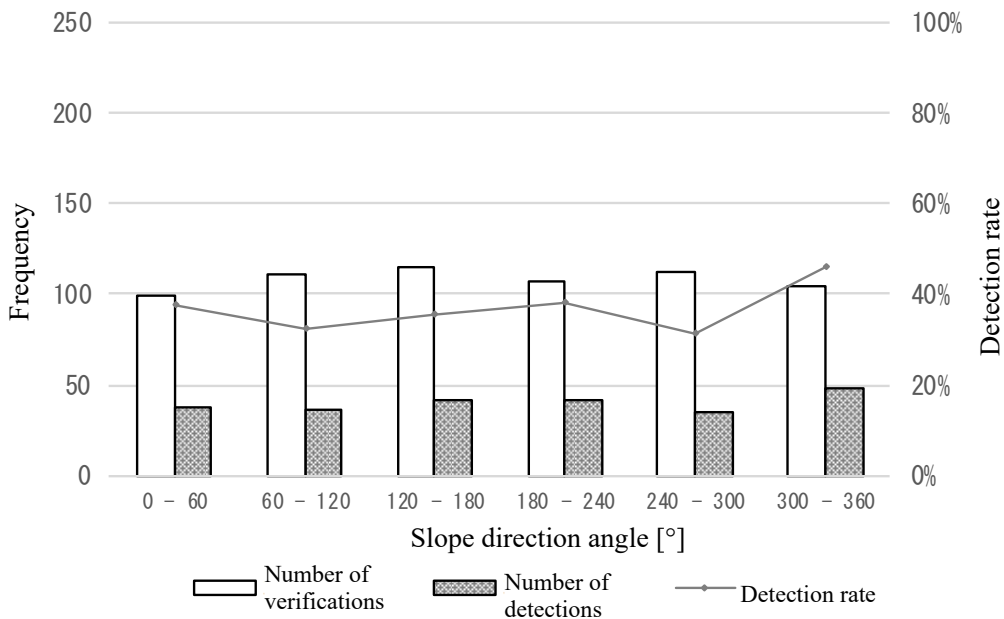
Fig.-3.2.4 Detection rate in the image interpretation survey of sediment disasters by means of intensity difference SAR images (slope direction angle)

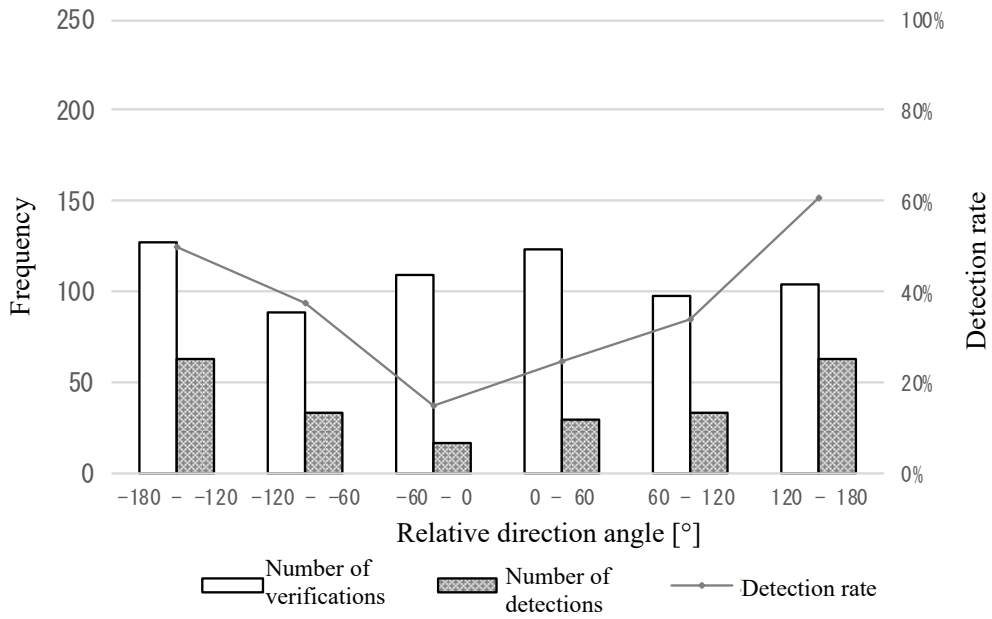
Fig.-3.2.5 Detection rate in the image interpretation survey of sediment disasters by means of intensity difference SAR images (relative direction angle)

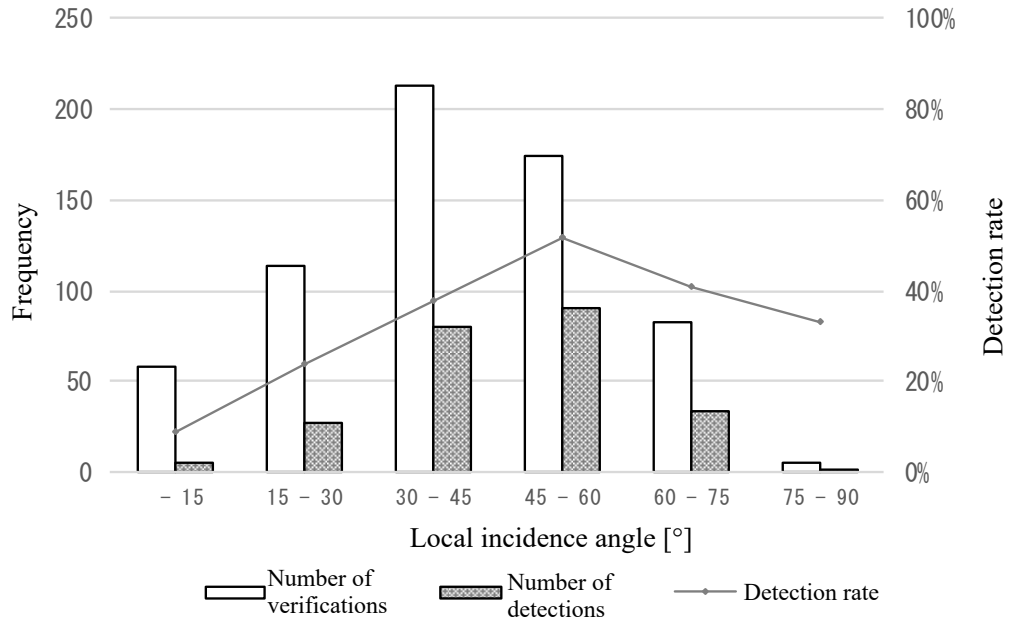
Fig.-3.2.6 Detection rate in the image interpretation survey of sediment disasters by means of intensity difference SAR images (local incidence angle)

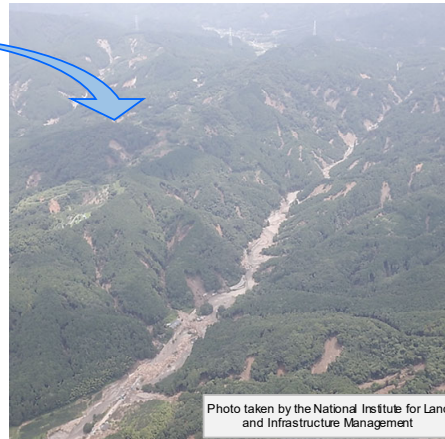
(Left) Intensity difference SAR image around Asakura City

(Right) Area where failure occurred frequently that was identified by the

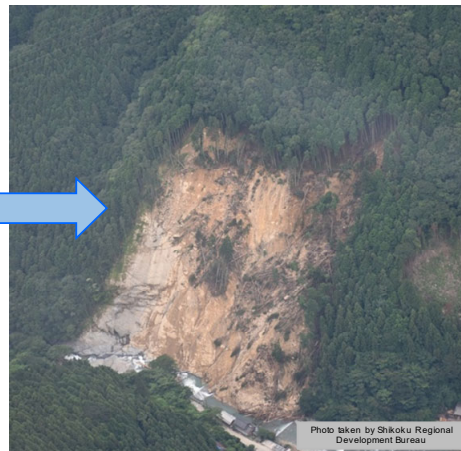
(Left) Place of sediment movement reported during SAR image interpretation

(Right) Large-scale failure identified at the site

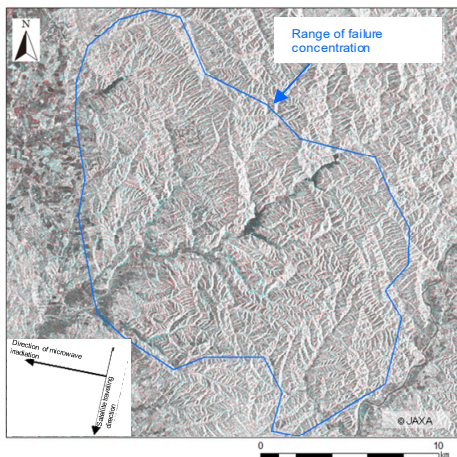
(Left) Range of failure concentration reported during image interpretation of SAR images

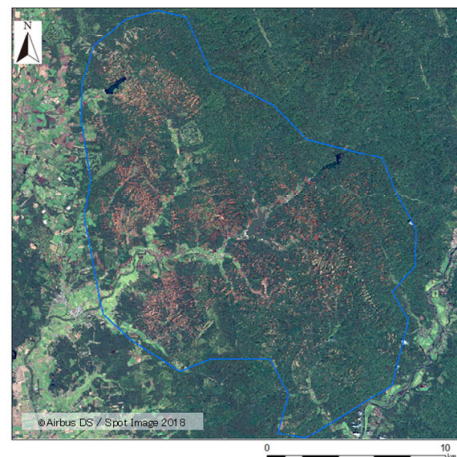
(Right) Range of failure concentration confirmed by optical satellites

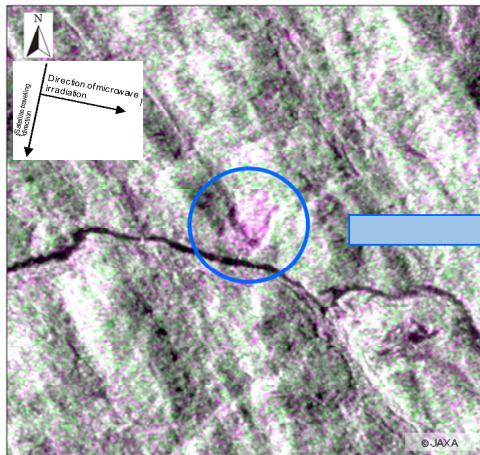
(Left) Place where sediment movement occurred reported during the image interpretation of SAR images

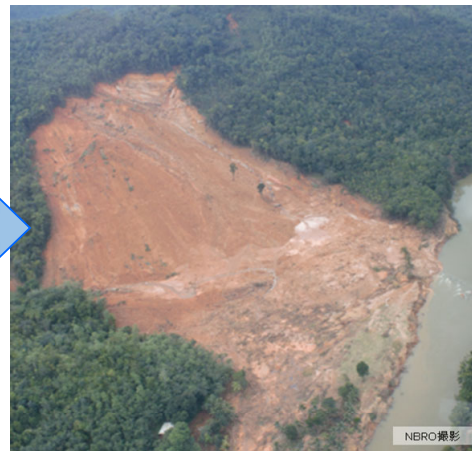
(Right) Large-scale failure confirmed at the site.
