国土技術政策総合研究所資料

TECHNICAL NOTE of
National Institute for Land and Infrastructure Management

No.1159

Expository casebook of scattering changes
in synthetic aperture radar (SAR) in time of disaster

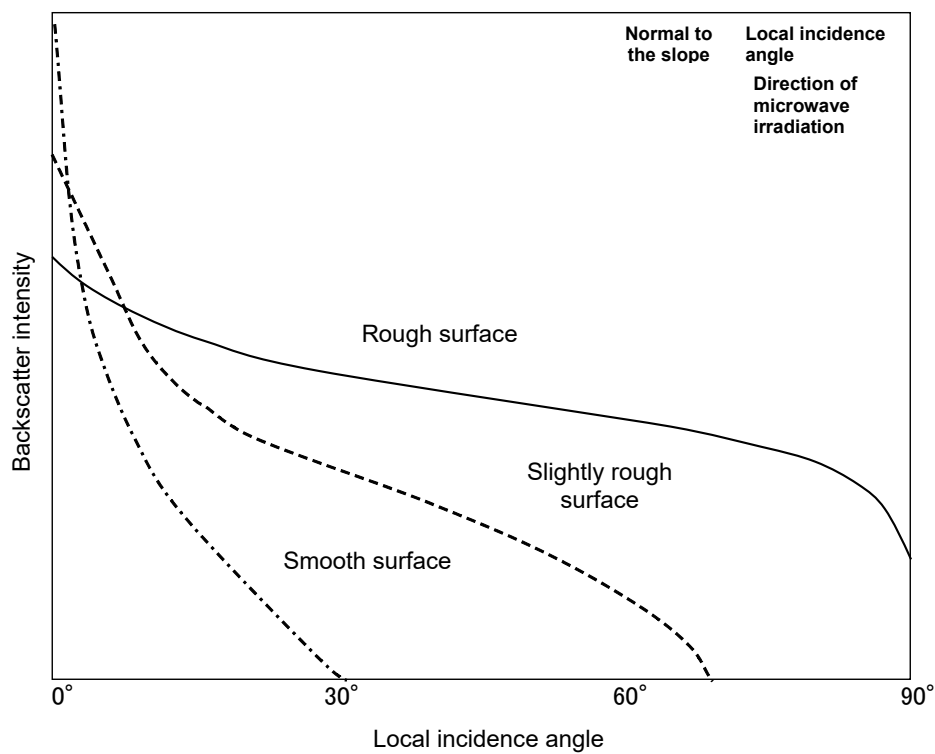
As shown in Fig.-1.5, generally there is a tendency that the greater the local incidence angle, the smaller the backscatter intensity. The local incidence angle greatly affects a smooth scattering surface, as compared with a rough scattering surface. In a volume scatterer that is dominant in a forest, changes in the backscatter intensity according to the local incidence angle are small⁶⁾.

Fig.-1.5 Relationships between backscatter intensity and incidence angle relative to roughness of the scattering surface

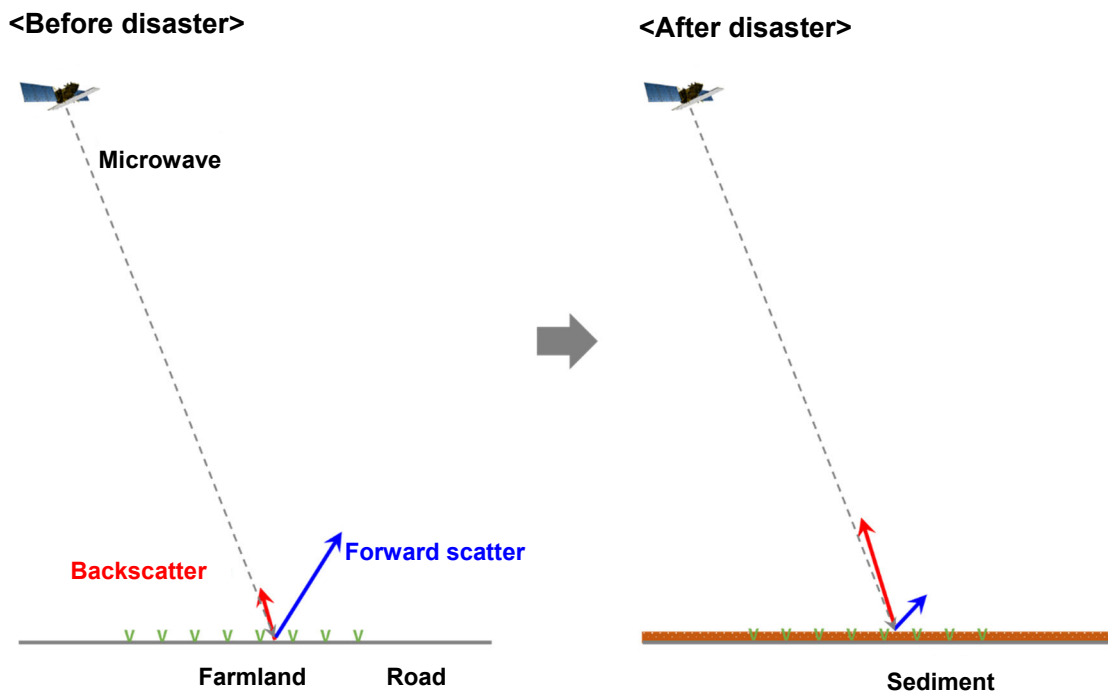
Microwaves irradiated from SAR are subjected to scattering on a flat ground surface without undulations such as farmland or paved roads in which forward scatters are dominant. For this reason, the backscatter intensity before the disaster decreases. If sediment flows into farmland or roads, etc. due to a disaster, the deposited sediment facilitates the backscatter of microwaves, and therefore the backscatter intensity after the disaster increases^{1), 7)}. Based on such changes in the scattering of SAR, places where sediment deposited on farmland or roads, etc. may be identified.

Fig.-3.1 Concept concerning scatter changes when sediment is deposited on farmland or roads

- The ground surface needs to be smooth before the disaster, such as farmland or paved roads.
- When the road width is great such as that on a truck road, the visibility of scatter changes is high.
- Under specific conditions, the backscatter intensity may decrease after the disaster (for details, see P. 15).

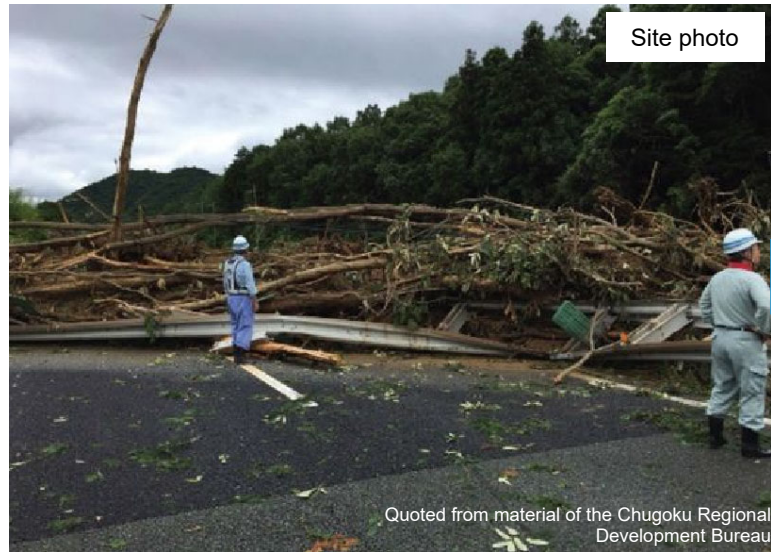
A-2 Torrential Rainfall in July 2018 (Takaya JCT)

Fig.-3.3 Site photo (top) and intensity difference SAR image (bottom)
(Higashihiroshima City, Hiroshima Prefecture)

As a result of sediment deposition on roadways in the vicinity of the Takaya JCT of the Sanyo Expressway, the backscatter intensity after the disaster increases. The places are shown in cyan on the intensity difference SAR image.

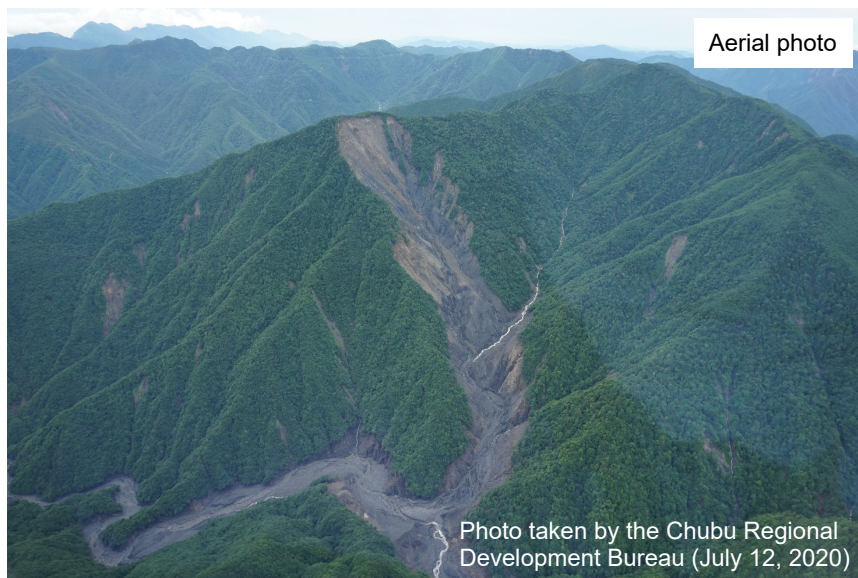
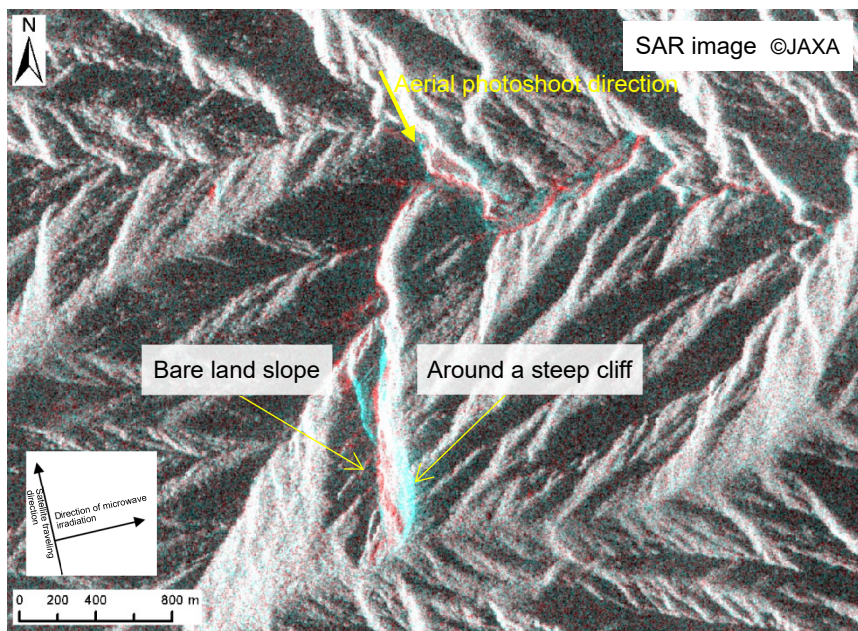
H-1 Torrential Rainfall in July 2020 (Amehatagawa River)

Fig.-3.31 Aerial photo (top) and intensity difference SAR image (bottom)
(Hayakawa Town, Minamikoma County, Yamanashi Prefecture)

As a result of occurrence of an expanded failure on a bare land slope that is an existing failure land, the backscatter intensity after the disaster slightly decreases. On the intensity difference SAR image, the place is shown in light red.

Also, since double bounce scatters occur around a steep cliff where the expanded failure has occurred, the backscatter intensity after the disaster increases, and on the intensity difference SAR image, the place is shown in cyan.

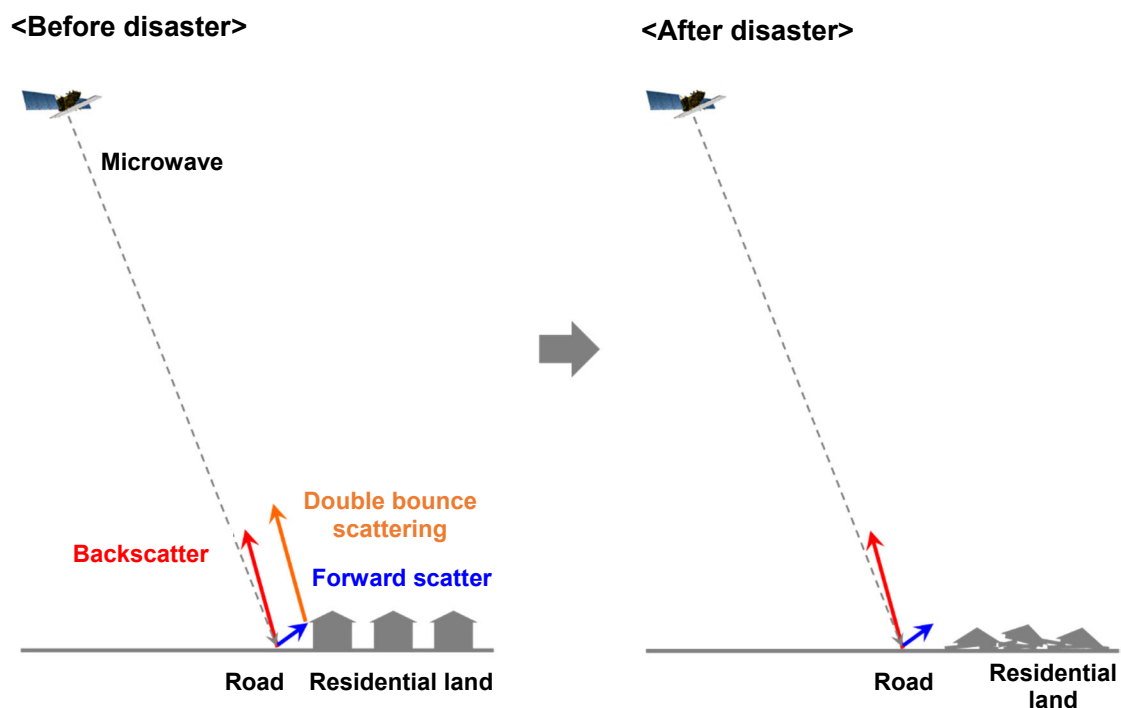
Microwaves irradiated from SAR are subjected to double bounce scattering on residential land. For this reason, the backscatter intensity before the disaster becomes very high. When a building or structure is collapsed by the disaster, the double bounce scattering of microwaves weakens, and the backscatter intensity after the disaster slightly decreases¹²⁾. Based on such changes in the scattering of SAR, the areas where the building or structure collapsed may be identified.

Fig.-3.36 Concept concerning scatter changes when a building or structure has collapsed

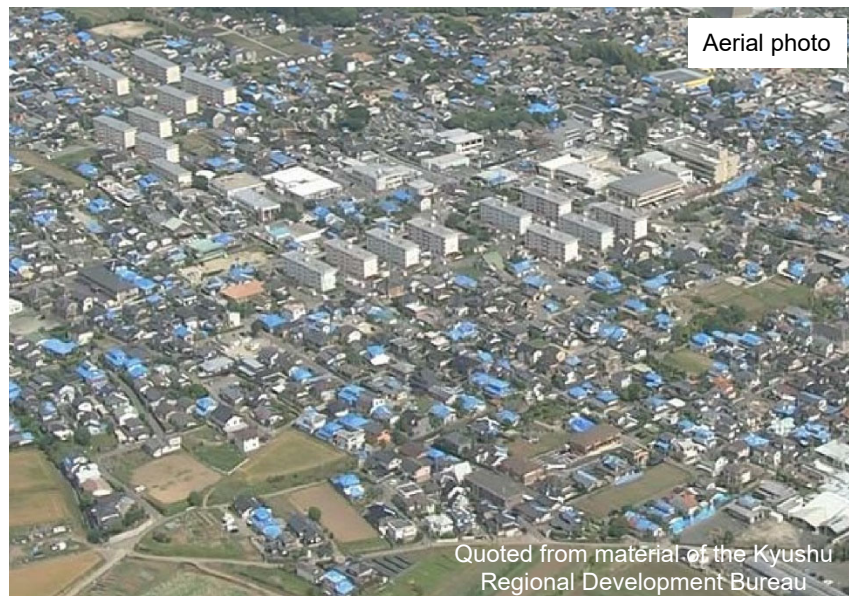
J-1 2016 Kumamoto Earthquake (Mashiki Town)

Fig.-3.37 Aerial photo (top) and intensity difference SAR image (bottom)
(Mashiki Town, Mashiki County, Kumamoto Prefecture)
