**Technical Note of National Institute for Land and Infrastructure Management**

**BRI Research Paper**

**Summary of the Field Survey and Research on  
“The 2011 off the Pacific coast of Tohoku Earthquake”  
(the Great East Japan Earthquake)**

National Institute for Land and Infrastructure Management (NILIM)  
Ministry of Land, Infrastructure, Transport and Tourism, Japan

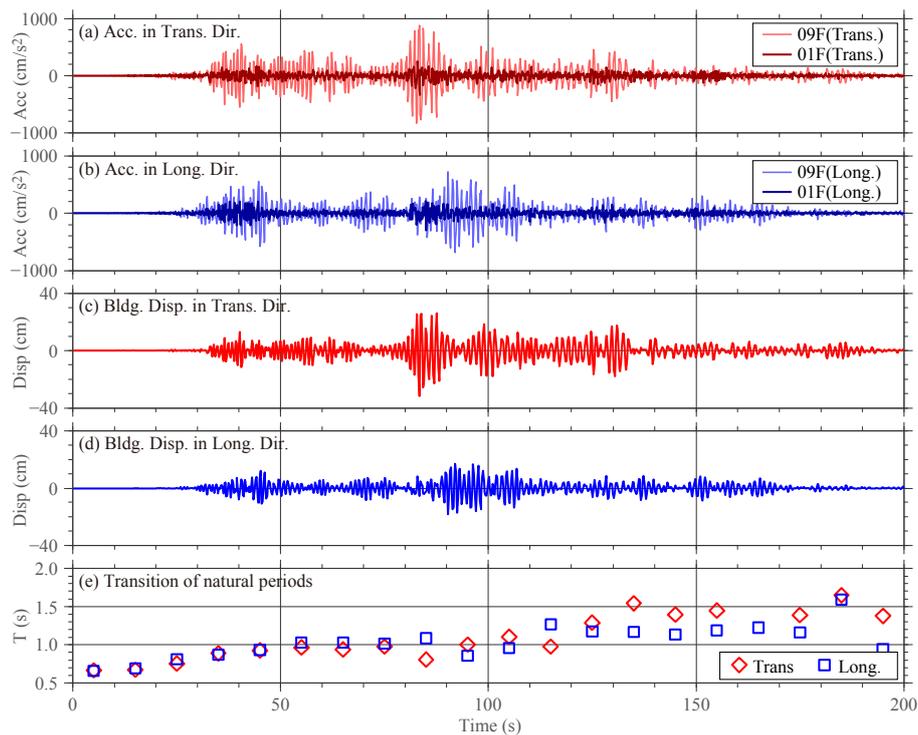
Fig. 5.3-3 Strong motion records of the research building of Tohoku University and transition of natural periods with time. (a) acceleration waveforms in the transverse direction, (b) acceleration waveforms in the longitudinal direction, (c) building displacement in the transverse direction (relative displacement to first floor of the 9-story building), (d) building displacement in the longitudinal direction, and (e) fundamental natural periods of the building that were calculated every 10 s<sup>5-3</sup>). Thick and thin lines in Fig. 5.3-3 (a) and (b) represent acceleration waveforms on the first and ninth floors, respectively.

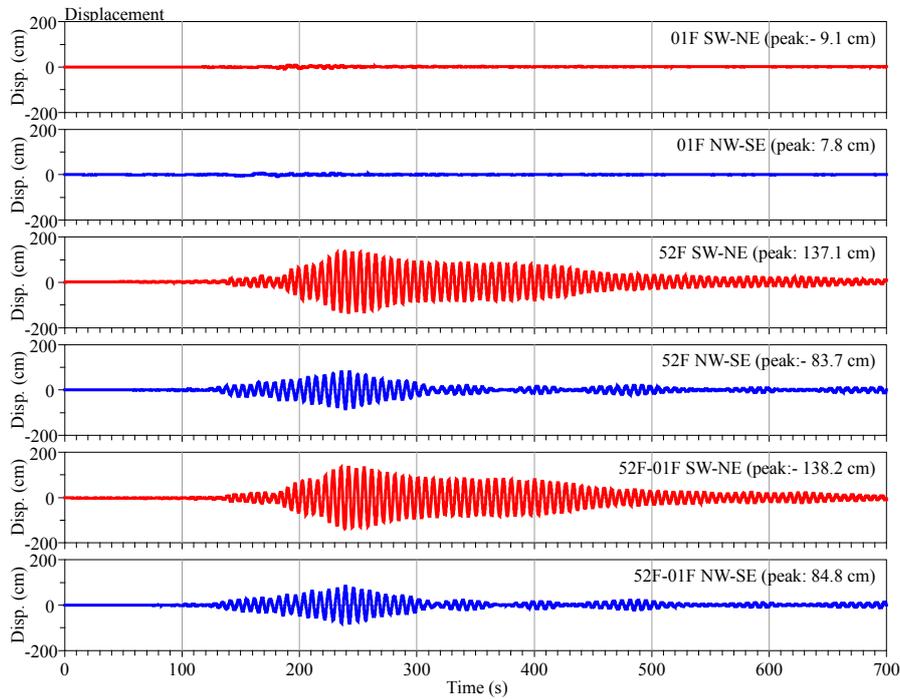
On the other hand, the response spectrum (left) in the records on the coast of Osaka Bay had a large peak at 7 s, and amplitude of the response was not much different from on the coast of Osaka Bay. The coincidence of the fundamental natural period (6.5 to 7 s) in the office building with a predominant period of the earthquake motion is considered to have caused a resonance phenomenon and then large building motions.

Fig. 5.3-5 Displacement waveforms observed at a 55-story office building in Osaka Bay area. From the top to the bottom; absolute displacements in the SW-NE and in the NW-SE on the 1st floor, absolute displacements in both of the directions on the 52nd floor, and building displacements (relative displacements of 52th floor to 1st floor) in both of the directions.

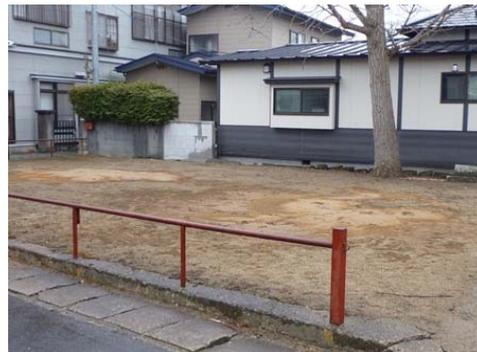
Photo 6.2-2 Sand boil due to liquefaction

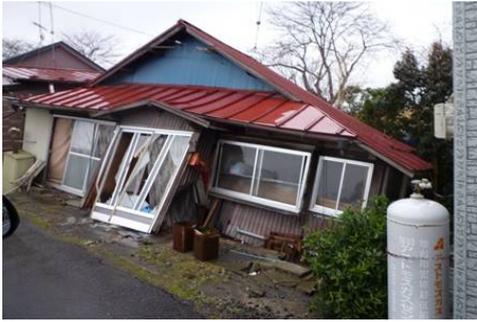
K-NET Kurihara Tsukidate (MYG004 : Instrumental seismic intensity 6.6) is set up on the hillock 3m higher (by eye measurement) than south of parking lot of Kurihara lyceum. There was a possibility of the amplification of earthquake motions (Photo 6.2-1). In Wakayanagi district, the ground was bad and sand boil due to liquefaction was observed (Photo 6.2-2). Damage to houses caused by ground transformation (Photo 6.2-3) and damage to houses with store were also observed (Photo 6.2-4).

Photo 6.2-3 Damage of houses caused by ground transformation

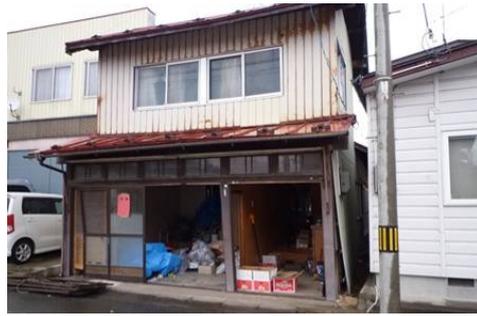
Photo 6.2-4 Damage of houses with store

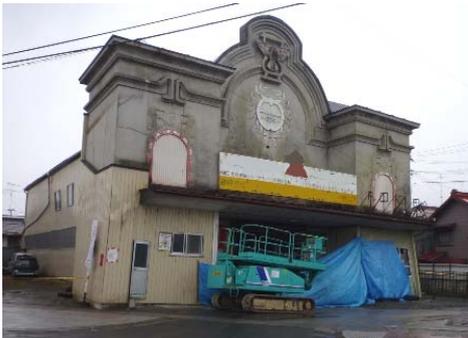
A large residual deformation was observed in the longitudinal direction in the large-scale wood building used as a movie theatre then renovated to a factory (Photos 6.2-5, 6.2-6)

Photo 6.2-5 Large-scale wood building renovated to a factory

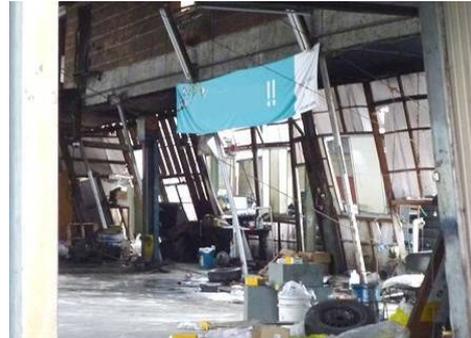
Photo 6.2-6 Inside of the building shown in Photo 6.2-5

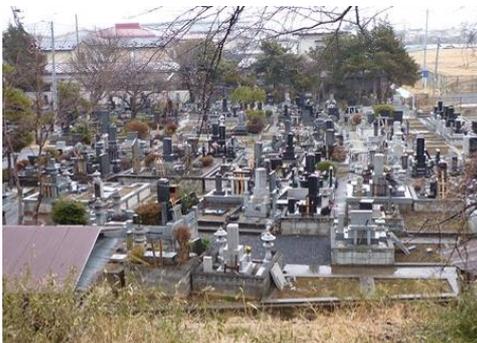
Photo 6.2-7 Overturning of tombstone

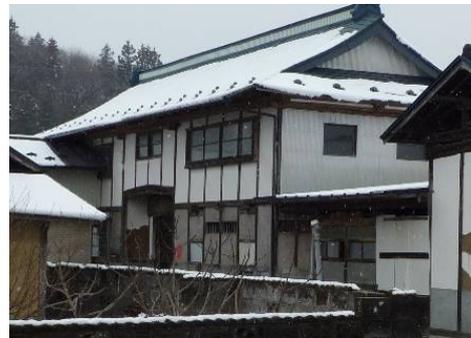
In Kurikomasakurada district, the collapse of work hut, the drop of the mud plasters of Nagaya-mon gates (Photo 6.2-8), the damage of plastered storehouses were observed, but the great damage in house was not observed.

Photo 6.2-8 Drop of mud plasters of Nagaya-mon gate (Kurikomasakurada)

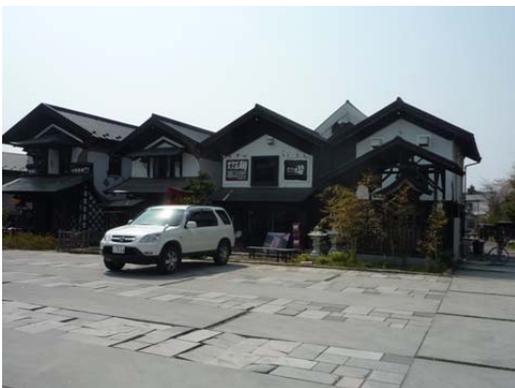
For example, warehouse with the mud walls renovated as store or gallery (Photo 6.2-11) was damaged heavily or slightly. There was the one whose roof system with roof tiles collapsed and fell down, as shown in Photo 6.2-12. In the area of these warehouses, there was a Japanese traditional post and beam construction house with large deformation (Photo 6.2-13) which was renovated as a store. In the opposite side of this house, there was the house with store (Photo 6.2-14) with story shear deformation whose exterior mortar came off and wood lath under the mortar near the opening of the ventilation fan was deteriorated and attacked by termites, as shown in Photo 6.2-15. Such damage was confirmed in the other buildings. Most of these damage occurred along a small river, except for a few case, and it was considered that the soft ground near the river might amplify the earthquake ground motion.

Photo 6.2-11 Warehouse with mud walls damaged heavily or slightly

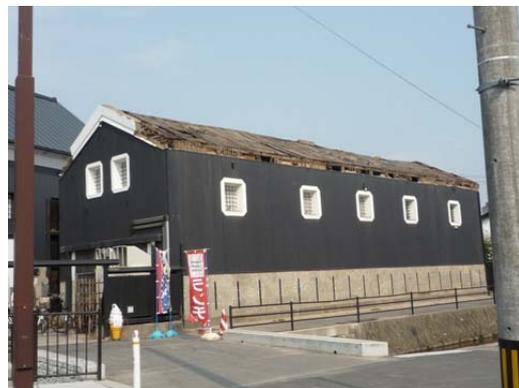
Photo 6.2-12 Warehouse with mud walls whose roof system with roof tiles fell down

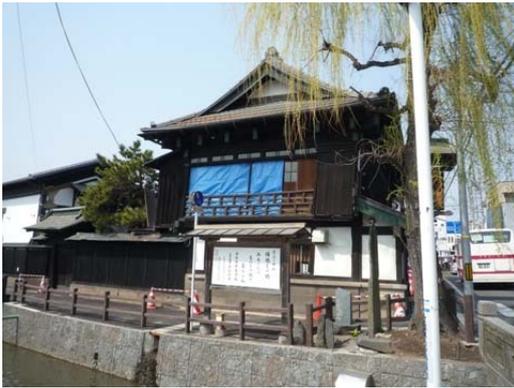
Photo 6.2-13 Damaged Japanese traditional house with large story deformation

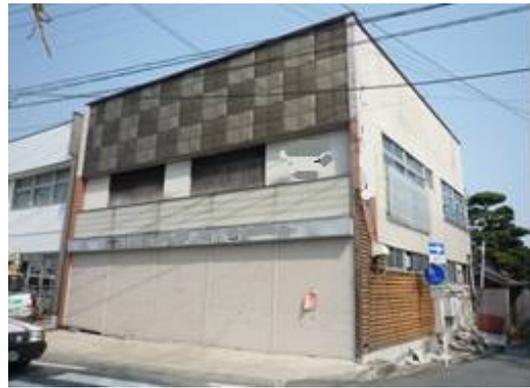
Photo 6.2-14 House with store with large story deformation

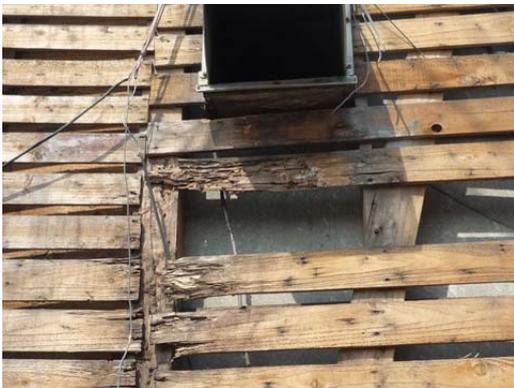
Photo 6.2-15 Deterioration in building of Photo 6.2-14

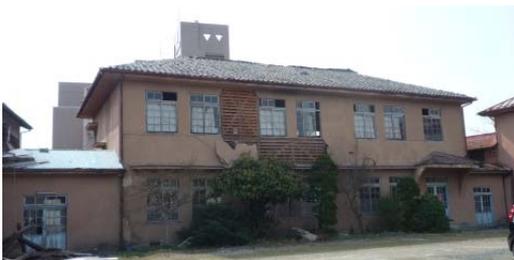
Seismograph at JMA Furukawa (Photo 6.2-16) which recorded seismic intensity 6+ was located in the northeast corner of the Mikkamachi park. There were the former school buildings around it. One of them was not almost damaged (Photo 6.2-17), while the other was damaged on roof tiles and exterior mortar without story drift. In addition to them, a rare damage example (Photo 6.2-18) that only the 2<sup>nd</sup> story collapsed was observed. On the other hand, a wood school building (Photo 6.2-19) in the west of the Osaki city office seemed not to be damaged in the appearance. Besides these, the house with store with large story drift in 1<sup>st</sup> story (Photo 6.2-20), those with large story drift in 2<sup>nd</sup> story (Photo 6.2-21), and 1-story wood house with large story drift caused by the land liquefaction were observed.

Photo 6.2-17 School building suffering damage on roof tiles and exterior walls

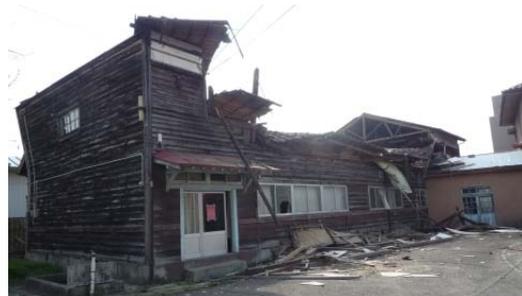
Photo 6.2-18 School building whose 2<sup>nd</sup> story collapsed

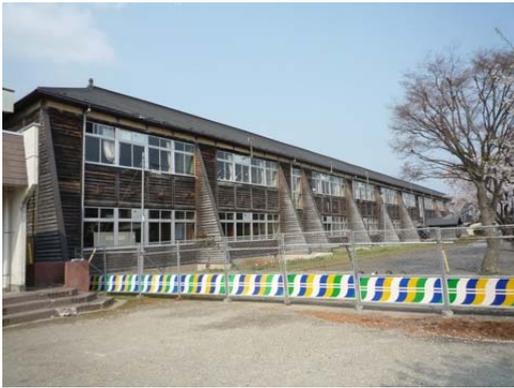
Photo 6.2-19 Seemingly slightly damaged School building

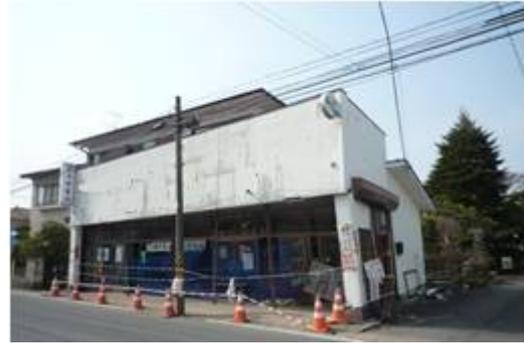
Photo 6.2-20 House with store with large story deformation

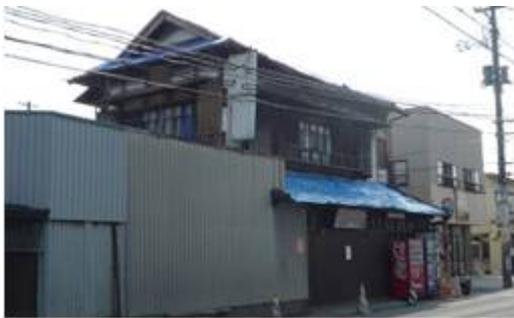
Photo 6.2-21 House with store with 2<sup>nd</sup> story drift more than that of 1<sup>st</sup> story

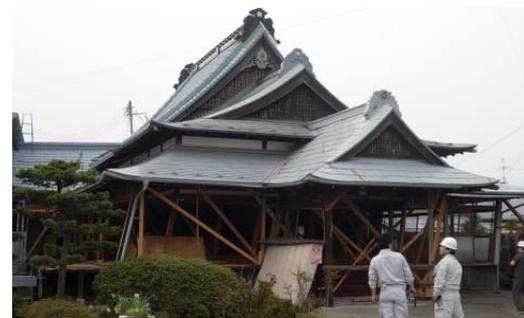
In the northwest of JR Freight Company Furukawa Station, a collapsed steel frame building, an RC structure apartment house with rocking drift caused by the land deformation, and a temple building (Photo 6.2-22) with large story deformation were observed.

Photo 6.2-22 Heavily damaged temple building

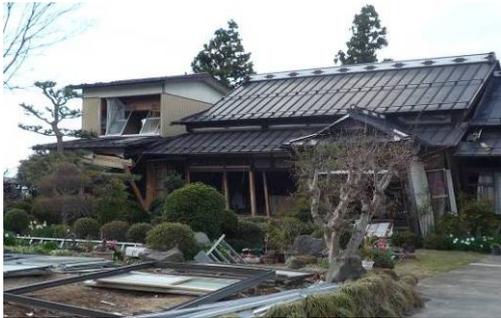
Photo 6.2-23 Largely tilted house

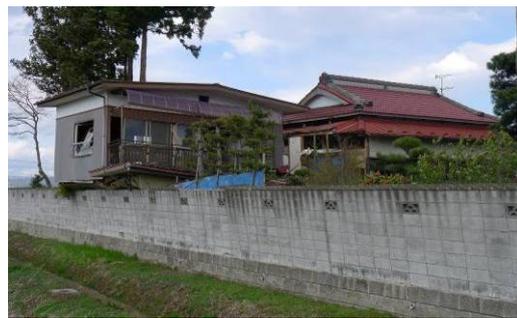
Photo 6.2-24 Collapsed wood house

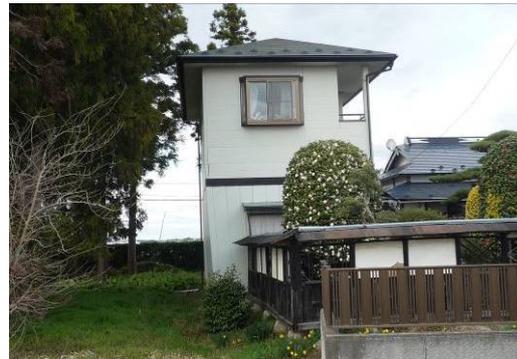
Photo 6.2-26 Tilted two-story house

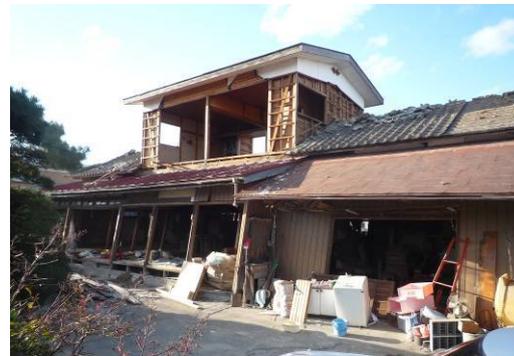
which two-story might be extended. In the southern side of Eaigawa river, there were log house without damage (Photo 6.2-27), wood house which tilted largely at first story (Photo 6.2-28) and tilted shrine building (Photo 6.2-29).

Photo 6.2-28 Largely tilted wood house

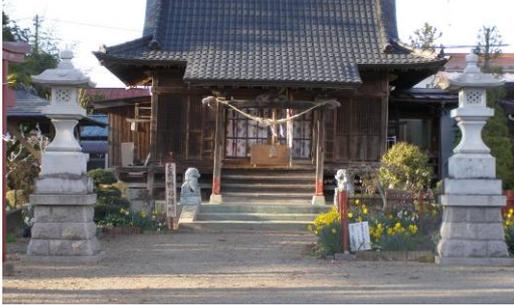
Photo 6.2-29 Damaged shrine

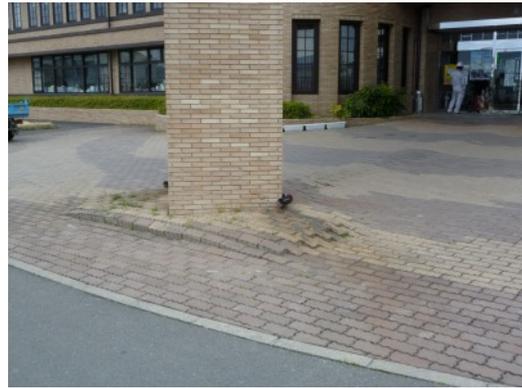
In Nango area, ground deformation was observed in the branch town office (Photo 6.2-30), but there was few damaged houses. Photo 6.2-31 is the tilted wood house in Nango area. The structures in this area were damaged in a certain level during the 2003 northern Miyagi prefecture earthquake. There is a possibility that damaged buildings were retrofitted or rebuilt after the 2003 earthquake, because structures in this area seemed to be new.

Photo 6.2-30 Ground deformation in Nango branch town office

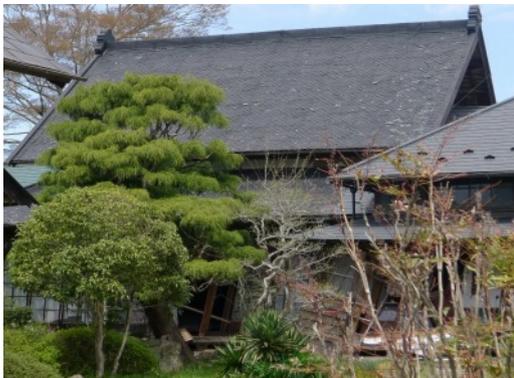
Photo 6.2-31 Heavily damaged house

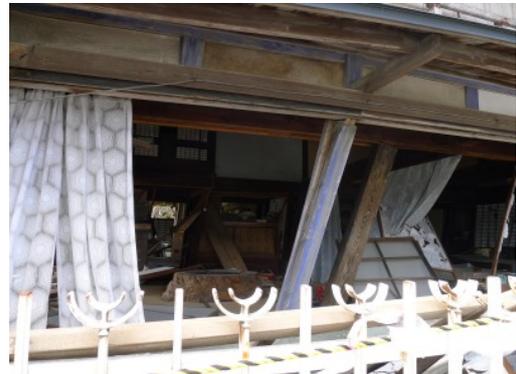
Photo 6.2-32 Inside of the house in Photo 6.2-31

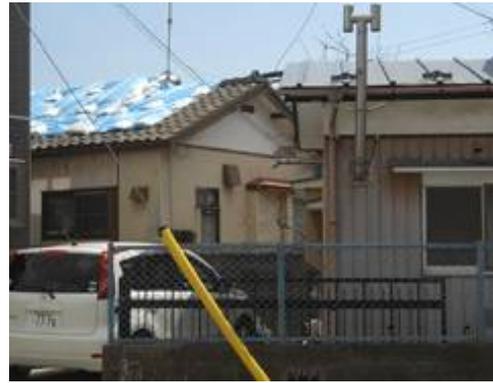
Hiyorigaoka and Izumi-cho in Ishinomaki city is located on a hill (The altitude is 56.4m) at the western side of Kyu-kitakami river, almost all of the buildings are residence without public facilities (Photo 6.2-33). There were not heavily damaged wood houses and a few wood houses of which roof tile damaged (Photo 6.2-34).

Photo 6.2-34 Damaged roof tile in Hiyorigaoka

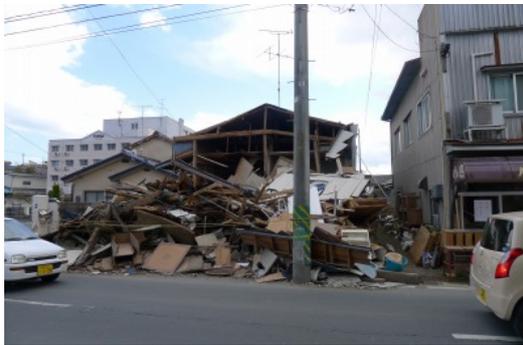
At the both side of the street, there were collapsed wood house by earthquake (Photo 6.2-35) and tilted wood house with store (Photo 6.2-36). It was estimated that the wood houses with store which have less seismic elements at the first story were heavily damaged.

Photo 6.2-35 Collapsed wood house

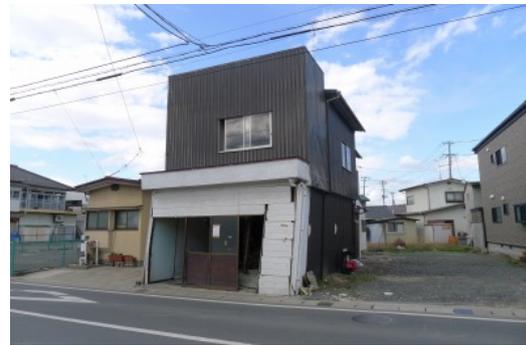
Photo 6.2-36 Tilted wood house with store

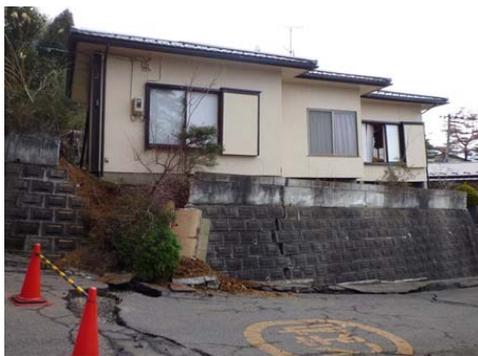
From the results of investigations on Oritate and Seikaen where the damage of the houses were serious, it was found that almost all of the damage of house were caused by ground transformation. Moreover, ground transformation caused retaining wall collapse (Photo 6.2-37, 6.2-38), landslide and damage of houses (Photo 6.2-39). On the other hand, there were some sloping lands in Kaigamori and Asahigaoka where, the number of damage of retaining wall was minor, and damage of roof tile, collapse of concrete block wall and outer wall were observed. In Komatsujima, Aoba ward, drop off the mortar wall and damage of columns and biodeterioration by ants were observed in the house with store (Photo 6.2-40). Moreover, the house with large residual deformation on the 1st floor was observed (Photo 6.2-41). In Mukaiyama, Taihaku ward, collapse of a Japanese-style hotel was observed because of the sudden fall of stone of hillback (Photo

Photo 6.2-37 Damage of retaining wall and houses (Oritate, Aoba ward)

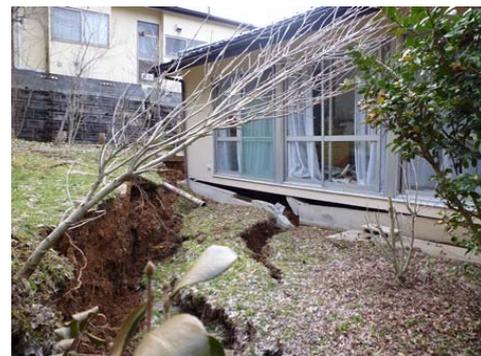
Photo 6.2-38 Damage of house in Photo 6.2-37

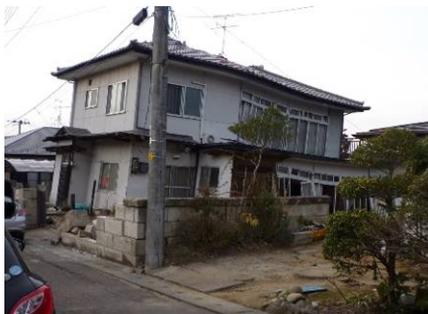
Photo 6.2-39 Damage of house caused by the ground transformation (Oritate)

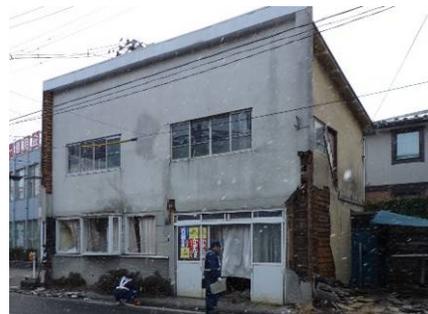
Photo 6.2-40 Drop off the mortar wall (Komatsujima)

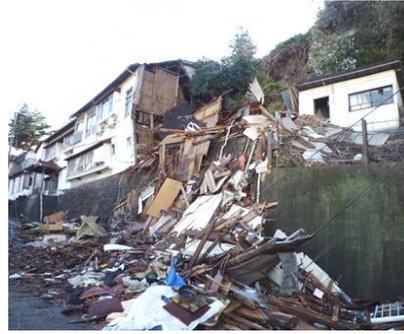
Photo 6.2-42 Collapse of Japanese-style hotel (Mukaiyama)

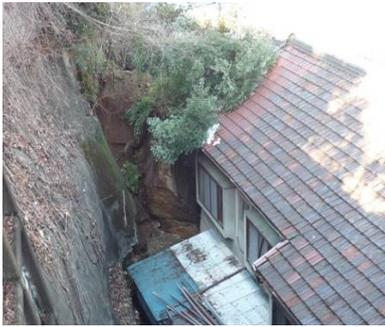
6.2-42, 6.2-43).

Photo 6.2-43 Hillback of the hotel

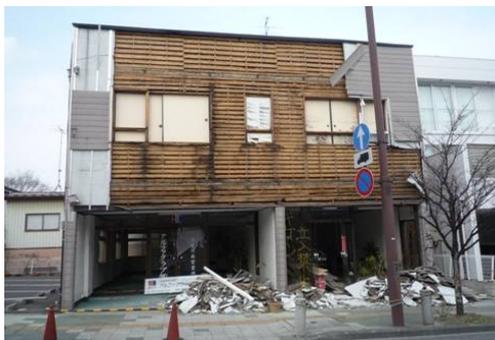
A lot of damaged wood houses were observed around the collapsed RC structure building. Examples are as follows: the failed exterior mortar wall of the 2<sup>nd</sup> floor in a house with store (Photo 6.2-44), deterioration and damage by *Reticulitermes* on a part of structural member and wood lath of exterior mortar wall (Photo 6.2-45), a wood house whose stair hall was removed and collapsed (Photo 6.2-46), and so on.

Photo 6.2-44 Fallen mortar of wall (Wood house with store)

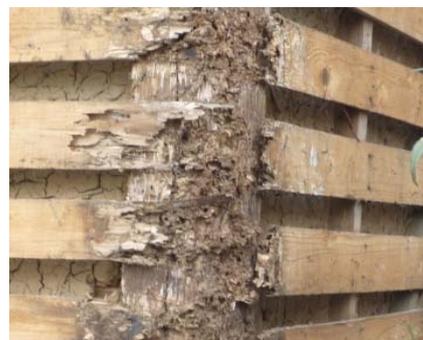
Photo 6.2-45 Deterioration and damage due to termite on column and wood lath of exterior mortar

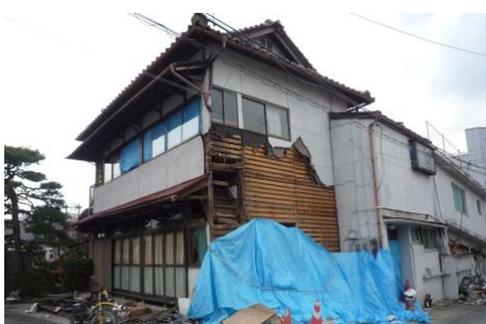
Photo 6.2-46 Collapsed stair hall

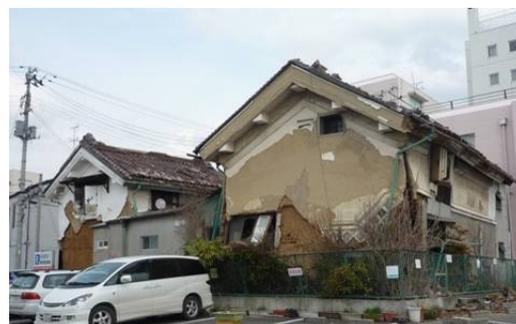
The wood warehouses with mud wall were heavily damaged near the hotel with the window glass broken. For example, the warehouses which deformed much (Photo 6.2-47) and whose roof system collapsed (Photo 6.2-48) were observed. A few wood houses with roof tiles damaged (*e.g.* Photo 6.2-49) were found. On the other hand, roof tiles of temple gate (called as “*Sanmon*”) was damaged, while the main hall of the

Photo 6.2-47 Failed warehouse with mud wall

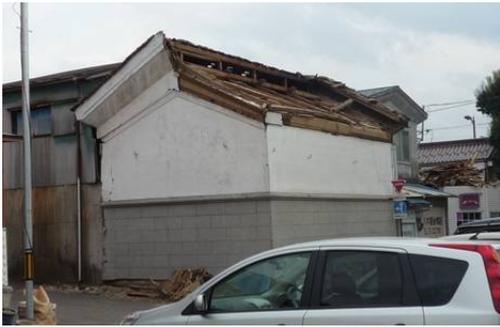
Photo 6.2-48 Fallen roof of warehouse with mud wall

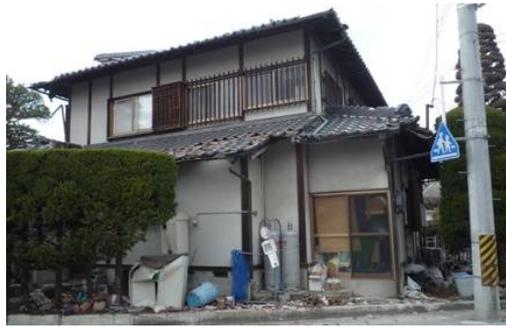
Photo 6.2-49 Damage on roof tile

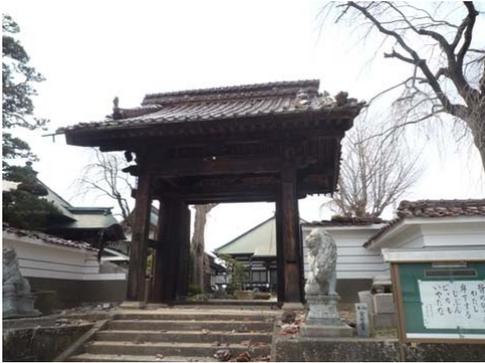
Photo 6.2-50 Minor damage of temple gate

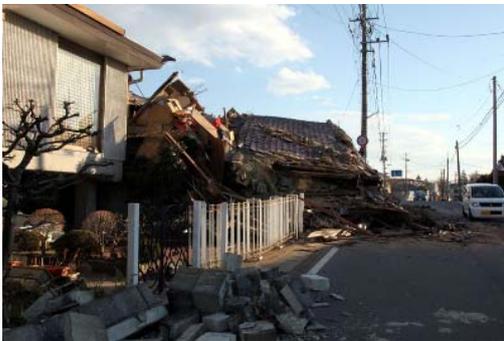
temple was not so damaged (Photo 6.2-50 and 51). The sand eruptions caused by the soil liquefaction and the damage on the roof tiles were seen here and there in Minami-machi, Sukagawa city. In addition, on the web site of the city, the collapsed house was reported (Photo 6.2-52, From the city website).

Photo 6.2-52 Collapsed wood house at Minami-machi (From Sukagawa city website)

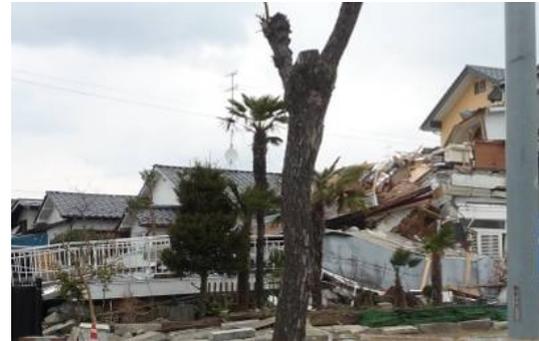
Another collapsed building with uncertain structural type was found (Photo 6.2-53). According to the damage overview seen from the east of Minami-machi (Photo 6.2-54), it was observed that the wood houses with roof covered temporarily with blue vinyl sheet which was guessed to be damaged to roof tiles were many relatively.

Photo 6.2-53 Collapsed building (Unknown structure type)

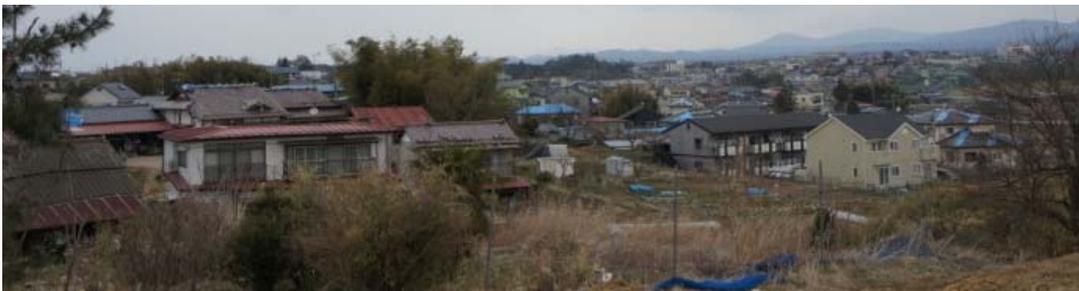
Photo 6.2-54 Damage overview from the east of Minami-machi (Many roofs covered with blue vinyl sheet)

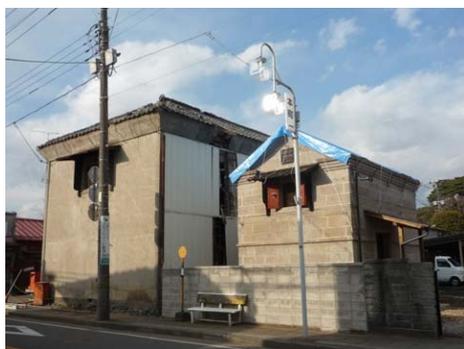
The stone-built warehouse was heavily damaged near the town office (Photo 6.2-55). The exterior stonewall of the former post office was failed (Photo 6.2-56).

Photo 6.2-55 Damage of stone-built warehouses

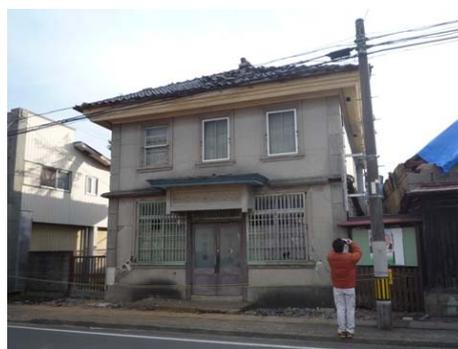
Photo 6.2-56 Damage of old post office

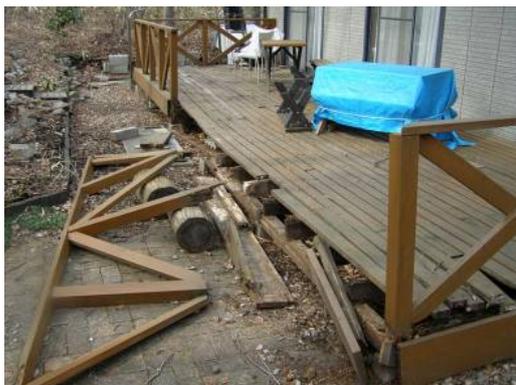
Toyohara-Otsu area is in the north of Nasu Town, and cottages are built along the path on slightly elevated hills. The movement and collapse of the wood deck (Photo 6.2-57) and collapse of the stone exterior were often observed. The several damages on wood houses caused by the slope land or the embankment were observed. The damage on the wood house due to large ground deformation caused by the earthquake motion was also found (Photo 6.2-58). It was confirmed that the metal fasteners were installed in the column end joint and the brace end joint of this house. (Photo 6.2-59). Besides the story drift, the crack of concrete foundation (Photo 6.2-60), the crack and loss of the exterior siding board, the broken window glass, and the failed ceiling of eaves (Photo 6.2-61) were observed.

Photo 6.2-57 Damage of wood deck in Toyohara-Otsu, Nasu Town

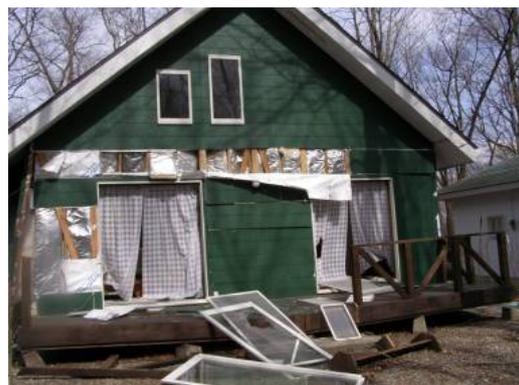
Photo 6.2-58 Heavily damaged wood house

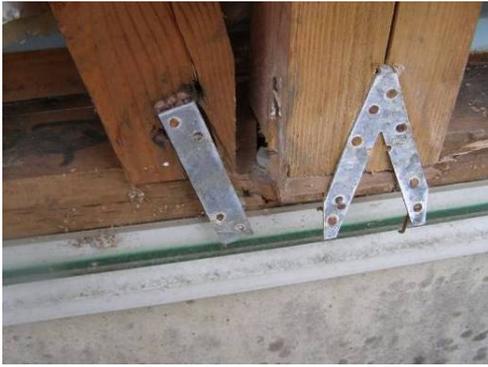
Photo 6.2-59 Metal fastener at the end of column and brace

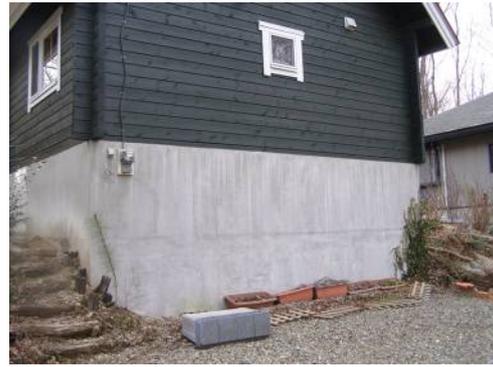
Photo 6.2-60 Crack of foundation

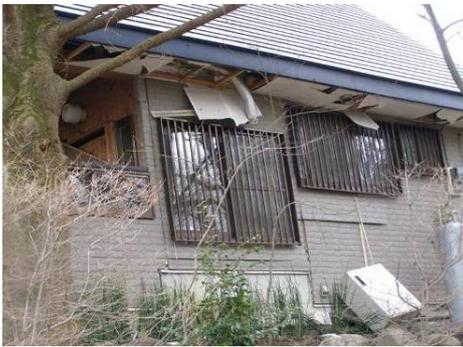
Photo 6.2-61 Failed ceiling of eave

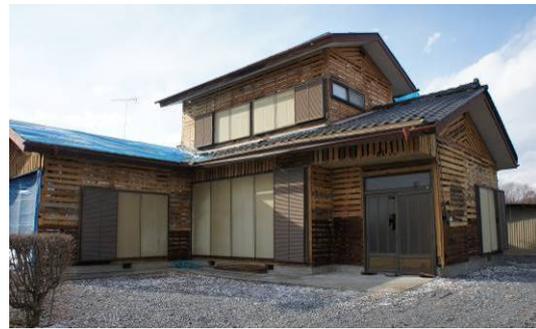
In Nishi-Ohkubo area, the several wood houses whose exterior mortar wall in the 1<sup>st</sup> floor was almost failed were found (Photo 6.2-62). And, the wood house with large story drift (Photo 6.2-63) and the other one damaged due to deformation of the residential land (Photo 6.2-64) were found.

Photo 6.2-62 Damage of exterior mortar wall

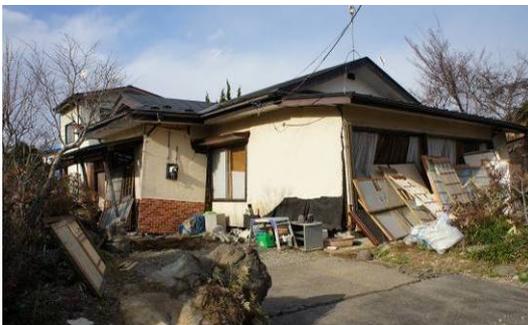
Photo 6.2-63 Wood house with large story drift

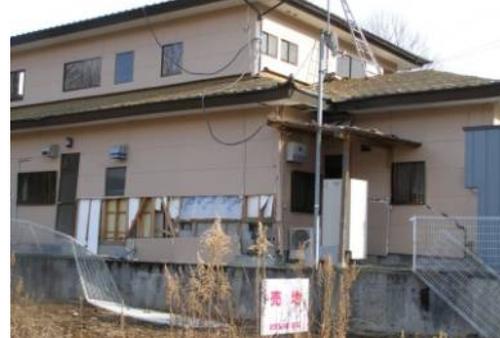
Photo 6.2-64 Damaged house due to deformation of residential land

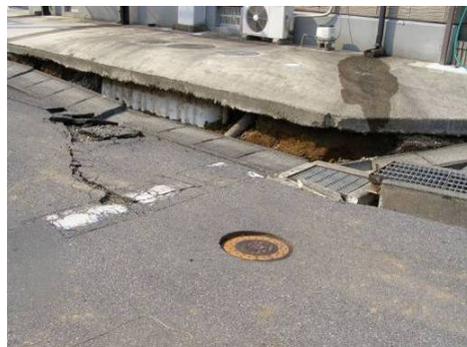
In Lobin-city (Photo 6.2-65), the cracks of fence and retaining wall, the caving of road bed, the ups and downs of the residential land (Photo 6.2-66) and the crack of the foundation concrete (Photo 6.2-67) were often observed. In addition, damage on the roof tile, especially top of the roof, and collapsed concrete block fences were observed.

Photo 6.2-66 Ups and downs of residential land

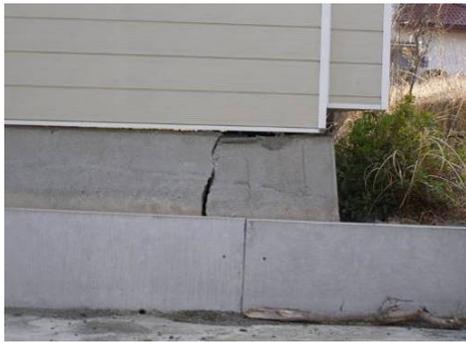
Photo 6.2-67 Crack of foundation

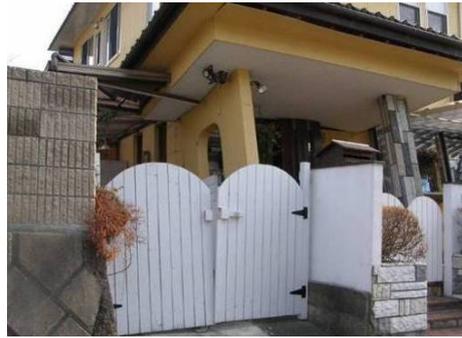
Narita-Happy-Highland at the north of Lobin-city was a developed residential land. Most of the damage on buildings was due to the deformation of the residential land. A wood house with 1/10 radian shear deformation (Photo 6.2-68) was found.

Photo 6.2-68 Wood house with large shear deformation

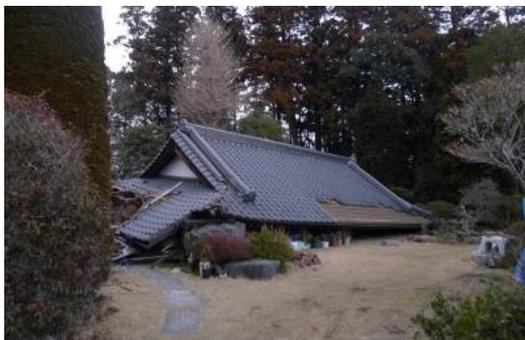
There were a lot of damaged fence made by the Ohyaiishi stone. A collapsed farm type house was observed (Photo 6.2-69, 6.2-70). The mortar plastered wall finish of the wood house at the land filled paddy field fell down (Photo 6.2-71).

Photo 6.2-69 Collapsed wood house

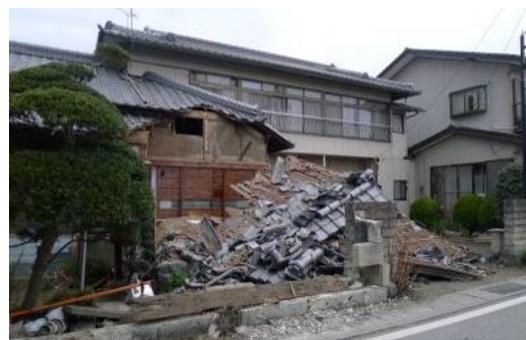
Photo 6.2-70 Breakage of entrance part.

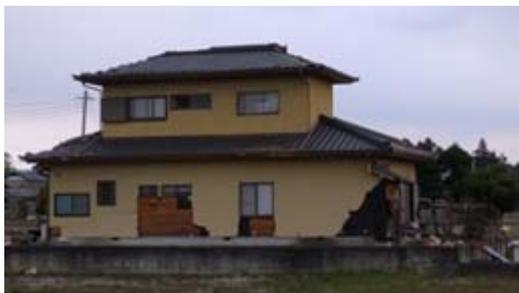
Photo 6.2-71 Falling down of mortar plastered wall

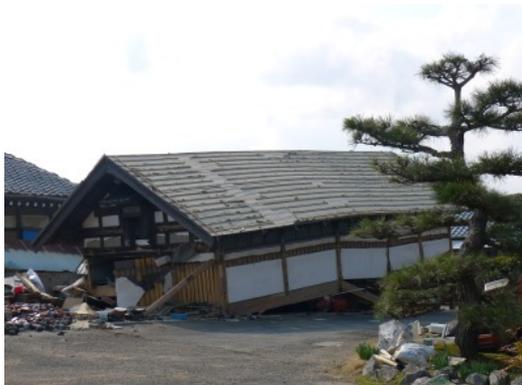
At Kadobeshimogawara in Naka city, there were a lot of collapsed barns (Photo 6.2-72) and heavily damaged nagayamon gates (Photo 6.2-73). A damaged house with store was observed (Photo 6.2-74). A lot of collapsed barns were observed at Kadobeakutsu.

Photo 6.2-72 Collapsed nagayamon gate (Kadobe)

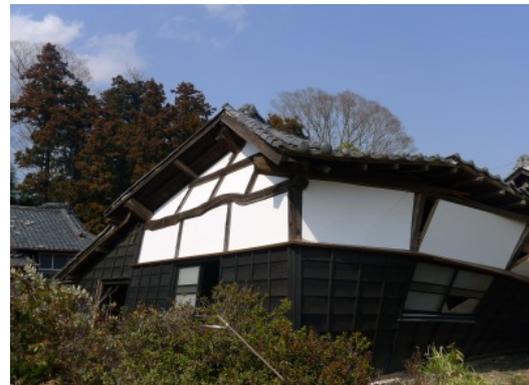
Photo 6.2-73 Tilted nagayamon gate (Kadobe)

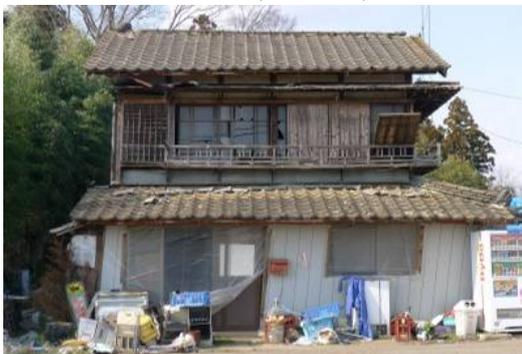
Photo 6.2-74 Damaged house with store (Kadobe)

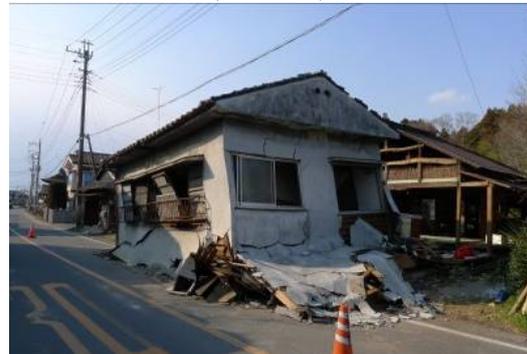
Photo 6.2-75 Collapsed house (Urizura)

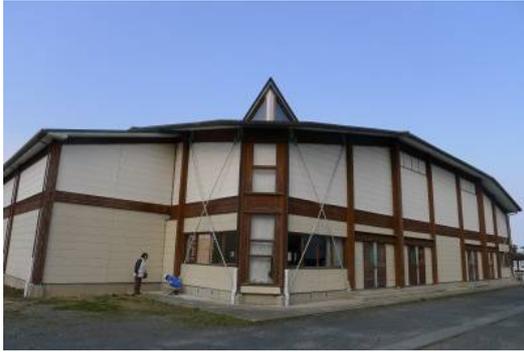
At the wood gymnasium (Photo 6.2-76, Photo 6.2-77) with curved glue laminated timber built in 1985-1989 in Urizura, buckling and tensile failure of the steel braces, the breakages of the foundation concrete at the brace joint were observed (Photo 6.2-78). At the wood school building (Photo 6.2-79), the slip of wood braces (Photo 6.2-80), the deformation of steel roof plate, wood flooring and interior material due to the contact with the stairway made by reinforced concrete were observed.

Photo 6.2-76 Wood gymnasium

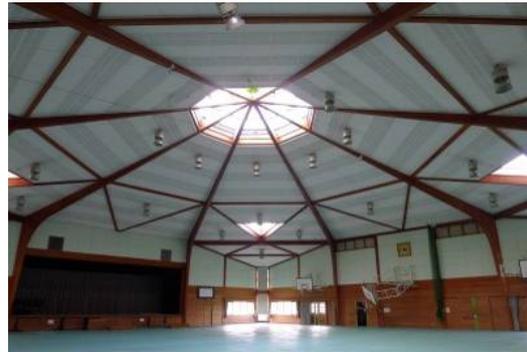
Photo 6.2-77 Inside of the gymnasium

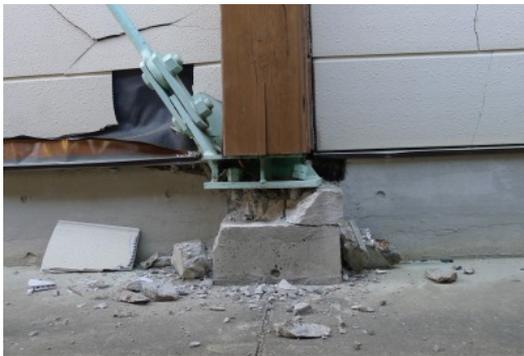
Photo 6.2-78 Breakage of the foundation concrete

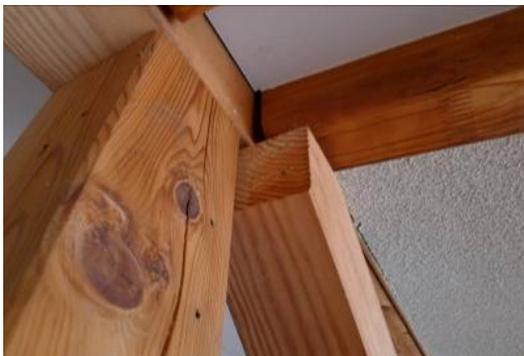
Photo 6.2-80 Slip of the wood brace

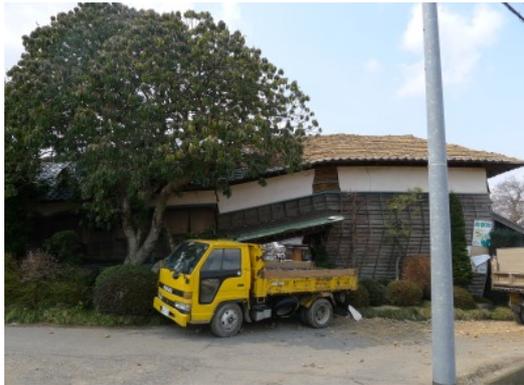
There was a heavily damaged Nagayamon gate at Yoshinuma-cho (Photo 6.2-81). The damaged barns were observed at Aoyagi-cho, Yanagawa-cho, Taya-cho (Photo 6.2-82).

Photo 6.2-81 Heavily damaged Nagayamon gate (Yoshinuma-cho)

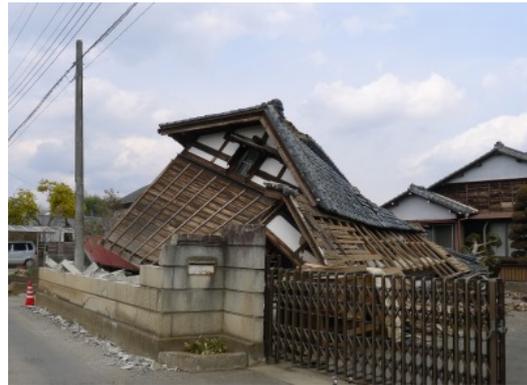
Photo 6.2-82 Damaged barn (Aoyagi-cho)

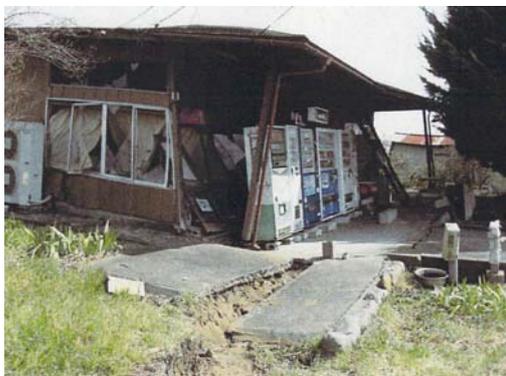
Photo 6.2-83 Damage of resting place (Joja-machi, offered by Joso city office)

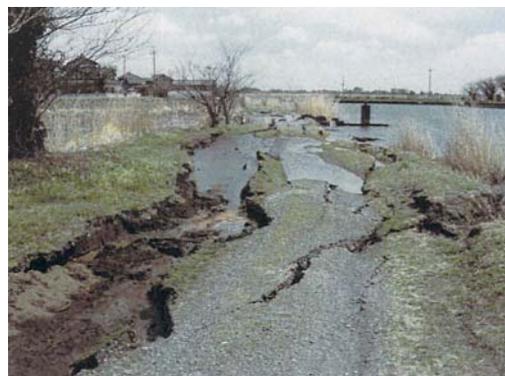
Photo 6.2-84 Damage of ground near the resting place (offered by Joso city office)

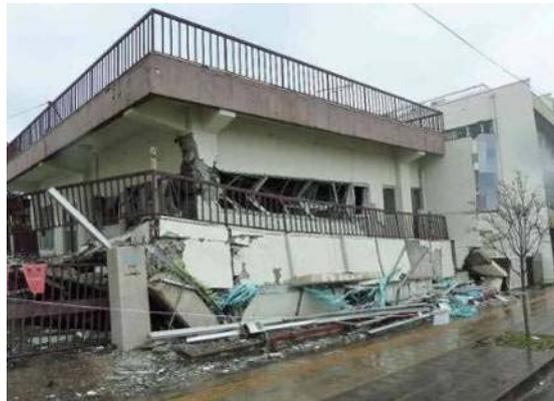
The first story in a two-story RC office building shown in Photo 6.3-1 was completely collapsed in Wakabayashi ward, Sendai city. In addition, the shear failure and the axial deformation of the columns on the second floor of this building caused the buckling of the longitudinal reinforcements and the fracture of the hoops of columns in the first story.

Photo 6.3-1 First-story collapsed building (Wakabayashi ward, Sendai city)

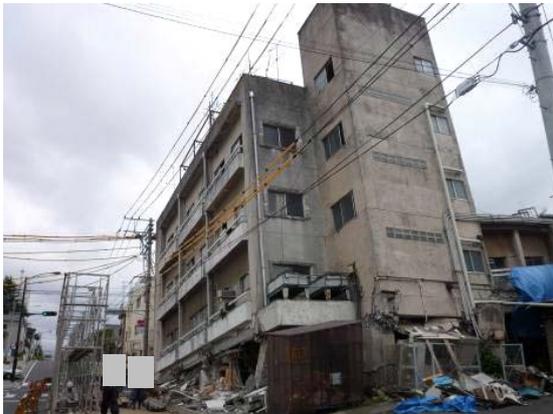
The soft-first story collapse occurred on the four-story RC residential building with a shop in the first floor in Koriyama city, and is attributed to the shear failure of the columns on the first story and the torsional deformation (Photos 6.3-2 and 6.3-3). The RC shear wall on the first story was collapsed out-of-plane with buckling of reinforcing bars.

Photo 6.3-2 First-story collapsed building (Koriyama city)

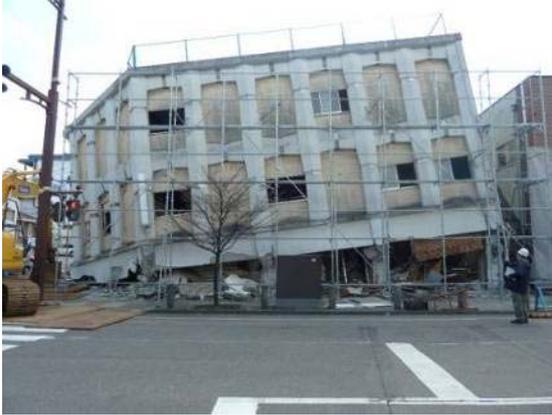
The three-story RC building shown in Photo 6.3-4 was severely damaged on the first story, which was located at the intersection in Sukagawa city, had a few walls on the facade on the first story and many walls on the back of the first story and the second story and higher. The corner columns faced to the intersection were significantly destroyed as shown in Photo 6.3-5. The loss of axial load carrying capacity of the first-story columns caused the drop of the second and higher stories.

Photo 6.3-4 First-story collapsed building (Sukagawa city)

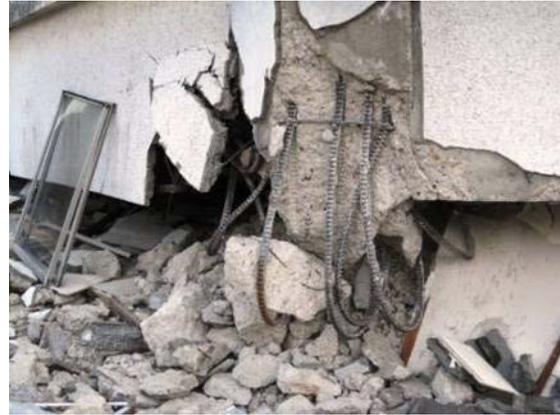
Photo 6.3-5 Close-up view of the fallen story

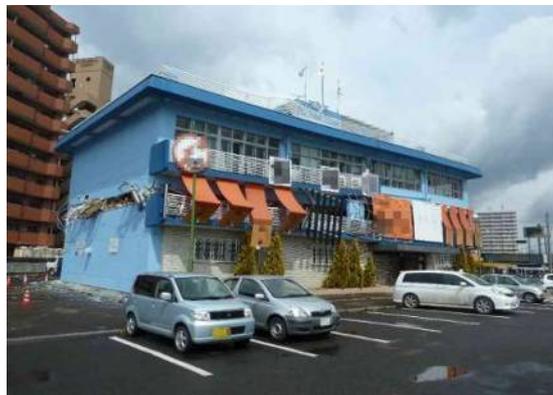
The three-story office building shown in Photo 6.3-6 in Wakabayashi ward, Sendai city partially collapsed on the second story and the building tilted. Only the second story has openings on the wall at the gable side, as shown in the left of Photo 6.3-6. For this reason, it was assumed that the openings were intensively deformed and resulted in shear failure of the short columns formed by the hanging and spandrel walls. The shear failure of the long columns on the third story was observed possibly due to the effect of the collapse of the second story. The damage to the columns and beams on the first story was not seen, while shear cracks were observed on the nonstructural walls.

Photo 6.3-6 Mid-story collapsed building (Wakabayashi ward, Sendai city)

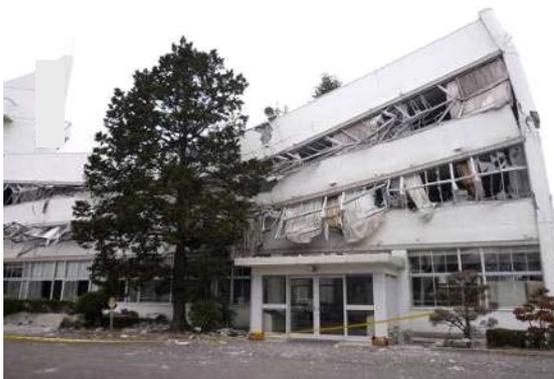
1966 and has a Y-letter shape plan in Fukushima city. The mid-story collapse occurred on the second story, and the part of the third story was heavily damaged. In addition, the shear failure also occurred on the columns in the first story, as shown in Photo 6.3-8. Visual damage was not seen in other school buildings and the gymnasium on the same site. The seismic indices of the structure,  $I_S$  on the first and second stories of the building were below the seismic demand index of structure,  $I_{S0}$  by the seismic evaluation method <sup>6.3-1)</sup>, therefore the seismic retrofit of the building was being planned.

Photo 6.3-7 Mid-story collapsed building (Fukushima city)

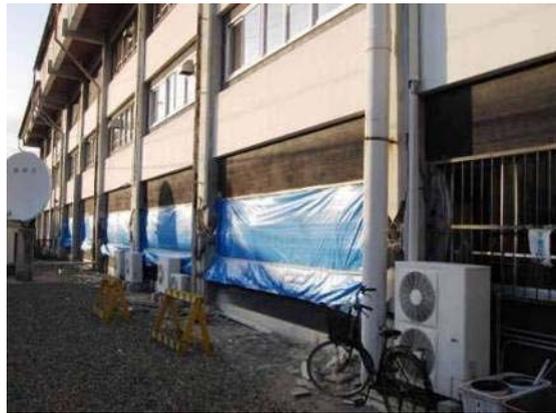
The three-story RC building constructed in 1963 was suffered from the shear failures of columns in Tono city, where the JMA seismic intensity was 5 upper (5+) (Photo 6.3-9). Two extremely short columns on the first-story, four columns on the northern plane of structure and an interior shear wall were failed in shear as shown in Photo 6.3-10, and short columns with spandrel wall, some long columns on the southern plane of structure had shear cracks. The post-earthquake damage evaluation <sup>6.3-2)</sup> was conducted for the building in the longitudinal direction. In the result, the building was determined to represent heavy damage (residual seismic performance ratio,  $R=57.8\%$ ). The building had been damaged in the South Sanriku Earthquake in 2003 (JMA seismic intensity 6 lower). For this reason, cover concrete was then recast on the shear-cracked columns, and the existing columns were temporary strengthened with H-shaped steel, as shown in Photo 6.3-11. However, the 2011 Tohoku earthquake affected these columns again.

Photo 6.3-9 Appearance of the damaged building (Tono city)

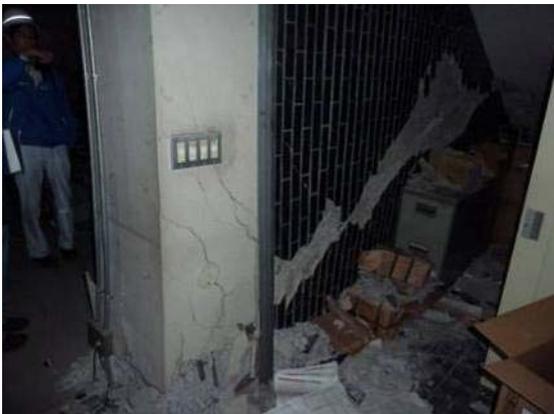
Photo 6.3-10 Shear crack on shear wall

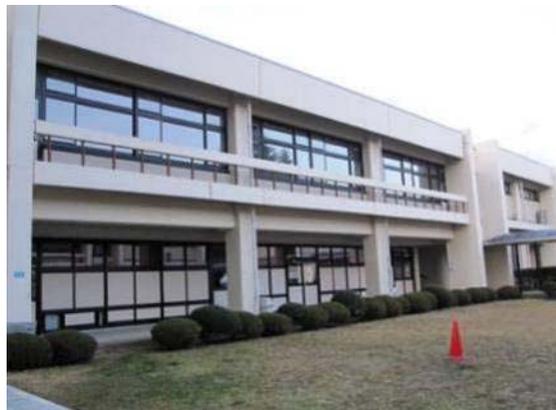
The next case is that the shear failure occurred on the first-story columns in the two-story RC building in Aoba ward, Sendai city (Photos 6.3-12 and 6.3-13). Some columns of the building were intact after the mainshock on March 11, but aftershocks caused shear failure to some of them, as shown on the right of Photo 6.3-13. It was confirmed that the aftershocks accelerated the damage level of this building.

Photo 6.3-12 Appearance of the damaged building (Aoba ward, Sendai city)

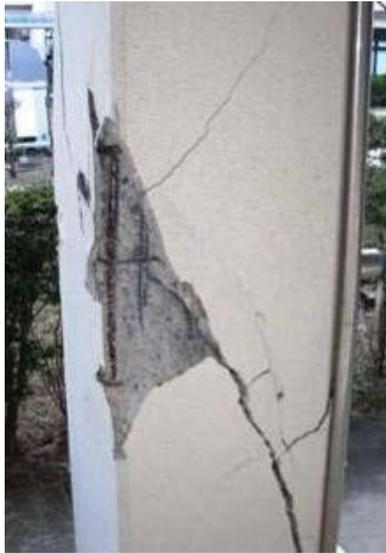
Photo 6.3-13 Shear cracks of first-story columns

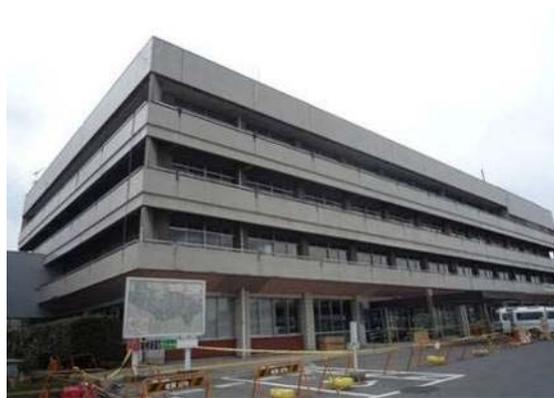
Photo 6.3-14 shows the four-story RC building that was constructed in 1970 in Sukagawa city. The columns with the spandrel wall on the first story were heavily damaged in shear and shorten in the axial direction as shown in Photo 6.3-15. The same damage was seen on the second-story exterior columns. Some of the reinforcing bars of the damaged columns that were raised from the foundation are anchored with a 180-degree hook near the mid height of story. It is considered that the shear failure began at the point. Two shear walls were severely damaged, which are arranged in the center core of the building to resist mainly horizontal forces. In particular, the second-story core wall was failed in shear in both of the span and longitudinal directions, and the longitudinal reinforcements in the boundary column of shear wall were heavily buckled as shown in Photo 6.3-16.

Photo 6.3-14 Appearance of damaged building (Sukagawa city)
