**Technical Note of National Institute for Land and Infrastructure Management**

**BRI Research Paper**

**Summary of the Field Survey and Research on  
“The 2011 off the Pacific coast of Tohoku Earthquake”  
(the Great East Japan Earthquake)**

National Institute for Land and Infrastructure Management (NILIM)  
Ministry of Land, Infrastructure, Transport and Tourism, Japan

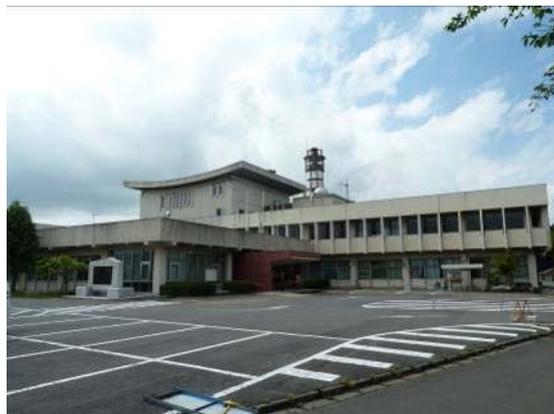
The three-story RC building constructed in 1964 on a hill in Kasama city shown in Photo 6.3-17 suffered also damage. Cracks in the ground were observed around the building. As seen in the photo, the RC structure on the first story was severely damaged. Shear failure occurred on many exterior columns, which were made shorter in clear height by the hanging and spandrel walls without structural slit, as shown in Photo 6.3-18. In addition, the failures of the shear walls with openings were observed (Photo 6.3-19).

Photo 6.3-17 Appearance of damaged building (Kasama city)

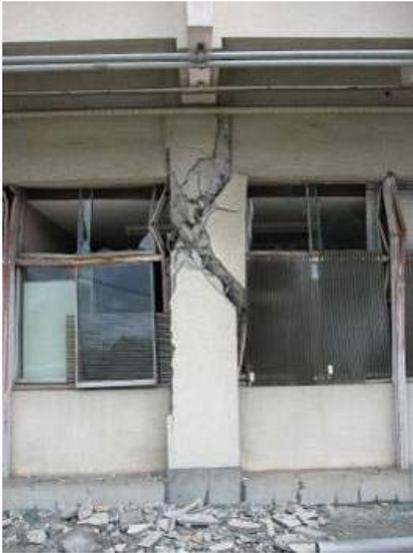
Photo 6.3-18 Shear failure of column

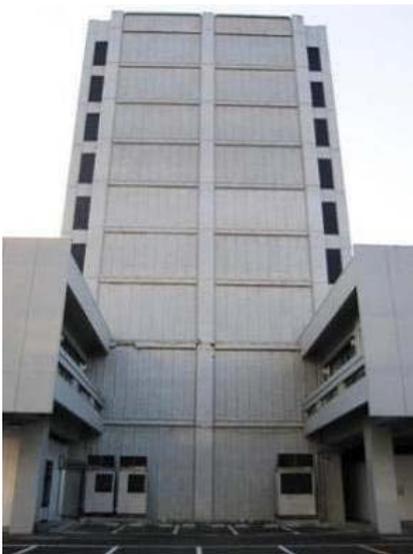
The building that consists of nine-story SRC and two-story RC structures in Aoba ward, Sendai city suffered from the earthquake (Photo 6.3-20). In the high-rise building, the multi-story shear wall of the gable side was subject to flexural failure at the third floor. Crushing of concrete and buckling of the longitudinal reinforcements was observed at the bottom of the boundary column of shear wall, as shown in Photo 6.3-21. This building was also damaged by the Miyagiken-oki Earthquake in 1978 and had been retrofitted.

Photo 6.3-20 Appearance of damaged building (Aoba ward, Sendai city)

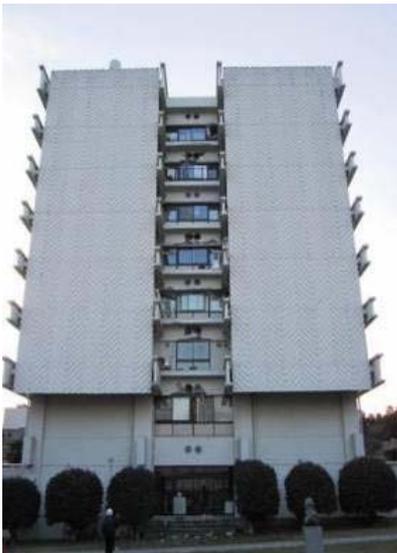
The shear failure or bond splitting failure occurred on the link beam connecting coupled shear walls from low-rise to high-rise stories on the eight-story RC building in Aoba ward, Sendai city, as shown in Photo 6.3-27. The link beams have two openings at the center of them, and were damaged around these parts (Photo 6.3-28).

Photo 6.3-27 Appearance of damaged building (Aoba ward, Sendai city)

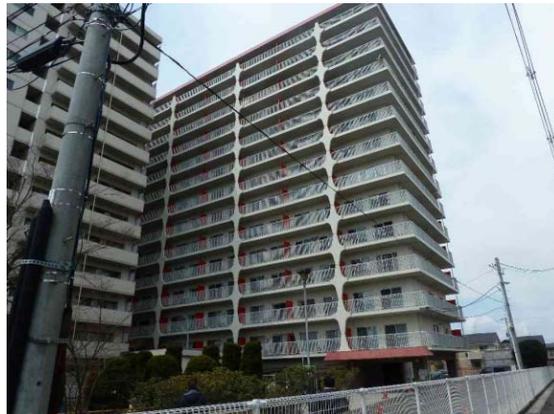
The fourteen-story RC building shown in Photo 6.3-29 was settled down and was tilted about 1/70 radian, which was one of two residential buildings located in L-shape with expansion joint in Miyagino ward, Sendai city. The shear cracks on the nonstructural walls over every story and some parts of mullions occurred in both buildings as shown in Photos 6.3-30 and 6.3-31, which damage was classified as B-2. Though the other building without inclination had same shear cracks on the nonstructural walls from first to sixth story in the Miyagiken-oki Earthquake in 1978 and had been repaired with concrete replacement, almost same damage was happened on the similar part.

Photo 6.3-29 Appearance of tilted building (Miyagino ward, Sendai city)

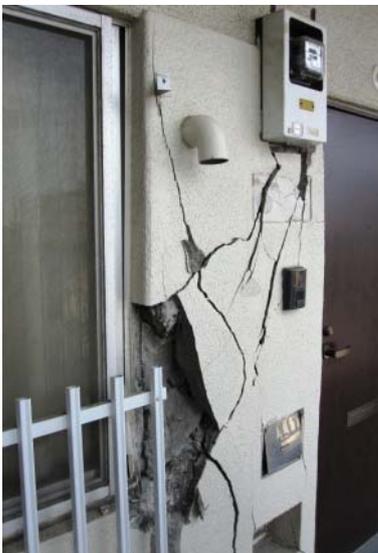
Photo 6.3-30 Shear cracks on nonstructural wall

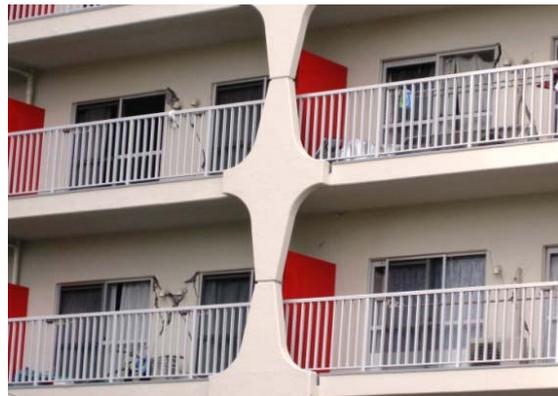
Photo 6.3-31 Shear cracks on mullion

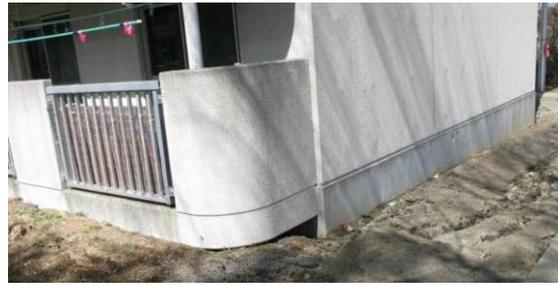
Photo 6.3-32 shows a residential building that sank and leaned in the longitudinal direction in Shirakawa city. The balcony, of which height above ground level was about 77cm, went down to ground surface in the gable side, as shown in Photo 6.3-33.

Photo 6.3-33 Sunken balcony

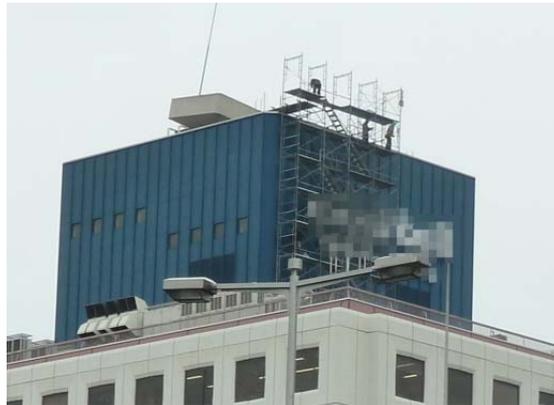
The damage on penthouses was observed everywhere, like tilting of it in Aoba ward, Sendai city, as shown in Photo 6.3-34. The clock tower attached to the five-story RC building constructed in 1954 was destroyed at the bottom of it, despite the building was hardly damaged in Fukushima city (Photos 6.3-35 and 6.3-36).

Photo 6.3-34 Damaged penthouse (Aoba ward, Sendai city)

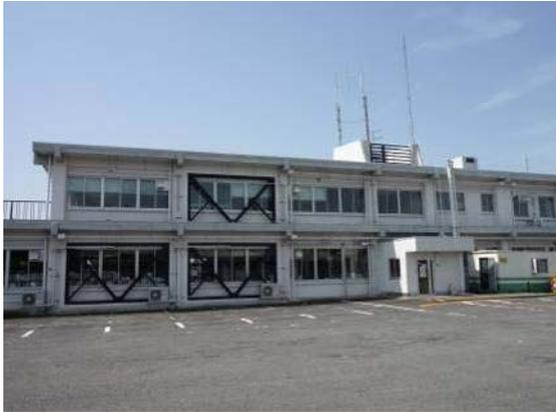
Photo 6.3-37 shows the two-story RC office building constructed in 1969 in Hitachiomiya city. The building has been retrofitted with framed steel braces in the longitudinal direction in 2003, because the seismic index of structure,  $I_S$  on the first story of the building was below the seismic demand index of structure,  $I_{S0}$  by the seismic evaluation method <sup>6.3-1)</sup>. Meanwhile, the building in the span direction was not retrofitted, as a consequence of that the seismic index of structure in the direction satisfied the seismic demand index of structure. The steel braces are eccentrically installed to the center axis of the beams and columns.

Photo 6.3-37 Appearance of damaged building (Hitachiomiya city)

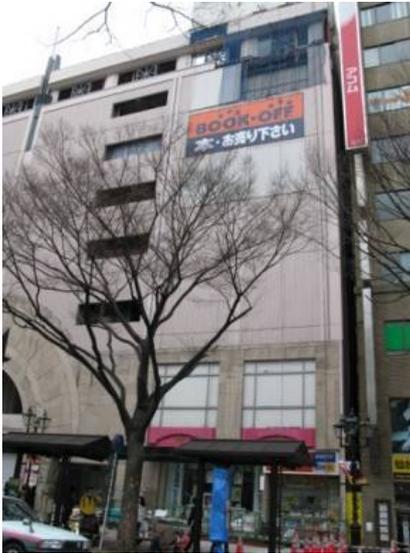
These kinds of damage relatively often occurred on buildings without structural damage, not limited to specific areas. Despite of the construction period and the seismic design codes applied to, these damage are often seen on many buildings.

Photo 6.3-47 Damaged building with AAC panels (Aoba ward, Sendai city)

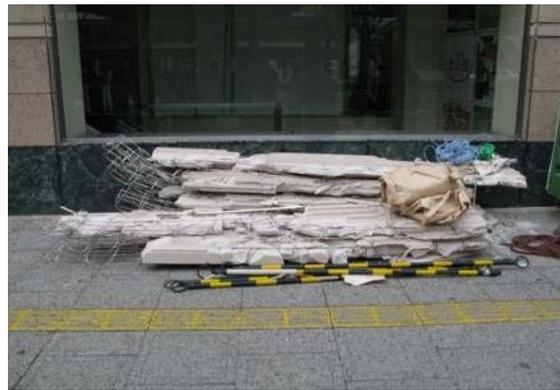
panel on the upper floor in the eight-story building fell away, and Photo 6.3-49 is the case where the tile on exterior wall was dropped, in Aoba ward, Sendai city.

Photo 6.3-48 Dropped AAC panels

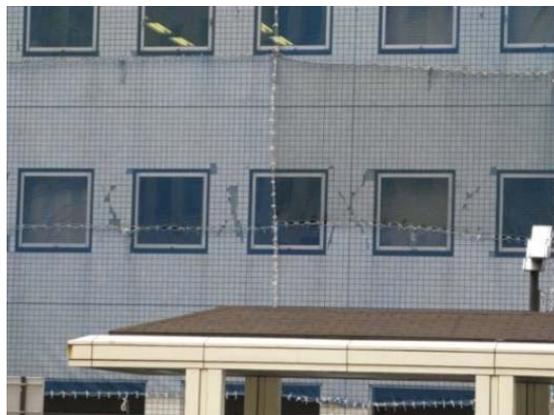
Photo 6.3-49 Damage of tile on exterior wall

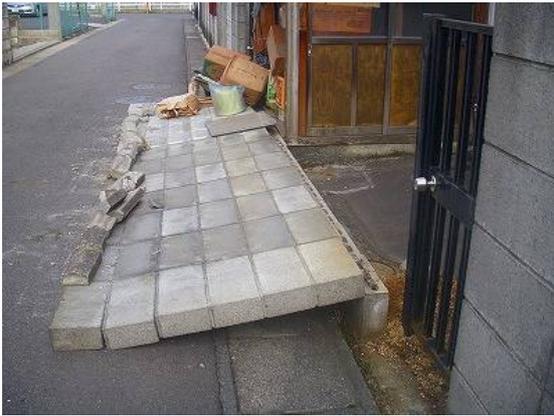
The collapse of concrete block wall and stone masonry wall are well known as earthquake damage caused by strong seismic motion. The damage of that type was often observed in the field investigation, as shown from Photo 6.3-50 to Photo 6.3-53.

Photo 6.3-50 Collapse of concrete block wall (Koriyama city)

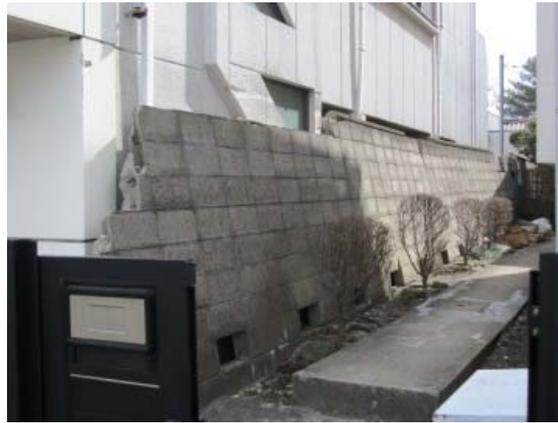
Photo 6.3-51 Collapse of concrete block wall (Sukagawa city)

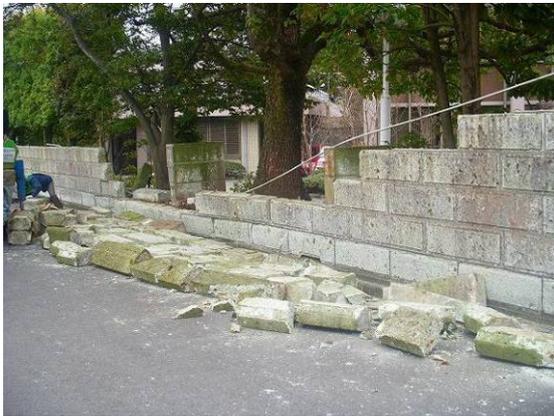
Photo 6.3-52 Collapse of stone masonry wall (Fukushima city)

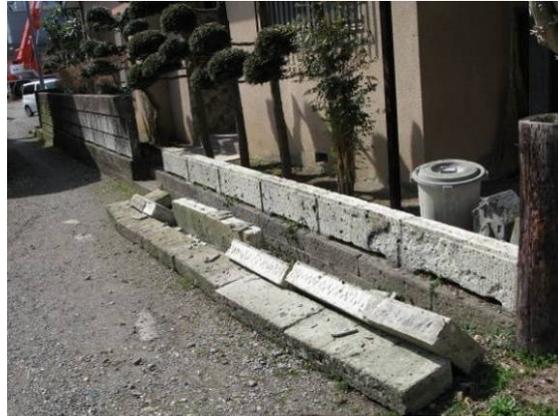
Photo 6.3-53 Collapse of stone masonry wall (Shirakawa city)

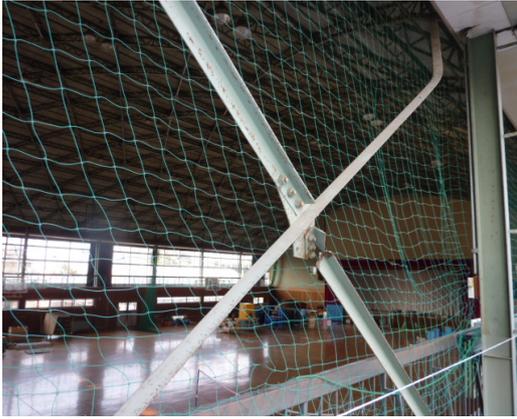
Buckling of brace member (Photo 6.4-1) and fracture of brace joint (Photos 6.4-2 ~ 6.4-4) were observed. Angle section was often used for many brace members, but circular hollow section steel (Photo 6.4-3) was also used for brace members. Fractured sections include steel plate inserted into steel pipe, end of bracing member and section loss part by bolt hole. These types of the damage are classified into the severe damage category based on the damage evaluation standard<sup>6.4-4)</sup>. The number of the gymnasiums of this type is 3. The gymnasiums constructed under the previous seismic code that were severely damaged by the Mid Niigata Prefecture Earthquake in 2004 had accounted for about 30% of the total<sup>6.4-1)~6.4-3)</sup>. It is impressed that a rate of the gymnasiums severely damaged by the 2011 Tohoku earthquake was lower than by the Mid Niigata Prefecture Earthquake in 2004.

Photo 6.4-1 Buckling of brace

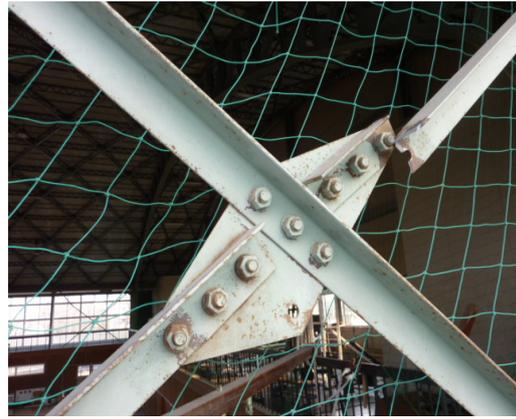
Photo 6.4-2 Net section fracture at bolt hole

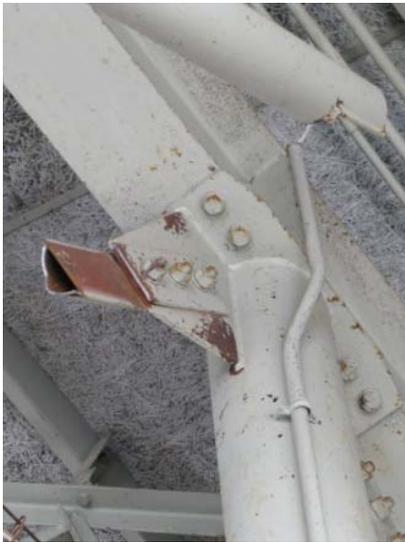
(a) Fracture at column top

Photo 6.4-3 Fracture of brace welded connection

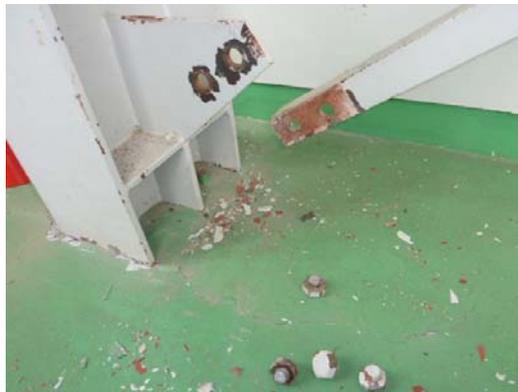
Photo 6.4-4 Fracture of bolts

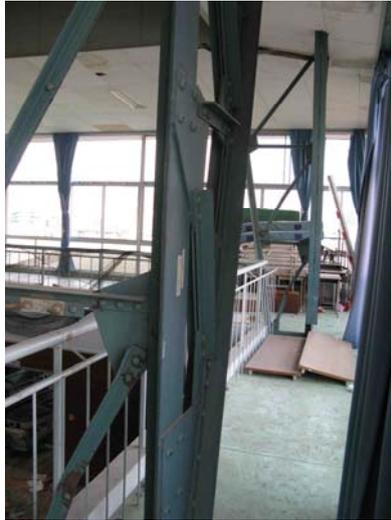
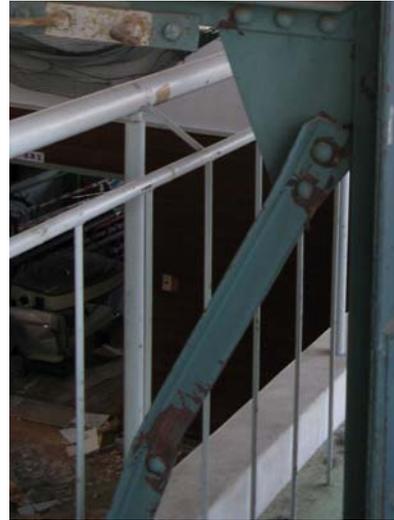
In one of the investigated gymnasiums, buckling of diagonal members in some latticed columns was observed (Photo 6.4-5). Damage of column buckling caused in steel frames for span direction had not been observed under the damage investigations of the Mid Niigata Prefecture Earthquake in 2004<sup>(6.4-1)~(6.4-3)</sup>.

Photo 6.4-5 Buckling of diagonal member of latticed column

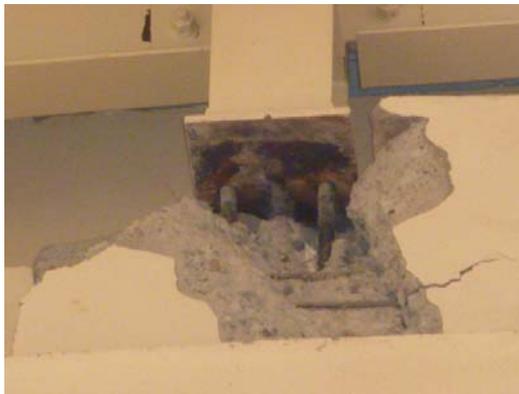
In the investigated gymnasiums, exposure of anchor bolts due to spalling of the concrete at connection (bearing support part) between the RC column and steel roof frame (Photos 6.4-6 and 6.4-7), spalling of finish mortars on the RC column at the roof bearing support part, and pullout of hole-in anchors (Photo 6.4-8) were often observed.

Photo 6.4-6 Spalling of concrete

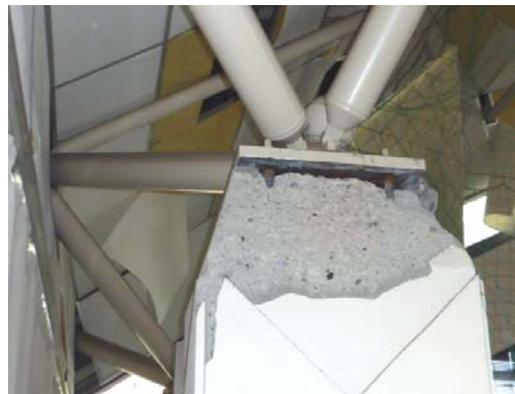
Photo 6.4-7 Spalling of concrete

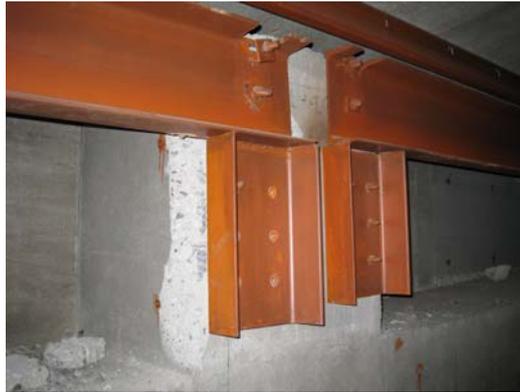
Photo 6.4-8 Pullout of hole-in anchors

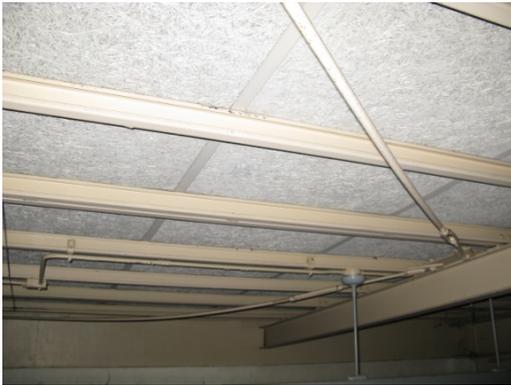
Roof horizontal braces were damaged in two high school gymnasiums and five elementary and junior high school gymnasiums. Such damage mainly occurred at horizontal braces with turnbuckles; obvious deflection of the horizontal brace (Photo 6.4-9) and fracture at thread and fracture of bolt connections were observed (Photo 6.4-10).

Photo 6.4-9 Deflection of horizontal braces

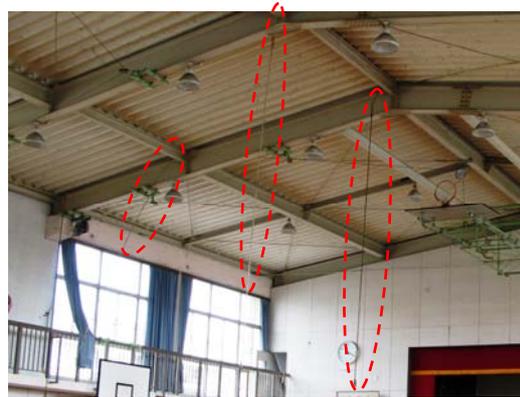
Photo 6.4-10 Fracture of horizontal braces

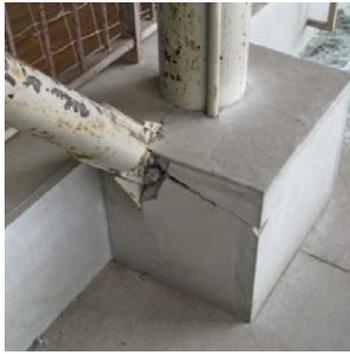
Damage of cracking of the column base concrete and mortar in the gallery of some gymnasiums was observed (Photo 6.4-11). Concrete and mortar of steel column base at a ground level was also cracked (Photo 6.4-12). However, almost all of these cracking are classified into minor or slight damage.

Photo 6.4-11 Cracking of column base concrete

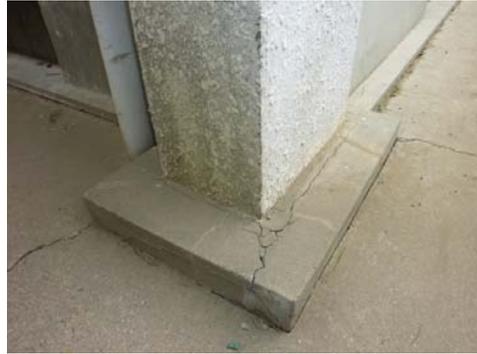
Photo 6.4-12 Cracking of column base concrete

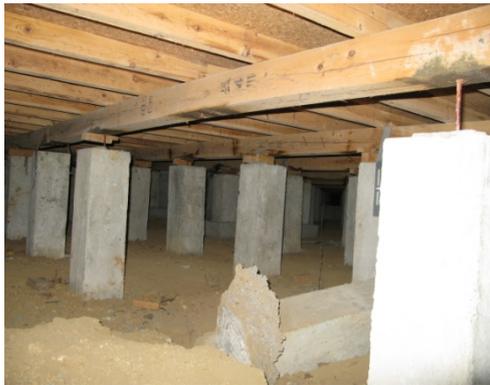
As the other types of the structural damage, the following damage was observed; (a) overturning of floor strut (Photo 6.4-13), (b) tilting of concrete block self-standing wall and (c) peeling of paint of beam members which was observed near the top of the V-shaped roof beams or arch beams (Photos 6.4-14 and 6.4-15). In terms of the peeling of paint, it is uncertain whether yielding of the beams occurred or not.

Photo 6.4-13 Overturning of floor strut

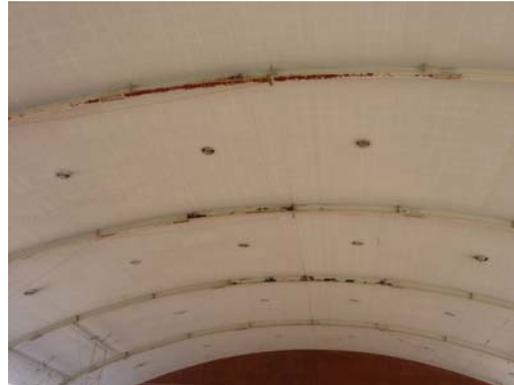
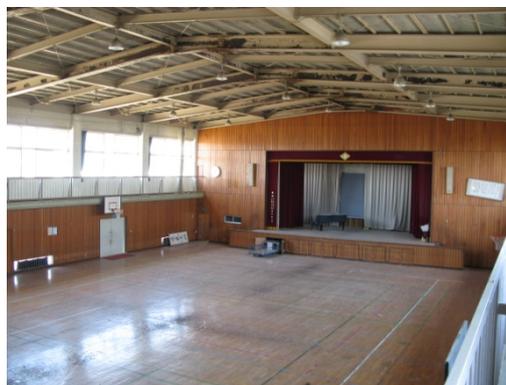
Photo 6.4-14 Peeling of paint of beams

Photo 6.4-15 Peeling of paint of beams

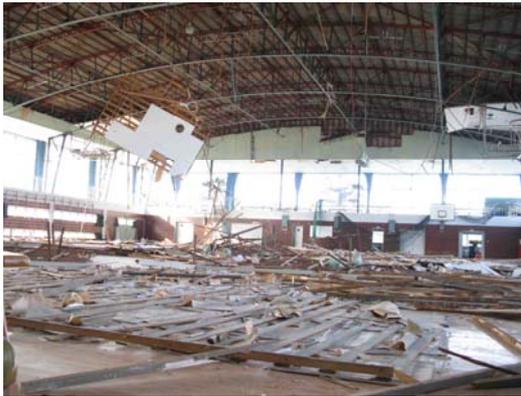
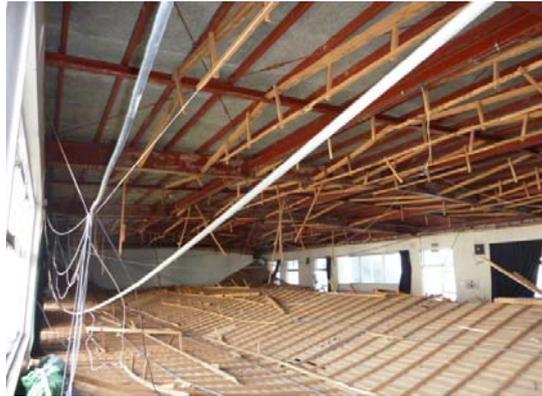
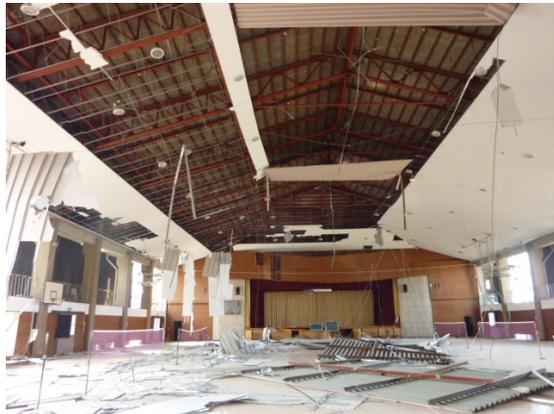
The types of nonstructural damage of gymnasiums include dropping of ceilings and lighting equipment (Photos 6.4-16 ~ 6.4-18), breakage of windows (Photo 6.4-19), dropping of exterior walls (Photo 6.4-20), dropping of interior walls and eave soffit (Photo 6.4-21). In particular, the severe damage such as dropping of extensive ceiling in the high school gymnasiums was observed more than in the elementary and junior high school gymnasiums.

Photo 6.4-16 Dropping of extensive ceiling components

Photo 6.4-17 Dropping of extensive ceiling components

Photo 6.4-18 Dropping of extensive ceiling components

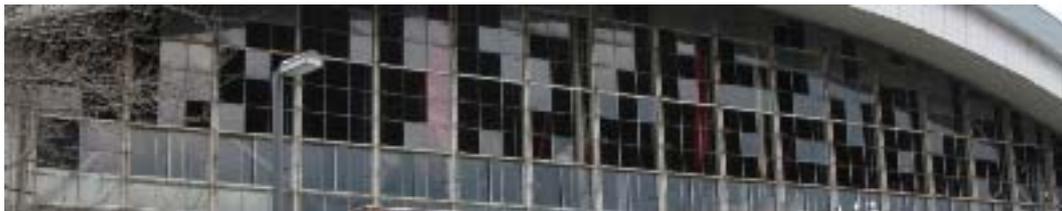
Photo 6.4-19 Breakage of windows

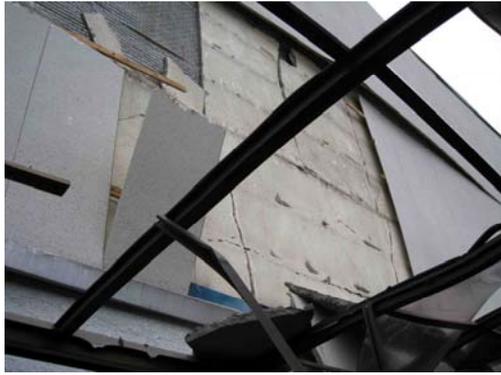
Photo 6.4-20 Falling of exterior finish components

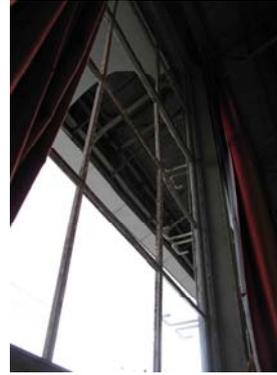
Photo 6.4-21 Falling of eave soffit

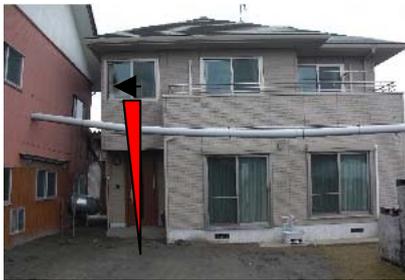
Photo 6.5-2 House tilted 5.0/100

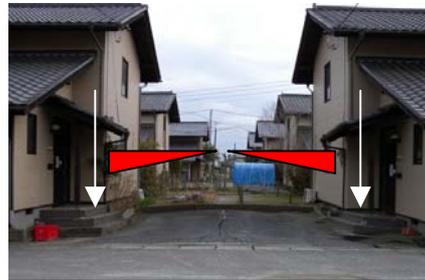
In Hinode, large-scale damage occurred in the area of about 200 m by 200 m along the Hitachi-tone River. Boiled sand, uplift of buried structures, and subsidence or tilting of utility poles, which were caused by liquefaction, were seen everywhere on the site. Many houses facing to the road subsided 20 to 30 cm from the front sidewalk (Photo 6.5-3). Foundation cracks or gaps were not observed.

Photo 6.5-3 Subsidence of two houses enclosing vacant land

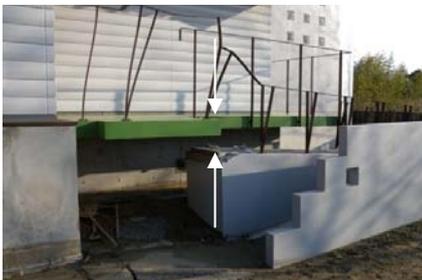
Photo 6.5-4 Slope difference in level

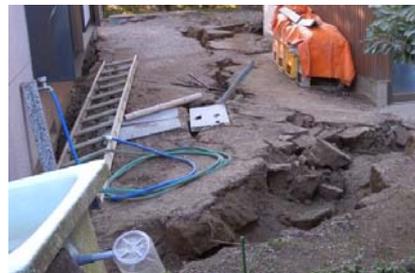
ground and caused about 30 cm of difference in level from the ground (Photo 6.5-5). Cracking or crack fissures on the foundations were not visually observed.

Photo 6.5-5 Crack in the site

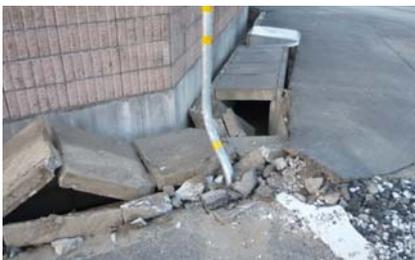
Photo 6.5-6 Damage of side ditch

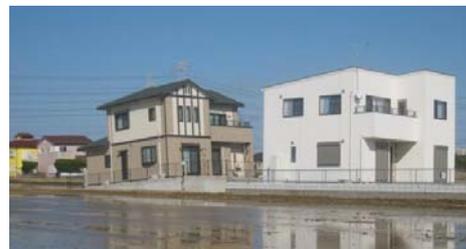
Fukashiba is located in the western part of Kamisu city and on the opposite side of Horiwai along Route 124. In this area, many houses were damaged due to ground deformation and embankment deformation. Most of the damage patterns of the houses seem to have included their movement, subsidence and tilting without structural damage on their upper structures or foundations (Photo 6.5-7).

Photo 6.5-7 Damage situations by liquefaction

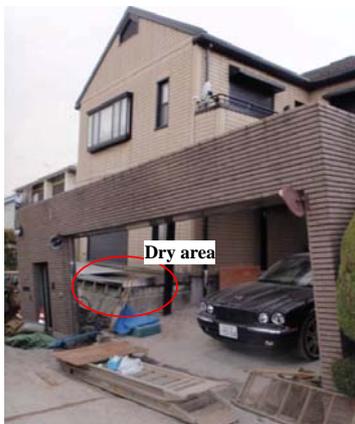
In Mihama, subsidence and tilting were observed in houses that have a dry area in the basement (Photo 6.5-8). An angle of tilting of the house was about 3 degrees. It is considered that the basement was uplifted and another remaining parts of the house was subsided. Around the house, in-site of house was totally covered with boiled sand by liquefaction, and a foundation of fence at site boundary was deformed. In addition, a carport in one building was ruptured and moved (Photo 6.5-9). A unit of the carport and the building was separated and moved about 50 cm due to the movement of the ground associated with liquefaction.

Photo 6.5-8 Tilted house

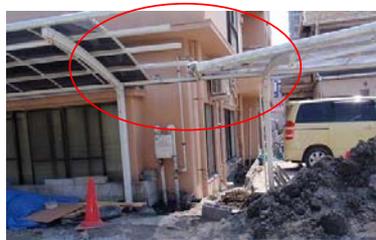
Photo 6.5-9 Moved carport

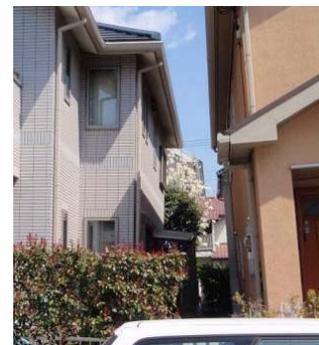
Significant tilting and subsidence of houses was observed at a zone in Benten (Photo 6.5-10). In another zone, the ground subsided by liquefaction, there were damage to which the road waved and a 10 cm of difference in level was generated between a side ditch and the road. These types of damage were concentrated on an extension line of the boundary between the sites of tilted houses. Inhabitants told us that there was an old river on a straight line where the damage was concentrated.

Photo 6.5-10 Settled and tilted house

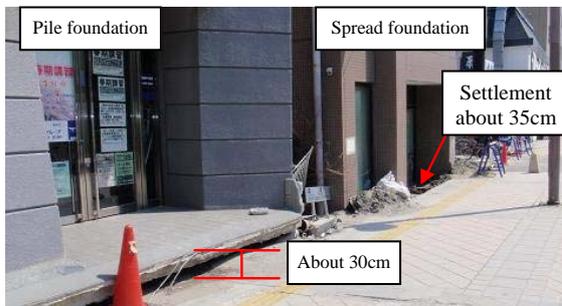
In Irifune, a difference in settlement between adjacent buildings on spread and pile foundations was observed. The building on spread foundation settled about 35 cm from the front sidewalk, while the case of building on pile foundation was about 30 cm of difference in level from the front sidewalk (Photo 6.5-11). Other settled and tilted buildings were dotted.

Photo 6.5-11 Difference in damage due to support mechanisms

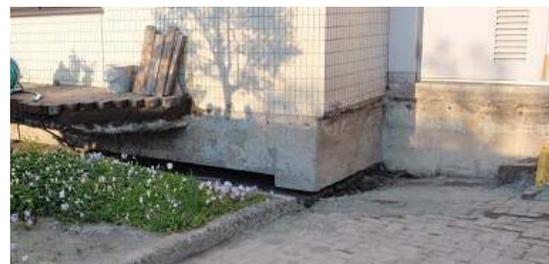
In Hinode, the ground subsidence was observed (Photo 6.5-12). This building is considered to have a pile foundation. A relative gap between the building and ground was about 50 cm. Building lifeline was damaged due to ground subsidence and displacement.

Photo 6.5-12 Building with subsidence of surrounding ground

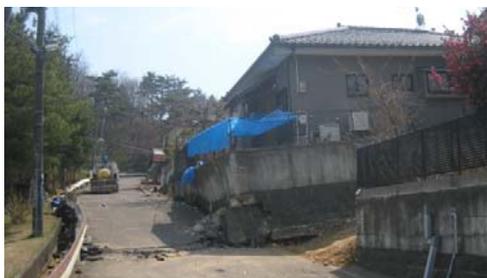
Photo 6.5-13 Damage to retaining wall and house by sliding and ground deformation

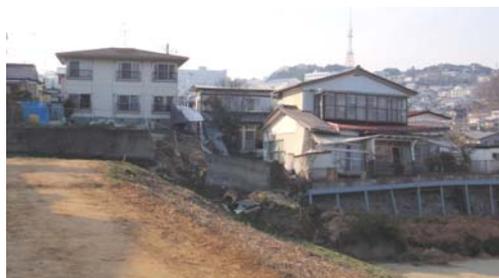
Photo 6.5-14 Group of houses damaged by sliding and ground deformation

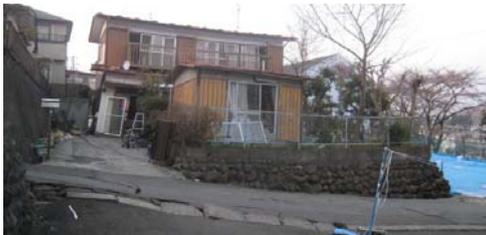
Photo 6.5-15 Damage to houses by sliding and ground deformation

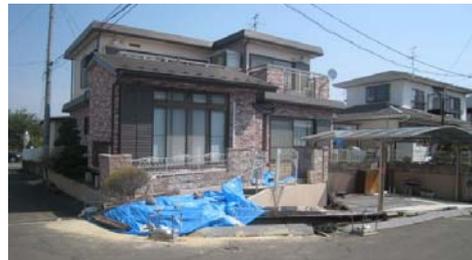
This is a housing area where a hill was developed. Fissures on the slope of the hill and near the top of the hill, and damage to housing foundations and retaining walls by deformation of the reclaimed area by banking, were observed in the area. The slope in 1-chome, Midorigaoka had been significantly collapsed under the 1978 Miyagi-oki earthquake. A level of ground deformation on the slope under the 2011 Tohoku earthquake was lower than that during the 1978 earthquake. Near at the top of the hill, ground deformation of the reclaimed area by banking caused fracture of the embankment retaining wall, damage to house foundations (Photo 6.5-16) and push-out of the retaining wall on embankment.

Photo 6.5-16 Houses damaged near the top of hill

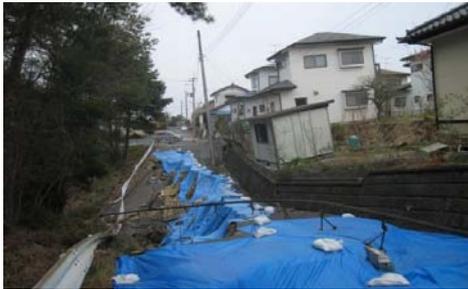
Photo 6.5-17 Fracture of embankment retaining wall and houses tilting by land sliding on the slope of hill end

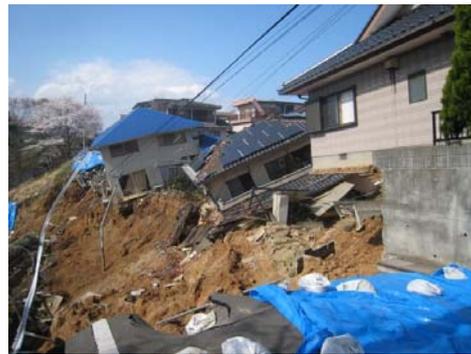
Photo 6.5-18 Land sliding of slope on the southwest of hill and sliding houses

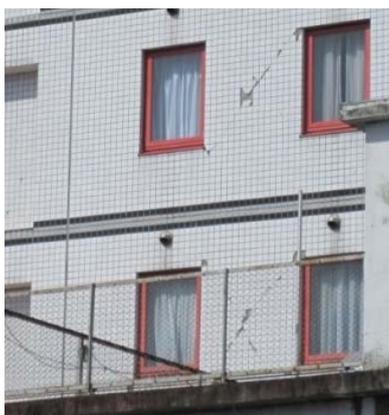
Detachment of ceramic wall tiles was often observed at buildings of RC nonstructural exterior walls. Types of the detachment are classified according to existence or nonexistence of crack on the damaged RC wall.<sup>6.6-1) 6.6-2)</sup> In Photo 6.6-1, ceramic wall tile detached from RC exterior wall. Cracks were observed on the damaged RC wall. Photo 6.6-2 shows detachment of ceramic wall tiles installed on a cylindrical RC wall above the building entrance (within a circle). No crack was externally observed on the undersurface RC wall. A net was placed over the damaged area to catch falling tiles.

Photo 6.6-1 Detachment of ceramic wall tiles from damaged RC exterior wall

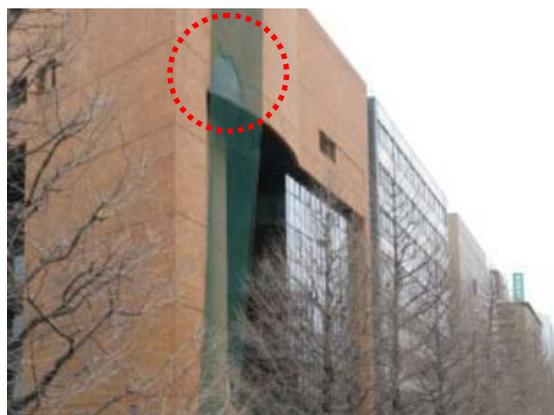
Photo 6.6-2 Detachment of ceramic wall tiles from RC wall

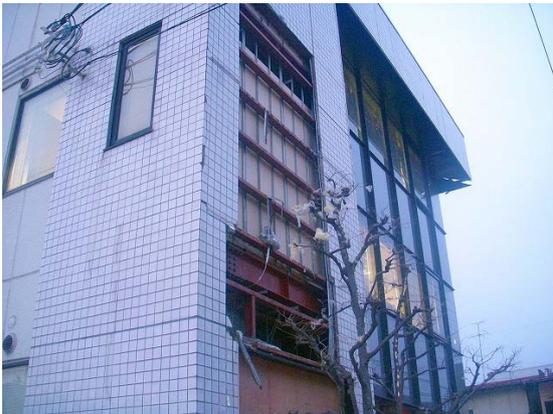
Damage to cement mortar and metal lath exterior walls was often observed in steel buildings. Photo 6.6-3 shows detachment of cement mortar and metal lath exterior wall in a 3-story building. Damage to the window glass was not observed, but cement mortar and metal lath fell from the exterior wall (shown in Photo 6.6-3) and from the parapet on another side. Photo 6.6-4 shows an one-story steel building in which cement mortar and metal lath detached from an exterior wall and from an eaves soffit. Photo 6.6-5 shows a damaged gable end wall of a gymnasium. This wall consisted of two layers. The undersurface wall was cement mortar and metal lath exterior wall. The surface one was exterior boards nailed to furring installed on the undersurface wall. Both were damaged and fell by the earthquake.

Photo 6.6-3 Falling of cement mortar and metal lath wall

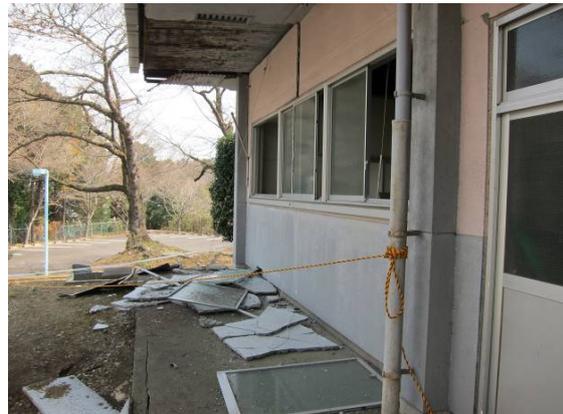
Photo 6.6-4 Falling of cement mortar and metal lath from eaves soffit

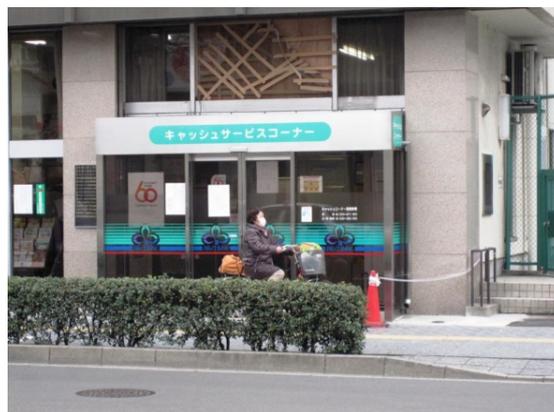
Photo 6.6-8 shows broken window glasses in the upper area of a windbreak room on the ground level of a 5-story building. Exterior wall ceramic wall tiles fell from another side.

Photo 6.6-8 Broken window glass

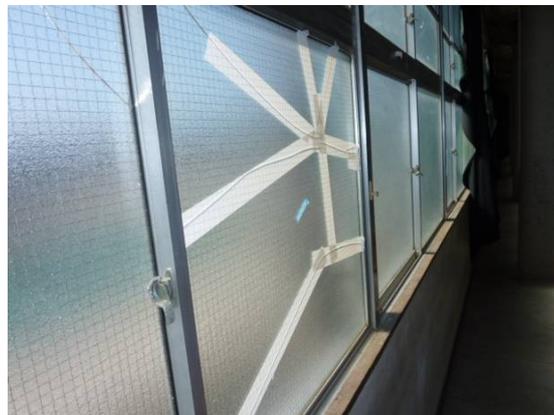
Photo 6.6-11 shows broken window glasses on the longitudinal surface in a gymnasium. Twenty-six wired window glasses were broken, which were installed to double sliding window frames with glazing bead. On the opposite side windows, there was no damage to the frosted window glasses and a detachment of a mullion cover of a window. No damage was observed in the structure.

Photo 6.6-11 Breakage of wired window glass installed to double sliding window frame with glazing bead

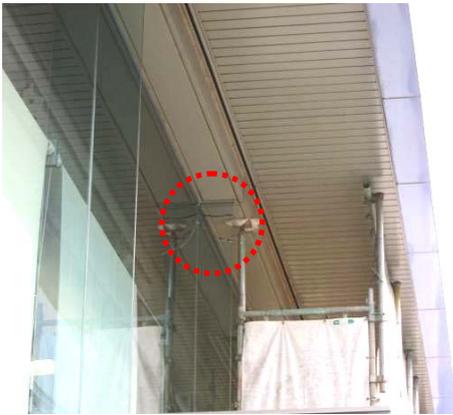
Photo 6.6-12 shows a damaged glass wall system at the 1st floor of a 6-story building. A glass mullion was broken in an area circled by a broken line (steel pipe adjacent to the broken glass were installed after the earthquake for the repair work).

Photo 6.6-12 Breakage of glass mullion of glass wall system

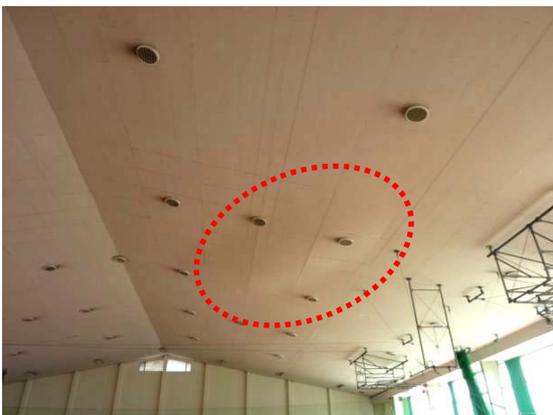
Photo 6.6-19 shows a damaged metal furring suspended ceiling in a gymnasium. Significant visual damage was not observed, but the ceiling board sagged near the center of pitched ceiling marked with a red dotted oval line in the photo. This was possibly due to the displacement of ceiling members in the plenum. Cement mortar finish of interior wall above the stage was flaked as shown in Photo 6.6-23, and the exterior boards were broken at the gable end wall. No damage to the structure was not observed.

Photo 6.6-19 Sagging of metal furring suspended ceiling

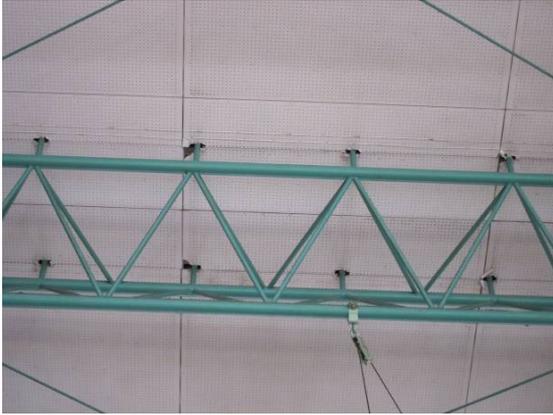
Photo 6.6-21 shows damaged ceiling boards at the connection with the structure of a gymnasium. It was reported that one window glass was broken. No damage to the structure was observed.

Photo 6.6-21 Damage to metal furring suspended ceiling at the connection

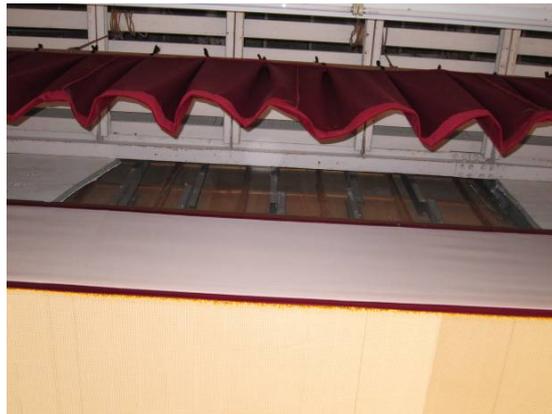
Photo 6.6-23 shows damaged walls above the stage in the gymnasium shown in Photo 6.6-19. Cement mortar finishes on the studs were broken and fell. Damage to the walls above the stage was observed also in some gymnasiums such as shown in Photo 6.6-15 or Photo 6.6-17.

Photo 6.6-23 Falling of cement mortar finish above stage

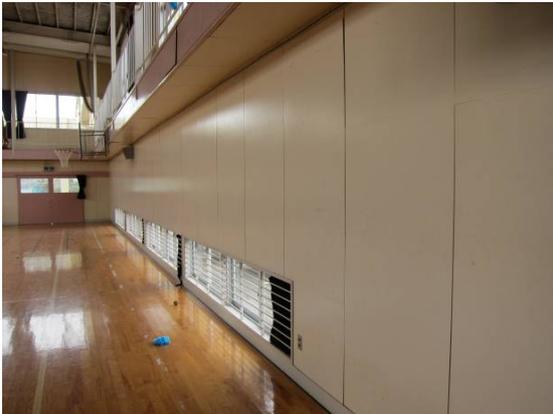
Photo 6.6-24 shows a lift of the nail fixing interior wall boards to the studs in the arena of gymnasium.

Photo 6.6-24 Loosen nails fixing board

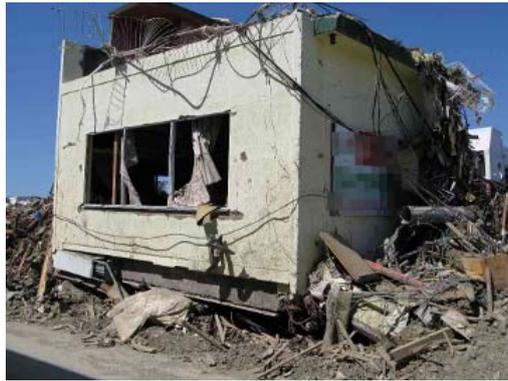
A case where column capitals and bases on the first floor in a building were subject to bending failure and subsequently to story collapse was seen in 2-story buildings (Photo 7.2-1).

These buildings have column-to-beam frames. The first floor has a relatively small number of walls, but many concrete block walls are placed on the second floor. The first and second floors of the building in Photo 7.2-1 are used as shop and dwelling, respectively. The relevant buildings are estimated to have structural characteristics of low strength and stiffness on the first floor. As an opening on the second floor is not large, it is assumed that the second floor suffered a large tsunami wave pressure and the shear force acting on the first floor exceeded the lateral load-bearing capacity, resulting in the collapse of the building. Story collapse of the first floor has not been observed in 3-story or higher buildings in the investigations. In 3-story buildings, in general, reinforced concrete walls are often used for the first floor. Therefore, the strength of the first floor of 3-story buildings is considered to have been larger than that of 2-story buildings.

Photo 7.2-1 Story collapse of a 2-story reinforced concreted building

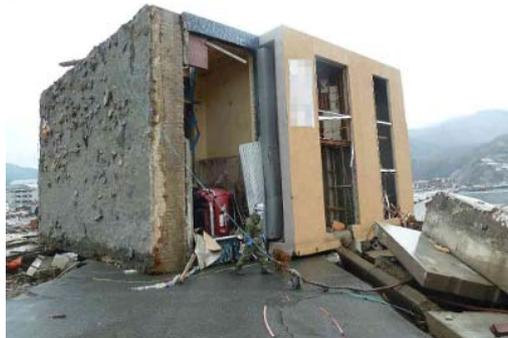
Overturning was observed in 4-story or lower buildings. In all overturned buildings, the maximum inundation depth exceeded their height. Overturning types include building that fell sidelong (Photo 7.2-2) and buildings that turned upside down. Most of the overturned buildings are of mat foundation. In some overturned buildings on pile foundation, piles were pulled out.

Photo 7.2-2 Overturning of a 3-story reinforced concrete building

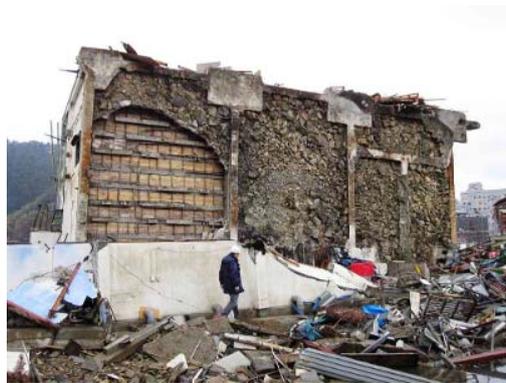
Most of the overturned buildings were moved from their original positions. It is estimated that large buoyancy acted on the buildings. Moved and overturned buildings left no dragged traces on the ground. One of the buildings moved over a concrete block fence with about 2m height on an adjoining land without destroying the fence (Photo 7.2-3). The building seems to have floated up by buoyancy. Some of the 2-story apartment houses with the same shape that were overturned were washed away and missing. A buoyancy and large horizontal force seem to have acted on these buildings.

Photo 7.2-3 A 2-story reinforced concrete building that moved over the fence and overturned

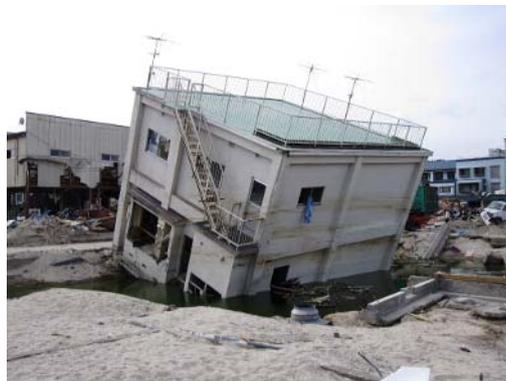
When tsunami acted on a building, a strong stream was generated around the corner of the building, resulting in many large holes on the ground that were bored by scouring. In one case, a building on mat foundation fell into a hole bored by scouring (Photo 7.2-4).

Photo 7.2-4 A 2-story reinforced concrete building that was tilted by scouring

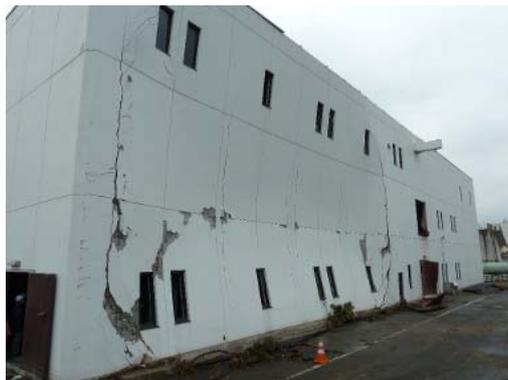
A case where such wall reinforcement was fractured is often seen in wall members with single layer bar arrangement. In one damaged building (Photo 7.2-5), a 300 mm-thick shear wall with double layer bar arrangement and a support span of more than 10 m and without the second and third floor slabs was bent inside by tsunami wave pressure. However, a shear wall in an area (Photo 7.2-5 Back of the building, right-hand side), where there is a floor on the second story and a support span is not long in the same building, was not bent.

Photo 7.2-5 Out-of-plane fracture of reinforced concrete shear wall without floor

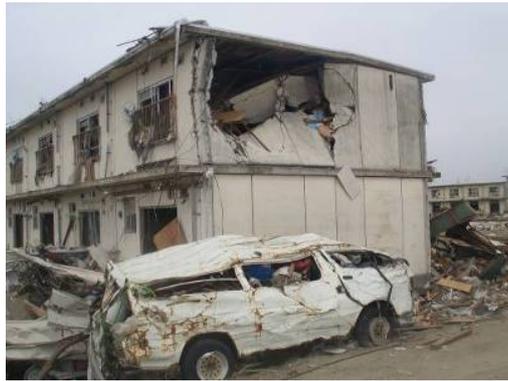
Debris impact was seen in most of the non-structural members such as window and ceiling materials. The number of cases of clear damage to skeletons was not large, but in one observed case, a multi-story wall in an apartment house was probably bored by debris impact (Photo 7.2-6).

Photo 7.2-6 Wall opening generated by debris impact

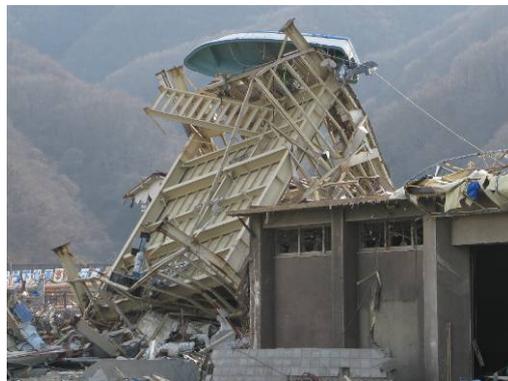
A typical case of building movement and washout is that a building moved and flew due to the fracture of anchor bolts and/or base plates at steel exposed column bases and the fracture of a weld between the column and the base plate (Photo 7.2-7). In most cases, a foundation and some column bases were left in a site, but the body of a building was moved beyond the site or missing.

Photo 7.2-7 Steel building overturned by fracture of column base anchor bolts

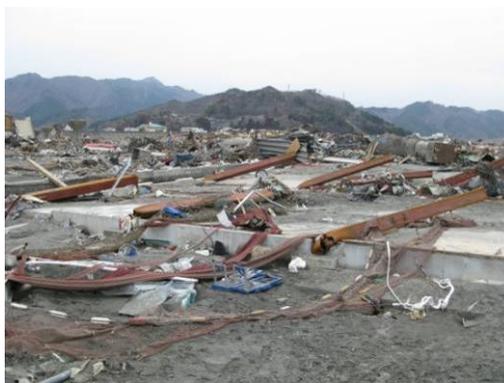
In most cases, welds between diaphragms with lower flanges and the first-floor columns were fractured and the sections of the columns were exposed. In one building, flanges of the second-floor H-shaped beams were torn. Based on the deformation states

near the column bases, it is estimated that a tensile force acted on the first-floor columns, and then the first-floor capital connections were fractured after the first floor was greatly tilted to the same extent as the inclination of the remaining columns.

Photo 7.2-8 First-floor columns falling in the same direction

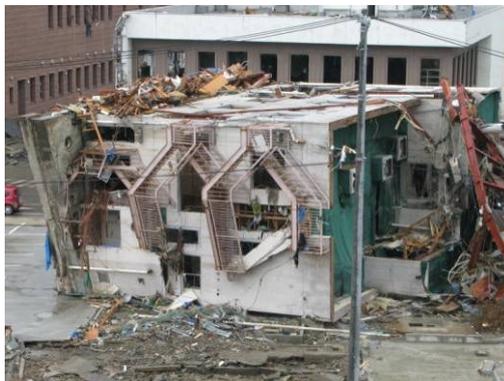
One case, in which a whole building including foundation is overturned, was confirmed. Most of the AAC panels of claddings were left (Photo 7.2-9).

Photo 7.2-9 Overturning of a 3-story steel building

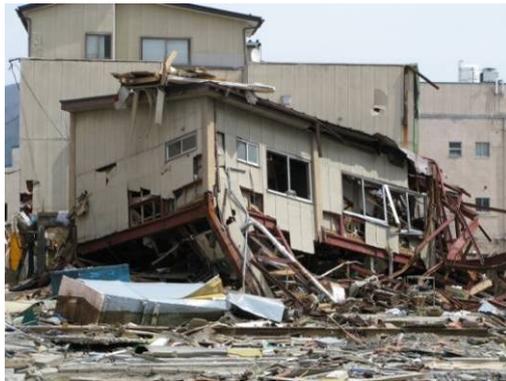
Skeleton collapse including story collapse of the first floor was seen in a 2-story steel building (Photo 7.2-10). Partial collapse of a warehouse was also seen on the coast.

Photo 7.2-10 Story collapse of first floor in a 2-story steel building

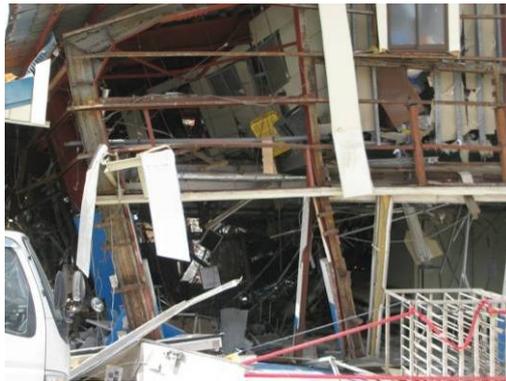
Slight tilting was often observed with remaining their skeletons in steel buildings. In one case (Photo 7.2-11), a gabled roof frame building did not collapsed despite large residual deformation.

Photo 7.2-11 Tilted gabled roof frame

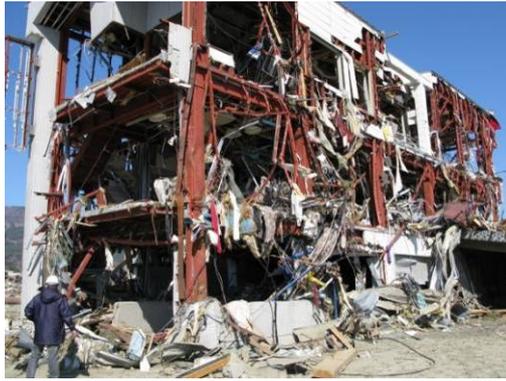
Cladding materials such as AAC panel were almost fully fractured and washed away, and then a steel frame as a skeleton was remaining. This case was often observed (Photo 7.2-12). It is considered that an external force that acts on the skeleton became small due to early washout of the cladding materials. In the remaining building, slight tilting of the skeleton, member deformation on the face affected by tsunami, or members locally damaged possibly by debris impact, were observed.

Photo 7.2-12 A remaining 3-story steel building

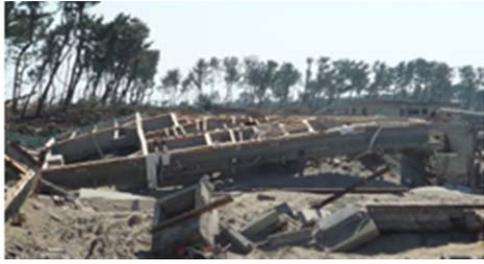
In the area with over 5 m flood water depth, most of the wood houses in the inundated area were washed away by the tsunami. How the houses were washed away; as for the case which the whole house including foundations was washed away (Photo 7.4-1), the case which only foundations were left (Photo 7.4-2), the case which sills and foundations were left (Photo 7.4-3), the case which sills, foundations and floor boards were left (Photo 7.4-4), and so on, were observed. There were several cases that the hold down fastener was failed, as shown in Photo 7.4-5. The foundations or wall of bath room made by concrete block often remained in, as shown in Photo 7.4-2.

Photo.7.4-1. Foundations washed away.

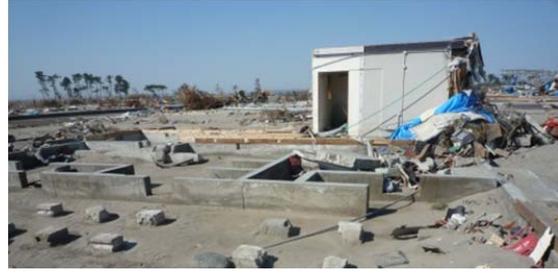
Photo.7.4-2. Only foundation remained.

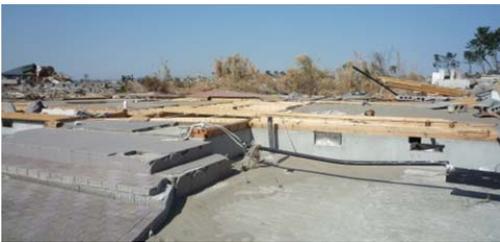
Photo.7.4-3. Foundations and sills remained.

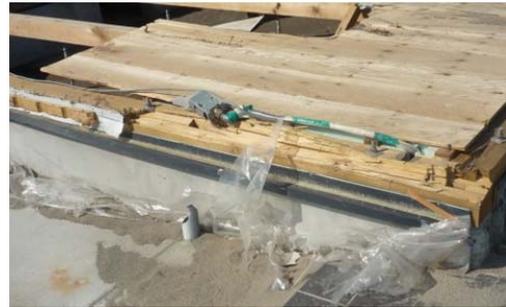
Photo.7.4-4. Sills, foundations and floor boards remained.

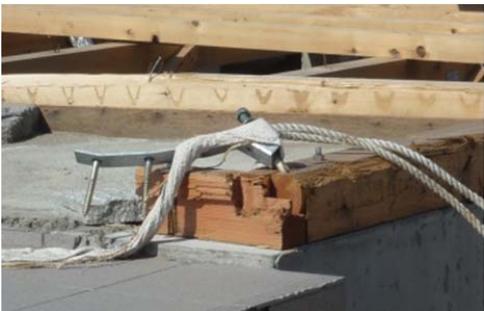
Photo.7.4-5. Failed hold down fastener.
