**Technical Note of National Institute for Land and Infrastructure Management**

**BRI Research Paper**

**Summary of the Field Survey and Research on  
“The 2011 off the Pacific coast of Tohoku Earthquake”  
(the Great East Japan Earthquake)**

National Institute for Land and Infrastructure Management (NILIM)  
Ministry of Land, Infrastructure, Transport and Tourism, Japan

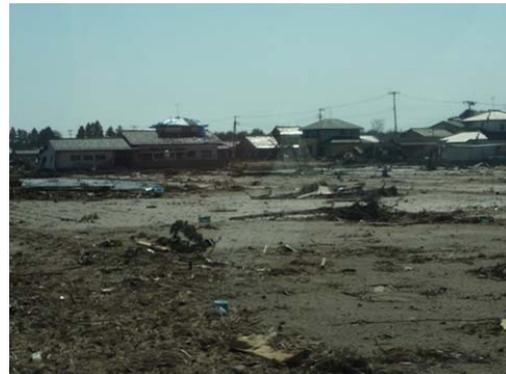
Photo.7.4-6. Many wood houses remained.

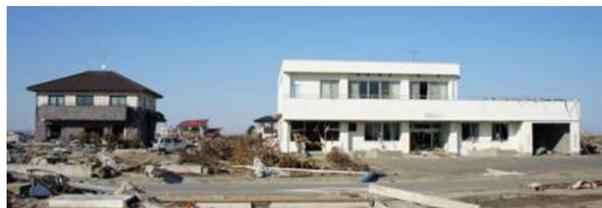
Photo.7.4-7. Wood house remained in the downstream of RC building in Arahama, Wakabayashi ward, Sendai city.

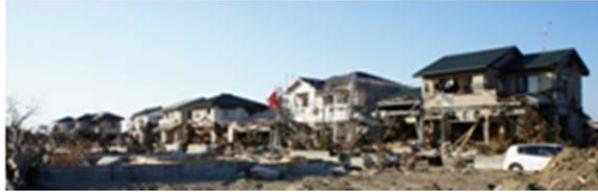
A line of wood houses remained were confirmed in Arahama-shin, Wakabayashi ward, Sendai city, as shown in Photo 7.4-8. The front survived house of the line was non-wooden. The flood water depth in this area was estimated at the level about 4-5 m. On the other hand, wood house which didn't have survived buildings in the direction where the tsunami came avoid being washed away, but suffered heavy damage, as shown in Photo 7.4-9. Several such houses were confirmed in each surveyed area, and they were built by the construction methods with many metal fasteners.

Photo 7.4-8. A line of wood houses remained in Arahama-shin, Wakabayashi ward, Sendai city.

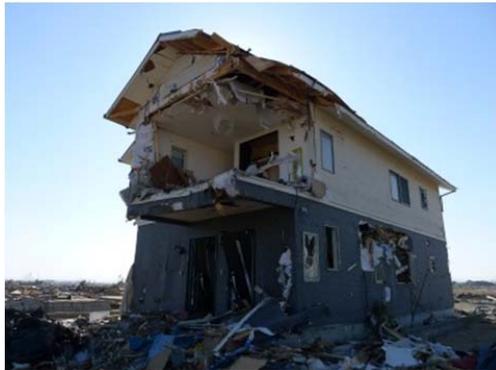
Photo 7.4-9. Remained house which didn't have survived buildings in the direction where the tsunami came in Arahama-shin, Wakabayashi ward, Sendai city.

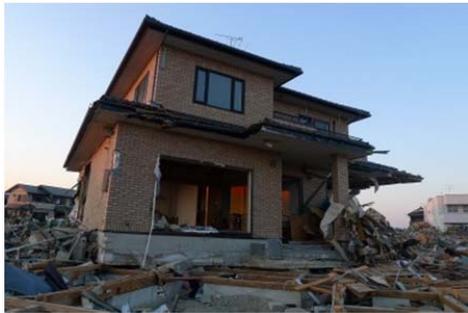
Photo 7.4-10. Wood house (<sup>1</sup>) that was carried away with the base in Yuriage, Natori city.

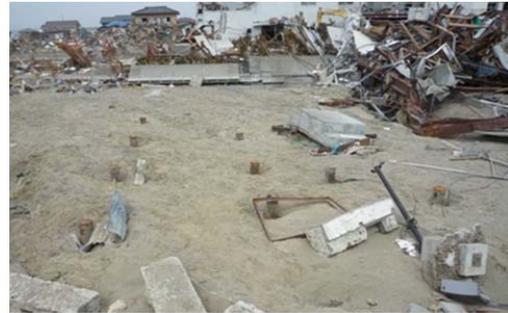
Photo 7.4-11. Steel tube pile left at the the original position (<sup>2</sup>) of photo 7.4-10.

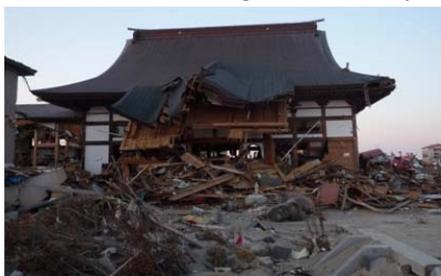
Photo 7.4-12. Heavily damaged temple (<sup>3</sup>) building in Yuriage, Natori city.

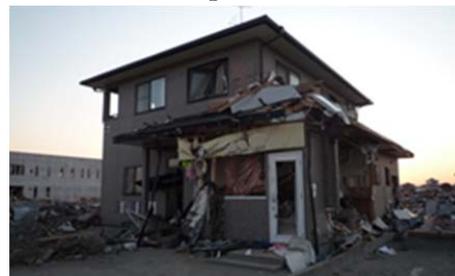
Photo 7.4-13. Wood house with store (<sup>5</sup>) remained in the downstream of the survived buildings in Yuriage.

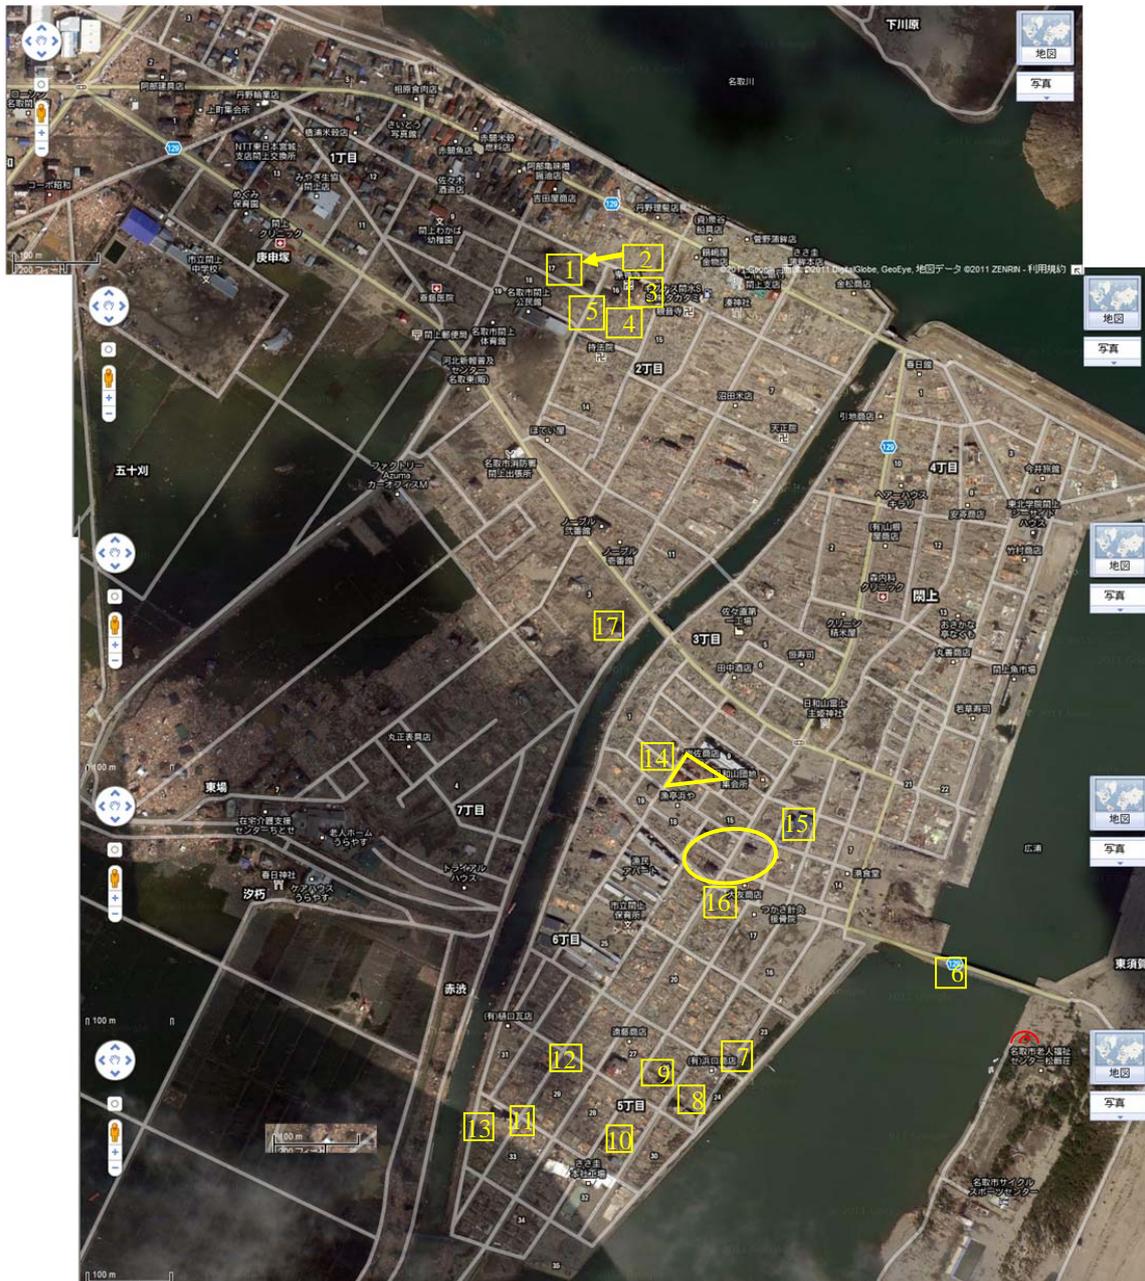
Fig. 7.4-2. Aerial photograph and the location related to surveyed buildings in Yuriage, Natori city.

Wood buildings also suffered crushing damage due to tsunami, as shown in Fig. 7.4-2. What parts of buildings remained, for example foundation, sill, and so on, were as same as mentioned in (1). Figures in rectangles in Fig. 7.4-2 show the locations of buildings mentioned in the followings. The wood house (Photo 7.4-10:①) united with the foundation and carried away. In the original position of it, steel tube piles remained as shown in Photo 7.4-11(②). Because a temple building (Photo 7.4-12:③) and a steel-frame house (④) were damaged heavily and remained, tsunami wave force was reduced to some extent, and the neighboring wood house with store avoided being carried away, as shown in Photo 7.4-13 (⑤). It might be possible for the survived low-rise building to make wave force reduce.

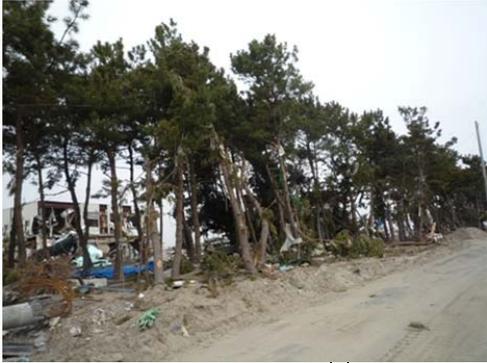
Photo 7.4-14. Protect forest (7) in Yuriage, Natori city.

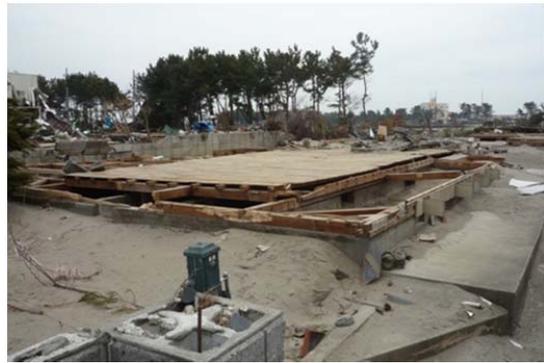
Photo 7.4-15. Fallen Protect forest and wood house (8) washed away in Yuriage, Natori city.

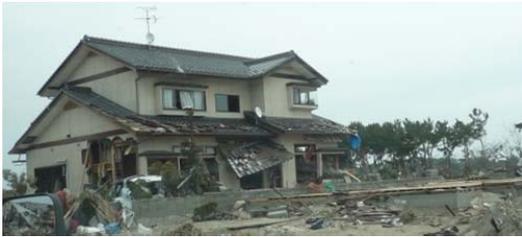
Photo 7.4-16. Protect forest and wood house (9) remained in Yuriage.

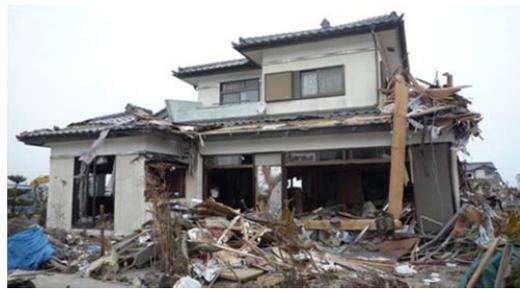
speed of the tsunami were different by factors such as the depth of water or the submarine topography in this case. There was a house (Photo 7.4-17:<sup>10</sup>) remained in the area where has no building and no protect forest existed in the direction of the wave. In addition, the relatively new Japanese conventional post and beam wood house (Photo 7.4-18 :<sup>11</sup>) and light frame construction house (Photo 7.4-19 :<sup>12</sup>) were confirmed at the location where there were no survived buildings in the direction of waves. Besides, in the downstream of the former, another Japanese conventional post and beam wood house (<sup>13</sup>) remained in. The flood water depth was estimated to be about 3.5 m in these locations.

Photo 7.4-17. Wood house (10) remained without the effect of protect forest.

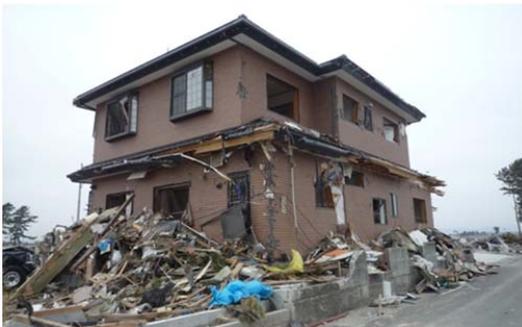
Photo 7.4-18. Japanese conventional post and beam wood house (11) remained alone.

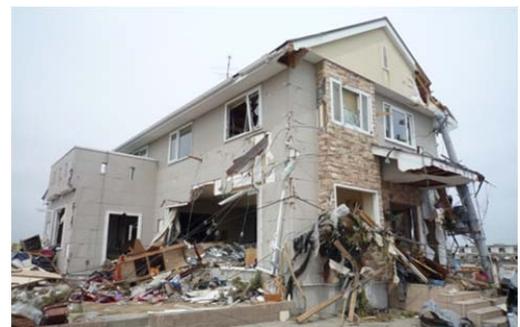
Photo 7.4-19. Light frame construction wood house (12) remained alone

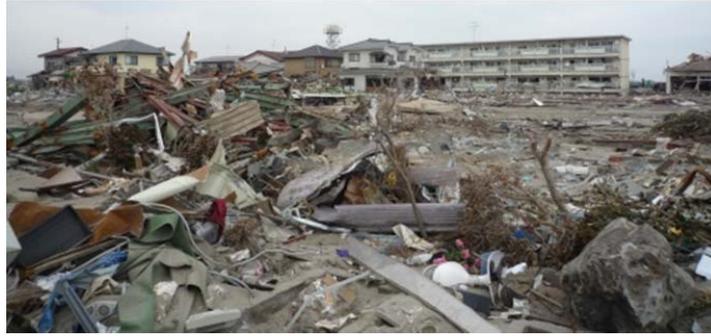
In the downstream of large RC building, houses with low structural specification (<sup>14</sup>) also remained, as shown in Photo 7.4-20. On the other hand, in the location where is the downstream of the relatively large factory building (<sup>15</sup>), the wood house (<sup>16</sup>) with relatively better structural specifications avoided being carried away, selectively.

Photo 7.4-20. Group of wood houses (14) which were not washed away in the downstream of a RC apartment house in Yuriage

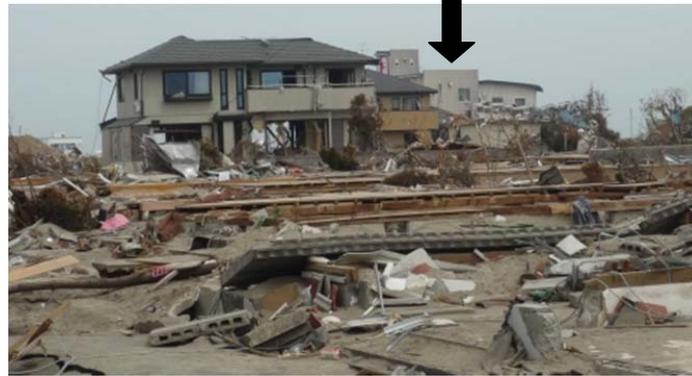
Photo 7.4-21. Wood house (15) which were not washed away selectively in the downstream of a factory building.

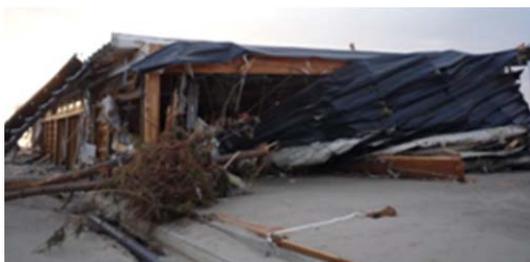
Photo 7.4-22. Glulam frame structure remained in Arahama, Watari town.

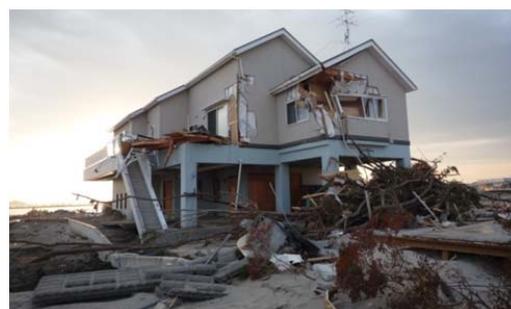
Photo 7.4-23. Mixed structure which has 1<sup>st</sup> story of RC structure and wooden 2<sup>nd</sup> story.

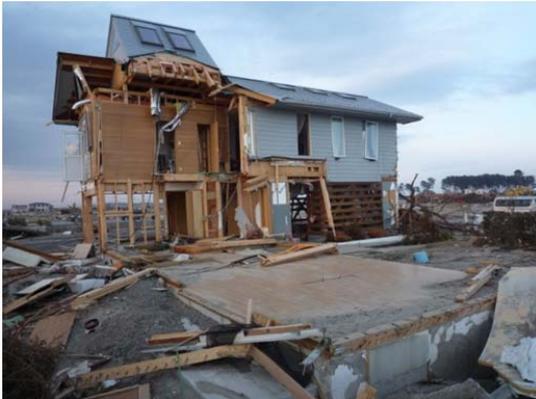
Photo 7.4-24. L-shaped wood house whose part was washed away in the east of Arahama port.

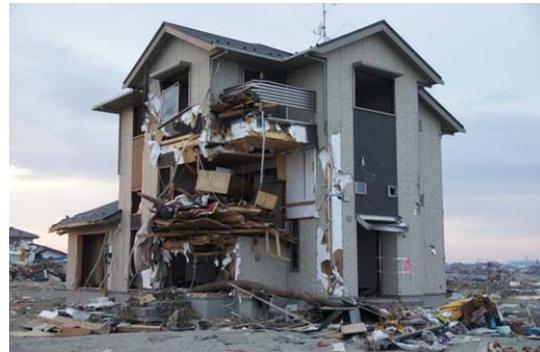
In the north area of the Arahama port, the 3-story wood house (Photo 7.4-25) remained. It might be the reason why the lateral strength of 1<sup>st</sup> story in 3-story building was larger than that in 2-story building.

Photo 7.4-25. 3-story wood house remained in the north of Arahama port.

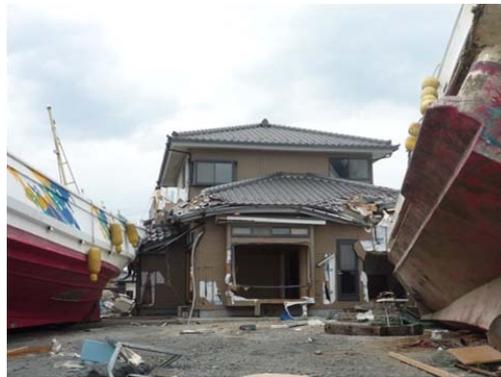
In the west area of the Arahama port, it was confirmed that the wood house (Photo 7.4-26) was crashed by two ships but remained. It was the reason why the wave pressure was low and the structural performance of the house high because the house was relatively new.

Photo 7.4-26. Wood house remained in spite of ship crashing in the west of Arahama port.

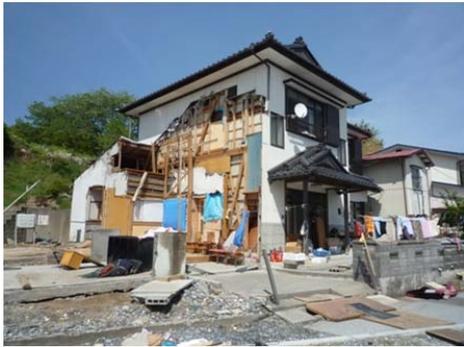
Photo 7.4-27. Wood house (1) remained under the flood water depth of over 7 m in Akasaki-cho, Oofunato city.

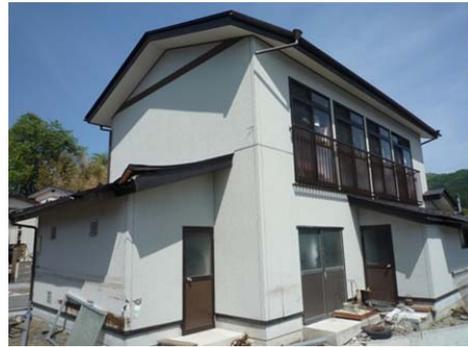
Photo 7.4-28. Wood house (3) without damage under the flood water depth of over 7 m in Akasaki-cho, Oofunato city.

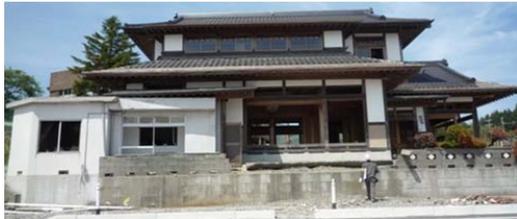
Photo 7.4-29. Japanese traditional wood house (5) which was not carried away under about 5 m flood water depth in Akasaki-cho, Oofunato city.

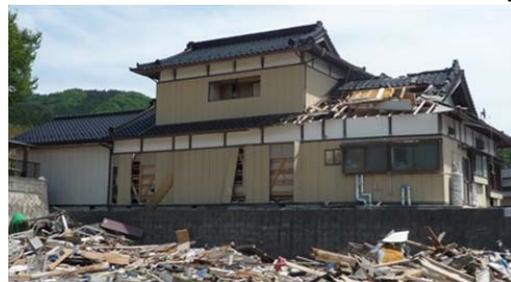
m, in spite of partial failure of walls. Near this house, the wood house (Photo 7.4-30:6) remained under about 6 m flood water depth in spite of partial failure in the roof system. It was considered that this failure caused by the floating materials. There was a house (7) remained in the next, but a house which was guessed to have many hole down fasteners (8) washed away. The house with hold down fastener may not avoid being washed away by the tsunami.

Photo 7.4-30. Wood house (6) which was not carried away in spite of damage on 1<sup>st</sup> floor roof system in Akasaki-cho, Oofunato city.

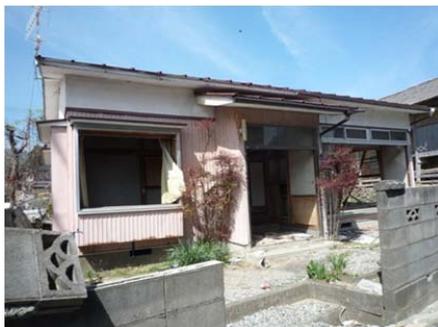
Photo 7.4-31. Survived house (9) which seemed to have comparatively slight structural specifications in Akasaki-cho, Oofunato city.

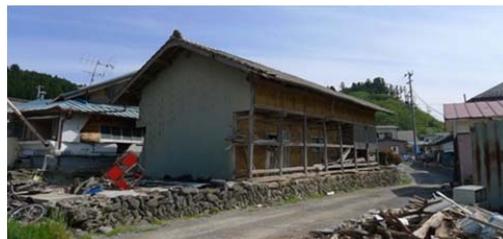
Photo 7.4-32. Survived soil warehouse (10) which seemed to have comparatively slight structural specifications in Akasaki-cho, Oofunato city.

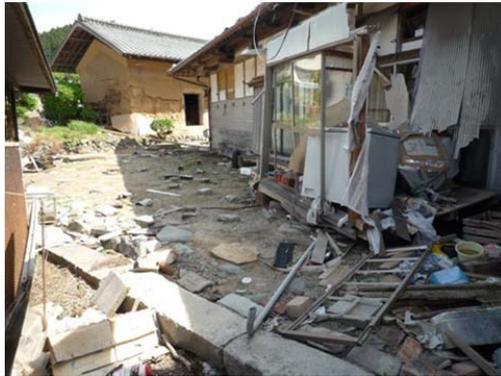
Photo 7.4-33. Survived old house (12) which rotated and moved horizontally in Akasaki-cho, Oofunato city.

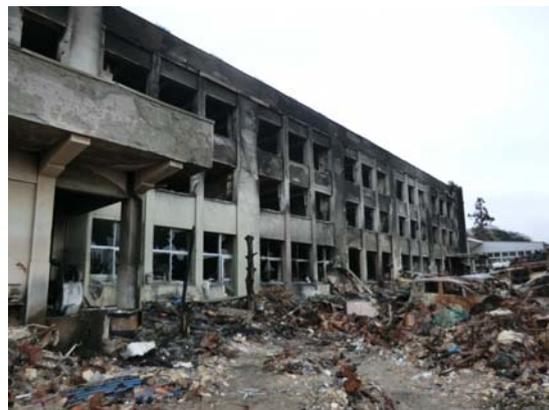
Photo 8.2-1 Tsunami fire at an elementary school (Ishinomaki city, Miyagi prefecture)

Photo 8.2-1 shows a fire scene of an elementary school building located at about 1 km from the coast. Almost all of the 3-story school building had been burnt by the flame flared up from cars, combustible debris and oil and so forth that drifted and accumulated by tsunami in the schoolyard in front of the building.

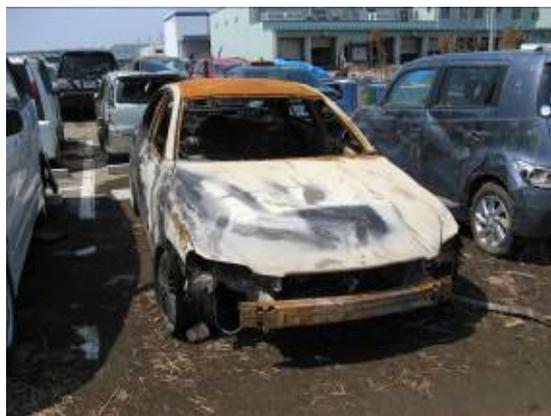
Building at a port is one of the most damaged buildings by tsunami with not only tidal wave but also debris, cars and ships and so forth drifted by tsunami (Photo 8.2-2 and 8.2-3). Several hundred automobiles which have been parked in a parking zone, being drifted to a port warehouse by the tsunami, caused fire at the place where it accumulated.

The cause of the fire is unclear, but it is assumed that the car collided severely each other, the gasoline tank of the cars were damaged, and sparked by malfunction of the electrical system by the seawater. There was no spread of fire in the interior of the building, only the external wall has been damaged by fire.

Photo 8.2-3 Vehicle fire due to tsunami at a parking lot (Iwanuma city, Miyagi prefecture)

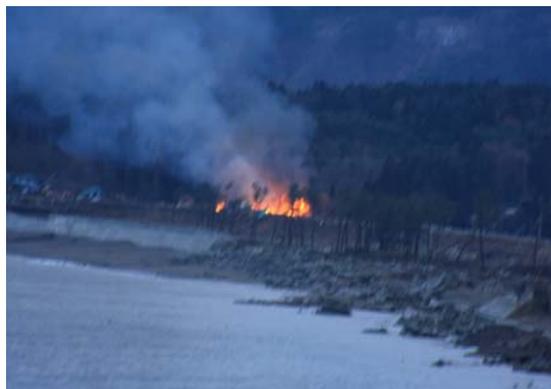
Photo 8.2-4 shows the fire at a coastal village after several hours of tsunami invasion. The fire continued for

Photo 8.2-4 Fire at a site of 8 buildings due to tsunami (Noda-village, Iwate prefecture), Courtesy of Noda-village

over 12 hours. Firefighters could not access to the site because the road had been destroyed by the tsunami.

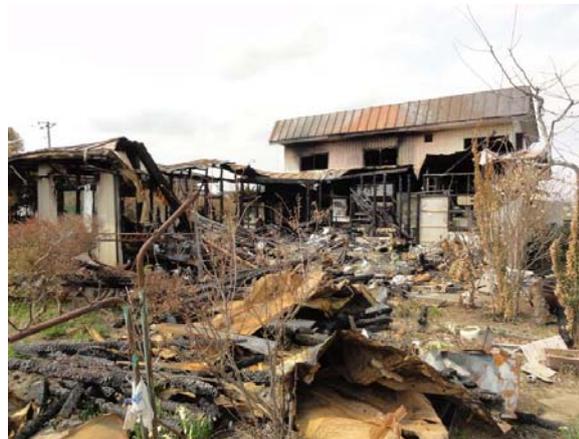
Photo 8.3-3 shows another house fire case in which two wooden houses were completely burnt out and three houses were partly burnt. The cause of fire is assumed to be misuse of candlelight for lighting in the midst of power failure on the night of the next day of the mainshock.

Photo 8.3-3 Fire scene at a house (Oushu city, Iwate prefecture)

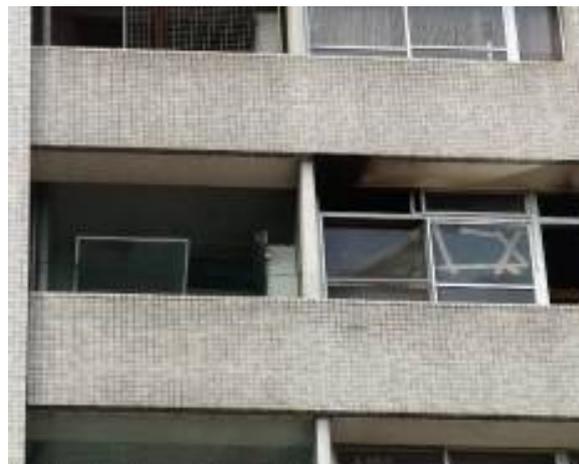
For a condominium fire, one case has been investigated: the fire broke out when electricity supply has been recovered at the night of the next day of the mainshock. The fire broke out on the 7<sup>th</sup> floor of a 17-story medium scale condominium. The residents of the room of fire origin were absent at the time, but some neighbors were aware of the fire and informed the fire station. Because of early suppression by firefighters, there was no spread of fire to the upper floor and the next rooms (Photo 8.3-4).

Photo 8.3-4 Fire scene at a condominium (Sendai city, Miyagi prefecture)

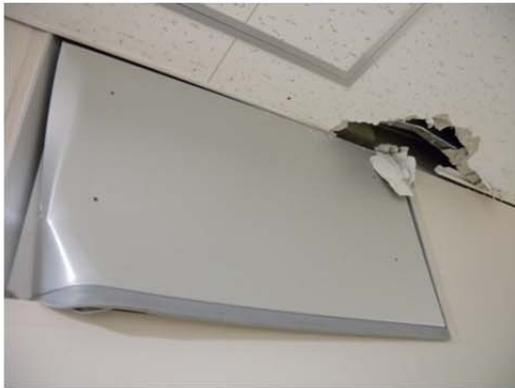
- According to the person in charge of the building, no furniture was turned over and no structural damage was observed.
- However, some damage was observed at the cover-panels of fire protection and the expansion joints near the boundary between isolated and non-isolated floors (Photo 9.2-2). It seems that parts of expansion joints were not well operated due to the large displacement of SI floor during the earthquake.
- The ground surrounding the building partially subsided around 10 cm.

(a) Damage to the panel

Photo 9.2-2 Damage near the boundary between isolated and non-isolated floors

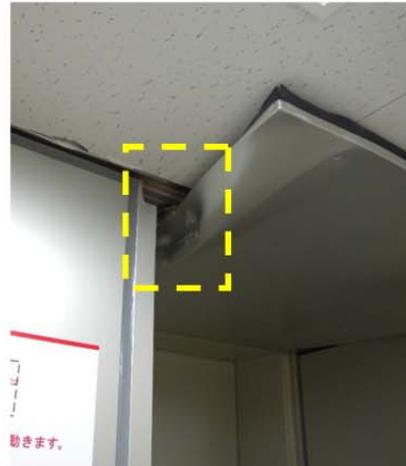
(b) Damage to the expansion joint

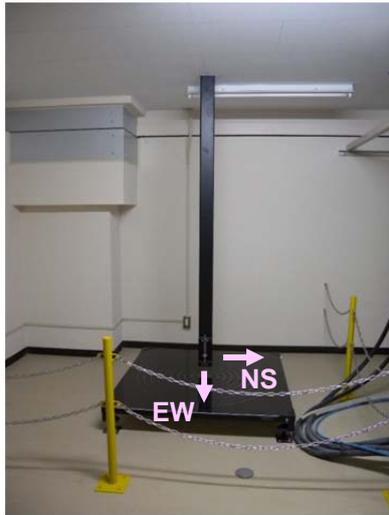
From the trace on the scratch board installed on the SI floor (Photo 9.2-3), the maximum displacement was estimated as around 18 cm at the mainshock on 11 March, 2011 and around 10 cm at an aftershock on 7 April, 2011 (Photo 9.2-4).

Photo 9.2-3 Scratch board installed on the SI floor

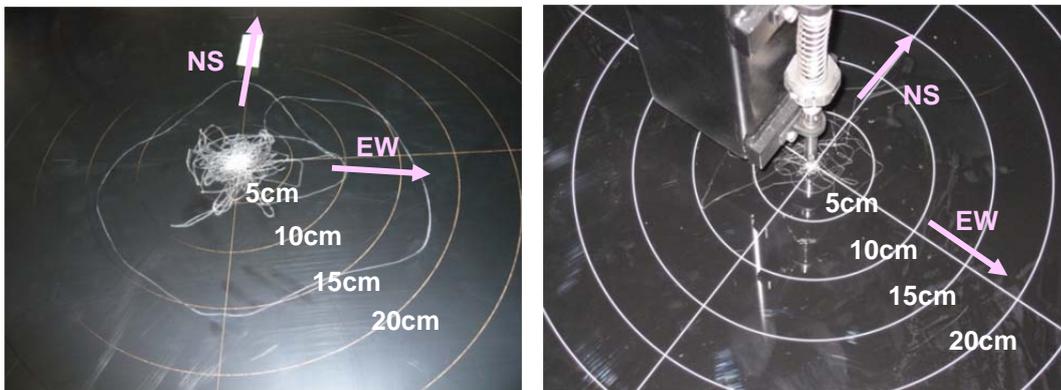
Photo 9.2-4 Trace of displacement of SI floor during earthquake

(a) Trace at the mainshock on 11 Mar. (b) Trace at an aftershock on 7 Apr.

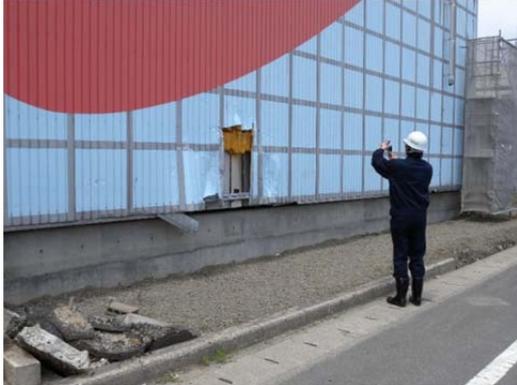
Since the building is located near the Sendai-Shiogama bay, tsunami reached the building and the SI floor was submerged under water. The building also suffered the damage to outer walls by the collision of floating debris (Photo 9.2-6). Observation results are summarized as follows:

Photo 9.2-6 Damage due to debris

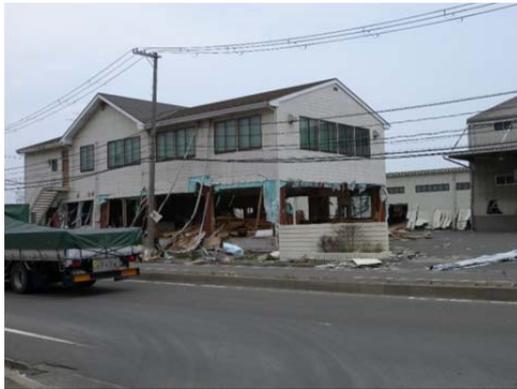
- b) Tsunami height was estimated ~4.0 m from the trace of water on the wall (Photo 9.2-7) and damage situation of surrounding buildings (Photo 9.2-8). There is no information about the direction and impact force of tsunami.

Photo 9.2-8 Tsunami damage to surrounding buildings

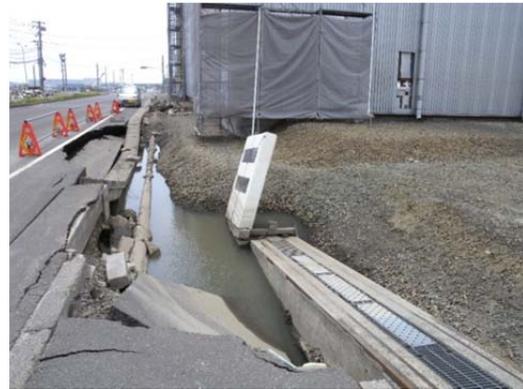
- c) The ground was excavated in northeast corner of the building around 1.0 m depth, probably because of the water flow from the building at the moment of tsunami (Photo 9.2-9).

Photo 9.2-9 Excavation of ground

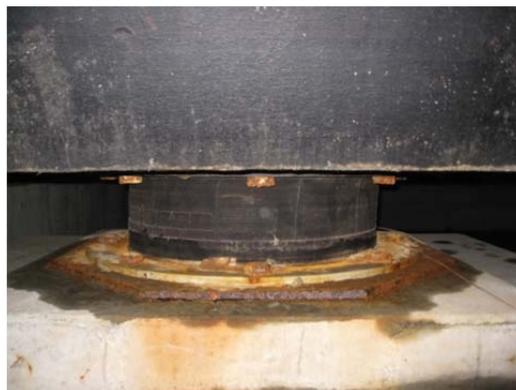
- d) From visual inspection, there was no harmful scratch or inflation of the rubber of HRB, however, severe rust was observed at the steel plates and bolts (Photo 9.2-10).

Photo 9.2-10 Rust of High-damping rubber bearing

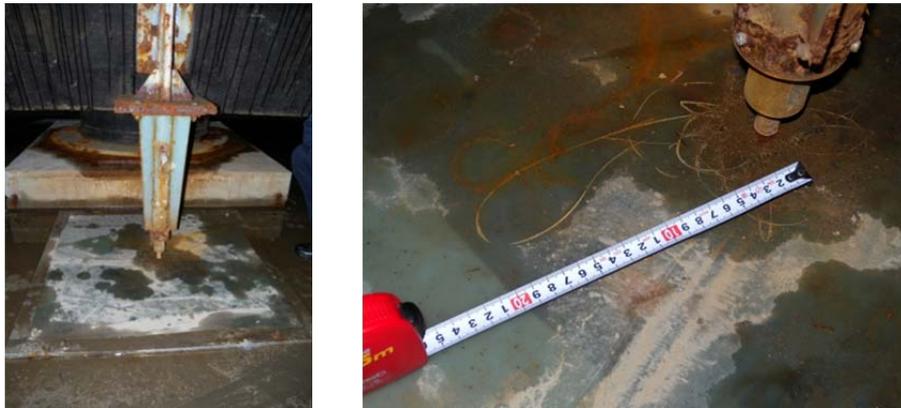
From the trace on the scratch board in the SI floor, the maximum displacement

was estimated as around 21 cm at the mainshock (Photo 9.2-11).

Photo 9.2-11 Trace of displacement of the SI floor on the scratch board

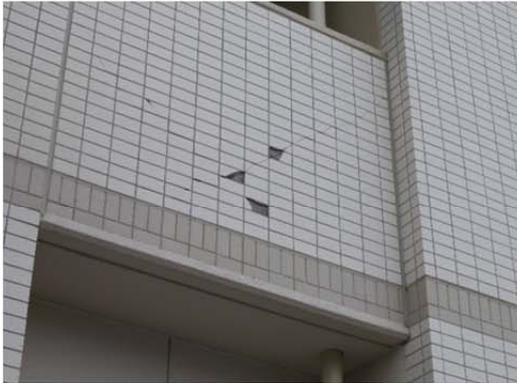
- a) According to the person in charge of the building, no furniture was turned over and no structural damage was observed inside of rooms. However, the damage to the expansion joint was observed.
- b) Drop of the ceramic tiles on outer wall (Photo 9.2-13) and shear crack on the wall in

the first floor parking space (Photo 9.2-14) were observed. The subsidence of ground ~10 cm was observed around the building.

Photo 9.2-13 Drop of ceramic tiles

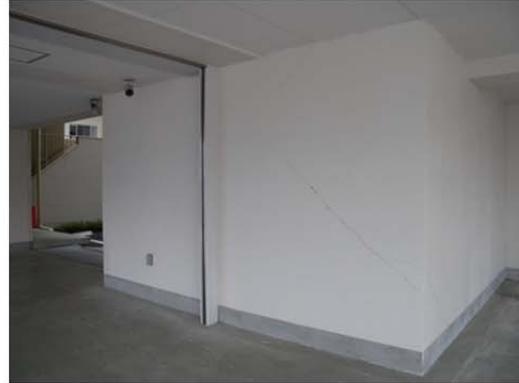
Photo 9.2-14 Shear crack on the wall

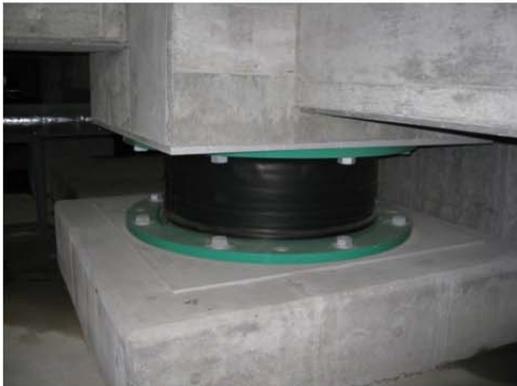
- c) No damage was found to RBs by visual inspection (Photo 9.2-15), however, paint of USDs was peeled off (Photo 9.2-16) and many cracks were found on LDs (Photo 9.2-17).

Photo 9.2-15 Natural rubber bearing

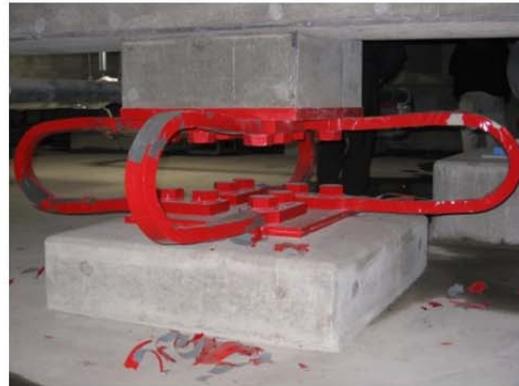
Photo 9.2-16 U-shaped steel damper

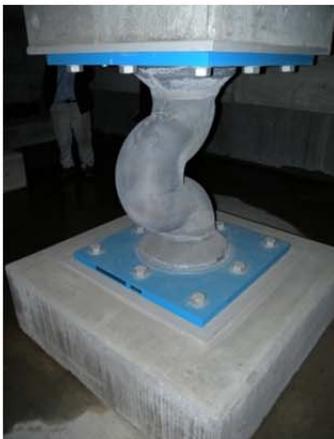
Photo 9.2-17 Lead damper and cracks on the surface

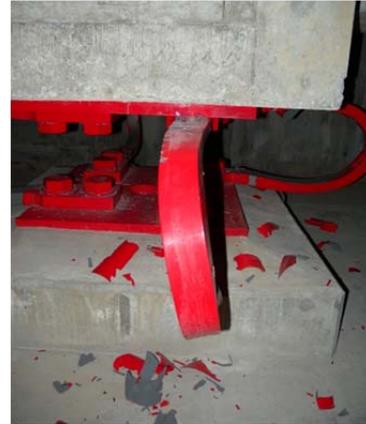
- According to the person in charge of the building, no furniture was turned over and no structural damage was observed.
- Because of the movement of the SI floor during the earthquake, the bolts of steel dampers became loose and the paint on the dampers was peeled off widely. Furthermore, a large amount of residual deformation of steel was remained (Photo 9.2-19).

(2) Deformation of steel

Photo 9.2-19 Deformation of U-shaped steel damper

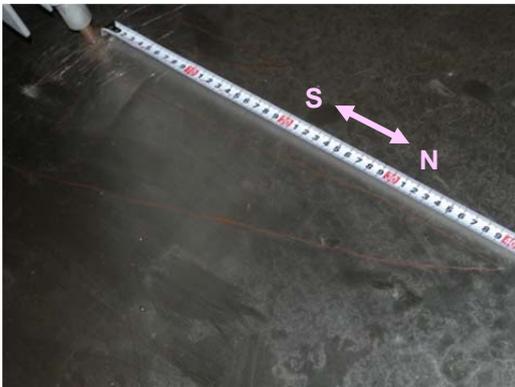
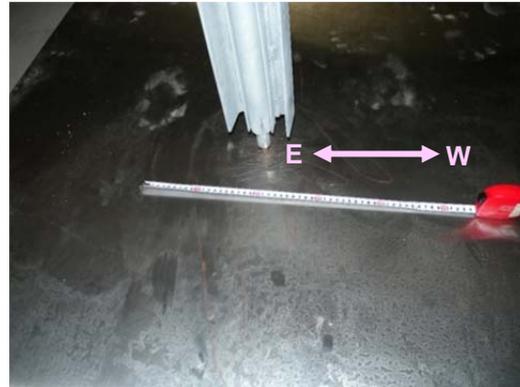
According to the scratch board in the SI floor, the maximum displacement was estimated as around 40 cm northward (Photo 9.2-20). The displacement was also confirmed from the trace of scratch found at the expansion joint outside of the building.

(a) Around 40 cm northward

(b) Around 15 cm eastward  
and 22 cm westward

Photo 9.2-20 Trace of displacement of the SI floor on the scratch board

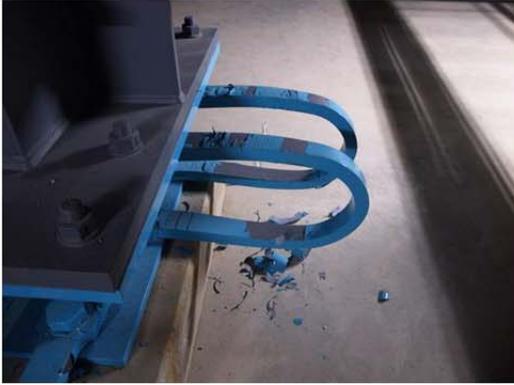
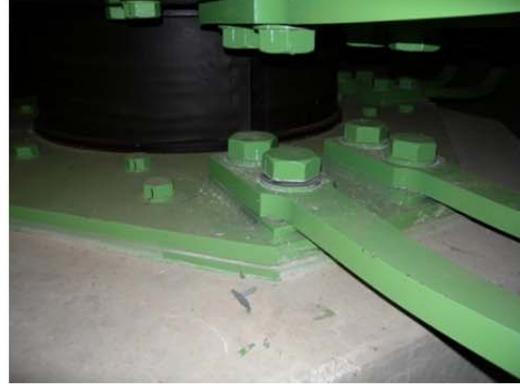
- a) According to the person in charge of the building, up-down shaking happened together with horizontal shaking during the earthquake. On the 6<sup>th</sup> floor, contents inside of the rooms such as refrigerators and shelves are moved or turned over, and the fire protection steel door moved to open and hit against the ceiling by vertical shaking causing the damage to the lamp covers. Above the 4<sup>th</sup> floor, PC monitors turned over.
- b) In the penthouse, anti-vibration rubber of a power generator was moved and the bottom part of a water tank was broken.
- c) Because of the movement of the SI floor during the earthquake, the bolts of the steel dampers became loose and the paint on the dampers was peeled off (Photo 9.2-22).
- d) The ground around the building subsided ~20 cm.

Photo 9.2-22 Peeling off of paint and loose of the bolts of U-shaped steel dampers

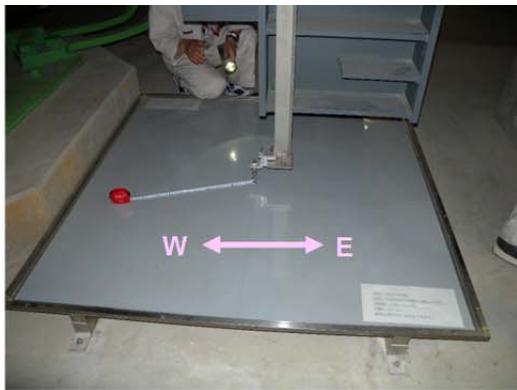
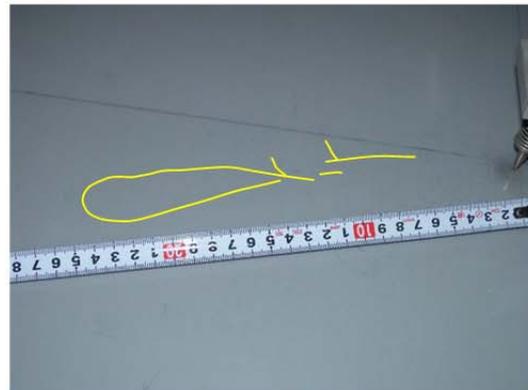
From the trace on the scratch board in the SI floor, the maximum displacement was estimated as around 25 cm westward (Photo 9.2-23). The displacement was also confirmed from the trace of displacement of the ESB (Photo 9.2-24).

Photo 9.2-23 Trace of displacement of the SI floor on the scratch board

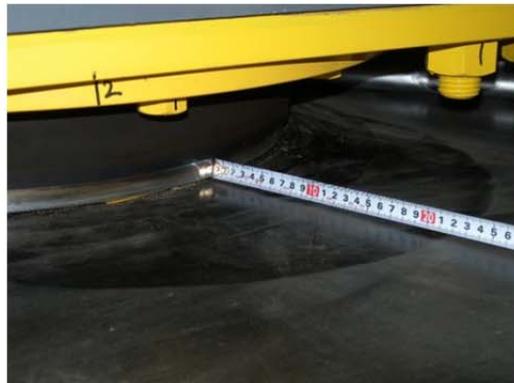
Photo 9.2-24 Trace of displacement of elastic sliding bearing
