NILIM Research Report No.52

Initiatives by the National Institute for Land and Infrastructure Management in
Response to the 2011 Great East Japan Earthquake

Emergency Responses and Engineering Contributions by NILIM
for the Recovery from the 2011 Great East Japan Earthquake

National Institute for Land and Infrastructure Management
Ministry of Land, Infrastructure, Transport and Tourism, Japan

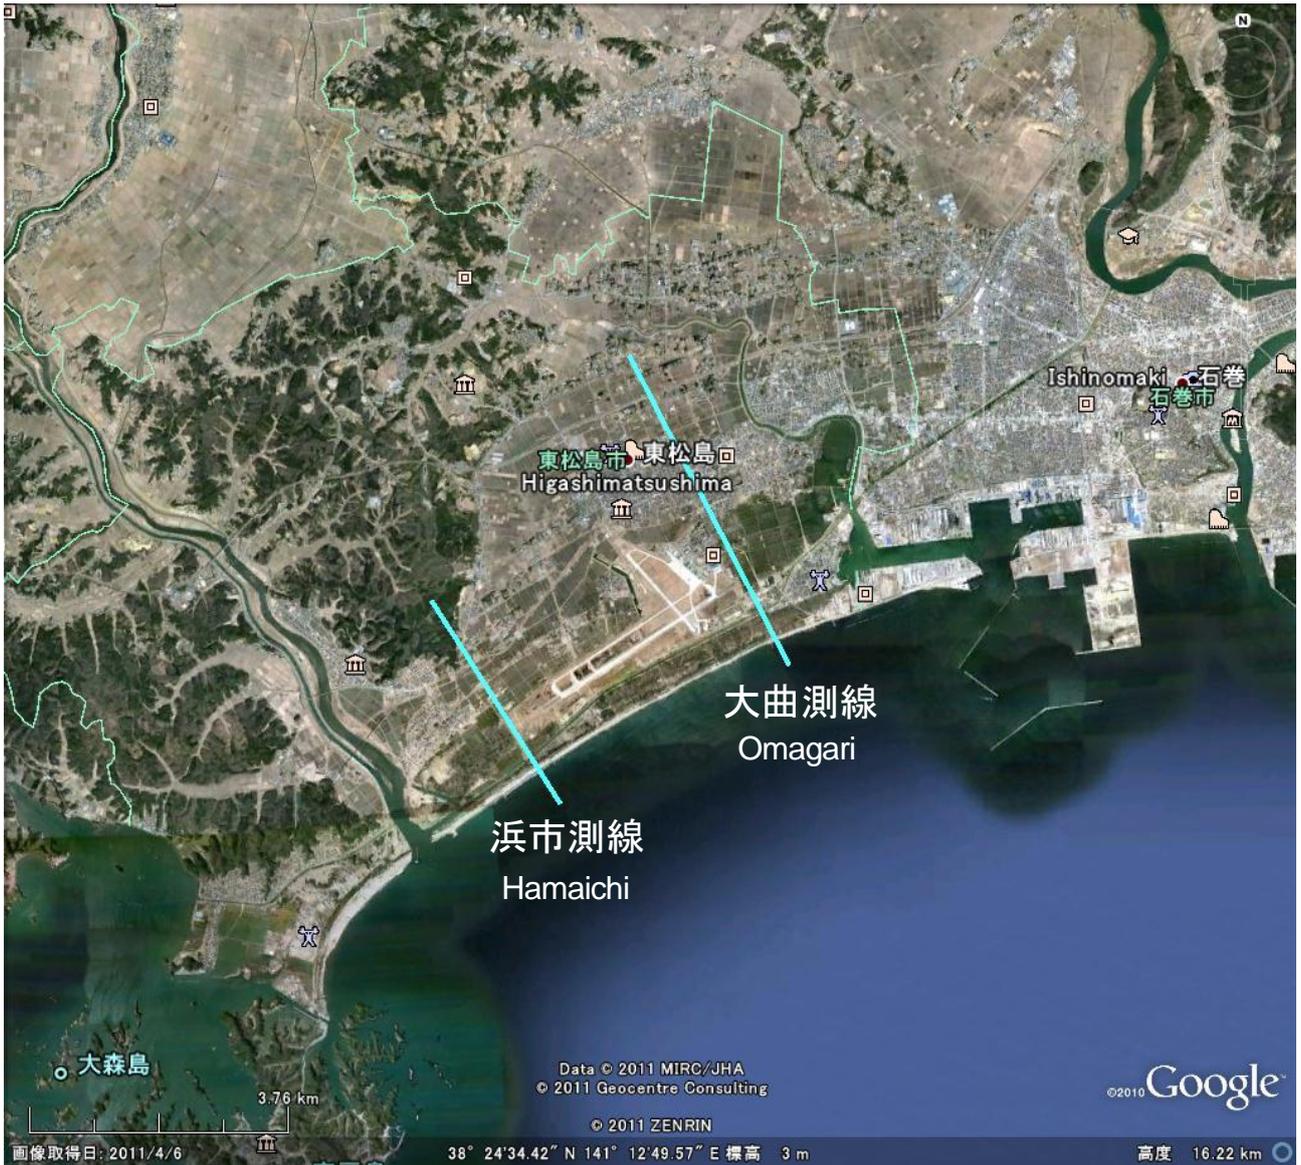
Figure 3.2.2.20 Tsunami Trace Height Survey Lines (Ishinomaki Plain)

Figure 3.2.2.20 shows the tsunami trace height survey lines on the Ishinomaki Plain. Moreover, Figures 3.2.2.21 and 22 show the trace height distribution for each of these survey lines. From Figure 3.2.2.21 and Figure 3.2.2.22, we can see that the trace height diminishes along the tsunami run-up direction, in the same way as on the Sendai Plain.

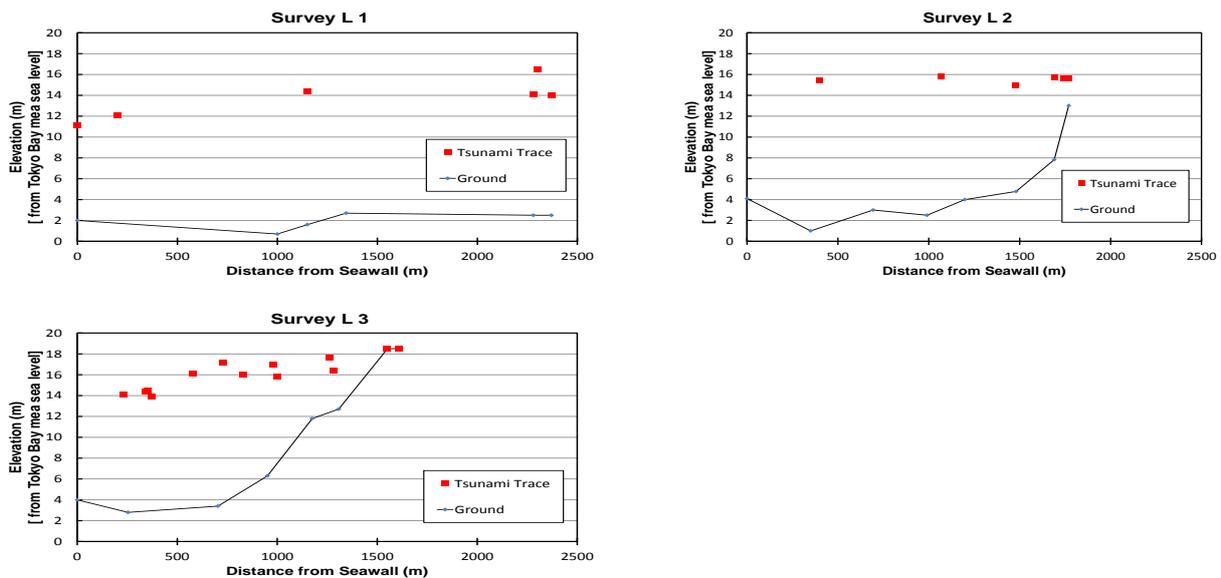
Figure 3.2.2.24 Trace Height Distribution (Rikuzentakata)

survey lines in Rikuzentakata. Moreover, Figure 3.2.2.24 shows the trace height distribution for each of these survey lines. In terms of characteristics identified from the results of survey lines 1-3 in Figure 3.2.2.24, we cannot see any attenuation in trace height along the

tsunami run-up direction, and the trace height continues to be parallel as same as observed on the southern Sendai Plain. This is thought to be because the plain is narrow and the hilly terrain impeded tsunami run-up.

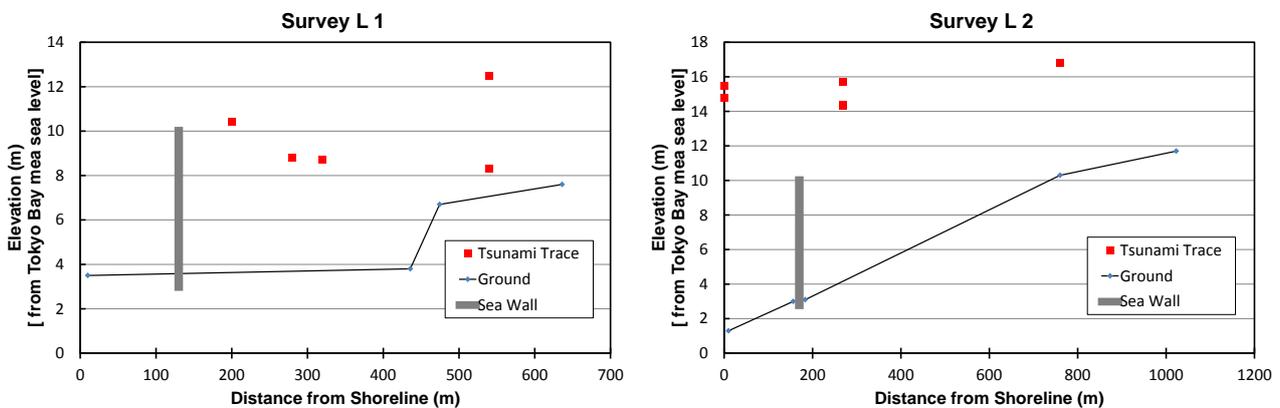
Figure 3.2.2.26 Trace Height Distribution (Taro District of Miyako City)

Figure 3.2.2.25 shows the tsunami trace height survey lines in the Taro district of Miyako City. Moreover, Figure 3.2.2.26 shows the trace height distribution for each of these survey lines. In terms of characteristics identified from the results of survey lines 1-2 in Figure 3.2.2.26, one cannot see any attenuation in trace

height in the tsunami run-up direction, and the trace height continues to be parallel, in the same way as the survey lines on the southern Sendai Plain and in Rikuzentakata, or rises. This is thought to be because the plain is narrow and the hilly terrain impeded tsunami run-up as in Rikuzentakata.

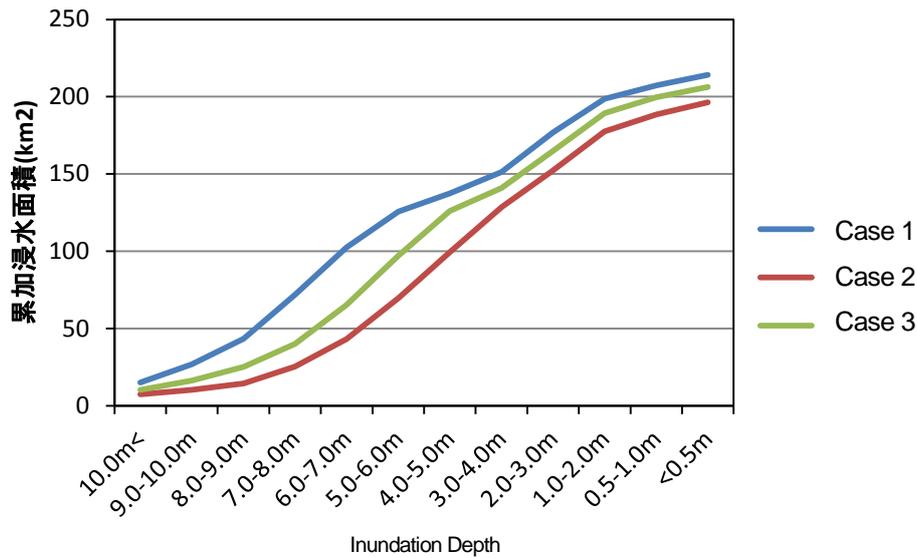
Figure 3.2.2.32 Cumulative Inundation Area by Inundation Depth Zone

Figure 3.2.2.32 shows the cumulative addition of the area of inundation, starting with the area with deeper inundation levels. Although the size of the total area of inundation increases in the order Case 1, Case 3, and Case 2, the difference is comparatively small, while the area with an inundation depth of at least 5m in Case 1 is approximately double that in Case 2. Accordingly, it would appear that, in this region, a seawall has the effect of reducing the area in which the inundation depth is comparatively high.

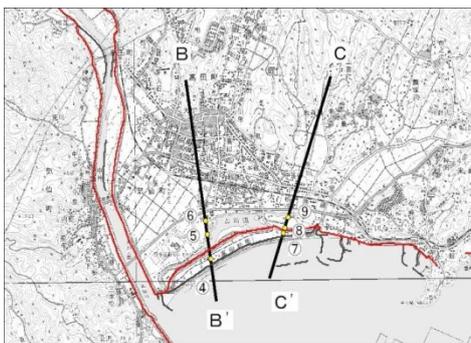
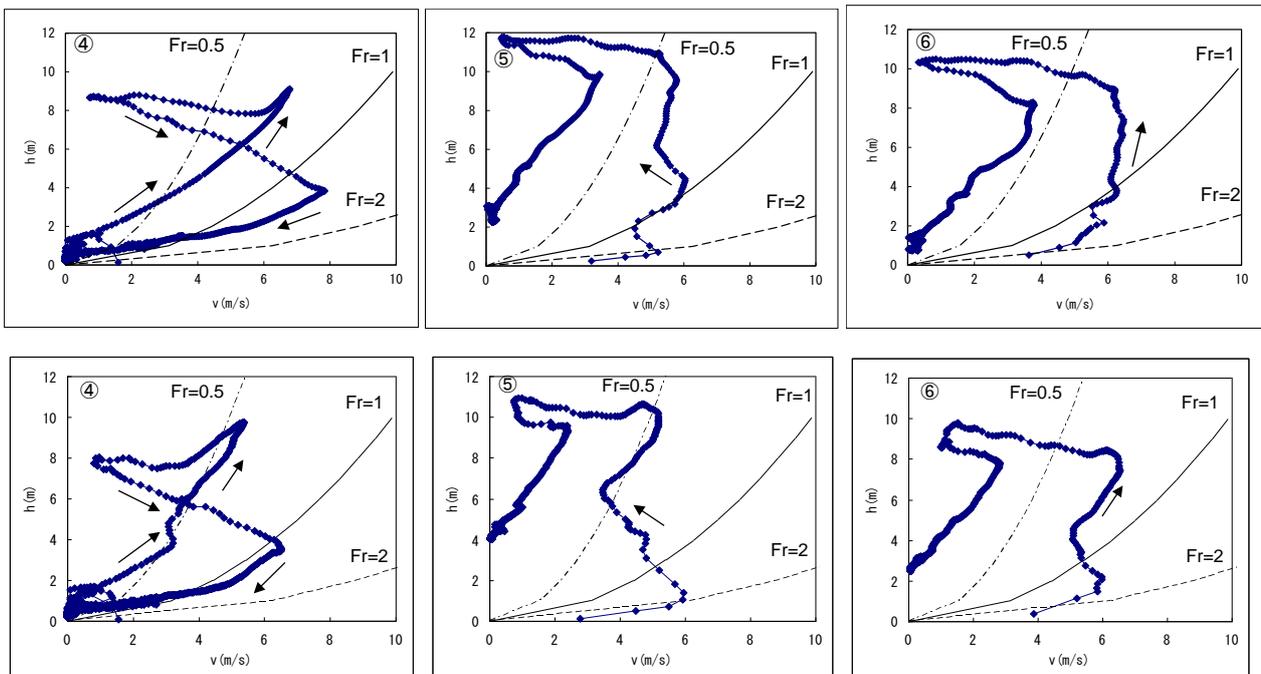
Figure 3.2.2.39 Relationship Between Inundation Depth and Flow Velocity (Top: Case 1; Bottom: Case 2)
 (Using the Geospatial Information Authority of Japan's Digital Map 25,000 (Map Image) as the background)

The diagrams in Figure 3.2.2.39 show the relationship between inundation depth h and flow velocity v at five-second intervals at three set points within the inundation zone in Cases 1 and 2. At Point (4), sandwiched between the primary and secondary

seawalls, the flow velocity during the wash and backwash of the first wave becomes enormous, and in Case 2, with an seawall, the inundation depth rises quickly. At Points (5) and (6), located on the landward side of the seawall, the same counterclockwise change over time can be seen as on the southern Sendai Plain, but the flow velocity is quite a bit lower at the point where the inundation depth is at its highest. This indicates that the tsunami that ran up on shore was a standing wave, which is consistent with the fact that the trace heights in Rikuzentakata did not diminish in the inland direction. It is surmised that the same phenomenon occurred in sectors where the plain is comparatively narrow, as on the Sanriku Coast.

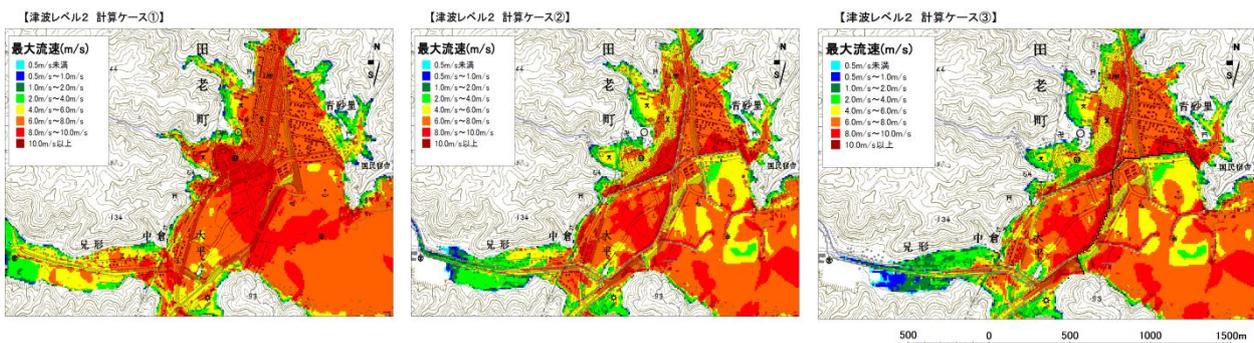
Figure 3.2.2.43 Maximum Flow Velocity (Left: Case 1; Middle: Case 2; Right: Case 3)
 (Using the Geospatial Information Authority of Japan's Digital Map 25,000 (Map Image) as the background)

Figure 3.2.2.43 shows the planar distribution of the maximum flow velocity in each case. In Case 1, which assumes that there is no seawall or similar structure, the area where the velocity is at least 6m/s is extensive, with velocity reaching at least 8m/s in some parts. In Cases 2 and 3, which assume the existence of a seawall, while there are places on the immediate landward side of the seawall where the velocity reaches at least 8m/s, it is less than 6m/s on the seaward side and a little way further inland from the seawall. The same tendency can also be seen in Figure 3.2.2.44, which compares the maximum flow velocities in Case 1 and Case 2. The decline in the maximum flow velocity in the cases where the existence of a seawall was assumed is pronounced compared with the situation on the southern Sendai Plain and in Rikuzentakata; this is believed to be an effect resulting from the fact that the seawall in the Taro district is comparatively high.

Thus, it was concluded that a seawall leads to a reduction in the maximum inundation depth on its landward side. However, it is necessary to bear in mind the fact that the maximum flow velocity will increase on the immediate landward side of the seawall.

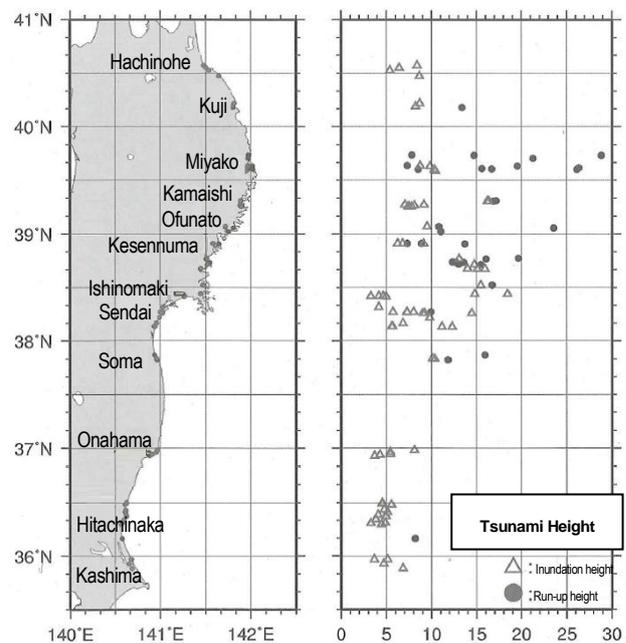
Figure 3.2.2.45 Distribution of Traces of Tsunami Height (Triangles and Circles Indicate Inundation Heights and Run-up Heights, Respectively)¹⁾

Figure 3.2.2.45 shows the distribution of traces of tsunami heights obtained from the field surveys (at a total of 105 points). For details of tsunami heights and their measurement conditions, please refer to the report in the Urgent Survey¹⁾. It should be noted that all of these tsunami heights are calculated from the astronomical tide level at the time of the tsunami arrival, because the time when the largest wave of the tsunami appeared was not clear.

Focusing on the inundation height (blank triangle in Fig.3.2.2.45), a massive tsunami in excess of 13m was observed along the coast from Kesenuma City to Onagawa Town and the maximum height was observed at Onagawa Port in Onagawa Town (18.4m). A tsunami of almost 10m was observed along the

coast from Miyako City to Ofunato City, and the coast from Sendai City to Soma City. At Kamaishi Port in Kamaishi Bay, the trace of the tsunami height was about 7-9m while in Ryoishi Bay it was about 16-17m, immediately north of Kamaishi Bay. This confirmed the tsunami reduction effect in the bay resulting from the breakwater at the mouth of the bay. Even within neighboring regions, there were variations in the tsunami height, due to the effects of existing structures and topography.

Each tsunami height shown in Figure 3.2.2.45 is much higher than that estimated in the damage prediction survey for the Meiji-Sanriku Earthquake. In particular, great tsunami heights were observed along the coast south of Iwate Prefecture.

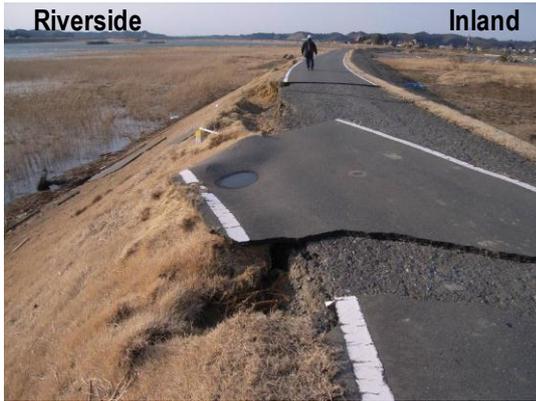
Photo 3.2.2.2 Detachment of Asphalt Paving at the Crest of the Levee (near the left bank of the Naruse River, 1kp)

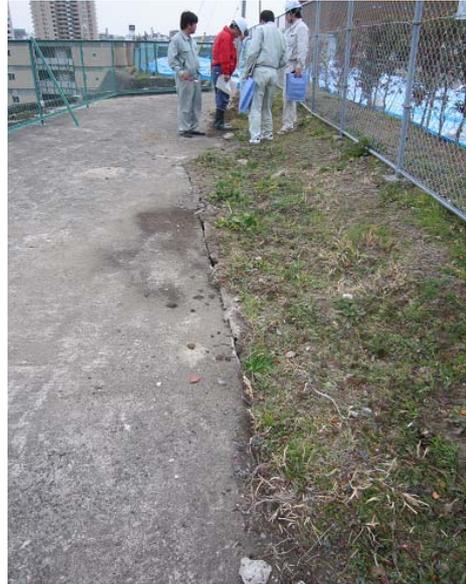
At the hospital site at the upper portion of the slope, cracks were seen for the entire area subject to slope failure prevention measures. The maximum crack size was 10 centimeters and the maximum crack depth was about 30 centimeters. Some cracks reached building wall borders (under construction) (Photos 3.3.1.1, 3.3.1.2, 3.3.1.3, 3.3.1.4 and 3.3.1.5).

Photo 3.3.1.3 A crack is seen in a parking area

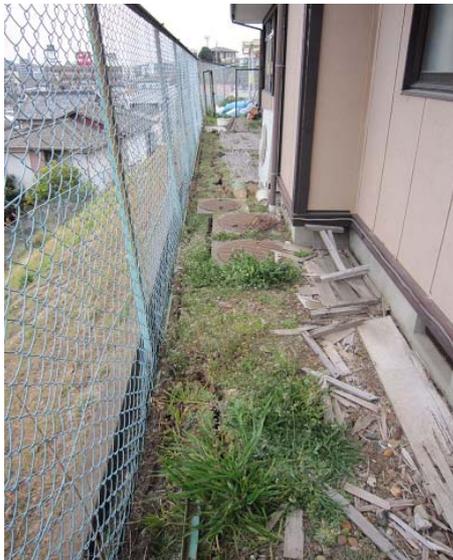
Photo 3.3.1.2 A crack is seen

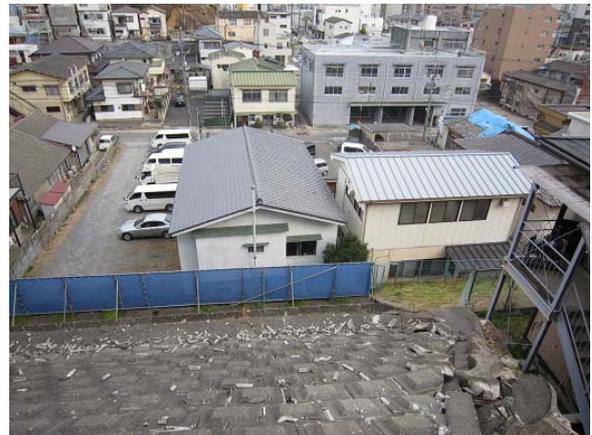
Photo 3.3.1.4 The slope's lower portion as seen from its top (broken cribwork pieces are scattered)

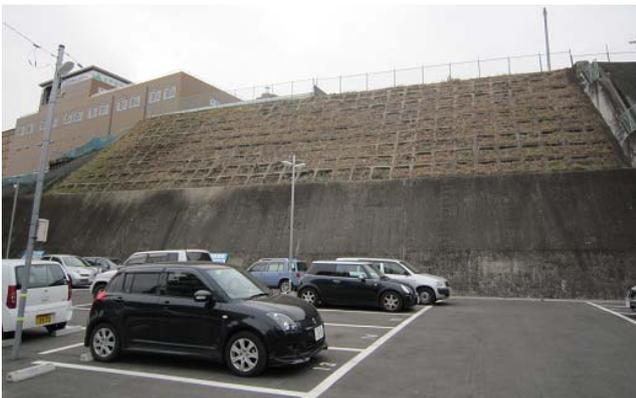
Photo 3.3.1.7 Retaining wall, cribwork (no anomaly seen on retaining wall)

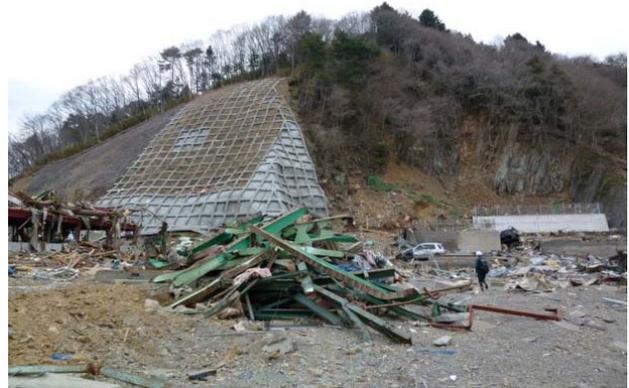
Photo 3.3.1.8 Earth falls on the right side of the cribwork (Onagawa)

Earth and rock falls that might have been caused by the series of earthquakes were confirmed at cribwork sides in Onagawa Town's Kawajiri area (Photo 3.3.1.8) and Ishinomaki City's Yoshinocho area (under a soil conservation project) (Photo 3.3.1.9). But no

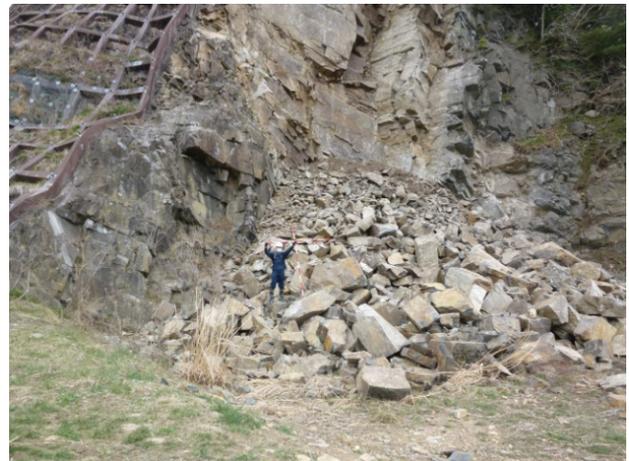
Photo 3.3.1.9 Earth falls on the right side of the cribwork (Ishinomaki)

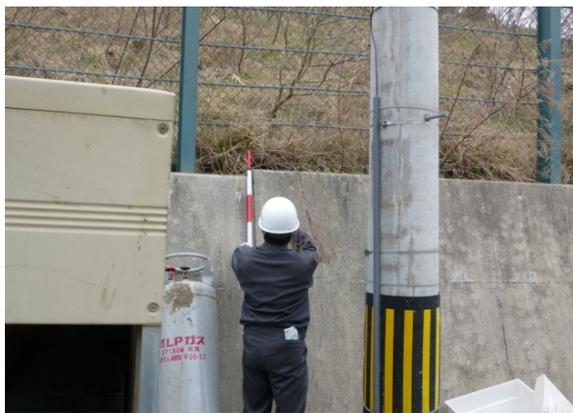
The retaining wall in Ishinomaki City's Yoshinocho area (under a soil conservation project) belonged to a tsunami-flooded area. But no leg portion erosion was detected. Nevertheless, there was a 3 centimeter dip slip at a construction joint that might have been caused by the earthquake (Photos 3.3.1.10 and 3.3.1.11).

Photo 3.3.1.10 A dip slip of the retaining wall

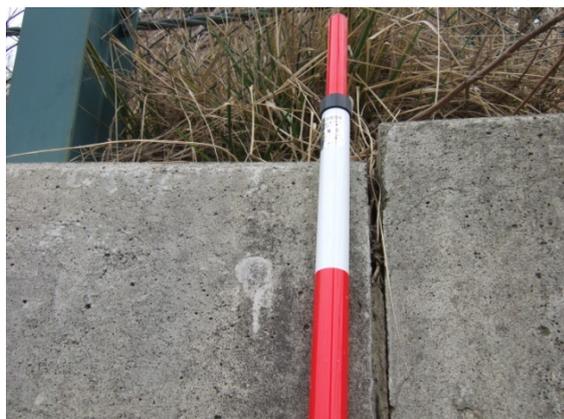
Photo 3.3.1.11 A dip slip of the retaining wall (zoomed)

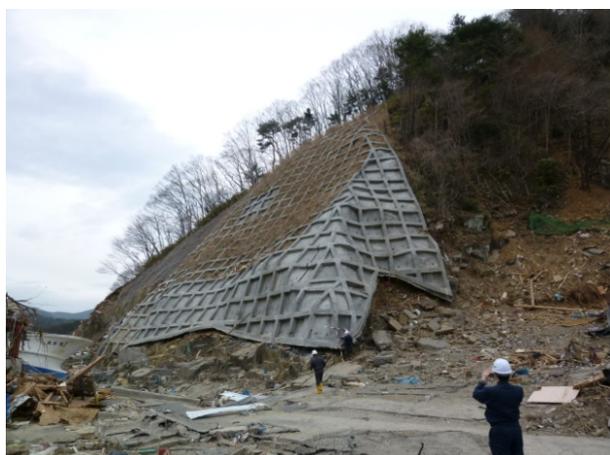
Meanwhile, the leg portion soil of the cribwork in Onagawa Town's Kawajiri was washed away by the tsunami, leaving the cribwork suspended (Photo 3.3.1.13). There was a crack caused by a 3-4 centimeter strike slip at a construction joint (Photo 3.3.1.13).

Photo 3.3.1.12 Cribwork leg portion washed away (Kawajiri area)

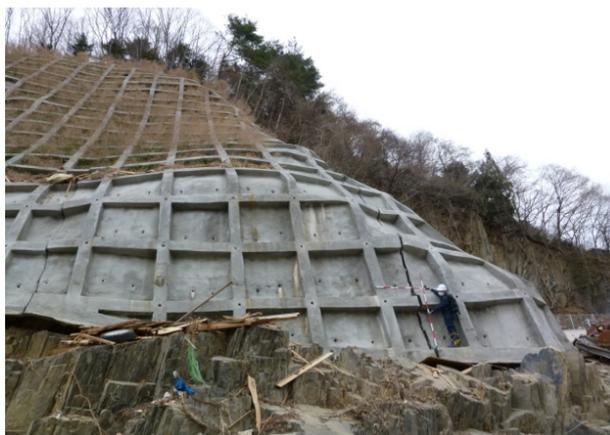
Photo 3.3.1.13 A crack at a cribwork construction joint

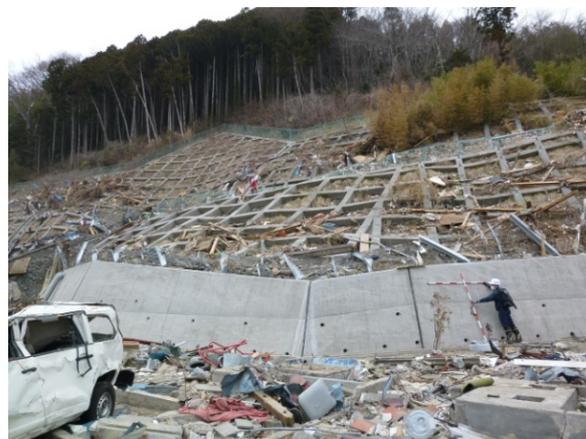
The bulging stone guard of a standby retaining wall at the lower portion of the south slope of Mt. Horikiri in Onagawa Town buckled at the upstream slope side due to the tsunami (Photo 3.3.1.14). Many scratch marks were seen on the surface of the concrete retaining wall, indicating that a substantial flow velocity and debris exerted heavy pressures on the wall in the initial phase of the tsunami flooding (Photo 3.3.1.15).

Photo 3.3.1.14 Stone guard buckling

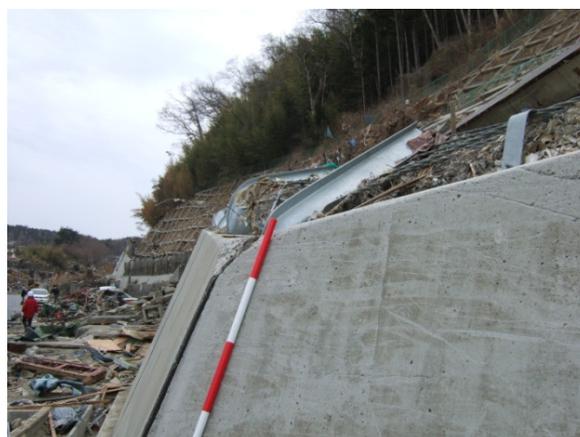
Photo 3.3.1.15 Scratch marks on the retaining wall

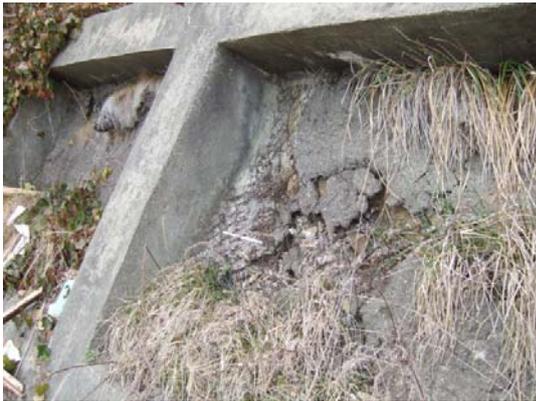
In the tsunami-flooded inside of the cribwork, sprayed materials were broken away or washed away at many points (Photo 3.3.1.16). But the lath remained almost undamaged (Photo 3.3.1.17). We suspected that the cribwork's functions had not declined so much (but the lath's rusting after the seawater flooding was a matter of concern).

Photo 3.3.1.16 Sprayed materials are broken away from the lath

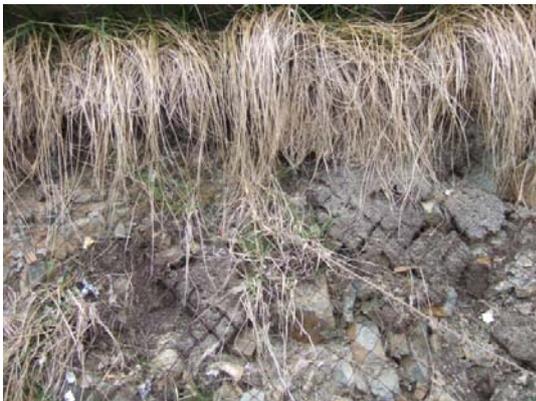
Photo 3.3.1.17 A zoomed lath inside the cribwork

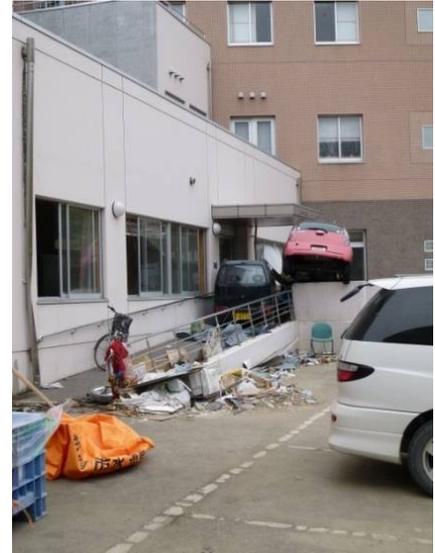
Photo 3.3.1.19 The south side wall of the elderly welfare center

Several cars were suspended at the south wall of the elderly welfare center (Photo 3.3.1.19). Trash was suspended on steel bars and the hedge (Photo 3.3.1.21) on the east (sea) side of the hill. But the steel bars and hedge were not damaged so greatly. There was no trace of debris flowing into the inner hospital and parking area. (This was also confirmed through a helicopter-based observation on March 12).

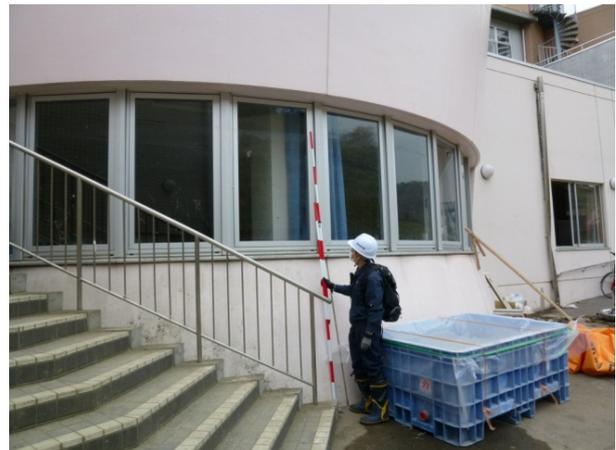
Photo 3.3.1.20 A flood trace (at the top of the pole) at the elderly welfare center

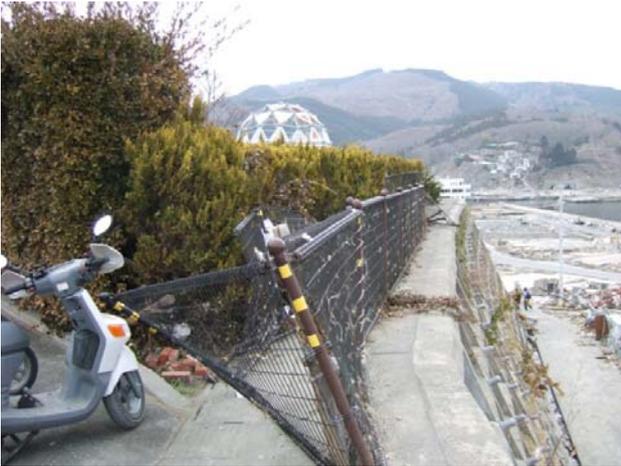
Photo 3.3.1.21 Steel bars and hedge on the east side of the hill

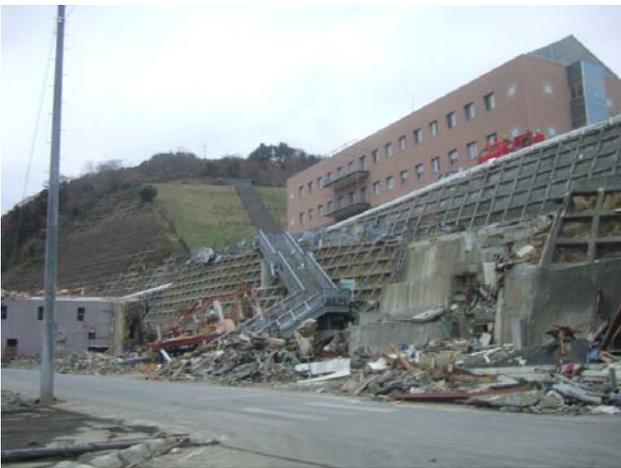
Photo 3.3.1.22 A steel stairway for evacuation from tsunamis

[2] In areas vulnerable to tsunamis, it is effective to develop evacuation pathways when steep slope failure prevention facilities are constructed.

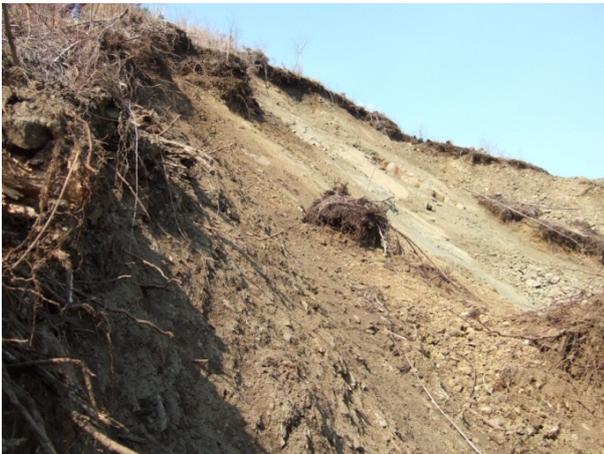
In the failure, a rockslide occurred on a dip slope with an inclination of about 30 degrees at a ridge (Photo 3.3.1.24). Soil mass collapsed downward over about 150 meters from the upper limit of the failure. The point 150 meters down from the upper failure limit

Photo 3.3.1.24 An upper portion of the collapse (an exposed rock is seen at the center)

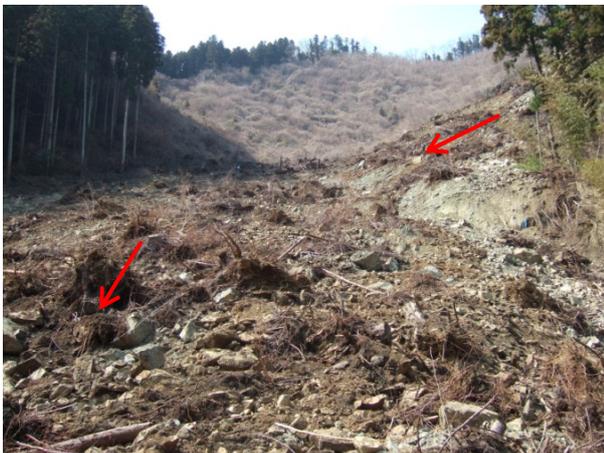
is a joint between the ridge and a valley on the left side of the slope (the point is called “the joint” hereinafter) (Photo 3.3.1.25). The failure/slide might have occurred as the earthquake shook the entire ridge where the earthquake vibration was released. Part of the collapsed soil mass was suspended on a terrace of a milder slope with an inclination of about 15 degrees at the joint. On the surface of the soil mass are stubs lined up in an orderly manner (Photo 3.3.1.26). Therefore, the movement pattern is suspected as a slide.

Photo 3.3.1.25 The left side valley and the joint

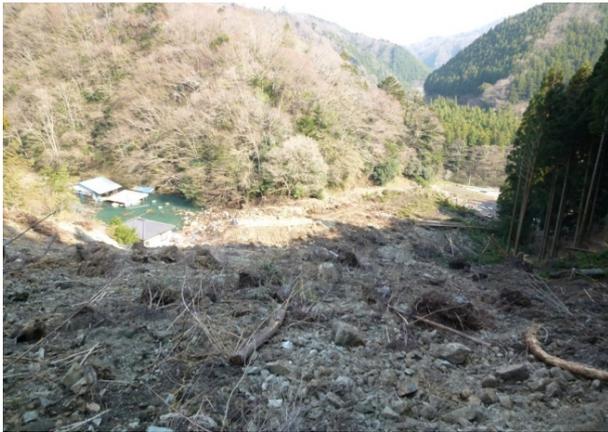
Sediment that flowed down from the terrace was scattered on the slope and reached a house at the lower portion of the slope (Photo 3.3.1.27). The sediment mainly included block-shaped rock pieces measuring 20 to 50 centimeters (Photo 3.3.1.28). Although the clayish matrix was somewhat wet, the sediment was not as wet as usual debris flow sediment. The slide might have been a dry sediment flow (there was no trace of mud water flowing down from the disaster-affected house).

Photo 3.3.1.27 Sediment reaching a house (seen from the terrace at the center of the slope failure)

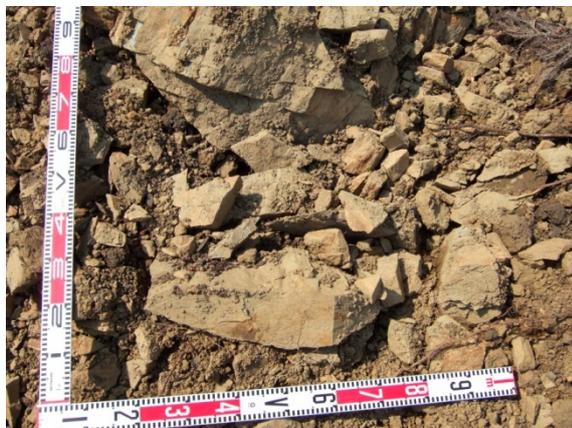
Photo 3.3.1.28 Collapsed sediment at the terrace

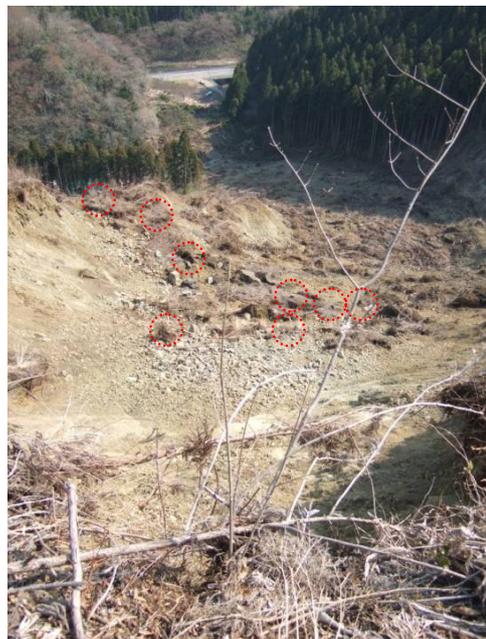
Photo 3.3.1.30 Stubs left close to the top (seen from the top)

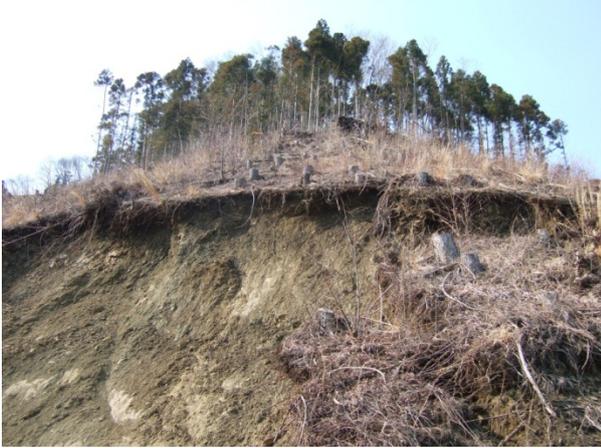
While there were no cracks or any other indications of destabilization on the slope surrounding the collapsed area, some unstable sediment was seen. At the right side of the collapsed area's top was a block measuring 5 meters wide, 10 meters long and 1 meter thick (Photo 3.3.1.31). Seen on the strip roads at both sides of the collapsed slope were many cracks normal to the collapse direction (Photo 3.3.1.32).

Photo 3.3.1.31 A block left on the right side of the top

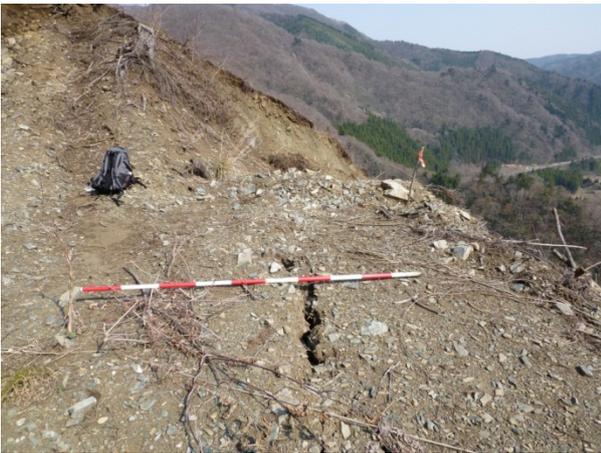
Photo 3.3.1.32 A crack seen on a strip road at the left side of the slope

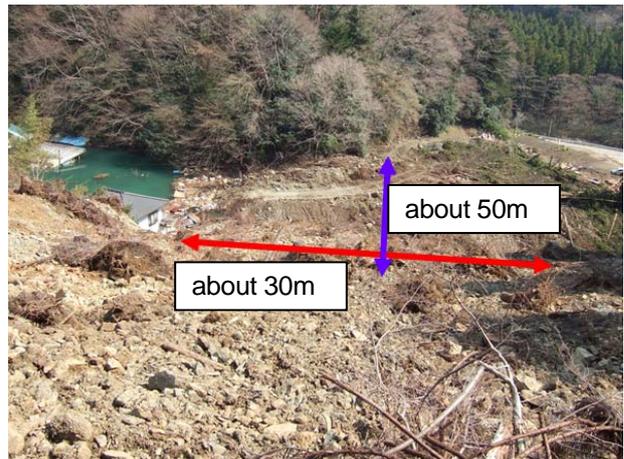
Sediment blocked up the river channel including a channel consolidation work (measuring about 3 meters deep and 3 meters wide) over an area measuring 50 meters wide (in the transverse direction) and 30 meters long (Photo 3.3.1.33). Sediment volume is estimated at about 3,000 cubic meters. The flood at the house on the right bank side was estimated at around 1 meter. The flood volume was estimated at about 5,600 cubic meters (about 40 m in width (transversal direction) x about 70 m in depth (traverse direction) x about 2 m in depth) (Photo 3.3.1.34). The sediment-blocked site was already opened with a cross-section measuring 1 meter deep and 1 meter wide (at the riverbed) (Photo 3.3.1.35).

Photo 3.3.1.33 A blocked river channel seen from the center of the collapsed slope

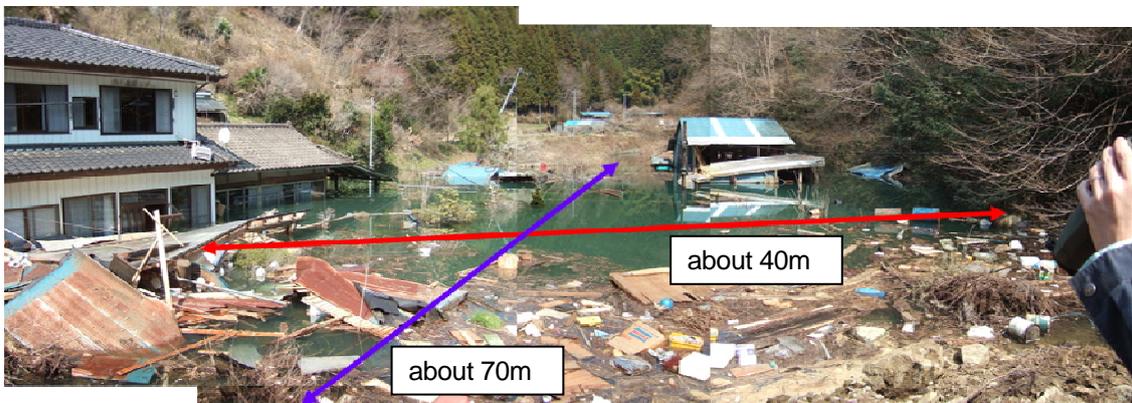
Photo 3.3.1.34 Situation of a flood pond

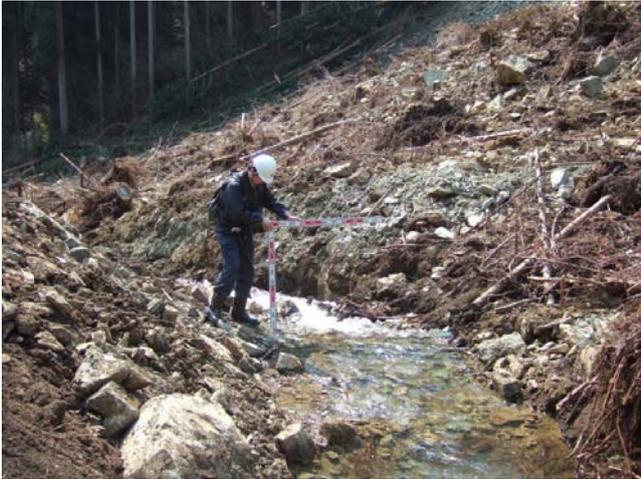
Photo 3.3.1.35 A cross section of the blocked river channel

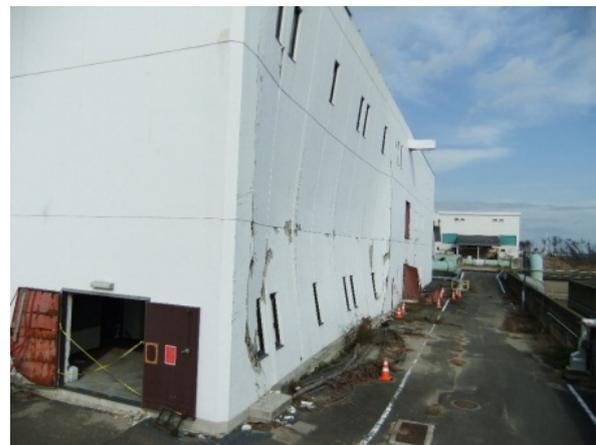
Tsunami damage factors include wave pressure, castaways and flooding. Figure 3.3.2.2 indicates factor-by-factor breakdowns of damage to sewage treatment plants and pumping stations (divided into 23 facilities). Each of flooding, wave pressure and castaways accounts for a large share of damage. At sewage treatment plants, particularly, flooding accounted for a larger share at 42%, followed by 35% for wave pressure. Mechanical energy might have been coupled with wetting and submerging to inflate damage. Representative damage is shown in Photo 3.3.2.2

(a) Wave pressure-caused damage to a sea-side wall

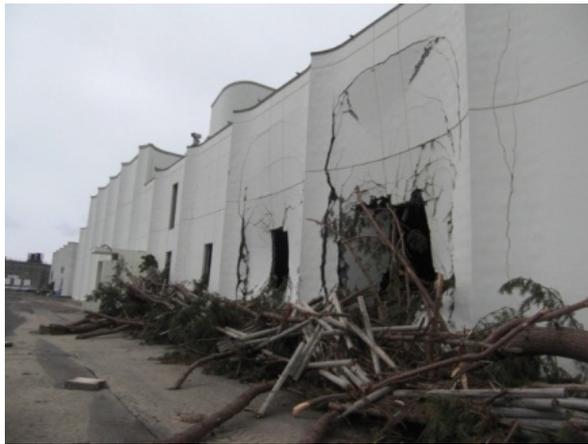
(b) Castaways' direct damage to a building

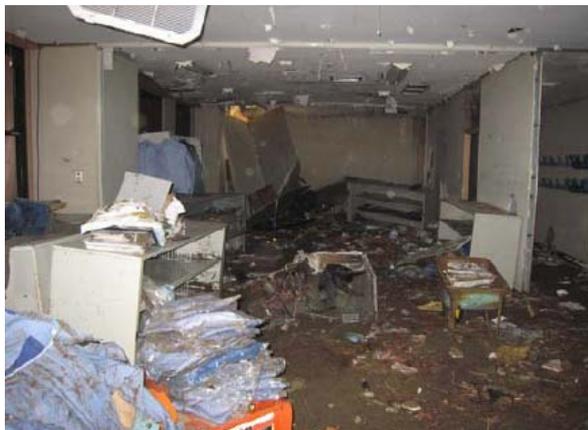
(c) Flooding-caused damage to interior equipment
 Photo 3.3.2.2 Representative Tsunami-caused Damage to Sewage Treatment Plants and Pumping Stations

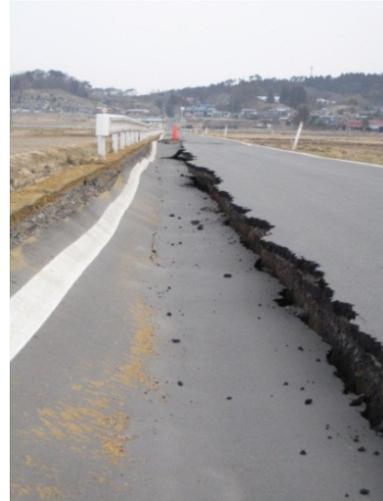
In the disaster-hit region, the measure has been used only for some districts of Kurihara City that logged a seismic intensity of 7. The district has a sewer pipe conduit that includes locations subject to the conventional backfilling and the anti-liquefaction measure. Upon the Great East Japan Earthquake, a location subject to the conventional backfilling saw a major road surface anomaly making vehicle traffic impossible (Photo 3.3.2.3). At locations subjected to the anti-liquefaction measure, damage was limited to a slight surface subsidence (Photos 3.3.2.4-5), confirming the effect of the anti-liquefaction measure.

Photo 3.3.2.3 Conventional construction (without any anti-liquefaction measure)

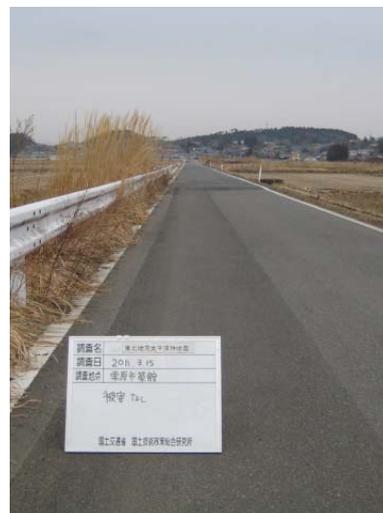
Photo 3.3.2.4 Construction subjected to the anti-liquefaction measure (no damage)

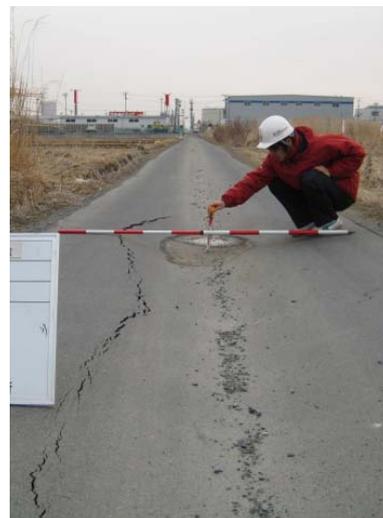
Photo 3.3.2.5 Construction subjected to the anti-liquefaction measure (slight damage)

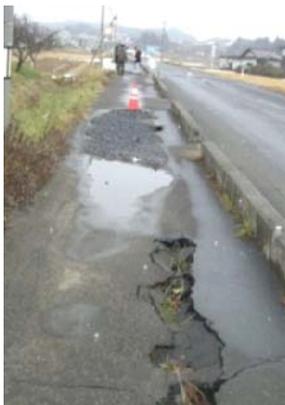
The earthquake damaged 54 meters out of a total 2,500 meters of sewer pipe conduits subjected to cement-based solidification of backfill soil in Kurihara. The damaged part was in Uguisuzawa, where soil improved when a cement fixation agent was used for restoring a sewer pipe conduit damaged by the Iwate-Miyagi Inland Earthquake. The damage was limited to loosening and joint disconnections at a sewer pipe conduit subjected to backfill soil solidification, not going so far as to block sewage flow. At some manholes subjected to backfill soil solidification, however, 4-to-11-centimeter uplifts were found. These uplifts were similar to the 5-to-10-centimeter uplifts seen in portions that were not subjected to any anti-liquefaction measure (Photos 3.3.2.6-7).

Photo 3.3.2.6 Conventional construction (without any anti-liquefaction measure)

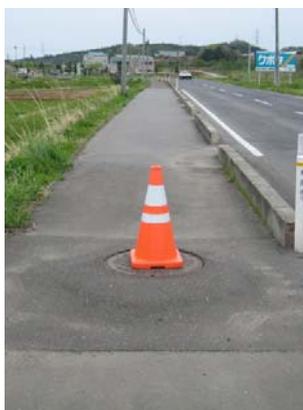
Photo 3.3.2.7 A portion subjected to the anti-liquefaction measure (damaged part)

The above results lead us to suspect that while the cement mixing ratio was sufficient, appropriate strength failed to be secured due to backfilling procedure problems.

- Solidification was limited to problematic parts, failing to produce sufficient effects.
- While cement and soil were mixed and churned three times by a backhoe at the construction site, insufficient churning resulted in mixed strengths.
- The churned cement-soil mixture was left untouched (for about one day), failing to achieve

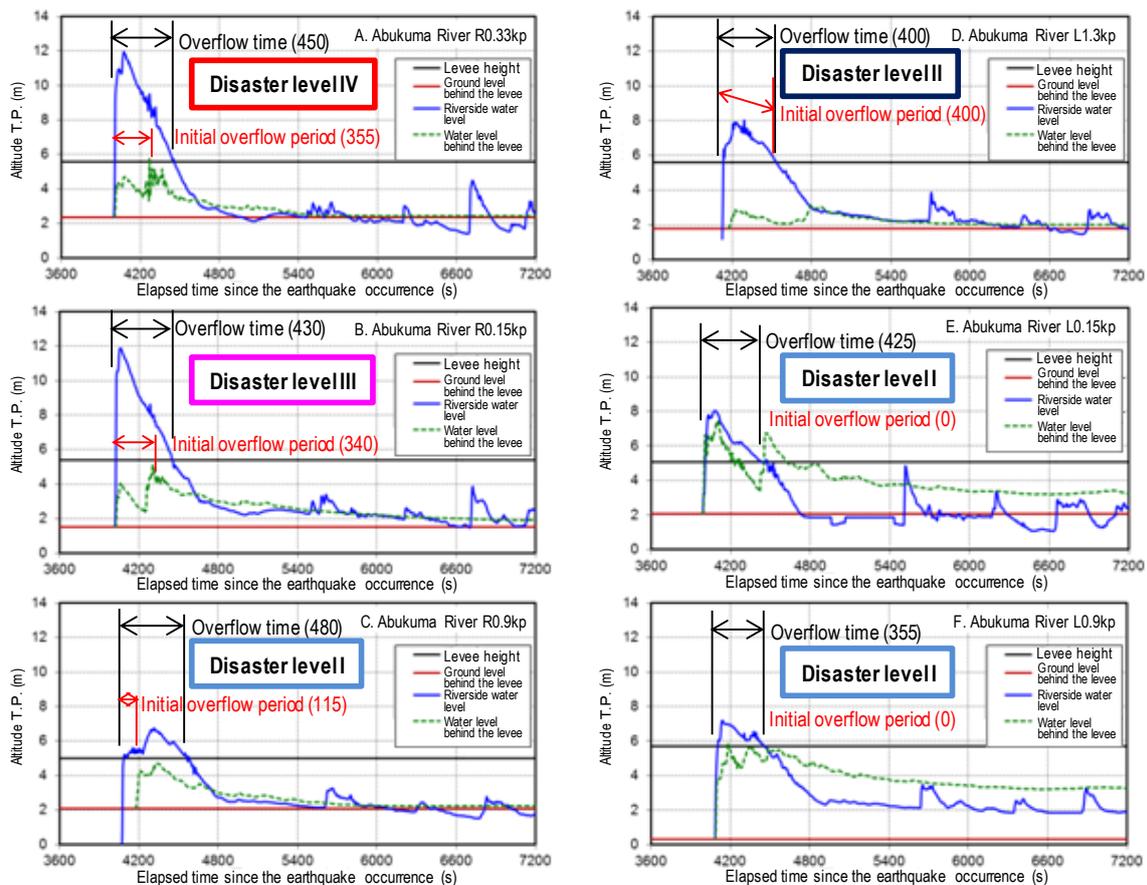
In order to elaborate this phenomenon, chronological change in the water level of the river and inside the levee at locations from A through F in Photo-3.3.3.1 were calculated from the simulation result, which are shown in Figure 3.3.3.3 together with the overflow period and damage level. The figures in the brackets next to overflow time, etc. are the overflow period and initial overflow period in the unit of seconds. Here, the term 'overflow period' refers to the time period during which the water level of the river exceeds the levee height. When the water level inside the levee exceeds the water level of the river side, like at the location E, time until that moment is identified as the overflow period. The initial overflow period is the time period between when the water level of the river side exceeds the levee height and when the edge of the levee is inundated to the level where hydraulic jump of the overflow water almost occurs near the toe of slope. This is thought to be the level where the effect of water cushion can be produced.

The overflow period of the location A and location E is almost the same. The maximum overflow water depth was different: about 6m at the location A and about 3m at the location E. Still, both figures are large considering the vulnerability against overflow of levee. While the initial overflow period at the location A is 6 minutes, that of the location E is zero, which confirms that the effect of water cushion occurred at the location E when the overflow started. Therefore, it is fair to conclude that the level of disaster at the location E was mitigated by the water cushion.

Figure 3.3.3.3 Chronological change in the water level of the river side and inside the levee at the toe of levee slope

When compared between the left and right sides of the levee in overflow zones, the maximum water depth at the locations B, C, and D on the right side of the bank is much higher than that at the location F on the left side of the bank; however, the overflow period is around 6 to 8 minutes with little difference between the left and right sides. Comparison of the initial overflow period shows the difference in locations with the location F zero and the locations B, C, and D from 2 to 7 minutes. The results of four profiles of these overflow zones show that the longer the initial overflow period is or the deeper the overflow water depth during this period is, the larger the magnitude of the disaster. The difference in the damage level by each zone observed on the right bank can be explained by the inundation inside the levee as seen in the three profiles at the locations B, C and D.

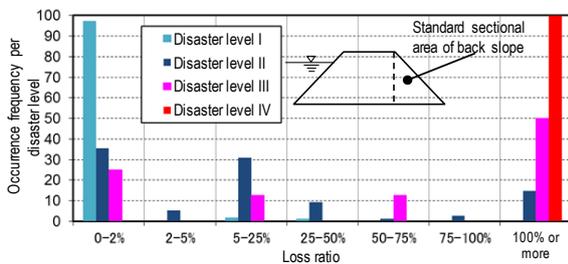
which horizontal and vertical displacements of the ground due to the earthquake were corrected. Before the volume of loss of the levee is used as a substitute for the survey result, the relations between the two were compared (see Figure 3.3.3.4). Most of the area in damage level I has a loss ratio of 0-2% and all the area in damage level VI has a loss ratio of 100% or more. Areas in damage level II and III are dispersed with different loss ratios, many areas in damage level II are found in lower loss ratios and many areas in damage level III are found in higher loss ratios, showing that the loss ratio corresponds to the magnitude of damage. From this, it is fair to use loss ratio as a substitute for the damage level.

Figure 3.3.3.4 Relations between loss ratio of dike and damage level

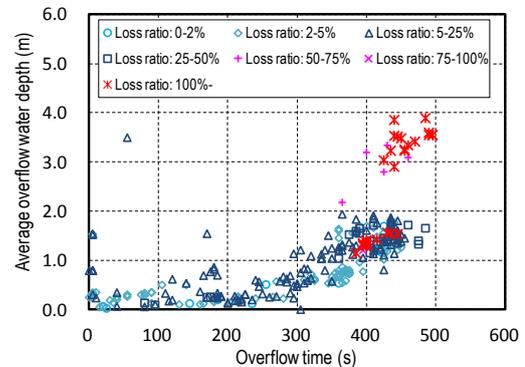
Figure 3.3.3.5 shows the overflow period assigned to the horizontal axis and the average overflow water depth to the vertical axis and the shape of the plot is changed by each loss ratio, plotted in accordance with the conditions of overflow. Also, the plots are shown in different colors. Here, the average overflow water depth refers to the average value of water depth of overflow that occurred during the overflow period. As it goes to the upper right corner, the conditions of overflow are thought to become severe and the loss ratio is believed to become larger; however, the boundary of plots by loss ratio is vague. Figure 3.3.3.6 is the result obtained by assigning the average value of water depth of overflow during the initial overflow period to the vertical axis of Figure 3.3.3.5 and the initial overflow period to the horizontal axis. Except for some parts surrounded by dotted red lines, the boundary of loss ratio is now clear.

Figure 3.3.3.5 Relations between overflow situations and loss ratio of levee

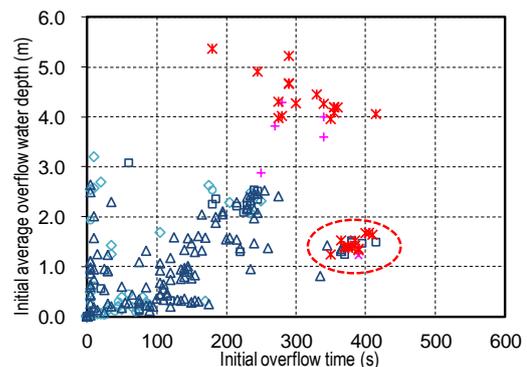
areas with relatively the same overflow conditions is the inundation situations in the protected land, and if the period of overflow without inundation is longer, the profile has larger erosion damage.

Figure 3.3.3.6 Relations between overflow situations and loss ratio of levee (with consideration to inundation in the protected land)

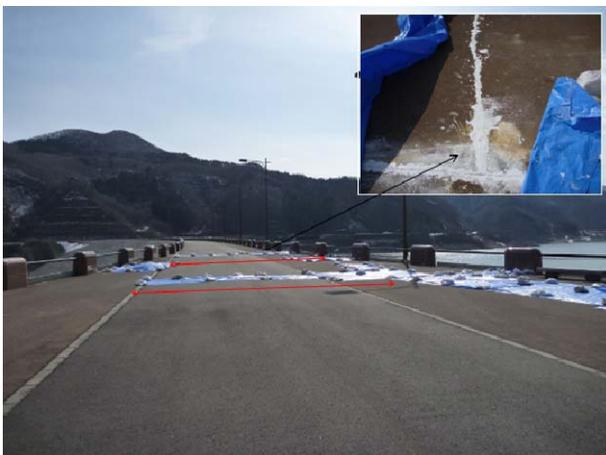
Photo: 3.3.4.1 A crack at the attaching portion of the left bank of the dam crest (Surikamigawa dam)

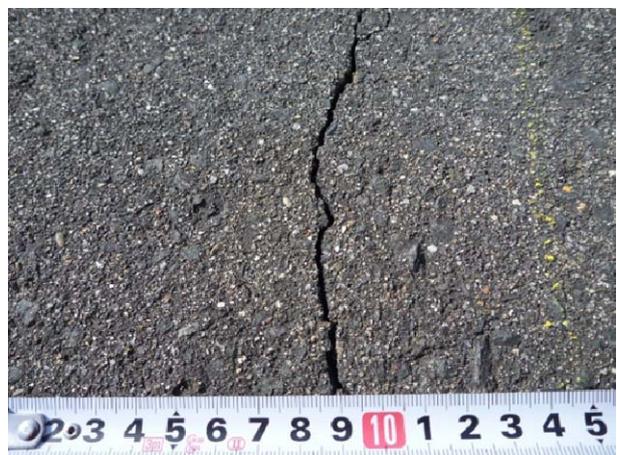
Photo 3.3.4.2 Close-up of a crack that appeared on the dam crest pavement (Surikamigawa dam)
